Figure 1. Site where construction barge *Athena 106* dropped a 5-ton mooring spud on the West Cote Blanche Bay natural gas sales pipeline. The pipeline carried excess natural gas from the Gulfport sales platform (where extracted natural gas was processed and injected back into oil-producing wells to aid in oil production) to a junction with Chevron’s Vermilion Bay gas sales pipeline. The pipeline between the Gulfport sales platform and the Chevron bay junction platform was about 19,650 feet long. The pipeline between the Vermilion Bay platform and the bay junction platform was about 32,300 feet long.

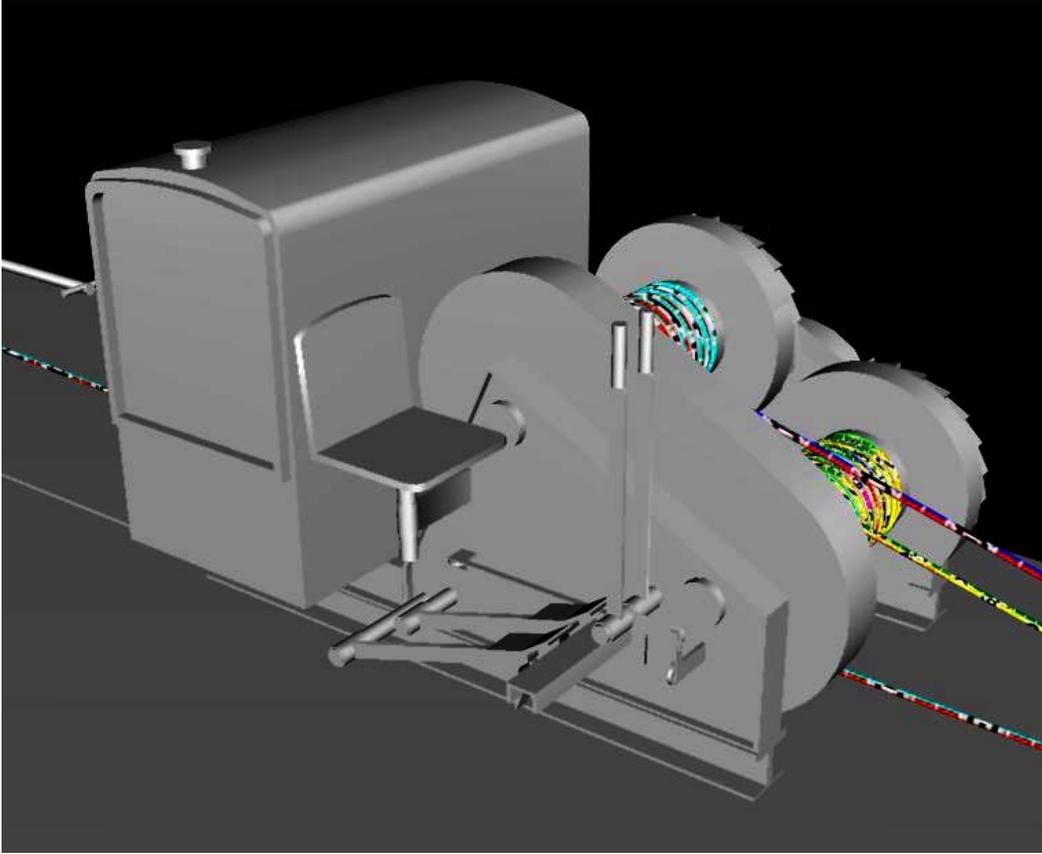
Figure 3. Computer-generated image of a spud winch unit. The spud-lifting cables are wound on the drums to the left of the operator's seat. The winch's foot brakes are below and forward of the seat.

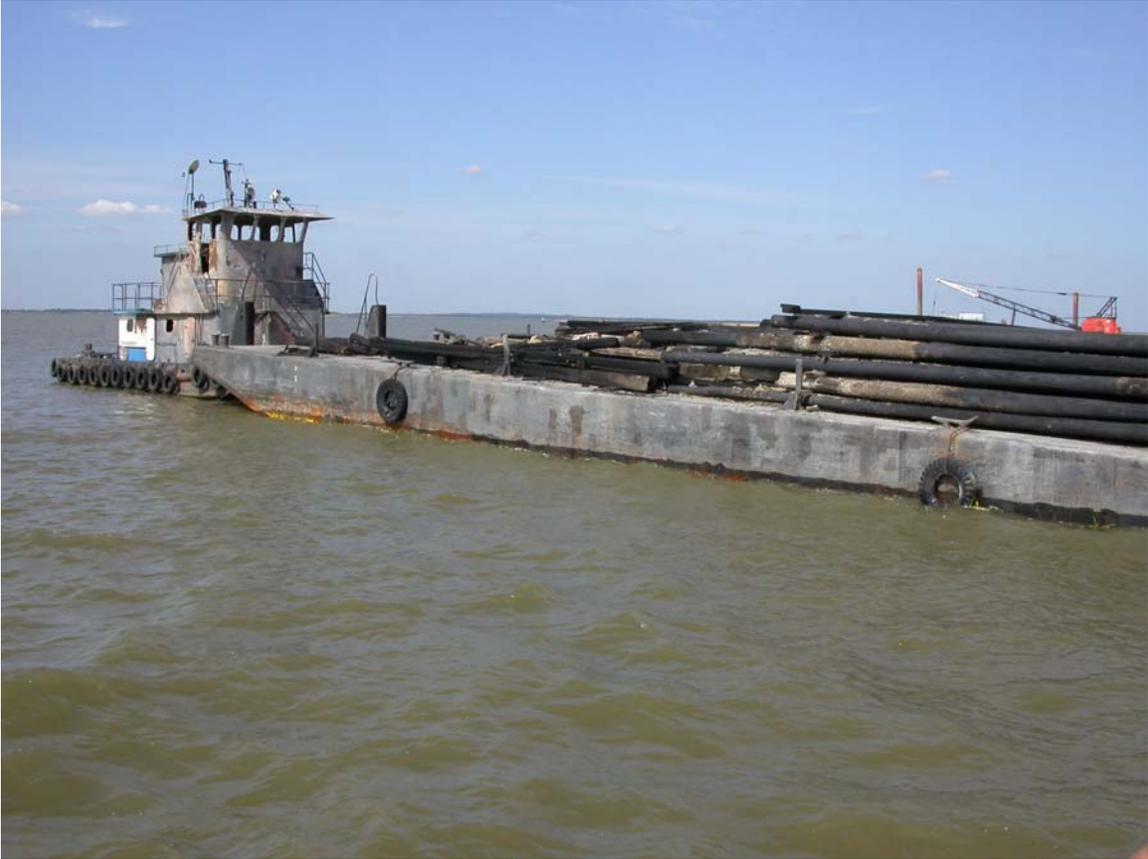
Figure 4. Barge *IBR 234* loaded with pilings (being pushed by the *Miss Megan*).

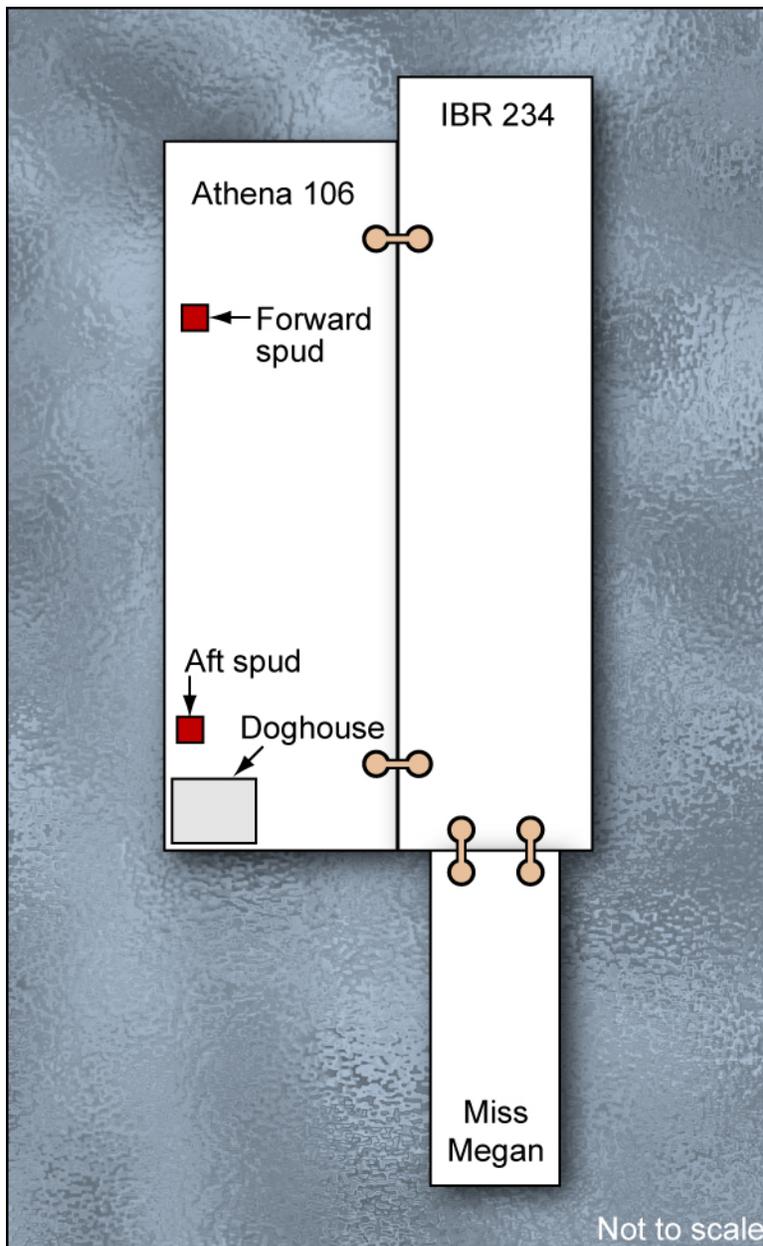
Figure 5. Towing arrangement of the *Miss Megan* and the two barges. The barges were tied together, with the *Miss Megan* secured to the aft end of the *IBR 234* and pushing both barges.

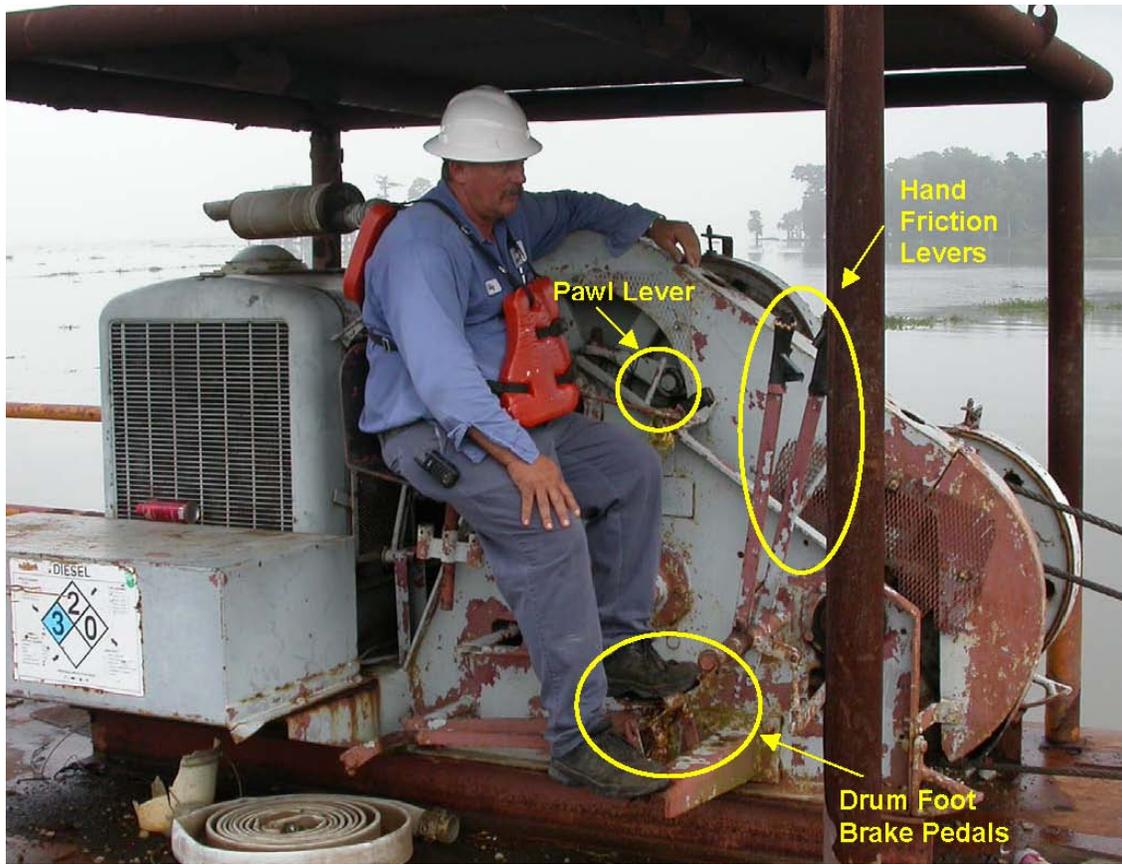
Figure 8. Operator in position at the spud winch on another Athena barge, not the *Athena 106*, used in the salvage operation after the accident. Highlighted are the foot brake pedals and hand levers that controlled the speed of the winch drums as they lowered or raised the spuds, and one of the levers that engaged or disengaged the drum pawls into a notched ring on the drums' outer edge to prevent the cables from paying out. Note the operator's work vest, the flotation device worn by barge workers on the job.
