National Transportation Safety Board

Factual Report of Operational/Other Factors

Accident No.: DCA08FM002

Accident Type: Allision with Ambrose Light tower, Entrance to New York Harbor

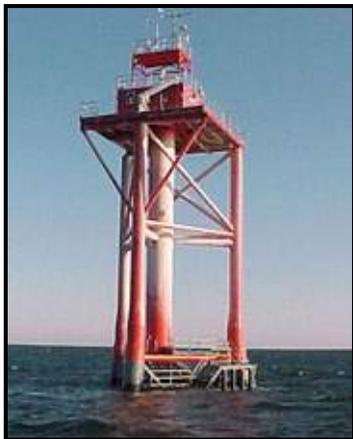
Fig 4. Ambrose Light (Prior to Allision)¹⁰

At 0143:14 the starboard side of the *Axel Spirit* struck the Ambrose Light tower, causing extensive damage to structure and causing the rotating beacon to stop rotating. At this time, the sound of two impacts are heard on the VDR. At 0143:23, a third impact is heard and at this time, the master ordered the rudder to starboard 10°; and at 0143:42 he ordered starboard 20°, and at 0144:06 he ordered hard starboard. At 0144:23, the master is heard to say “we touched” (See Figures 4 and 5, Photos of Ambrose light)

Ambrose Light tower was heavily damaged and was considered beyond repair. Rather than reconstruct a replacement tower or install a large navigation buoy, the Coast Guard decided not to replace the navigation aid. (See Waterway Information section for further discussion relating to Ambrose Light, extending Ambrose Channel, and reconfiguring the pilot area.)
