National Transportation Safety Board

Safety Recommendation

In reply refer to: H-01-03

Vehicle Group Chairman's Factual Report
(Excerpts)

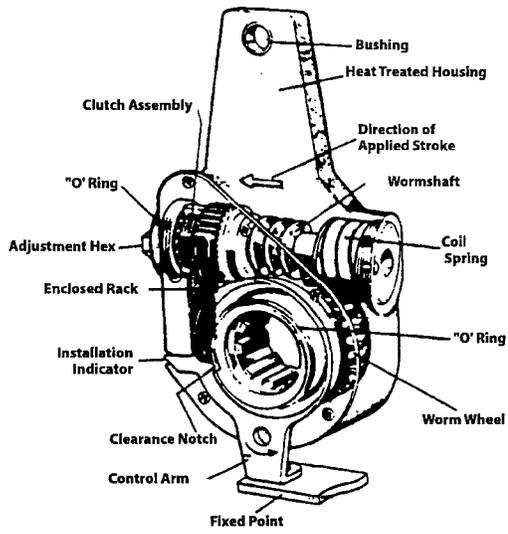
Figure 1. Automatic slack adjuster.

1. Push-rod stroke increases with repetitive brake applications.
2. The rate of stroke increase is greatest when the application air pressures are higher, the application and release times are faster, the control arm is constrained in motion (as on the accident bus), and the internal spring force in the automatic slack adjuster has deteriorated.

These test results are of concern since frequent brake applications and the high air-pressure rapid cycling with antilock brake systems are common real-world conditions. Similarly, a fractured control arm could constrain motion at the fracture plane of the control arm. Additionally, the internal spring force on the Haldex adjuster could be modified in field service or could deteriorate over time due to fatigue. These conditions, in the event of a control arm failure, could lead to a loss of brake performance at the affected wheel.

Determine how to prevent brake deadadjustment caused by a fractured or disconnected control arm, distribute service advisories notifying users of this danger, and take appropriate measures to prevent brake deadadjustment. (H-01-03)

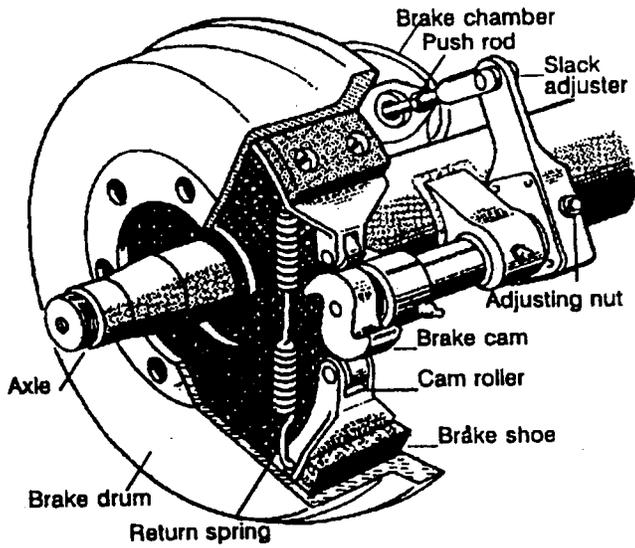
Figure 2. Foundation brake system.

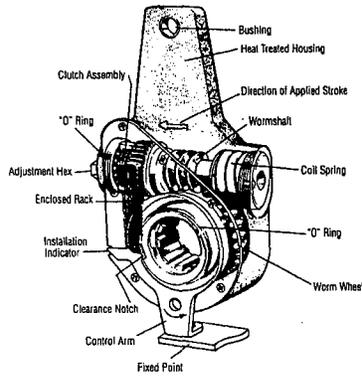
During the time period of the coach's manufacture, VanHool had been researching a braking issue that involved the over-heating of Eaton drive axle brake assemblies. The over-heating issue was thought to be caused by the over adjustment of the brakes caused by the Haldex automatic slack adjuster.

The Haldex Brake Products Corporation provided Safety Board investigators with information that mechanics with ABC Bus of Hillsboro MO, a VanHool distributor, had been instructed by VanHool to back off the rear cover of Haldex part number 70905 slack adjusters on Eaton drive axles. An official with ABC Bus in Winter Garden, Florida, stated to Safety Board investigators that the coil spring cover was being turned counter-clockwise to reduce pressure on the internal worm shaft providing additional brake lining to drum clearances in an effort to resolve the overheating issues with those brake assemblies.

Mechanical diagram of Haldex adjuster
