**In-Flight Separation of Vertical Stabilizer
American Airlines Flight 587
Airbus Industrie A300-605R, N14053
Belle Harbor, New York
November 12, 2001**

NTSB/AAR-04/04

**NTSB/AAR-04/04
PB2004-910404
Notation 7439B
Adopted October 26, 2004**

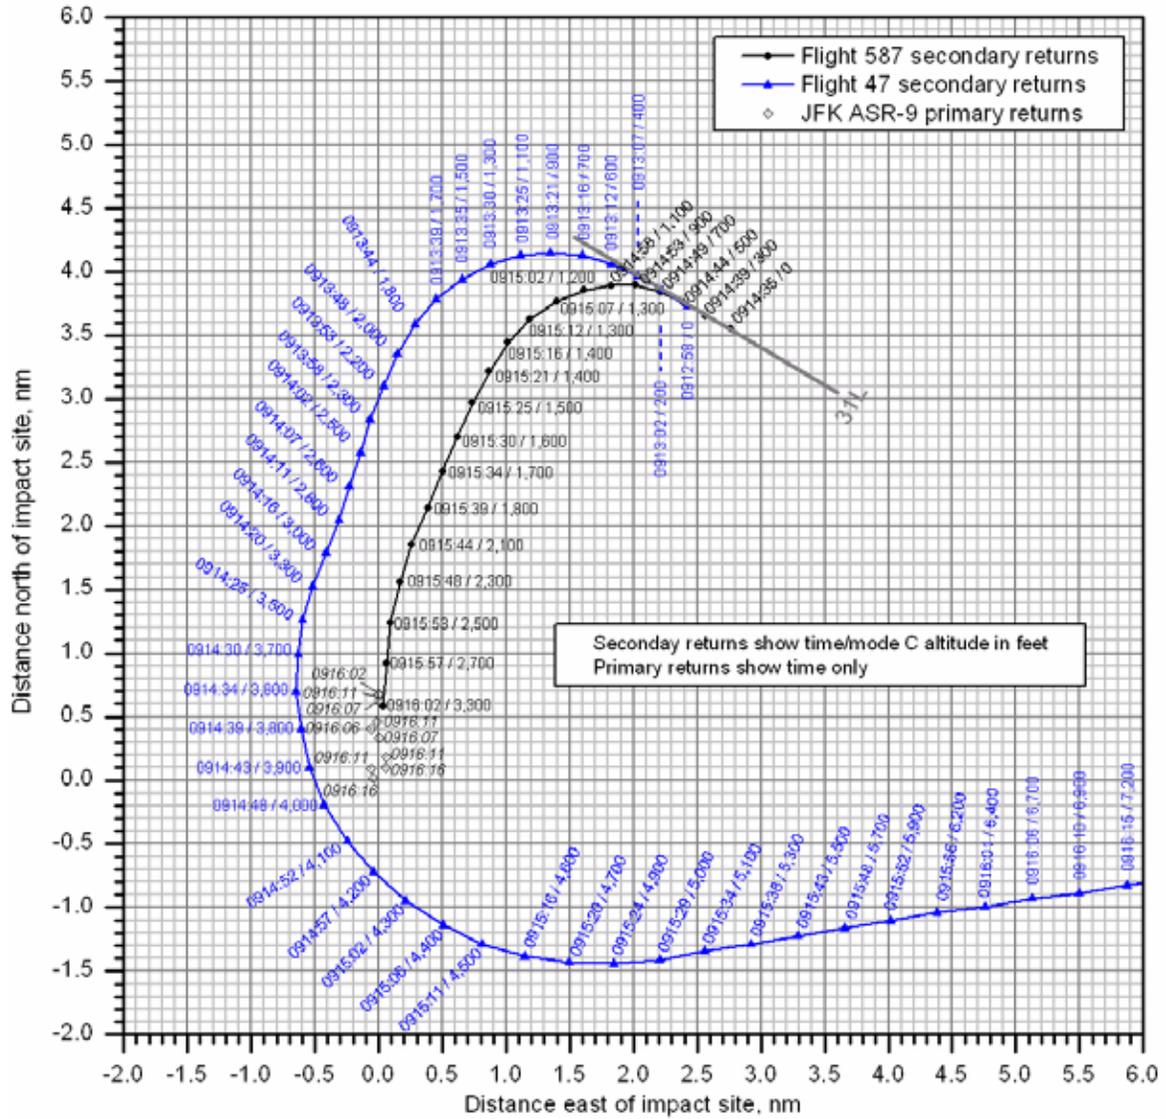
Figures 2 and 3 show flight 587's radar track based on JFK Airport Surveillance Radar-9 (ASR-9) information. Figure 2 shows flight 587's flightpath, from takeoff to impact, in relation to the flightpath for Japan Air Lines flight 47, and figure 3 shows flight 587's flightpath overlaid on a topographical map, along with key events.

Figure 2. American Airlines Flight 587 and Japan Air Lines Flight 47 Flightpaths

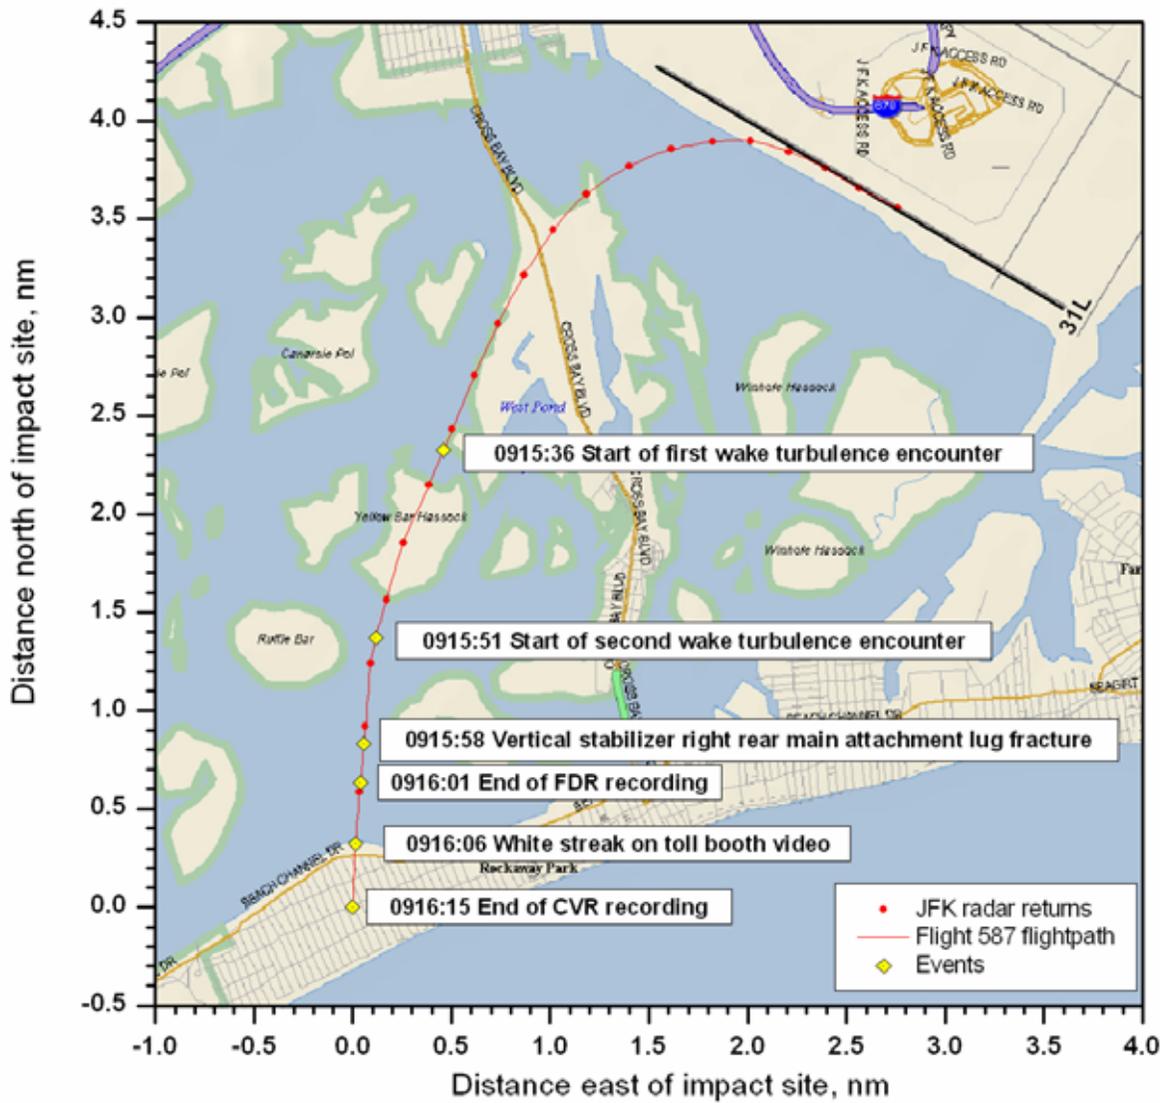
Note: The toll booth video and the white streak that appears on it are explained in section 1.16.1 of this report.

Figure 3. Flight 587's Flightpath and Key Events

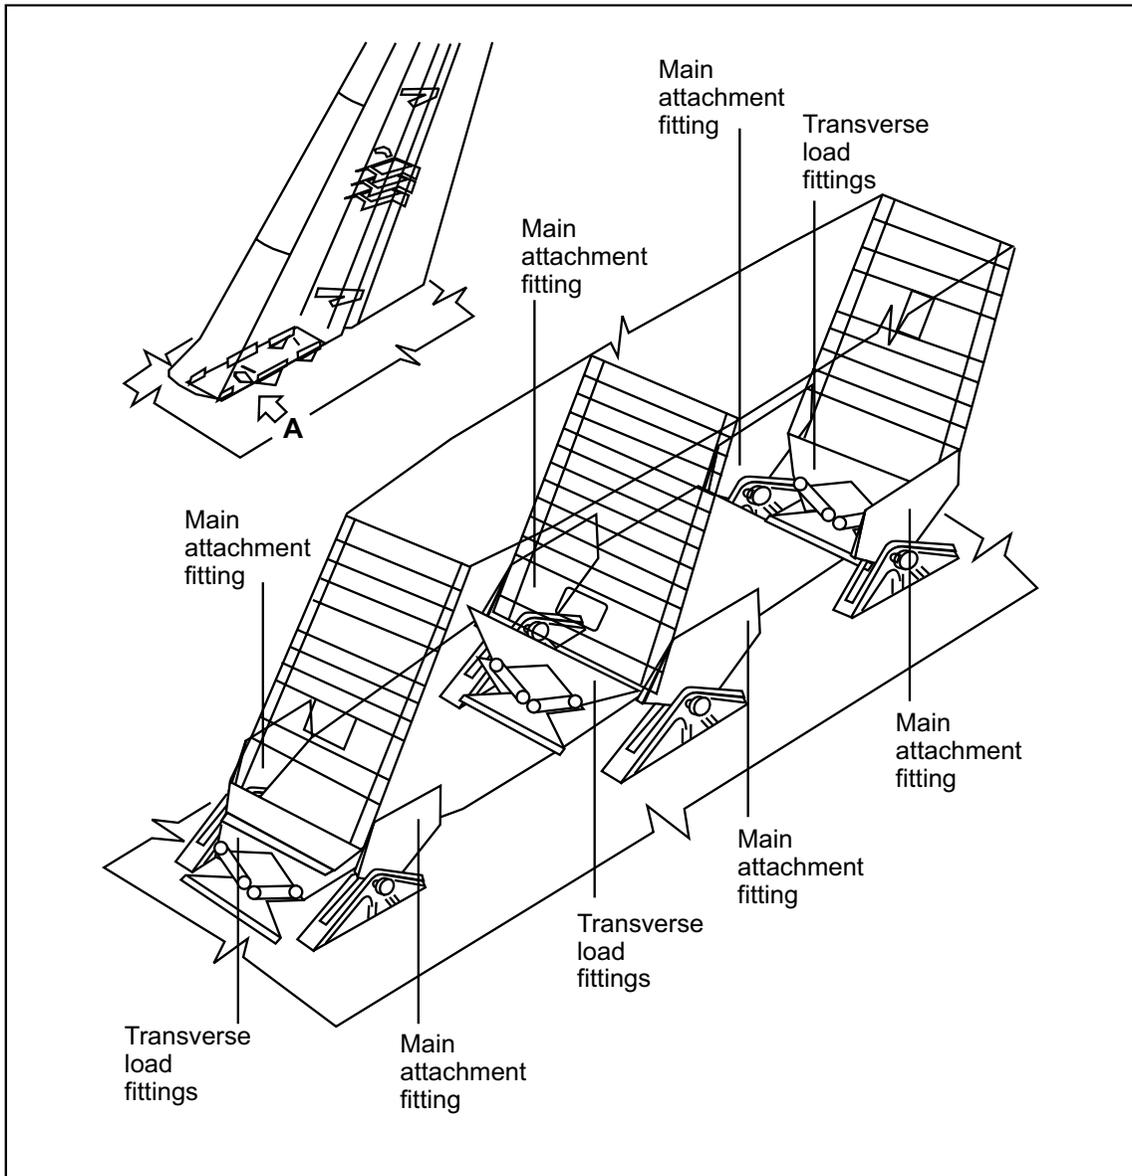
Note: Letter A in the left corner shows the location of a main attachment lug (which is shown in detail in figure 5).

Figure 4. Vertical Stabilizer-to-Aft Fuselage Attachment Points

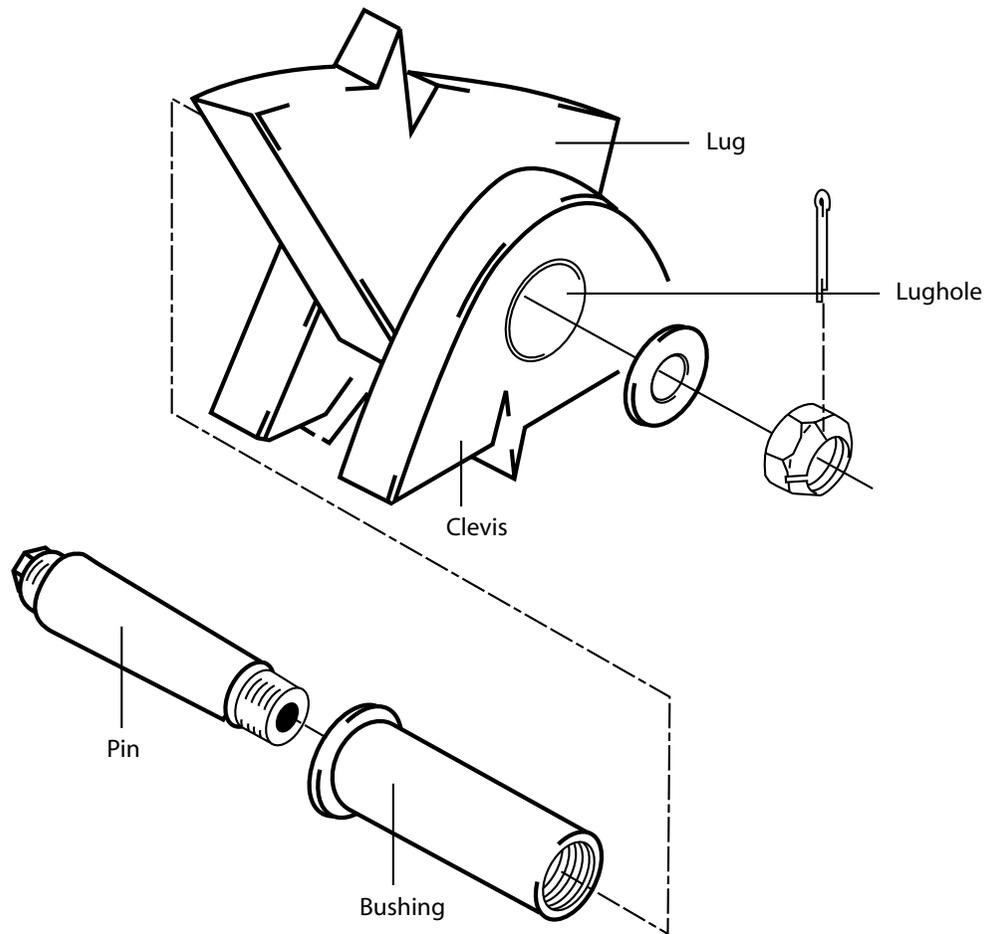
Figure 5. Main Attachment Lug

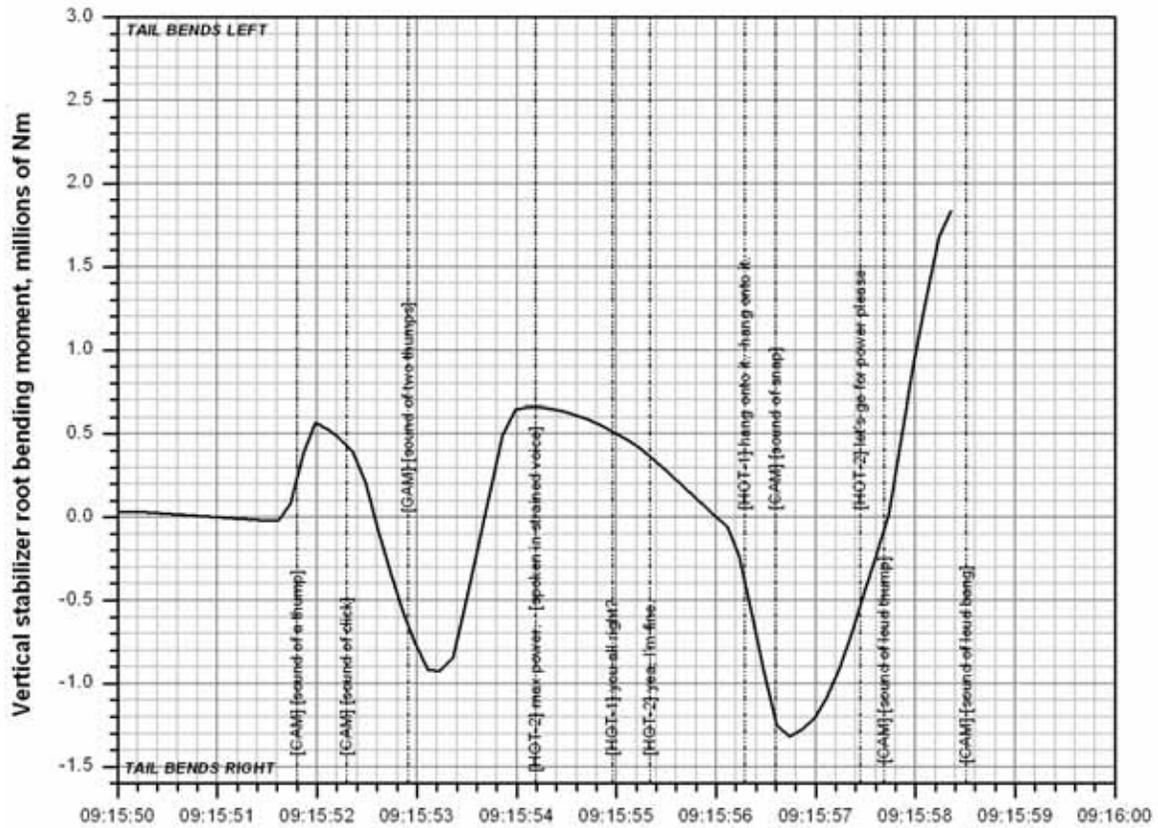
Figure 13. Bending Moment About the Root Chord in the Vertical Stabilizer Axis System

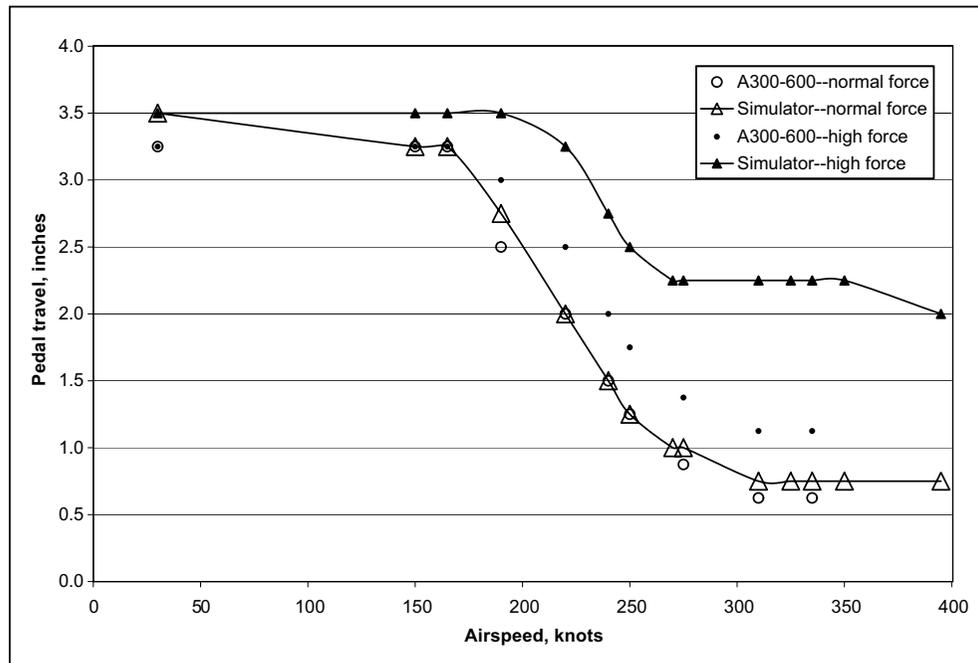
Safety Board investigators repeated these tests on April 23, 2003, in the American Airlines A310/300 training simulator. With the assistance of two American Airlines representatives, the investigators assessed how the portrayal of rudder pedal characteristics in the simulator compared with those of the actual A300-600 airplane. The investigators found that the rudder pedal motion in the simulator and the airplane produced by normal and high pilot input forces resulted in different pedal displacements despite the pedal travel limits, as shown in figure 18. The differences were attributed to the software representation of the elastic cable stretch in the simulator, which was less stiff than the cable stretch on the A300-600 airplane.

Figure 18. Rudder Pedal Motion With Normal and High Pilot Pedal Force in the A300-600 Airplane and the American Airlines A310/300 Training Simulator
