NTSB National Transportation Safety Board

Office of Highway Safety

Collapse Sequence and Postaccident Activities

James F. Wildey II

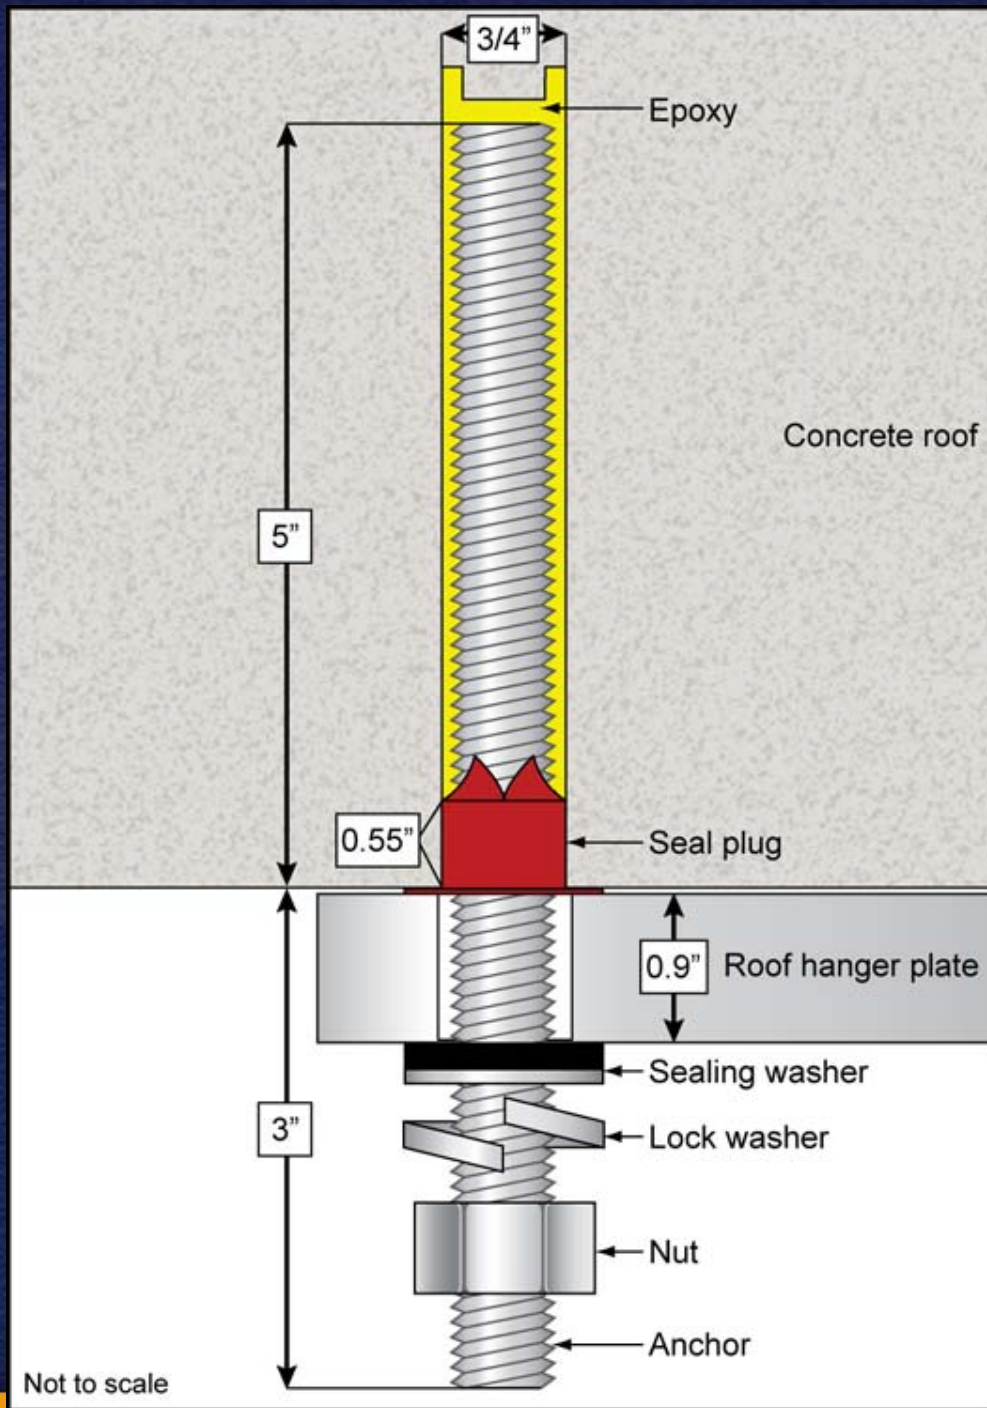
“Good” Installation

- Anchors from inside and outside the failure area examined
- Anchor holes examined using laser scanning equipment
- Core samples removed and examined

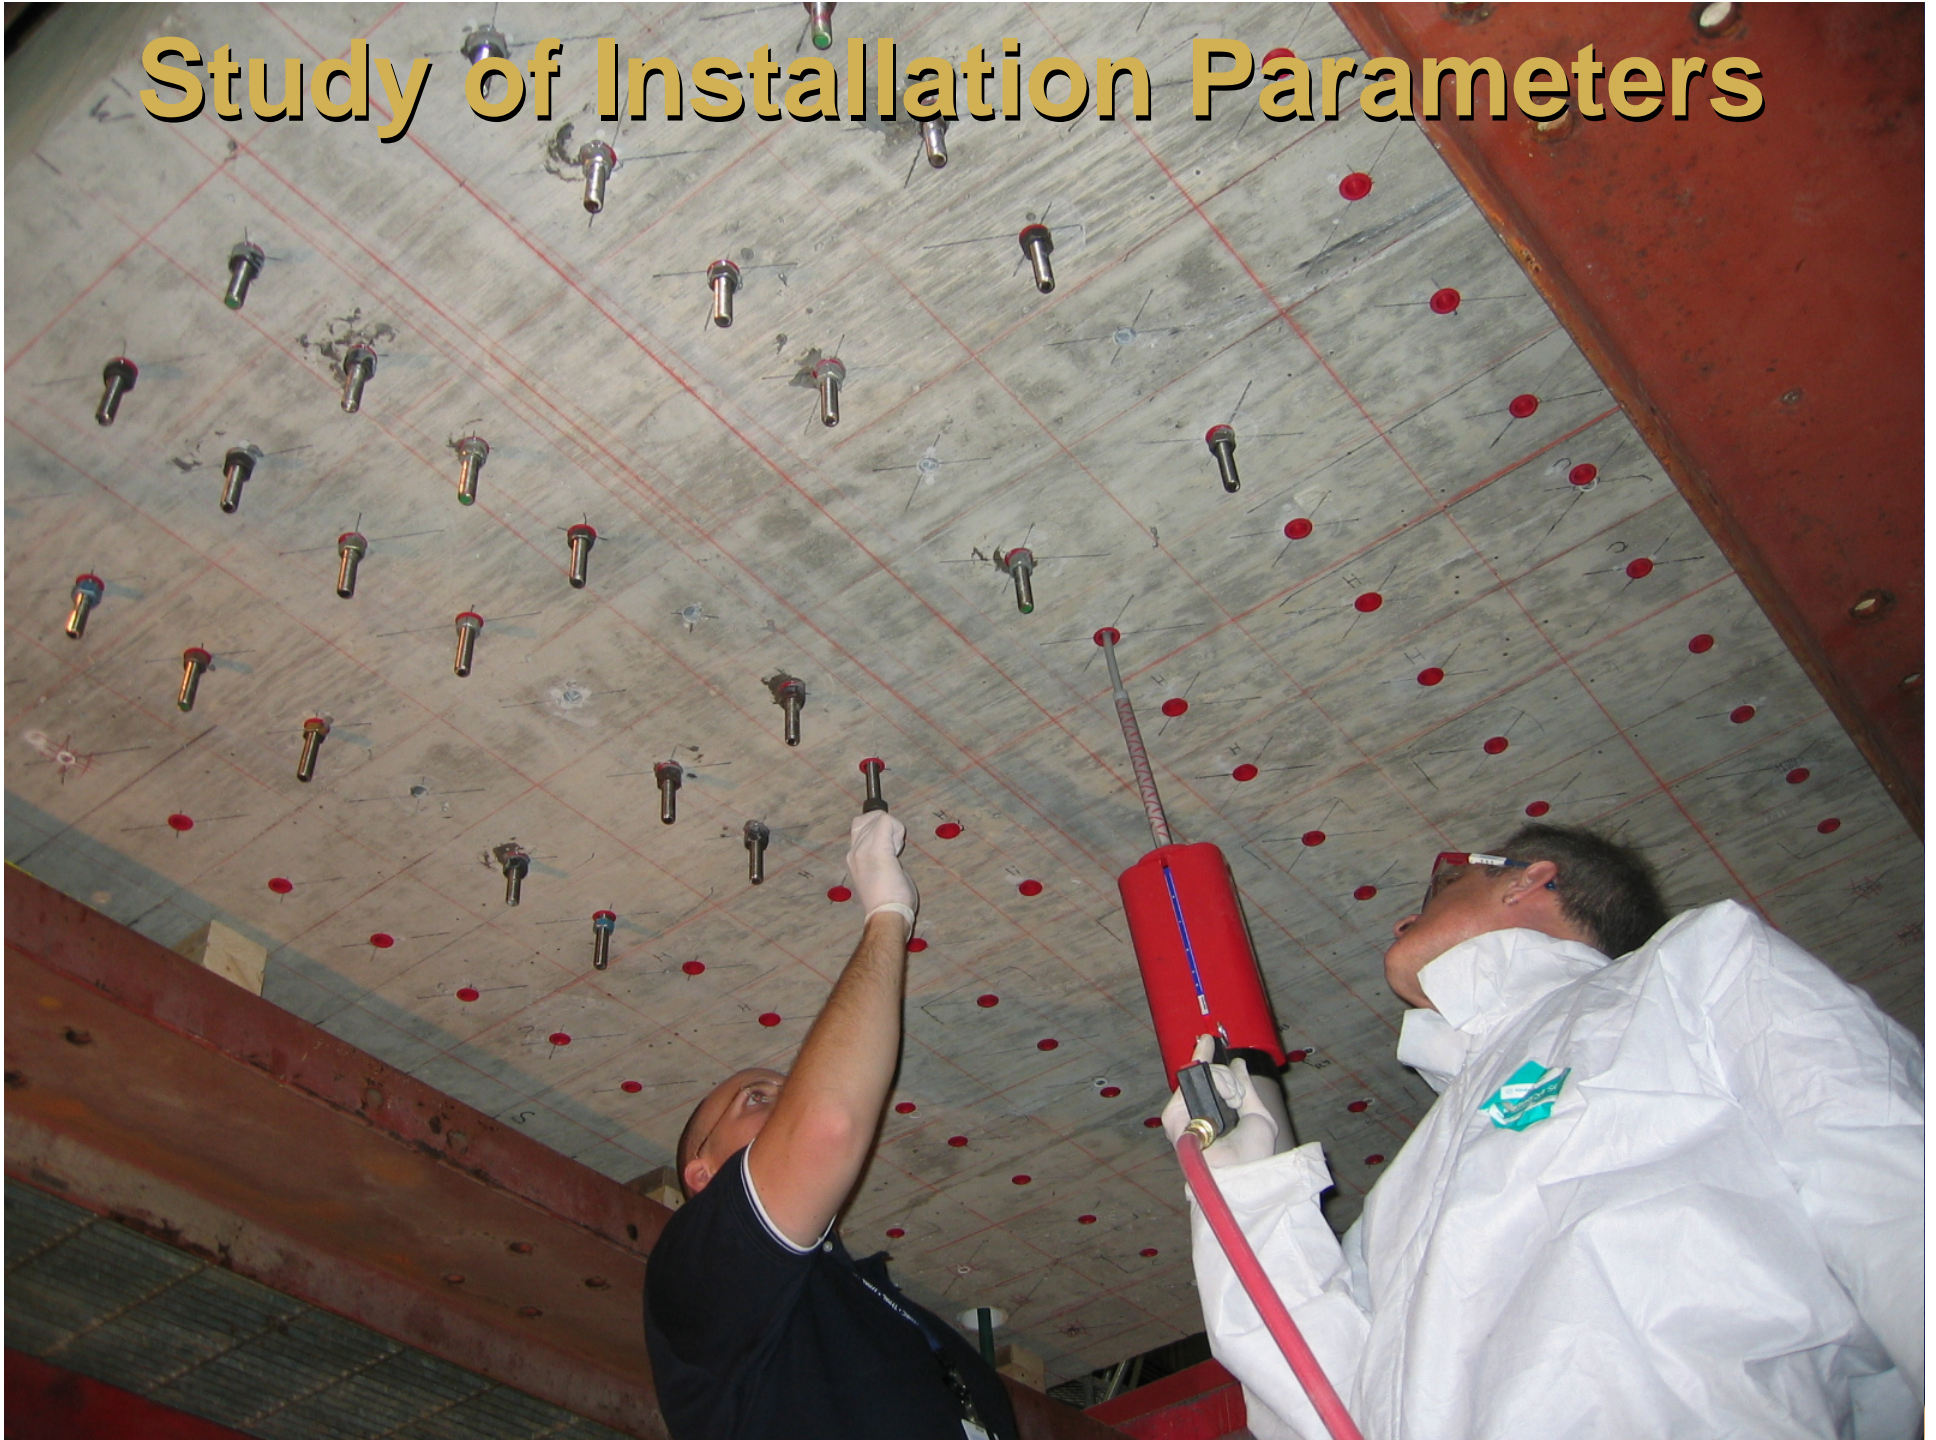
Study of Installation Parameters

- “Best practice” capacity over 22,000 pounds
- Parameters NOT degrading capacity:
 - Diamond coring bit (vs. carbide bit)
 - Installation through #11 rebar
 - Excess torque on anchors
 - Shortened epoxy nozzle
 - Excess resin

- Factors reducing load capacity:
 - Excess hardener
 - No cleaning
 - No cleaning or drying (“worst practice”)
 - Voids
 - Difficult to eliminate when installing overhead
 - Fewer voids when installing downward
