**Multivehicle Collision on Interstate 90
Hampshire–Marengo Toll Plaza
Near Hampshire, Illinois
October 1, 2003**

NTSB/HAR-06/03

Highway Accident Report

Abstract: On October 1, 2003, a multivehicle accident occurred on the approach to an Interstate 90 toll plaza near Hampshire, Illinois. About 2:57 p.m., a 1995 Freightliner tractor-trailer chassis and cargo container combination unit was traveling eastbound on the interstate, approaching the Hampshire–Marengo toll plaza at milepost 41.6, when it struck the rear of a 1999 Goshen GC2 25-passenger specialty bus. As both vehicles moved forward, the specialty bus struck the rear of a 2000 Chevrolet Silverado 1500 pickup truck, which was pushed into the rear of a 1998 Ford conventional tractor-box trailer. As its cargo container and chassis began to overturn, the Freightliner also struck the upper portion of the pickup truck's in-bed camper and the rear left side of the Ford trailer. The Freightliner and the specialty bus continued forward and came to rest in the median. The pickup truck was then struck by another eastbound vehicle, a 2000 Kenworth tractor with Polar tank trailer. Eight specialty bus passengers were fatally injured, a

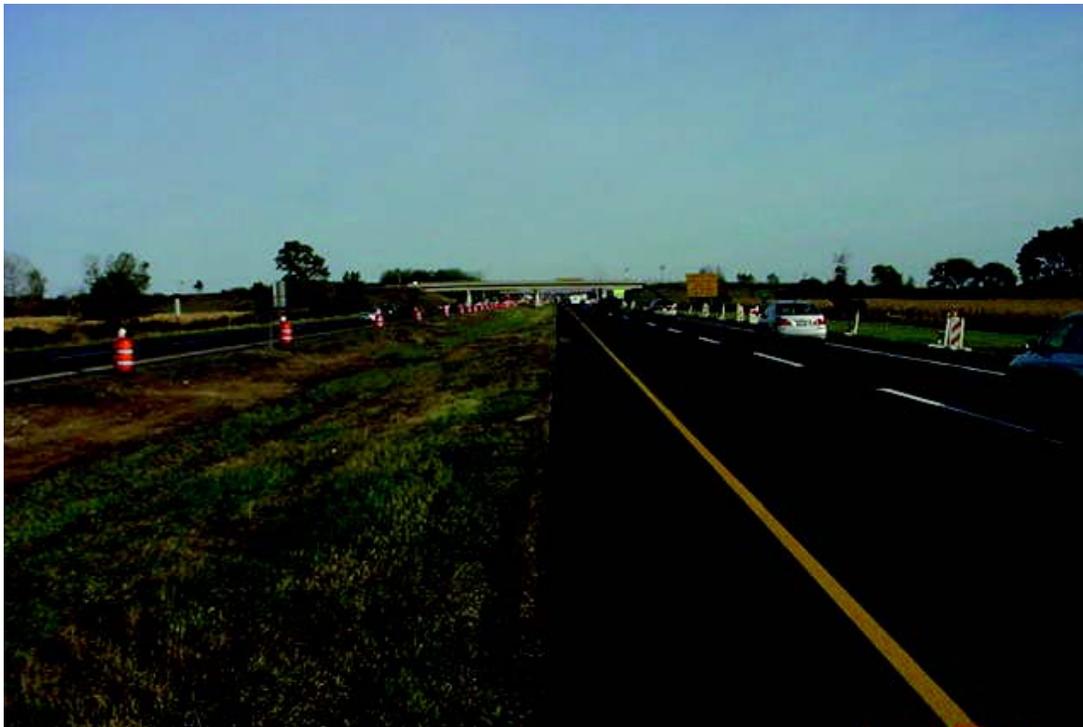
Figure 2. View of accident location, I-90 eastbound.

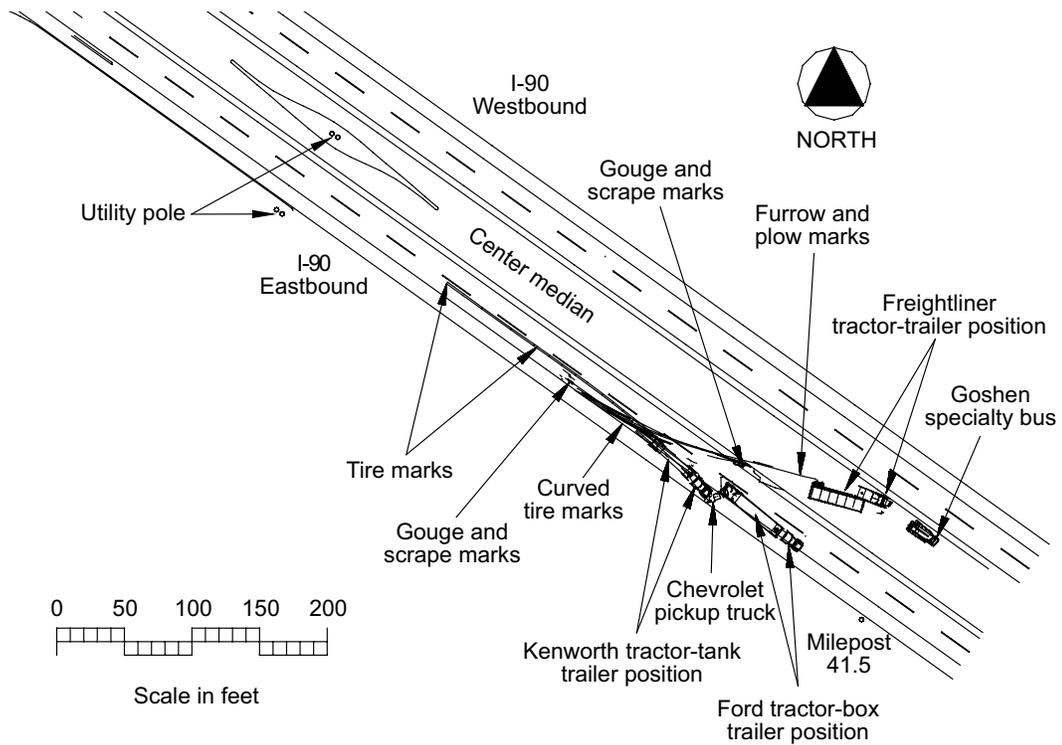
Figure 8. Accident scene diagram.

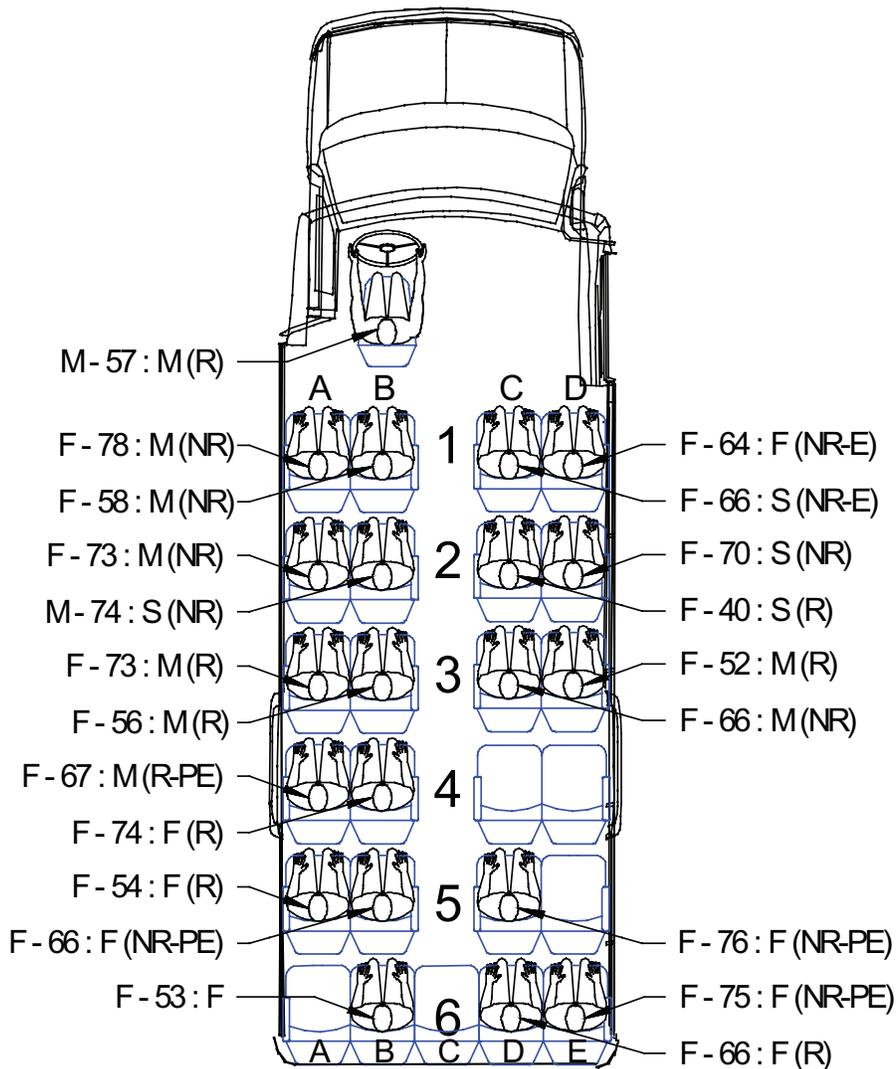
Eight specialty bus passengers were killed, four passengers received serious injuries, and eight received minor injuries. (See figure 9.) The bus driver, the pickup truck driver, and the Freightliner driver sustained minor injuries.⁶ The Ford driver and codriver and the Kenworth driver were not injured. (See table 1.)

Figure 9. Specialty bus seating diagram.

Safety Board investigators interviewed 11 of the 12 surviving specialty bus passengers, and most stated that they were sleeping when the accident occurred. Those passengers who reported that they were restrained⁷ recalled their seats being thrown forward and becoming entangled in the interior vehicle wreckage. Some passengers exited the bus onto the roadside, and rescue personnel extricated the entrapped passengers. Two passengers seated in the first row on the right were ejected from the bus, and one was fatally injured. One passenger seated in the fourth row on the left, though restrained with a lap belt, was partially ejected and sustained minor injuries. Three other fatally injured passengers, seated in the fifth and sixth rows, were partially ejected.

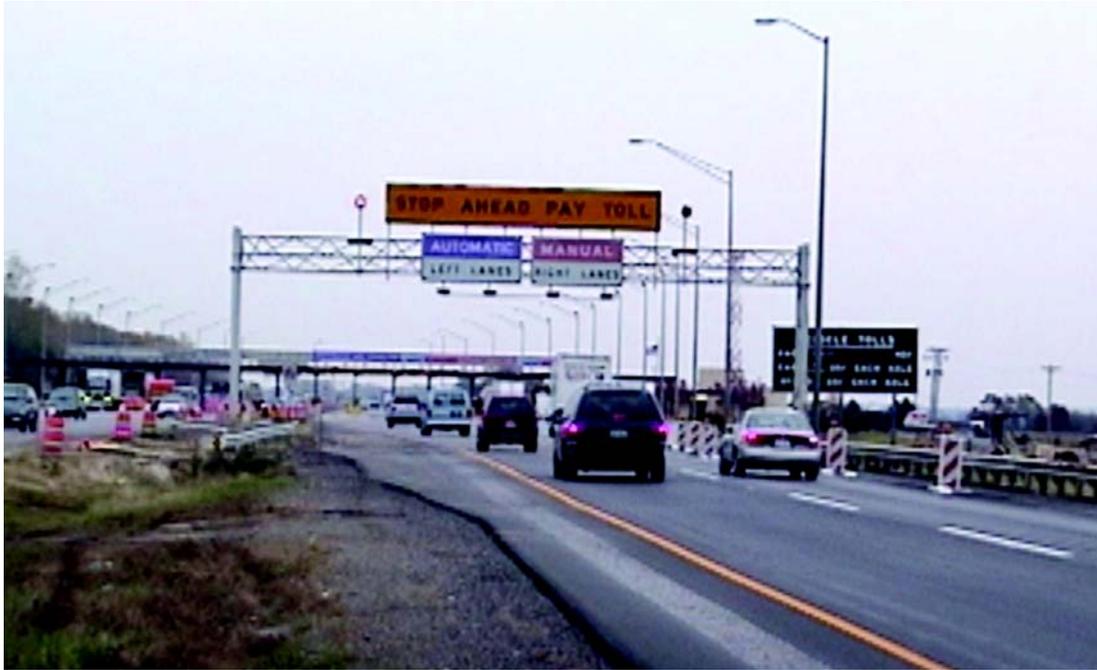
Figures 14 and 15 show the Hampshire–Marengo approach view and toll booth and toll lane configuration at the time of the accident. Lanes 1–3 (from right to left) were manual cash lanes with toll collectors for all vehicles, and lanes 4–6 (from right to left) were automatic coin lanes for cars only. At the time of the accident, the only manual lane available for commercial traffic was lane 3. Lane 1 was open weekdays during peak commercial hours, from 6:00 a.m. to 2:00 p.m., and closed the rest of the day. At the time of the accident, the toll collector for lane 2 was on break, and this lane was closed.⁵⁰ The

lane 3 toll collector stated that he observed no unusual queuing of traffic in lane 3 before the accident; he said that four or five tractor-semitrailers were in line to pass through the toll plaza.

Figure 14. Approach view of accident toll plaza.

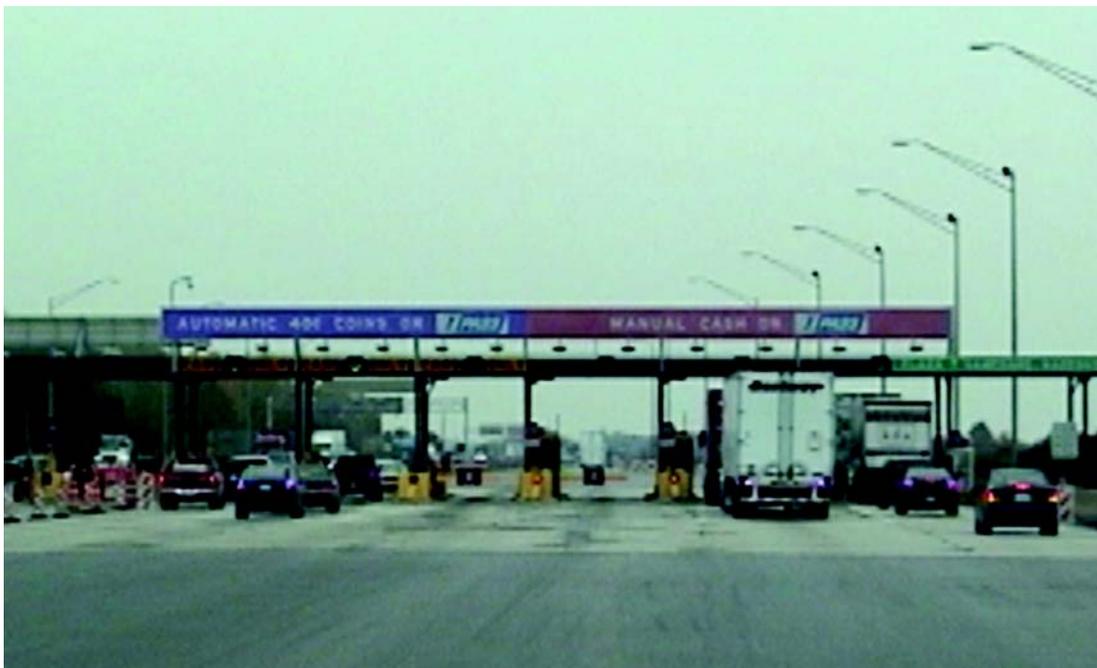
Figure 15. Accident scene toll plaza lanes.

At the time of the accident, the Hampshire–Marengo toll plaza was under construction for conversion of an existing manual lane (lane 3) to an I-PASS⁵¹-only lane for use by both passenger and commercial vehicles. (See figure 15.) The Hampshire–Marengo toll plaza I-PASS-only lane, completed in November 2003, was designed to allow I-PASS participants to drive through at a posted speed of 5 mph without stopping.

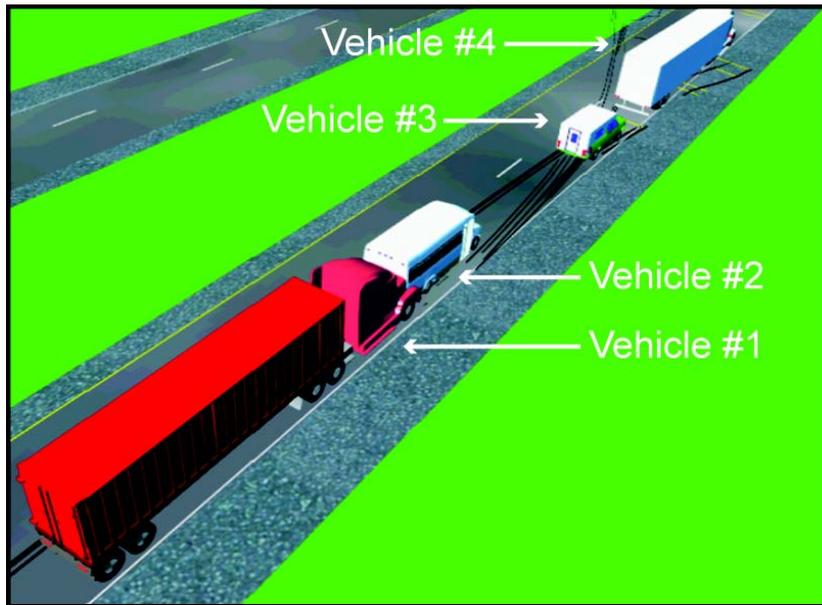
- Traveling approximately 50 mph, the Freightliner tractor-trailer struck the specialty bus, which was traveling about 10 mph. (See figure 18.)
- Following the collision, as the specialty bus was moving about 40 mph, its right front door area contacted the left rear corner of the pickup truck, which was traveling about 3 mph. (See figure 19.)

Figure 18. Freightliner tractor-trailer strikes specialty bus.

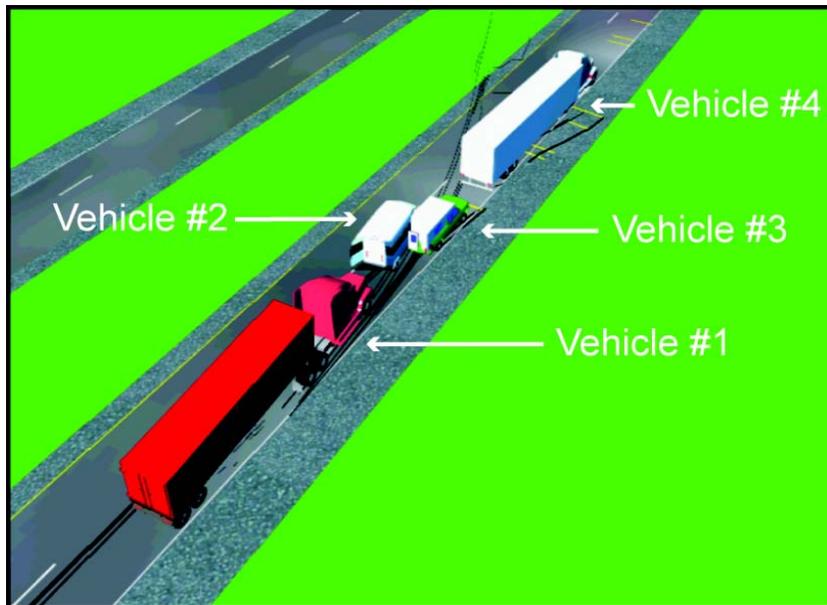
Figure 19. Specialty bus contacts left rear corner of pickup truck.

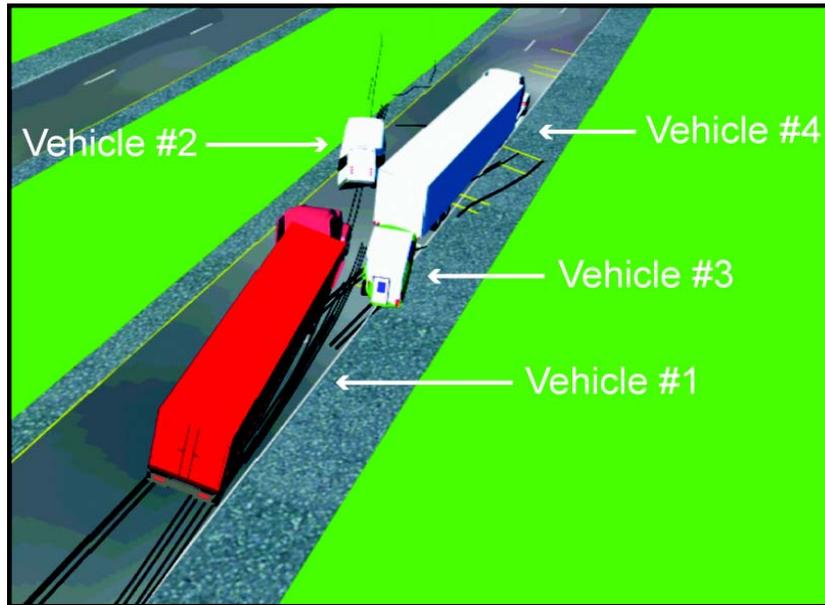
- The collision with the pickup truck pushed it forward; and within less than 1 second, the front of the pickup truck struck the rear of the Ford tractor-box trailer, which was traveling 0 to 3 mph.⁶¹ (See figure 20.)

⁶¹ As indicated by the simulation results, the speed of the Ford tractor-box trailer was substantially slower than the 30 to 35 mph reported by the driver. The simulations showed that if this vehicle had been traveling any faster than 10 mph, the pickup truck would not have been able to “speed up” during the collision in time to make contact with the rear of the trailer; the trailer's speed, if 30 to 35 mph, would have moved it forward, away from the slower vehicles colliding behind it.

Figure 20. Pickup truck, pushed forward, strikes Ford tractor-box trailer.

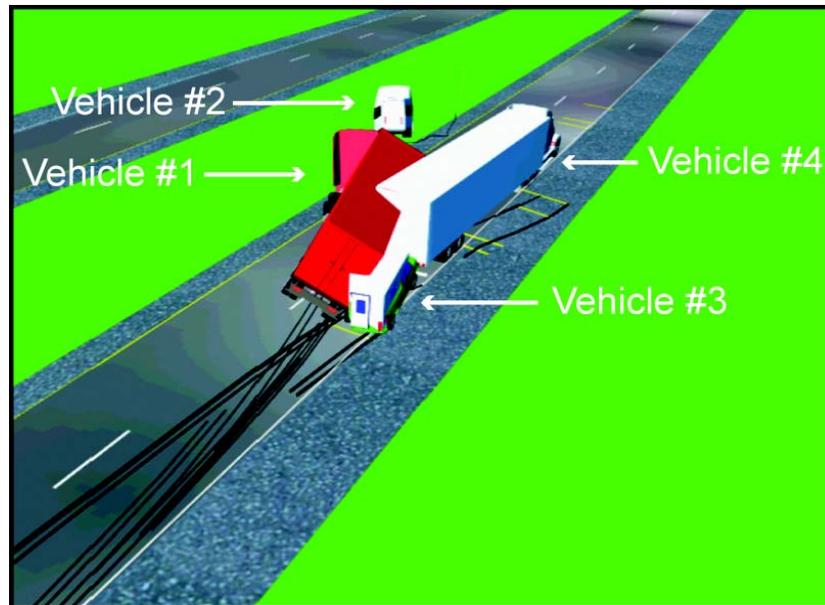
- As the Freightliner and the specialty bus veered toward the center median, the Freightliner's trailer rolled onto the bed-mounted camper of the pickup truck and then onto the rear upper left corner of the Ford box trailer. (See figure 21.)

Figure 21. Freightliner trailer rolls onto pickup truck camper and box trailer.

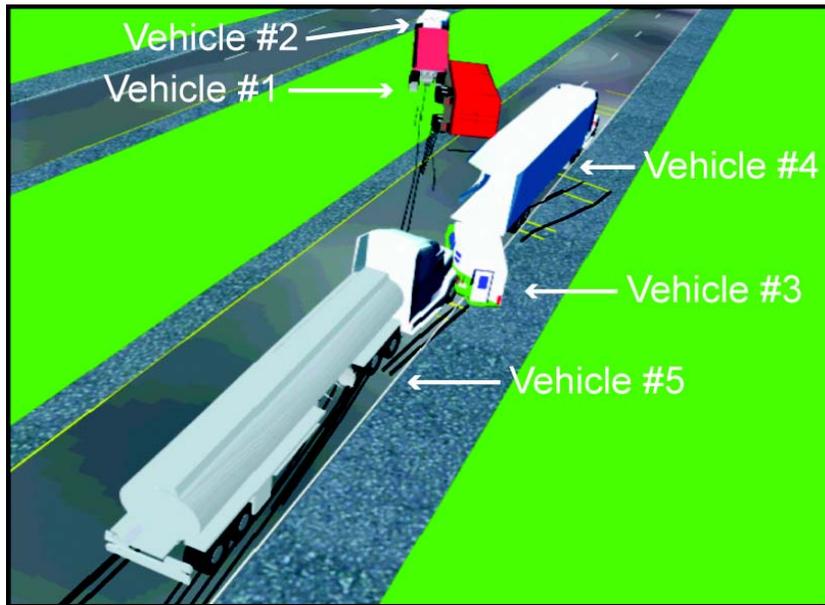
- Meanwhile, a trailing vehicle—the Kenworth tractor-tank trailer—struck the pickup truck, which had already been in contact with the rear of the Ford tractor-box trailer from its initial impact and partial rotation, and pushed the pickup truck and the Ford combination unit to their final rest positions. (See figures 22 and 23.)

Figure 22. Freightliner and specialty bus come to rest in median and Kenworth tractor-tank trailer strikes pickup truck, already in contact with box trailer.

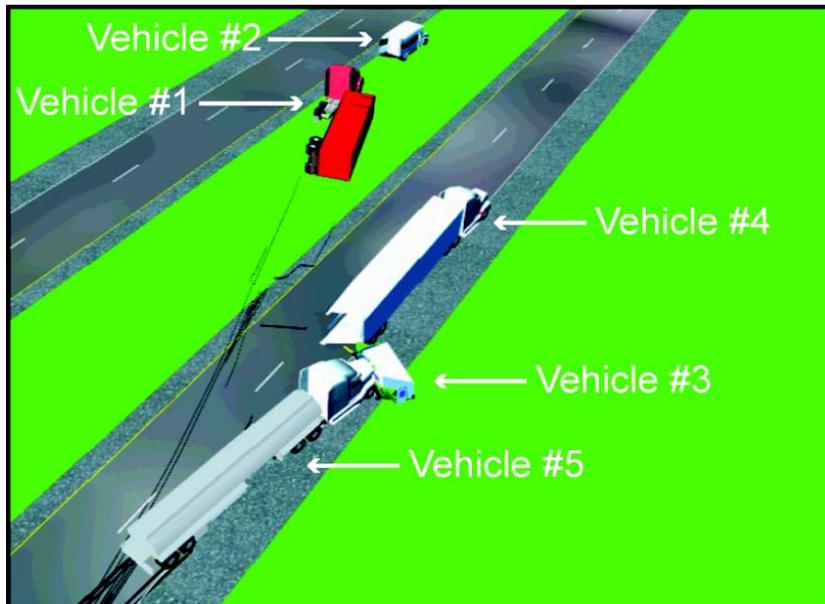
Figure 23. Final rest positions of all five vehicles.
