SAFER SEAS DIGEST

2019

Lessons Learned *from* Marine
Accident Investigations

NTSB | National
Transportation
Safety Board

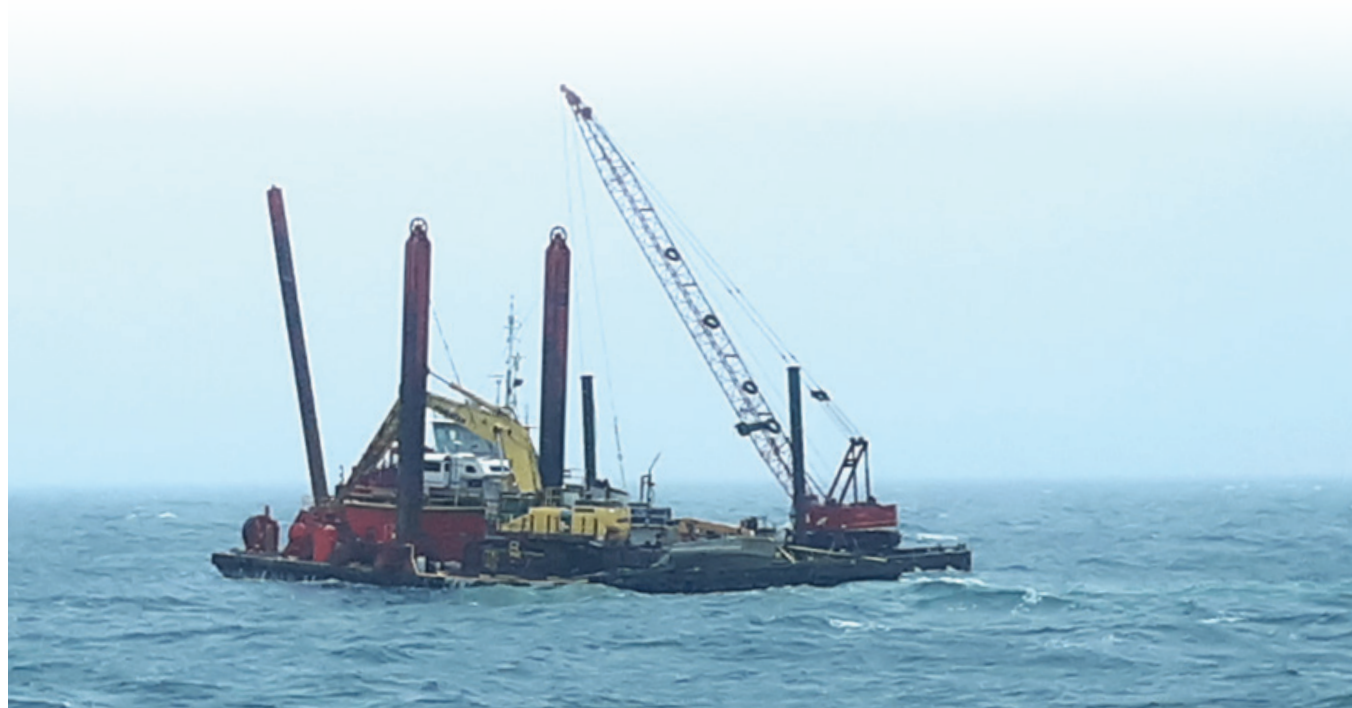
Figure 2. The *Big Jake's* tow with the *Dredge200* in the foreground during the accident.

The probable cause of the capsizing and sinking of the *Dredge200* and the *R.E. Pierson 2* was the decision by the tow captain and owner to attempt a transit in forecasted wind and waves that exceeded their original plan for the voyage.

Owners and operators should develop voyage plans that assess prevailing weather conditions and anticipate changes along the intended route. Regardless of requirements, planning and preparation before a tow commences is critically important, including the identification of safe harbors along the route and adherence to operational limits.

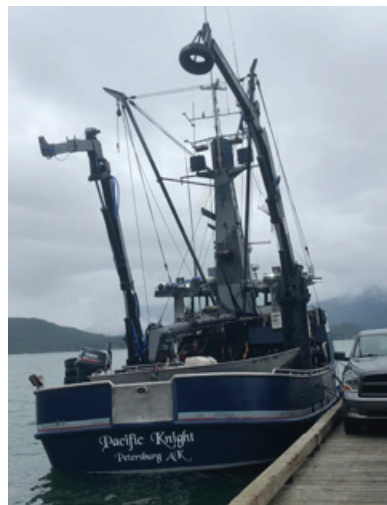
The last stability assessment of the *Pacific Knight* was conducted in 1996 and would not have included any vessel modifications completed since then. The weight and placement of the two cranes that the captain added to the *Pacific Knight* about a month before the sinking likely increased the vessel's vertical center of gravity. Though not required, once the vessel was substantially modified by removing and adding equipment, a revised stability assessment should have been conducted to give the captain the necessary information to safely load the vessel.

Figure 17. Left: the *Pacific Knight* while moored alongside a dock on June 10, 2018, with the two added cranes. Below: undated photo of the *Pacific Knight* (then named the *Lone Fisherman*) with the aft deckhouse that was removed (highlighted in yellow). SOURCE: LONE FISHERMAN, LLC

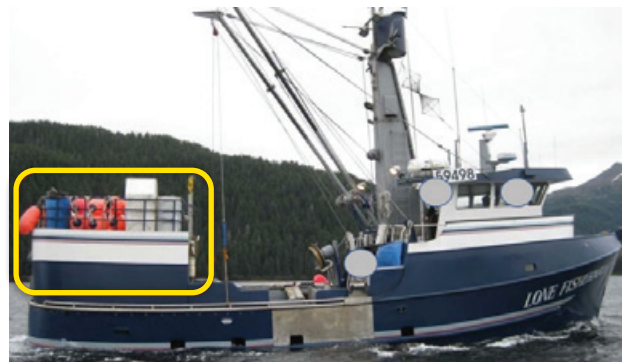
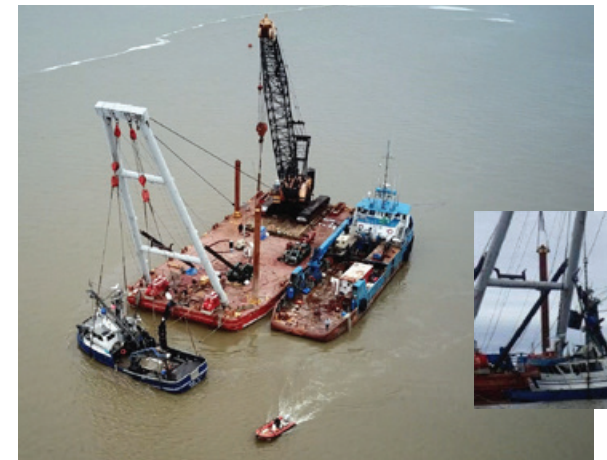
Figure 18. *Pacific Knight* while it was salvaged, with its crane positions visible in the inset.

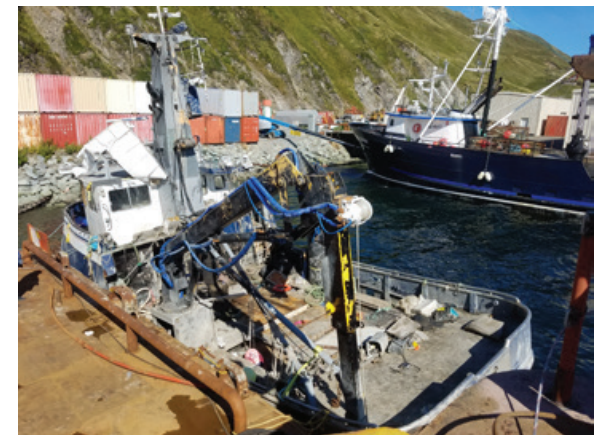
The probable cause of the capsizing of fish tender *Pacific Knight* was the captain's inadequate assessment of the vessel's stability and the risks related to vessel modifications, slack water in the tanks, and overloading of the vessel.

Figure 19. *Pacific Knight* postsalvage.

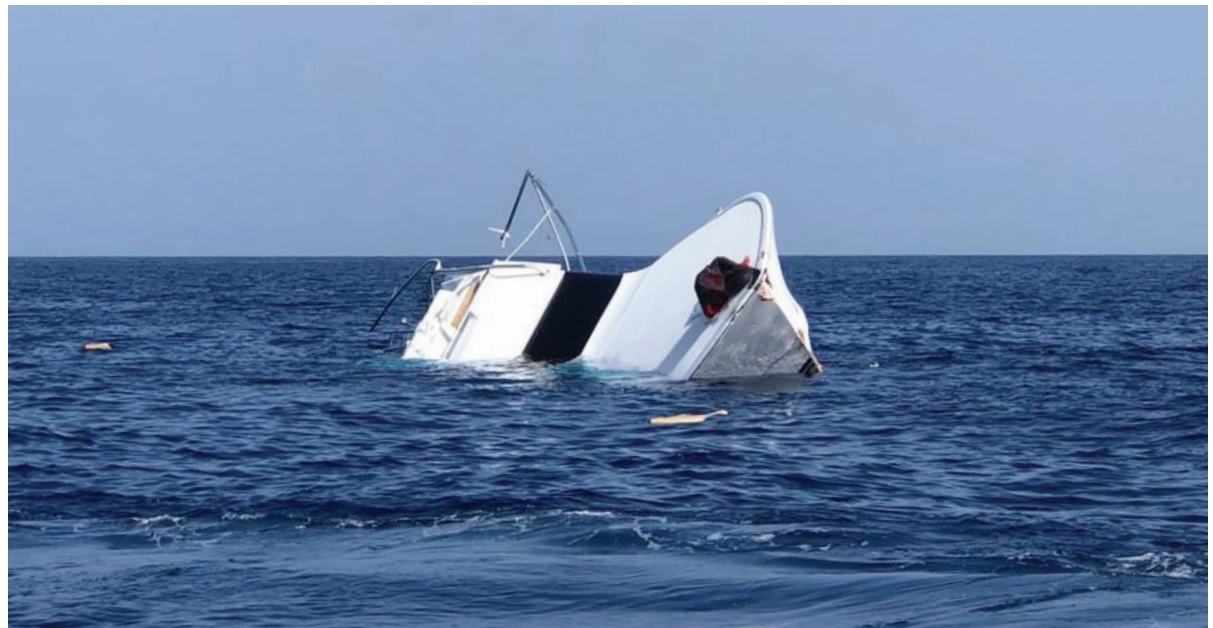
Figure 21. *Got 'M On*, shortly after the collision.

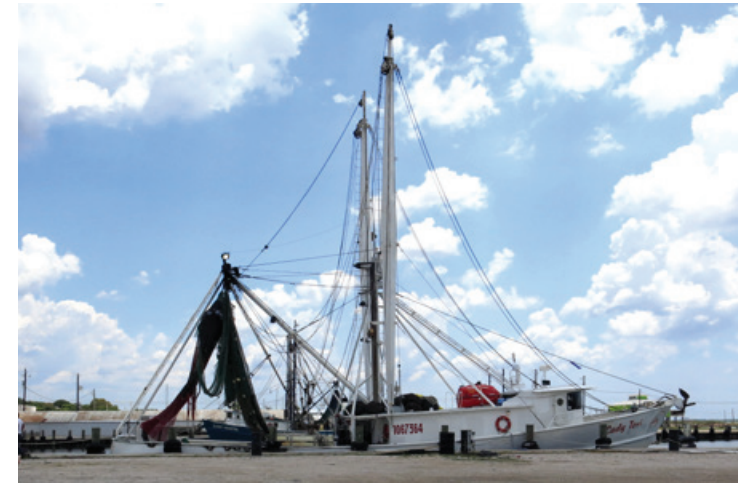
Figure 23. *Lady Toni* dockside, postaccident.

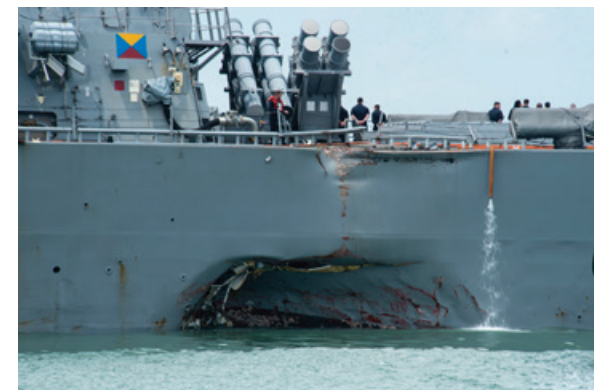
Figure 28. Portside damage to *John S McCain* caused by the bow of *Alnic MC*. SOURCE: US NAVY

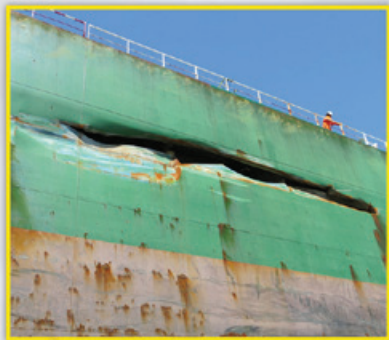
Figure 29. Main damage area of hull of *Tofteviken*.

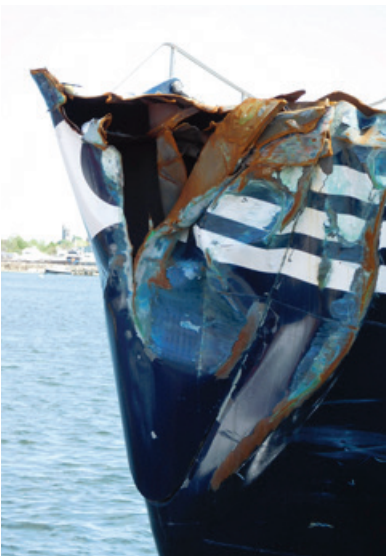
On board the *Polaris*, the mate said he was cleaning when he heard a sound and turned around to see "a wall of green" in front of him. He attempted to turn the vessel to starboard, but the bow of the *Polaris* struck the port side of the tanker. The *Polaris* mate said that he had been monitoring channels 16 and 22A but did not hear any calls or any sound signals from the *Tofteviken*. He last looked out the windows and at both the radars about 15 minutes before the collision. After the collision, the master of the *Tofteviken* and the captain on the *Polaris* assessed damage and reported the collision to the Coast Guard.

Figure 31. Area of greatest damage to hull of *Polaris*.

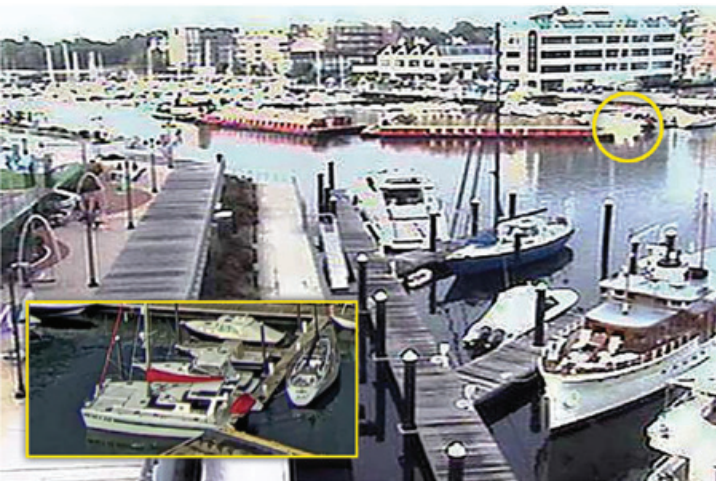
At 0835, less than 2 minutes after the mate ordered the lines let go, the port bow of *Weeks 207* swung to port, striking the port side of the *Sea Jay* at its stern and damaging the fiberglass hull. The impact pressed the *Sea Jay* against the dock on the sailboat's starboard side, causing movement of the floating pier, its finger piers, and four vessels moored to the dock. As the *Seeley* continued moving ahead, the barge came away from the *Sea Jay* and continued swinging to port.

Figure 36. Surveillance footage of (top) *Seeley* with *Weeks 213* and the separated *Weeks 207* angled and moving toward the *Sea Jay* (circled). Inset: Port forward corner of *Weeks 207* at the moment it falls away from the *Sea Jay*. SOURCE: COAST GUARD

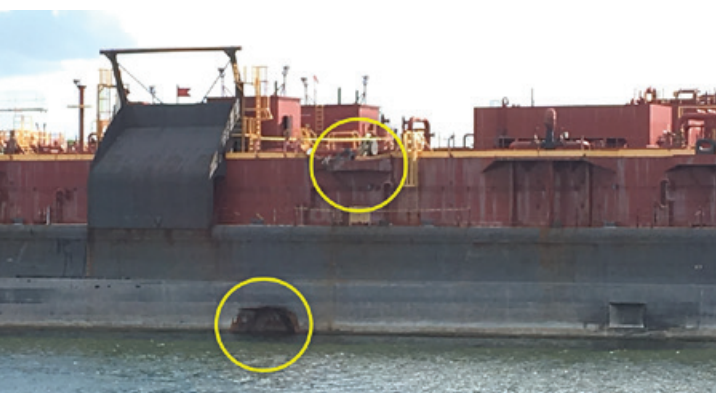
Figure 39. Damage to *OSG 243*, port side. Yellow circles identify, at top, cantilever deck damaged by *Yochow*'s bow rake and, at bottom, side shell at waterline in no. 5P ballast tank penetrated by bulk carrier's bulbous bow.

About 48 seconds after the original order to starboard, the *Yochow* was about one ship's length away from the *OSG Independence/OSG 243*, and the pilot ordered, "Stop engines. Let go anchor." He followed this order with full astern 7 seconds later and then ordered the whistle sounded. With the port anchor and two shots of chain deployed, the *Yochow* collided at approximately 4.5 knots with the port side of the tank barge *OSG 243* amidships at 02:49:45, damaging the barge, which in turn damaged the wharf.

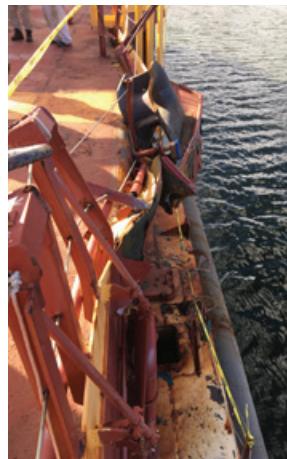
Figure 41. Left: *OSG 243's* port side damage and facility's pedestrian bridge damage.

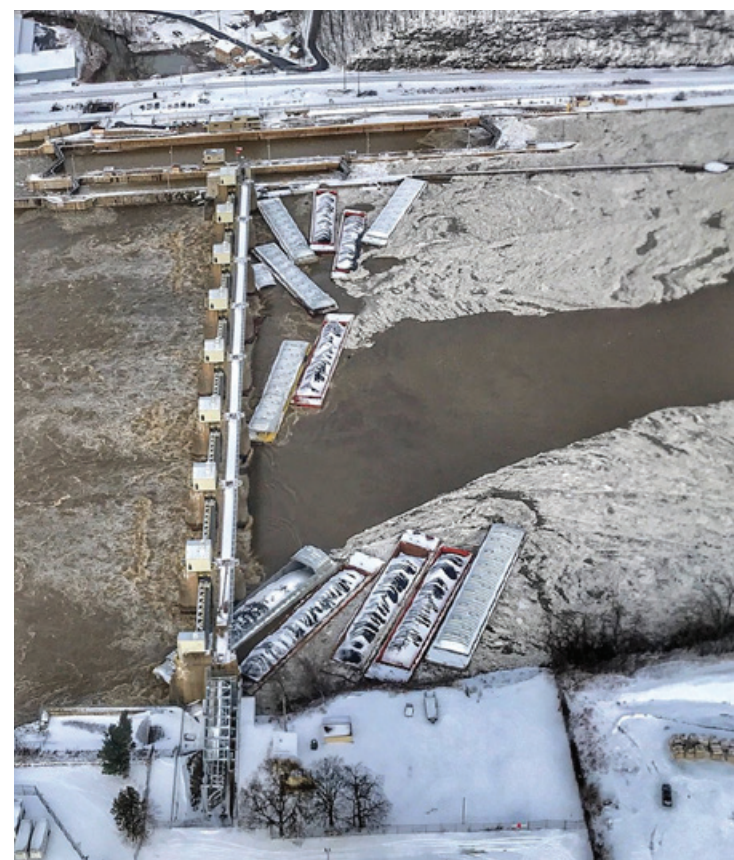
Four miles downriver of Pittsburgh, Jacks Run fleeting area contained both empty and loaded hopper barges (filled with coal or cement aggregate). The barges were moored by lines to steel rings attached to steel-pile mooring cells. In anticipation of the high-water conditions and ice buildup on the river, the company managing (operating) Jacks Run deployed two towing vessels to tend the barges, but crews were challenged to adjust mooring lines to accommodate the rapidly rising water. Ice formations accumulated at the head of the barge fleet and at 0615, with the towboats made up to the barges, a captain saw sparks near an upriver cell and the entire flotilla began moving downriver. The captains were concerned for their vessel's safety and released the barges, notifying other towing vessels and the Emsworth Locks and Dams of the breakaway. Twenty-five of the 27 barges reached the dam complex, where some struck moored vessels, 7 passed through the open lift gates, 2 sank and the rest lodged in various locations.

Figure 48. Aerial photo of Emsworth Locks and Dam with breakaway barges. SOURCE: COAST GUARD

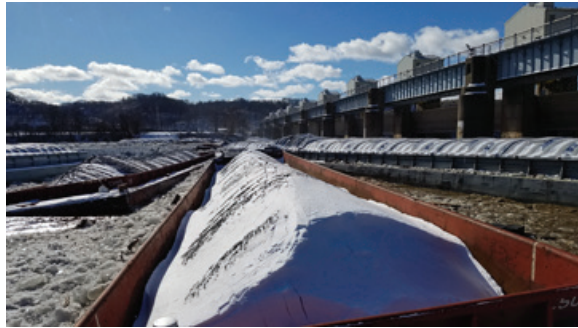
Figure 49. Left to right: Hopper barges after striking the main channel dam. Stern of barge *C508* after colliding with Corps of Engineers workboats *Emsworth* (foreground) and *Dashields* (background). SOURCE: COAST GUARD

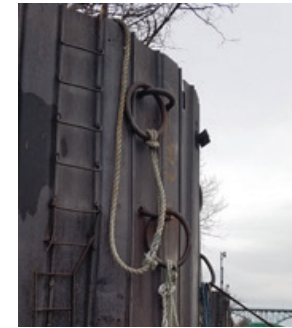
In addition to the rising water and increasing current, floating ice building up at the head of the barge flotilla significantly strained the barge moorings at Jacks Run. After the accident, the mooring ring on a forward cell was found missing, a ring on another cell was misshapen and broken mooring lines and cables remained attached to the cells. The breakaway occurred when the force of the river current acting on the extensive ice buildup at the front of the barge flotilla exceeded the capacity of the fleeting area's mooring cell fittings and the barge mooring wires.

Figure 51. Below, the forward piling at Jacks Run with a broken mooring ring anchor point and missing ring.

area had a regulated navigation area with condition-based mooring requirements similar to the Mississippi River and Gulf Intracoastal Waterway regulated navigation areas, it is likely that the poor condition of the Jacks Run mooring cells would have been discovered and addressed. The NTSB recommended that the Coast Guard develop a regulated navigation area for the Pittsburgh region, that the Corps of Engineers require fleeting area permittees to submit waterfront facility operations guides and ensure the guides address the maintenance of fleeting areas and procedures for operating in high-water and ice conditions, and that the Coast Guard and Corps of Engineers collaborate to develop a policy to ensure fleeting areas are maintained in compliance with permit requirements.

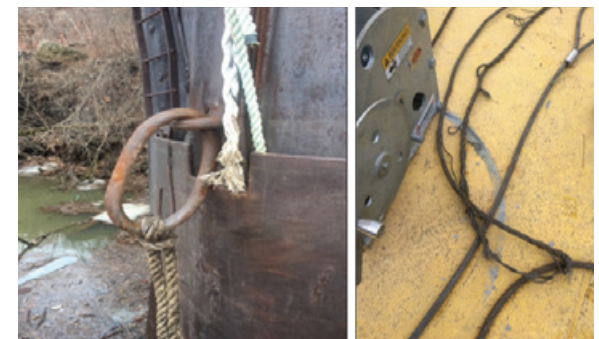
Figure 52. At left, a deformed anchor ring on third piling back from the forward piling at Jacks Run. At right, parted and frayed mooring wires from the lead shore-side barge during the accident.

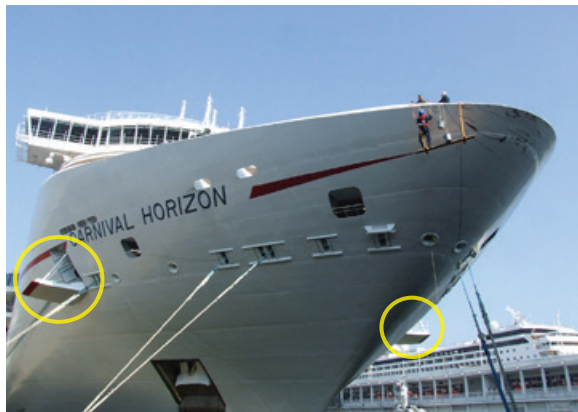
Figure 53. *Carnival Horizon*'s bow after the accident. The forward mooring platforms where the lookout was stationed (about a 100 feet aft from the tip of the bow) are circled in yellow. SOURCE: COAST GUARD

On the morning of August 28, 2018, the cruise ship *Carnival Horizon*, with a total of 6,361 people on board, was maneuvering to berth no. 2 at Manhattan Cruise Terminal's Pier 88 in New York City, New York, when its bow struck the southwest corner of adjacent Pier 90. No one was injured and no pollution occurred, but Pier 90's walkway, roof parking garage, and facilities suffered extensive structural damage, and the ship sustained minor damage above the waterline, totaling about \$2.5 million in cumulative damage.

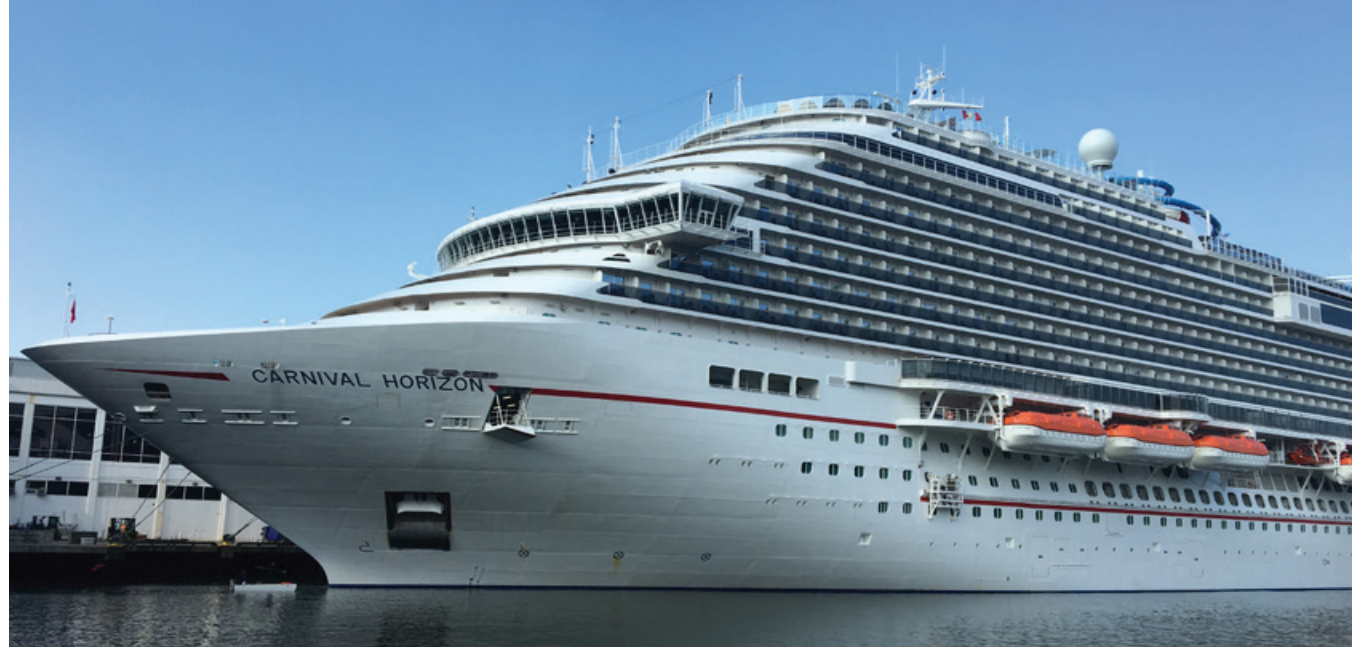
Figure 54. *Carnival Horizon* at the Manhattan Cruise Terminal after the accident.

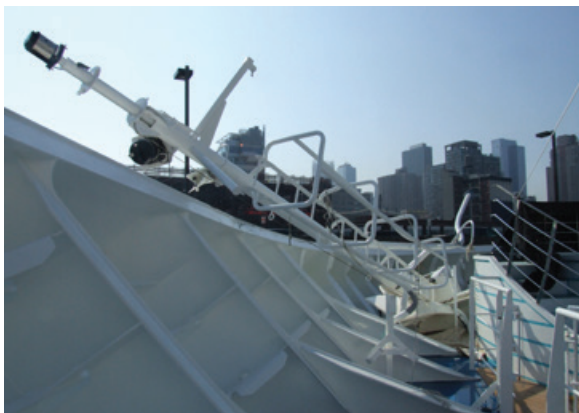
Figure 55. *Carnival Horizon's* damaged forward mast and support structure.

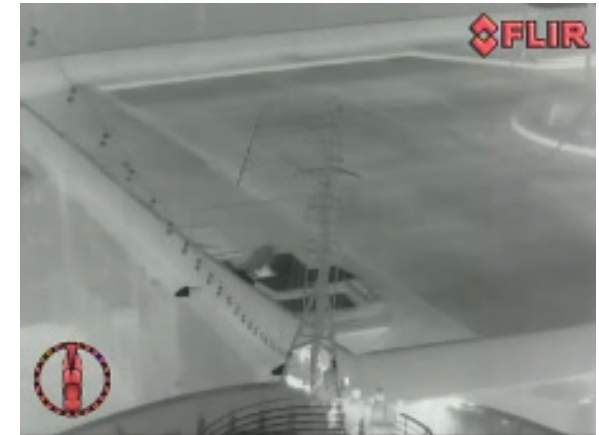
The probable cause of the *Carnival Horizon's* contact with Pier 90 was the ineffective interaction and communication between the master and the docking pilot who were maneuvering the vessel, and the bridge team's ineffective oversight of the docking maneuver. Contributing was the placement of the third officer in a location without view of the bow to monitor the close approach to Pier 90.

Figure 57. Screenshot from *Carnival Horizon's* thermal night vision bow camera at the time of impact with Pier 90.

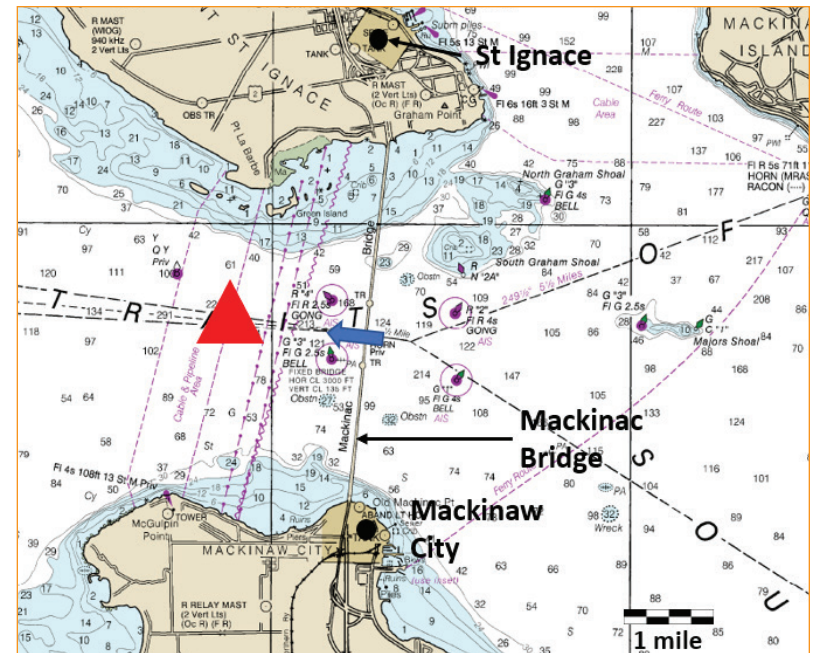
The Straits of Mackinac had underwater pipelines and transmission cables running in a general north and south direction. On April 3, the Coast Guard was notified of damage to the underwater transmission cables and the contact with the pipelines. The *Erie Trader's* starboard anchor was the likely source of the damage. The anchor damaged three of the six electrical cables, one could be repaired while two required complete replacement. The

anchor also struck the west leg of Enbridge's Line 5 dual pipeline, which transported crude oil from Canada to the United States, causing one minor dent in one pipeline and two minor dents in the other.

Figure 61. Section of NOAA chart 14881 showing a portion of the Straits of Mackinac. The location of contact with the underwater cables and pipelines is indicated by a red triangle. The blue arrow indicates the ATB's direction of travel. The soundings are indicated in feet.

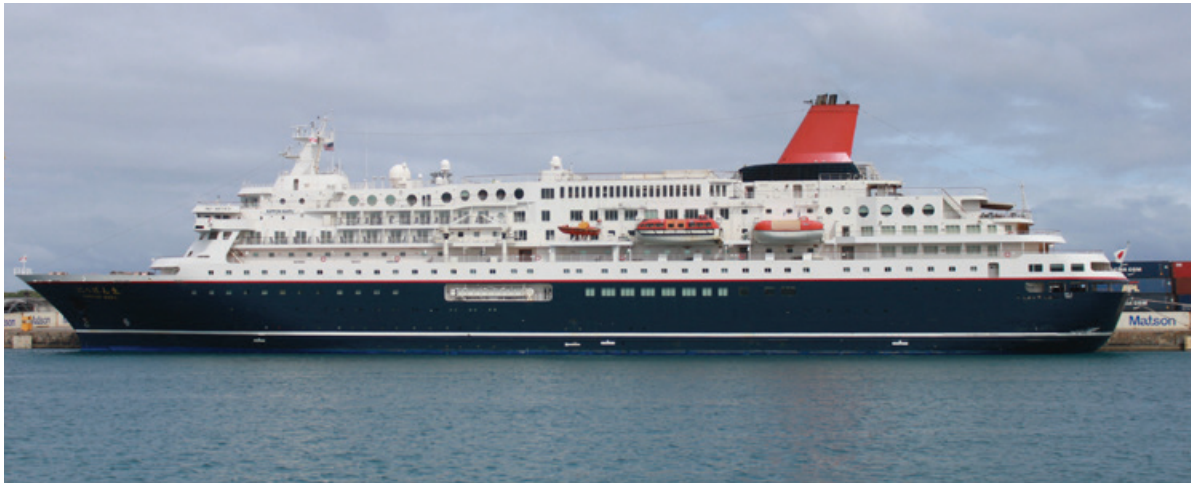
Figure 63. The *Nippon Maru* dockside after the accident.

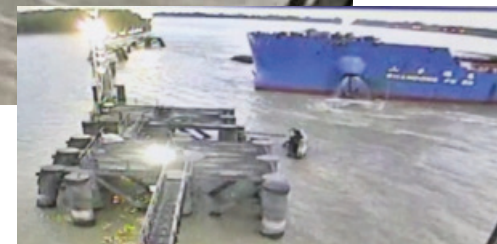
Figure 64. Damaged walkway at the Ergon-St. James Terminal about 4 hours after the accident.

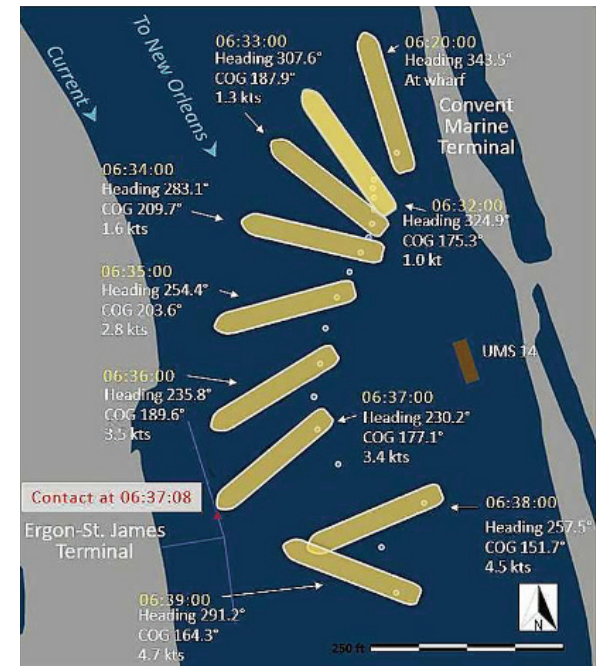
The probable cause of the contact of bulk carrier *Shandong Fu En* with the Ergon-St. James Terminal wharf was the fatigued pilot's misjudgment of a downstream turning maneuver during high-water conditions.

Figure 67. Trackline of the *Shandong Fu En* from 0620 to 0639, showing the vessel's heading and COG.

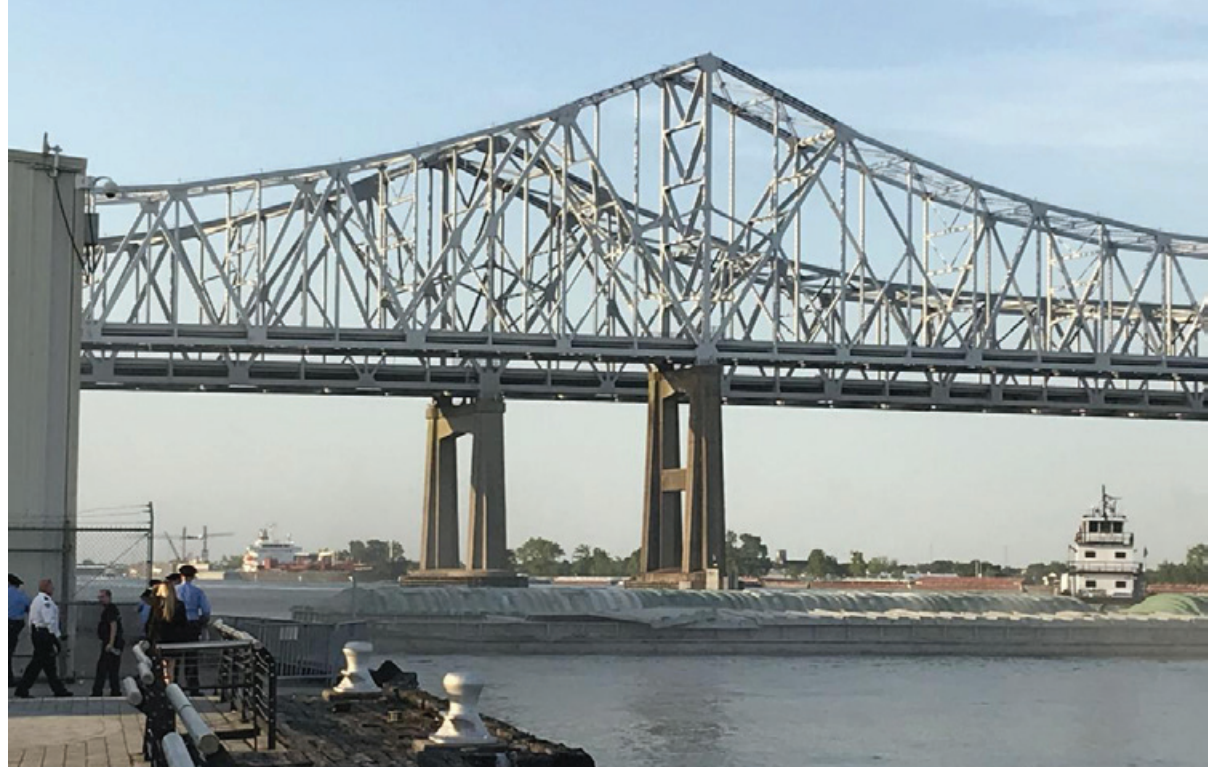
Figure 69. *Steve Richoux* and barges after the accident (view downriver with the Crescent City Connection Bridges in the background). SOURCE: MARDI GRAS WORLD

At 1847, the pilot radioed that he was losing control of the vessel. As the tow continued to approach the left descending bank of the river, the pilot placed both engines full astern, sounded the general alarm to warn the crew, and blew the vessel's whistle to warn the people on the wharf and inside Mardi Gras World warehouse. Before any assistance could arrive, the lead two barges of the tow struck the wharf, causing significant damage to both the wharf and the warehouse. Two forward barges sustained minor damage.

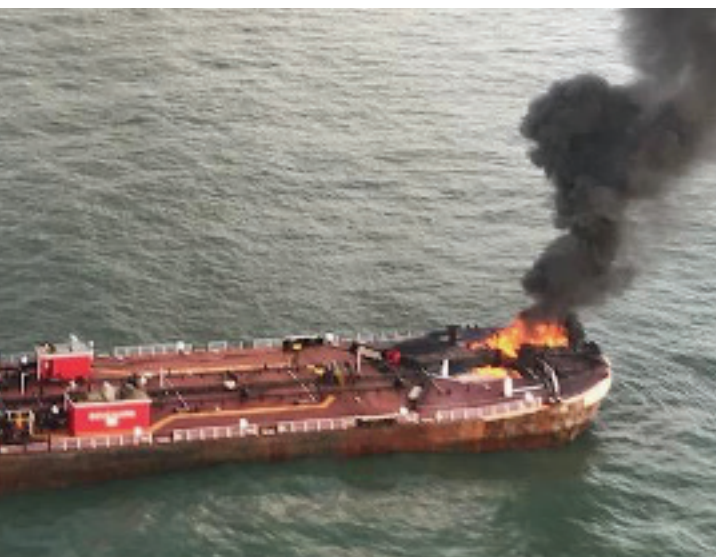
Figure 72. *B. No. 255* bow on fire following an explosion.
SOURCE: COAST GUARD

The majority of the damage to the *B. No. 255* was found in the forepeak of the barge, and photographs showed the fire in the same location, indicating the initial explosion originated in the forepeak. During postaccident examination of the bulkhead separating the no. 1 port tank from the forepeak, through-cracks were found in the area of the original bulkhead that had not been previously repaired; the steel around the cracks was pock-marked and pitted. Examination of the through-cracks indicated that this corrosion was present before the accident explosion, thereby compromising the integrity of the cargo containment in the no. 1 port tank.

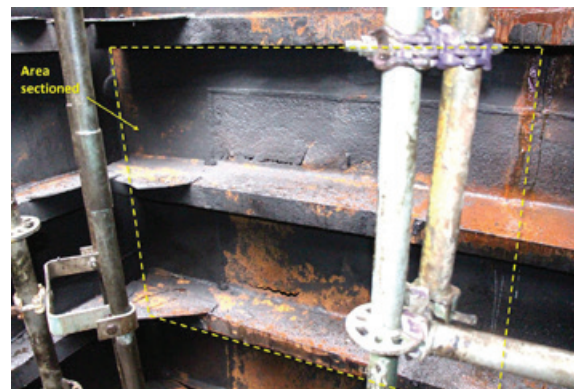
The no. 1 port cargo tank was 90 percent filled, placing the level of crude oil above the cracks. The oil seeped through the openings in the bulkhead and collected inside the forepeak, increasing the crude oil vapor content. While raising the anchor, the wiring in the forepeak was energized and could have been a source of ignition. In addition, an exposed electrical wire on an energized circuit on the cargo deck could have created an electrical arc capable of igniting fuel vapor.

Figure 75. Cracks in bulkhead separating the forepeak from the port no. 1 cargo tank. The dashed section was removed and sent to the NTSB Materials Laboratory for analysis. SOURCE: COAST GUARD

The probable cause of the explosion aboard the barge *B. No. 255* was the lack of effective maintenance and safety management of the barge by Bouchard Transportation, which resulted in crude oil cargo leaking through a corroded bulkhead into the forepeak void space, forming vapor, and igniting. Contributing to the accident were the ineffective inspections and surveys by the Coast Guard and the American Bureau of Shipping.

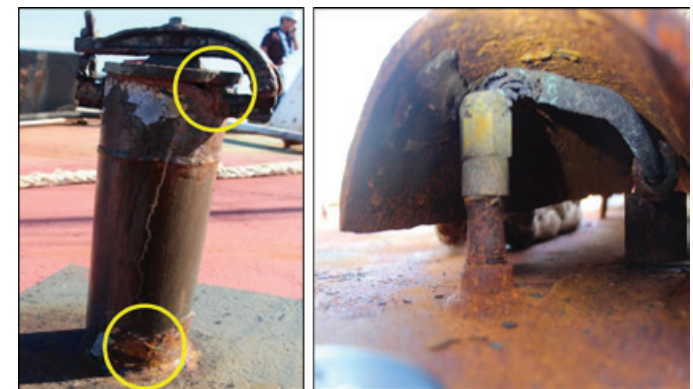
Figure 77. Postaccident photos of corroded no. 1 starboard cargo tank ullage tube (left) and wasted armored protected electrical cable with exposed wiring (right). SOURCE: COAST GUARD

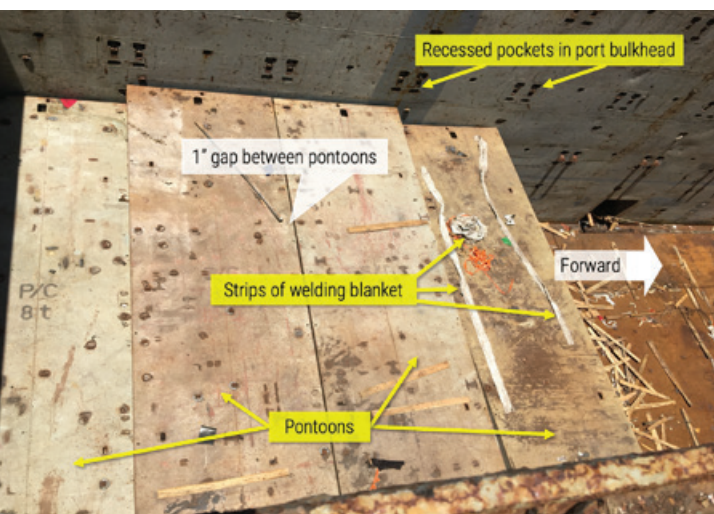
Figure 81. *Chipolbrok Moon* pontoon decks in cargo hold. A gap between the pontoons is labeled.

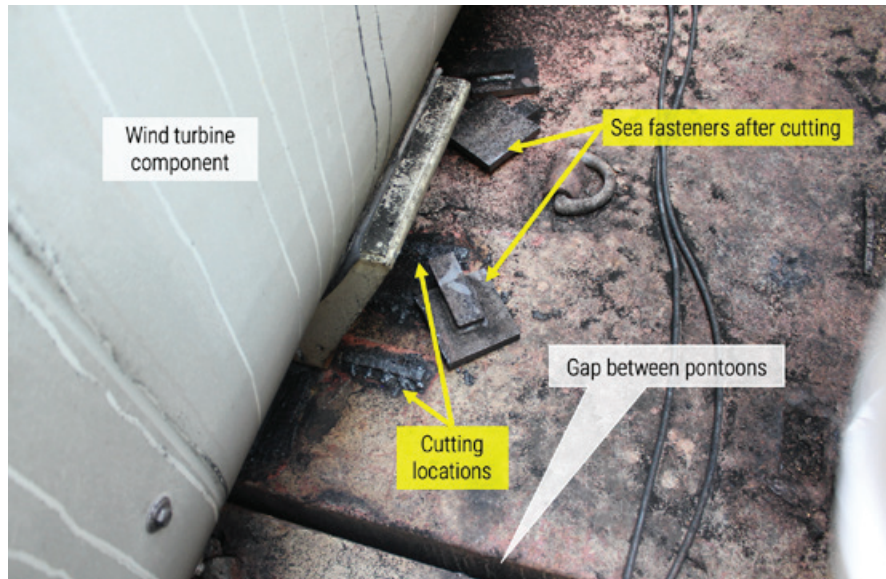
The fitter and the fire watch removed the steel tabs on the upper tween deck level, moved to the lower hold and cut away the tabs from the deck that had been installed to secure the cargo, then proceeded to the lower tween deck and cut the tabs off from that deck. They waited for about 25 minutes in the port cargo hold after completing hot work and then proceeded to the starboard cargo hold, where the oiler smelled smoke. About the same time, the fire alarm sounded throughout the ship, and the smoke detection system panel indicated an alarm in cargo hold no. 3. The crew closed the access manholes, and the third mate released CO₂ from the vessel's fixed fire-extinguishing system into cargo hold no. 3. The crew monitored the bulkhead temperatures in cargo hold no. 3 for the next 8 hours. The captain called and emailed the company offices in Houston and China but did not make any other notifications to the port or the Coast Guard, nor did he make any radio broadcasts during or after the fire, even though the vessel's response plan required doing so.

Figure 83. Left: Steel sea fasteners cut from deck in the portside no. 3 hold aboard *Chipolbrok Moon*, identified with yellow arrows. The gap between pontoons is also identified. SOURCE: HARRIS COUNTY FIRE MARSHAL

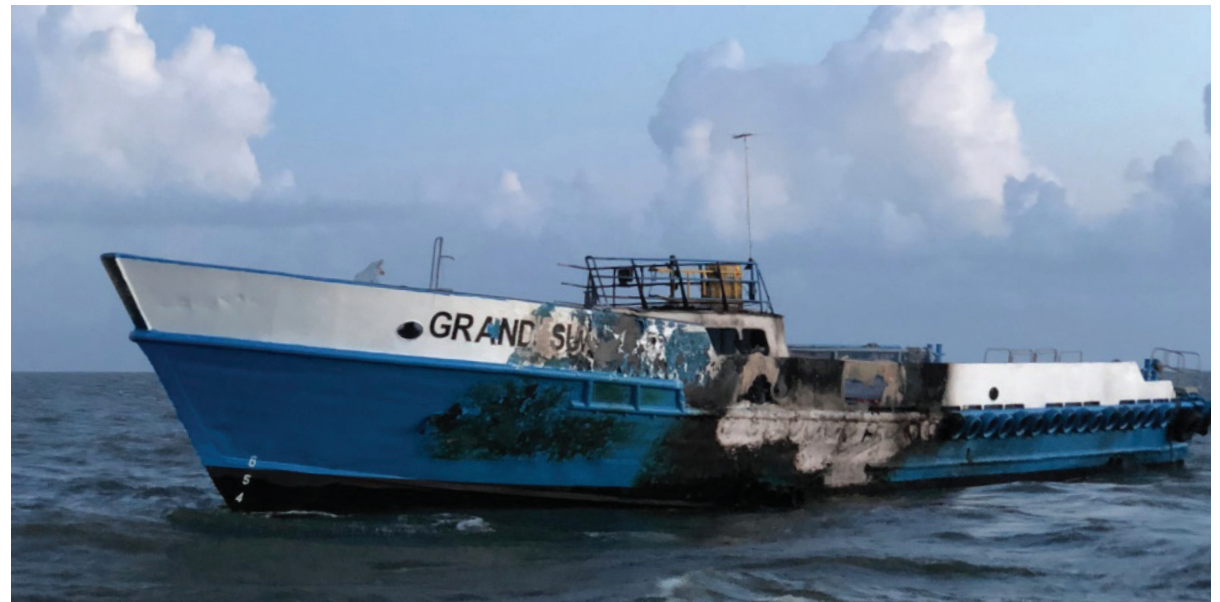
Figure 86. The *Grand Sun* post-fire.

The probable cause of the fire on the *Grand Sun* was the overheating of electrical wiring associated with a chest freezer or the receptacle powering it, which was located in an accommodation space. Contributing to the extent of the fire damage was the substantial use of combustible wood paneling and drapery throughout the accommodation spaces.

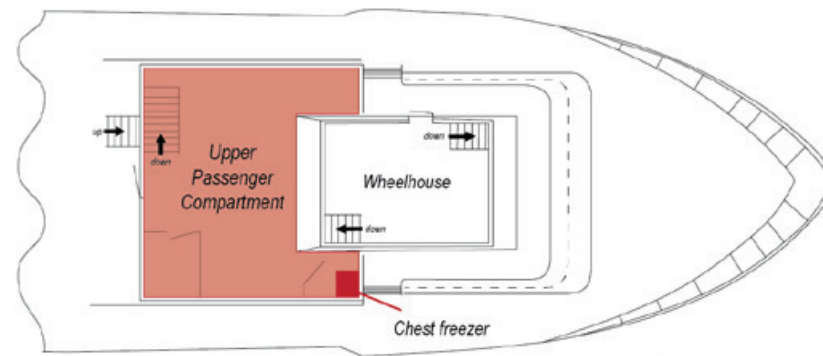
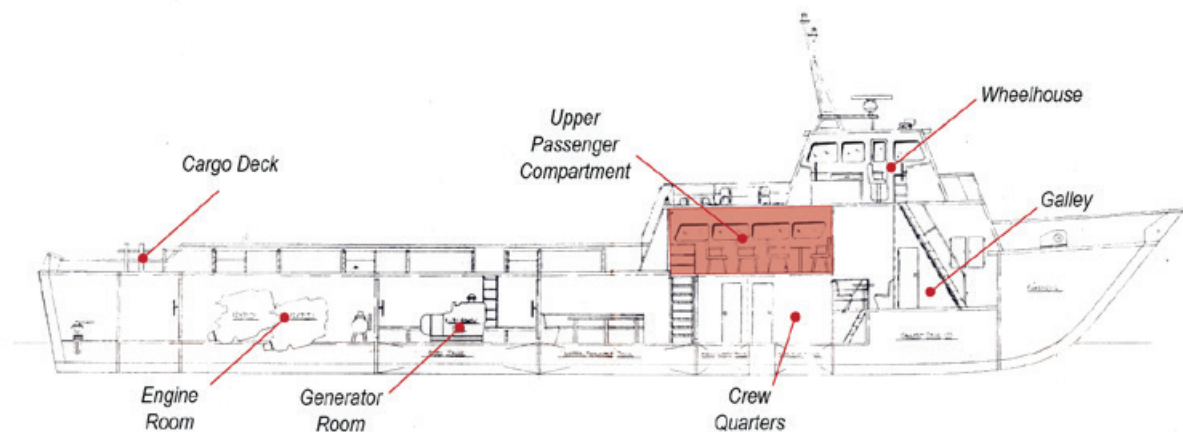
Figure 88. Vessel plans modified to show the wheelhouse, upper passenger compartment, galley, and crew quarters. The passenger compartment where the fire was discovered is highlighted in red, and the chest freezer is marked as a red square. SOURCE: Y&S MARINE INC , ANNOTATED BY NTSB

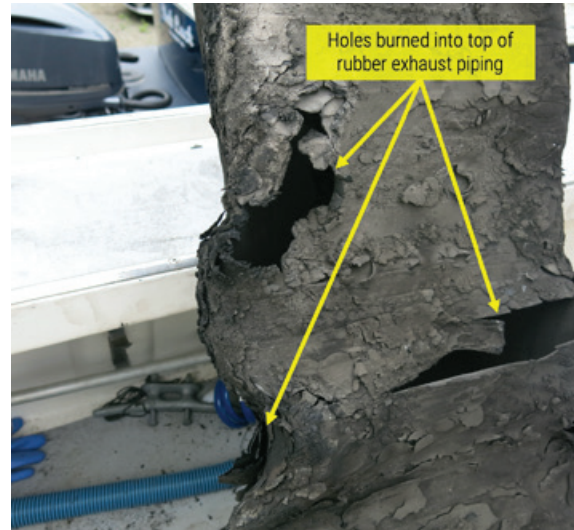
Figure 91. Damage to the engine as seen from above. Right: Damaged exhaust tubing after removal from engine room.

The vessel sank because of water used in suppression efforts and holes burned through the wet-exhaust hose from the heat of the fire, which allowed seawater to flood the engine compartment from the exhaust outlet on the port side of the vessel.

The probable cause of the fire aboard fishing vessel *Hit List* was the failure of a hydraulic hose fitting that sprayed pressurized hydraulic oil onto the engine, eventually causing the oil to ignite. Contributing to the sinking was water applied during firefighting efforts and flooding through the rubber engine exhaust tubing, which the fire burned through.

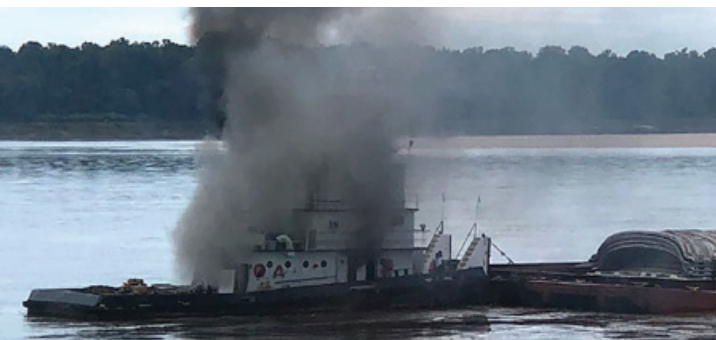
Figure 96. Smoke emanating from the open starboard-side and aft engine room doors on the main deck.

The *Jacob Kyle Rusthoven* was not fitted with a fixed fire-extinguishing system in the engine room, nor was it required to have one. By the time the mate reached a fire hose, the vessel had lost electrical power, and the fire pump in the main engine room therefore was not operable. Because the captain did not instruct the crew to activate the emergency fuel shutoff valves, and no one closed the main deck doors to the engine room, the fire was able to spread rapidly.

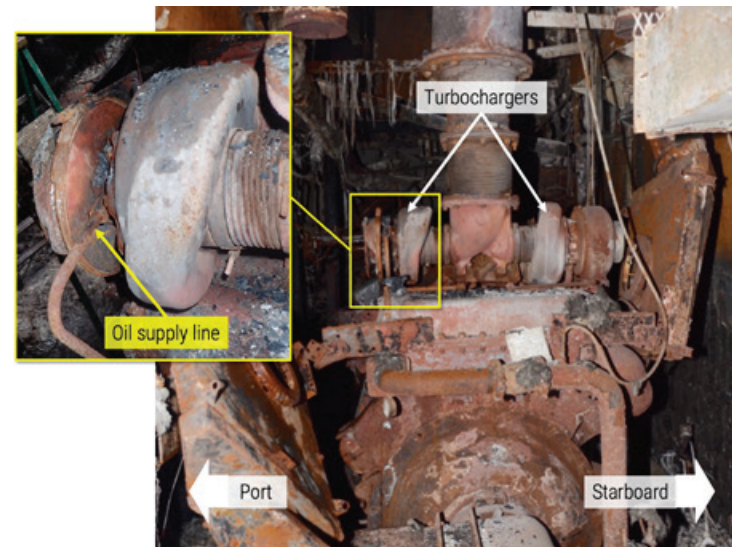
The fire was determined to have originated at or near the inboard turbocharger on the starboard-side main engine based on the heat damage at that location. A commercial forensics science firm found that a loose fitting on the lube oil supply line was a likely fuel source. Considering witness accounts of the captain operating the vessel at full power, it was likely that when smoke first appeared, the lube oil in the line to the turbocharger was at or near its maximum operating pressure. The pressurized lube oil could have atomized from the loosened fitting and consequently come into contact with a hot surface on the starboard engine near the turbocharger. The atomized oil would have likely ignited and eventually spread the fire to adjacent combustible materials in the engine compartment, before spreading upward.

Figure 97. Fire-damaged starboard main engine, while looking forward. The yellow box highlights the inboard turbocharger with its casing and compressor missing due to the damage. The inset shows the lube oil supply line fitting that was found to be loose.

The probable cause of the engine room fire on board the towing vessel *Jacob Kyle Rusthoven* was an engine lube oil leak that ignited off a hot surface near the starboard main engine turbocharger. Contributing to the severity of the fire was the lack of crew measures to activate the engine fuel supply shutoffs and secure open doors ventilating the engine room.

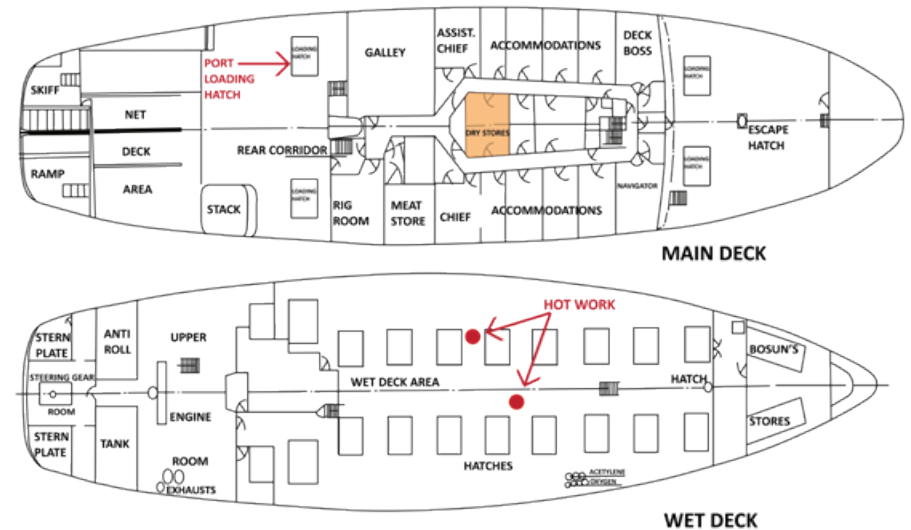
As a result of firefighting efforts, the *Jeanette's* wet deck began to flood, and the vessel began to list slightly to port. The vessel continued to burn, so at 1552, it was towed south into the Pacific Ocean. On December 6, at 1039, the vessel sank in open water about 15 miles offshore.

Figure 102. Vessel deck plans modified for clarity and to show the location where the hot work occurred on the wet deck (represented by red circles) and the location of the dry stores locker where the fire was discovered on the main deck (shaded in orange). Note the port loading hatch on the main deck, where water entered and caused listing.

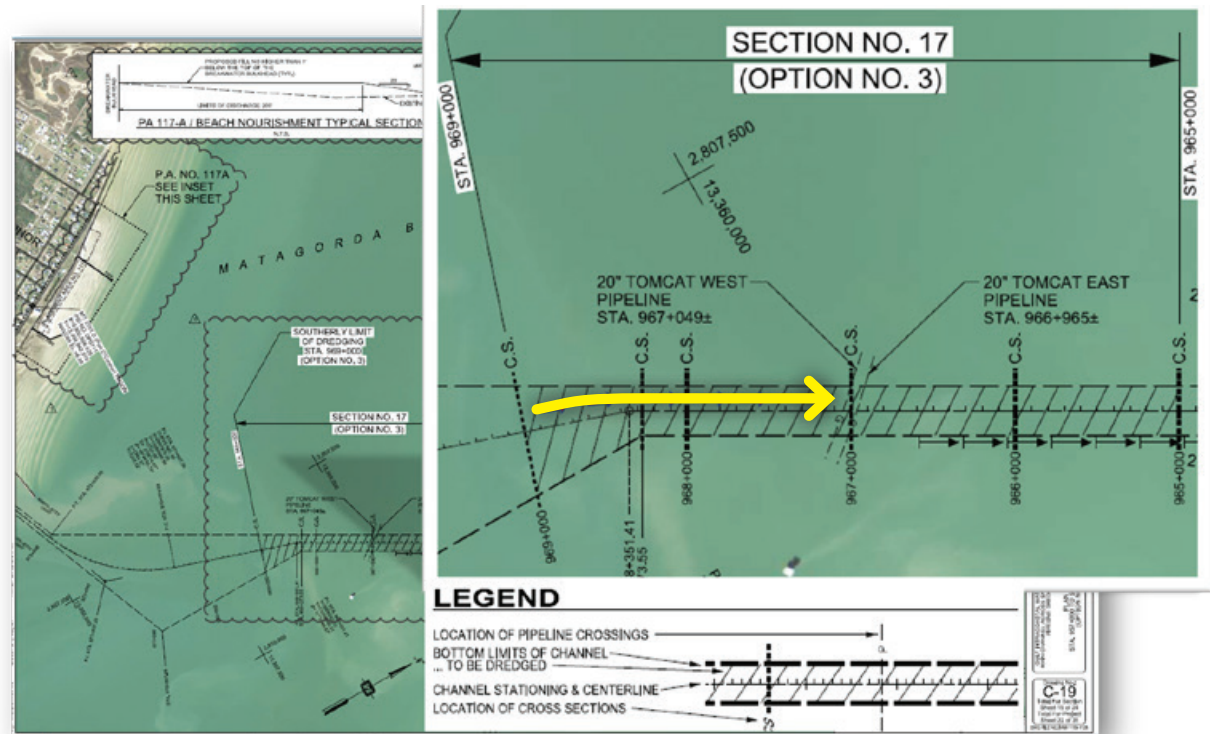
Figure 105. Extracts from Corps of Engineers Drawing No. C-19 depicting the dredging plan for Option No. 3, Section No. 17 for the Gulf Intracoastal Waterway. The yellow arrow displays *Jonathon King Boyd's* easterly dredging trajectory, commencing at the southern section (STA. 969+000).

Pipeline positions could, and as per company policy should, have been entered into the HYPACK software, but according to the crew, the positions were not displayed in the software they had. According to the company, the production engineer was responsible for entering the location of utilities and that information was typically provided to them at the beginning of the project. RLB Contracting relied on a single shoreside individual (the production engineer) to carry out appropriate notifications and to input the data for the vessel software, which, in this instance, led to a single-point failure.

The probable cause of the fire aboard the cutter suction dredge *Jonathon King Boyd* was RLB Contracting's failure to inform the crew about utilities in the area due to ineffective oversight, which led to dropping a spud onto a buried submarine pipeline, causing natural gas to release and ignite.

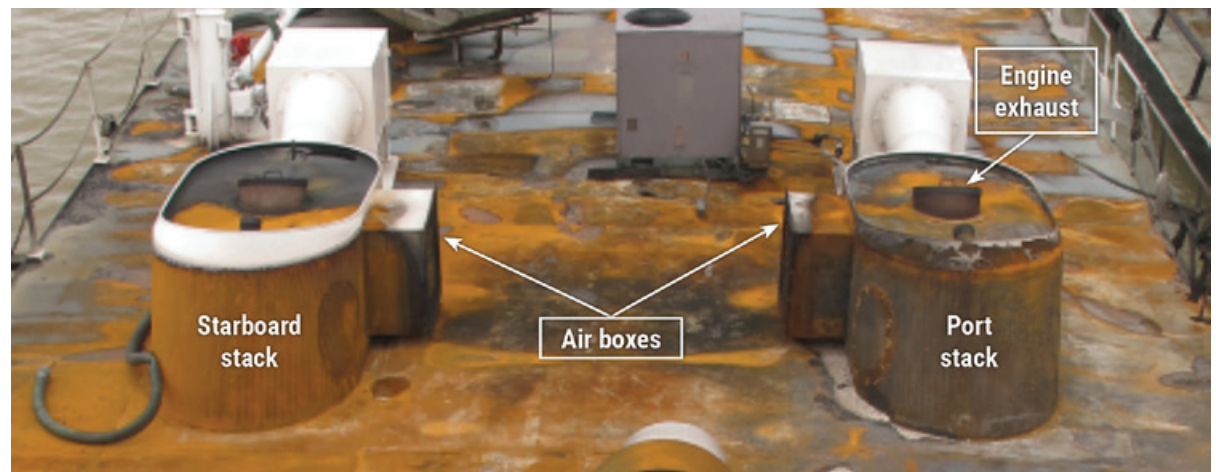
The probable cause of the engine room fire on board the *Leland Speakes* was a catastrophic failure and crankcase breach of the port main engine resulting from failure of the caps that secured two piston connecting rods to the crankshaft. Contributing to the severity of the fire was the vessel's lack of a fixed fire-extinguishing system for the engine room and lack of redundant fire pumps.

Figure 109. Looking aft at stacks and air boxes post-fire.

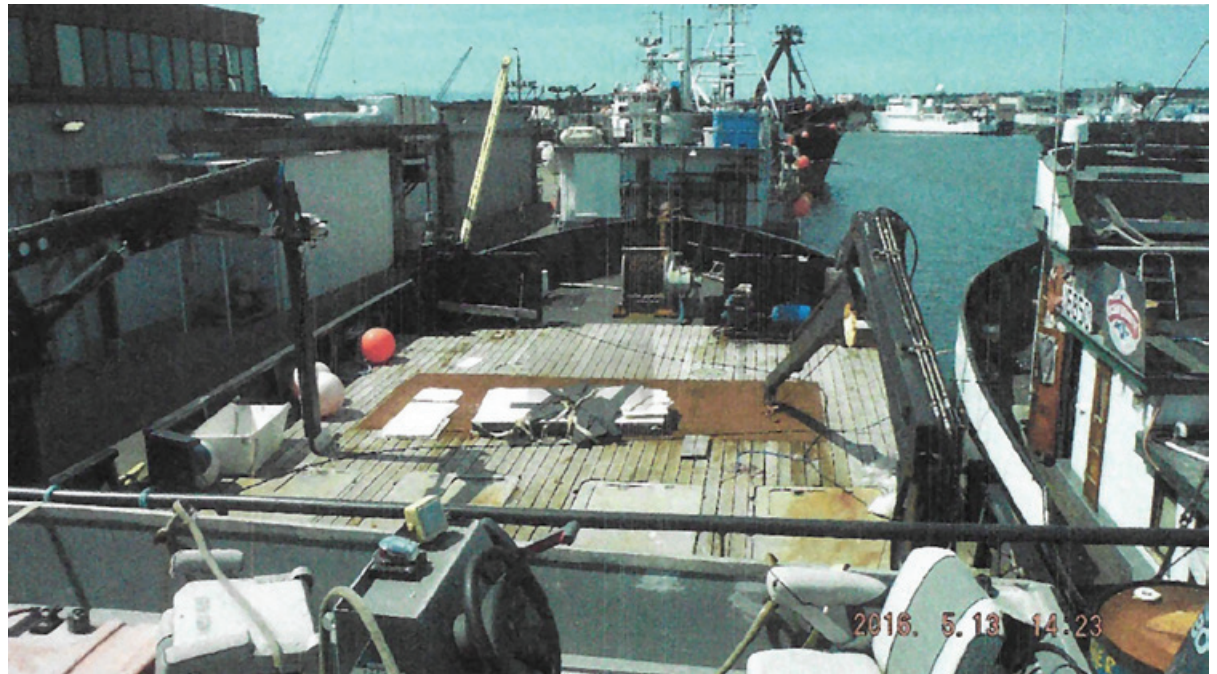
Figure 112. Photo from a 2016 survey report documenting the condition of *Logger* shows wooden deck boards on the main deck, from where the captain saw smoke emanating.

The captain surmised that the fire may have been started by wiring that led to the forepeak for the fish hold pumps, based on the smoke he saw emanating from the main deck and the wooden planks on the main deck, which indicated to him that there may have been a fire below the deck. He noted that the fire had to be substantial in size for smoke to penetrate the deck. However, he stated that the fire spread so rapidly that he could not confirm this possibility with certainty.
