SAFER SEAS DIGEST

2019

Lessons Learned *from* Marine
Accident Investigations

NTSB | National
Transportation
Safety Board

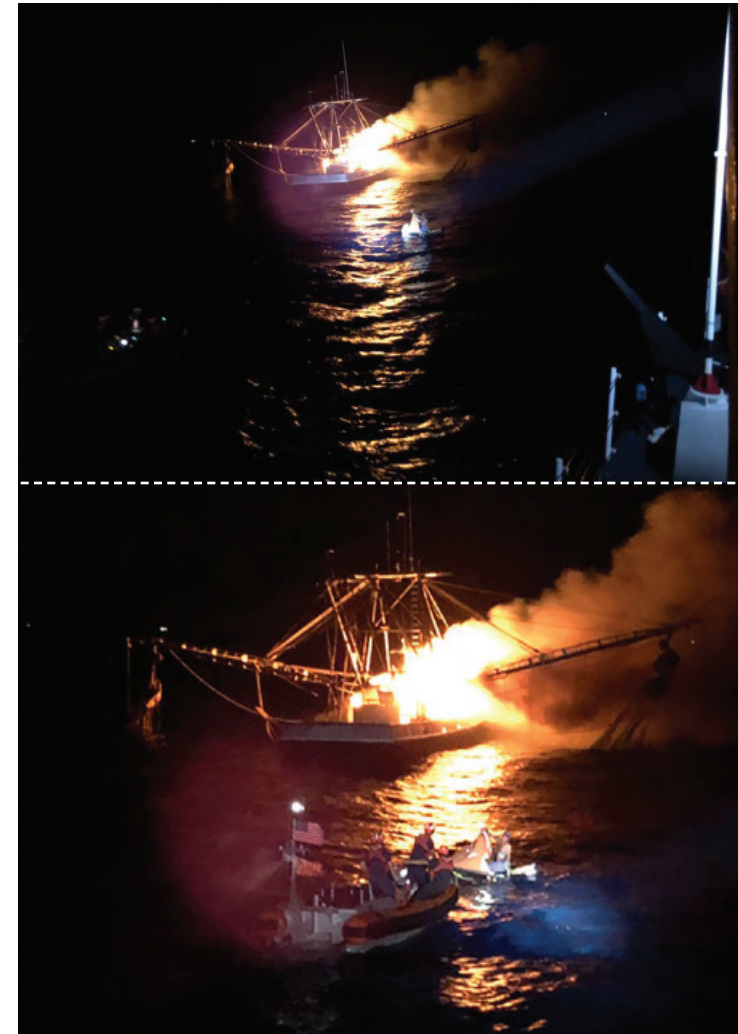
The destruction of the nonmetallic hoses connecting intake piping to the vessel's through-hull fittings, due to the long-term exposure to the heat of the fire, most likely resulted in the sinking of the vessel. As nonmetallic hoses failed, water would have entered the hull, causing the vessel to slowly sink.

The probable cause of the fire aboard the fishing vessel *Master D* was leaking lube oil from the diesel generator that contacted a hot engine surface and ignited. Contributing to the eventual sinking was the failure of fire-damaged nonmetallic hoses connected to through-hull fittings below the waterline.

Figure 115. *Master D* on fire while the crew is rescued by the Coast Guard. SOURCE: COAST GUARD

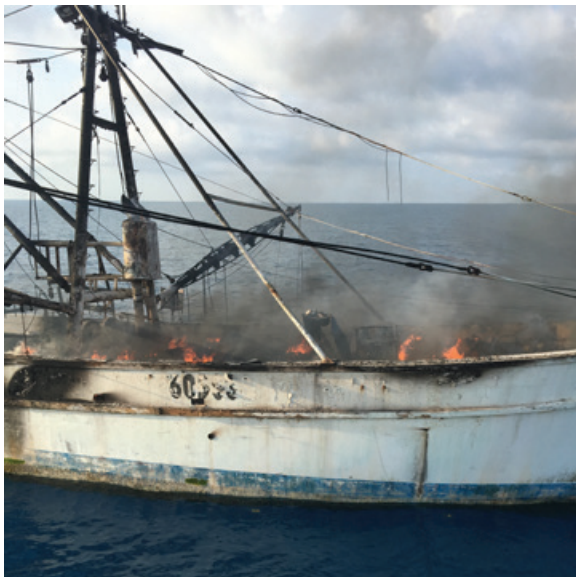
Figure 116. Burning hull of *Ole Betts Sea*.

The *Ole Betts Sea* was not salvaged, and thus it was not possible to determine the exact cause of the fire. However, based on the sequence of events, sounds, and vibrations reported by the crew, investigators developed a likely cause for the initiating "boom," heavy gray smoke, and subsequent explosion and fire that burned out of control.

The probable cause of the fire and sinking of fishing vessel *Ole Betts Sea* was a mechanical failure of the generator's diesel engine, which led to a fuel-fed fire that burned out of control.

Following the initiation of an engine room fire, it is imperative to remove the source of available fuel to the fire found in the fuel oil and lube oil systems. In this accident, the vessel had no remote emergency cut-off valves for fuel and lube oil systems outside the engine room, and thus fuel to the fire could not be stopped and the vessel was eventually consumed by the flames. Vessel designers, builders, owners, and operators are encouraged to install, regularly test, and have emergency drills that incorporate remote cut-off valves for fuel and lube oil lines.

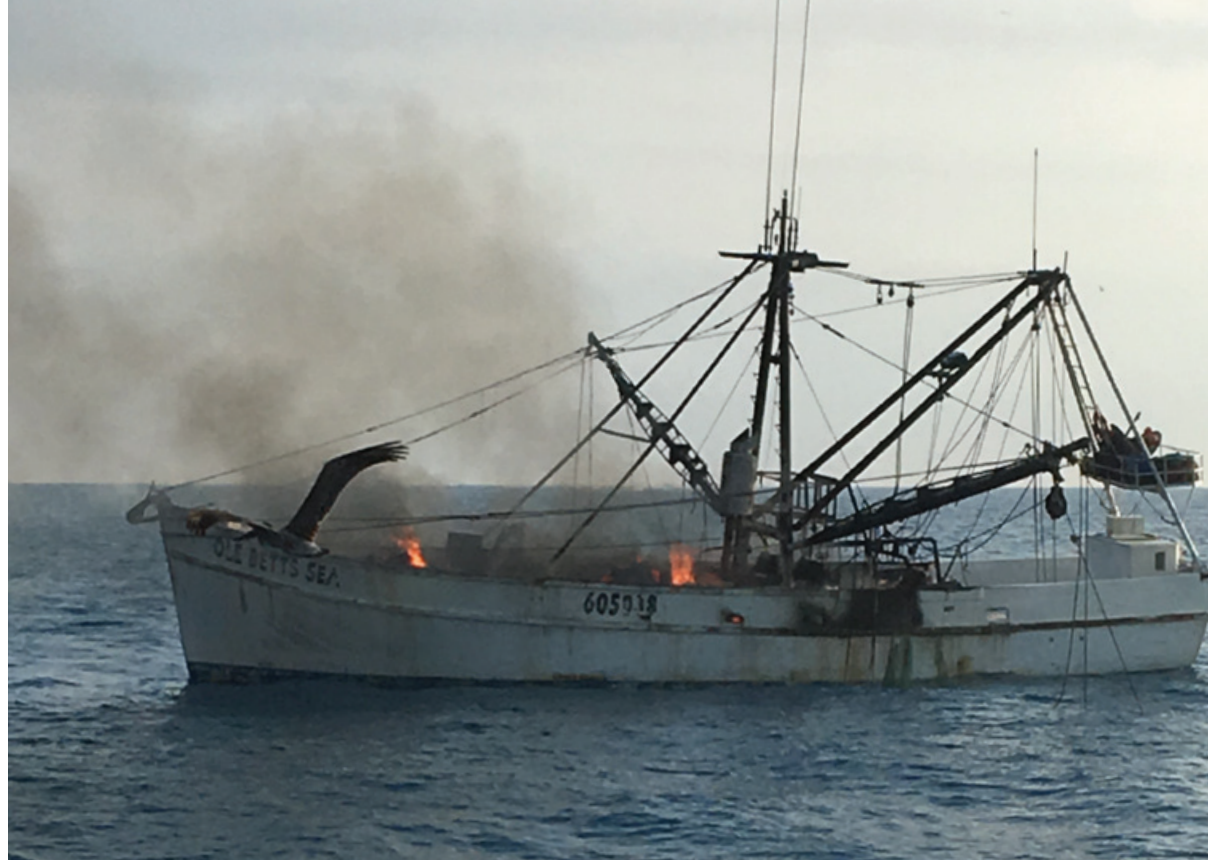
Figure 117. Burning hull of *Ole Betts Sea*. SOURCE: TRICO SEAFOOD, INC.

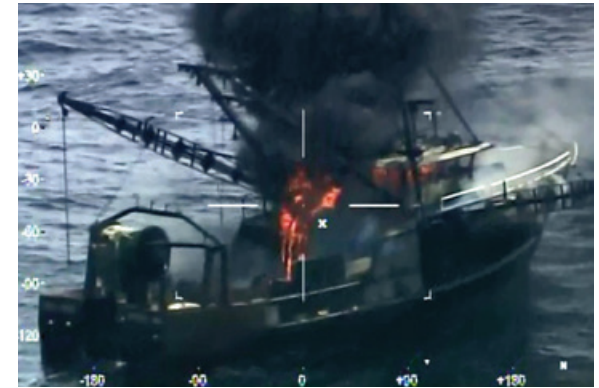
Figure 120. Video screenshot of the *Rose Marie* from the Coast Guard's aircraft, which had been dispatched to the fire. The camera's crosshairs capture the flames consuming the net on the drum. SOURCE: COAST GUARD

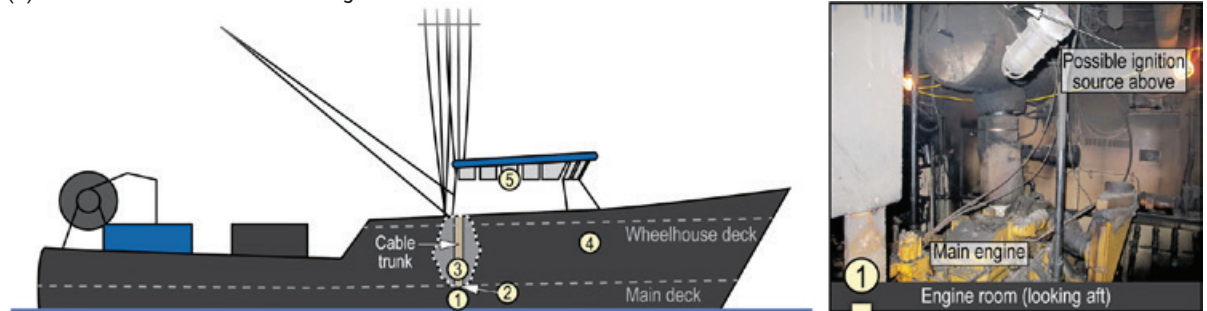
Flames cannot spread easily through insulated steel decks or bulkheads. The deck between the accommodation space and the wheelhouse was steel, but the cable trunk running through it was constructed of uninsulated flammable material (wood). Had the trunk opening been sealed and its surrounding structure insulated with fire-retardant materials, the fire would not have been able to rapidly spread, and damage may have been limited to the engine room.

The probable cause of the fire aboard the fishing vessel *Rose Marie* was arcing of an electrical wire in the engine room overhead igniting a wooden cable trunk. Contributing to the severity of the damage was the installation of a trunk that compromised the steel boundary of the engine room, allowing the flames to spread to the combustible materials in the upper decks.

Figure 121. The sequence of the fire's path can be traced in these images as flames (1) began above the main engine in the engine room, (2) traveled through the wooden cable trunk opening overhead, (3) entered the accommodation space through the cable trunk opening, (4) spread through the galley and throughout the accommodation space, and (5) entered the wheelhouse through the cable trunk and ladder access.

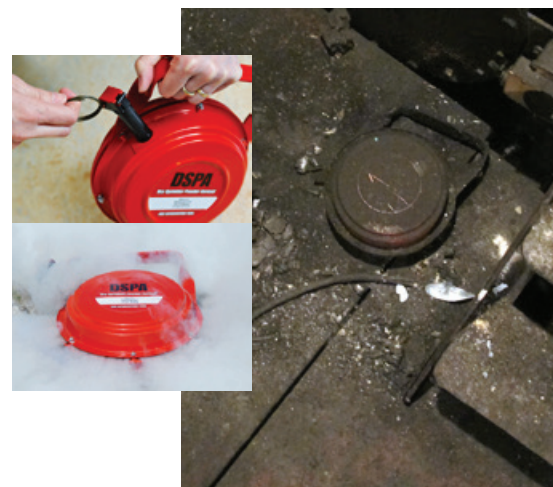
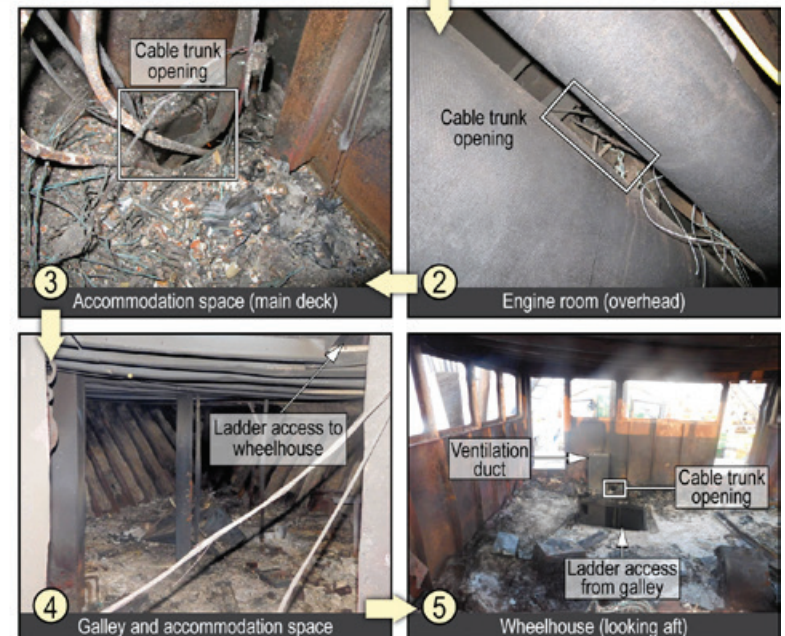
Crewmembers attempted to fight the fire using a grenade-type aerosol extinguisher rated for spaces up to 5,300 cubic feet in volume. The manufacturer recommended that spaces be sealed completely when using the handheld aerosol grenade, yet the engine room door and vents remained open throughout the fire, rendering the extinguisher ineffective.

Figure 122. Below: grenade-type aerosol fire extinguisher used initially to combat the fire sits on the deck of the engine room near the entrance ladder. Inset: two photos from the manufacturer's website demonstrate how the device activates.

Grenade-type aerosol fire extinguishers were used to fight engine room fires in this accident and an earlier fire on the fishing vessel *Logger*—but did not extinguish the fire in either accident. In both cases, the crews did not close all openings, such as engine room doors and other ventilation, thus reducing the effectiveness of the extinguisher. When using such devices or designing any vessel space for the prevention of fires, vessel owners and operators should identify openings, provide means to ensure they can be properly secured in order to contain a fire, and train crewmembers on how to secure them during a fire emergency.

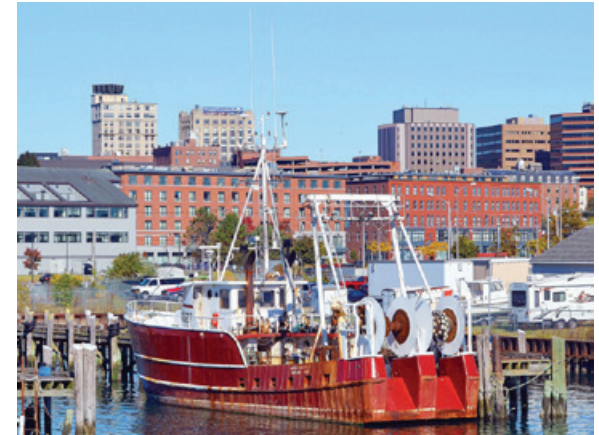
At 0200, waves hitting the stern of the vessel sheared the pins holding the port and starboard stern ramp gates closed, letting them open, and increasing the amount of water on the deck. The crew was able to secure the two stern ramp gates using rebar, but the makeshift rebar pins kept breaking. About the same time, the port lobster tank cover loosened again and moved off the tank opening.

Figure 125. Aft view showing the ramp gates.

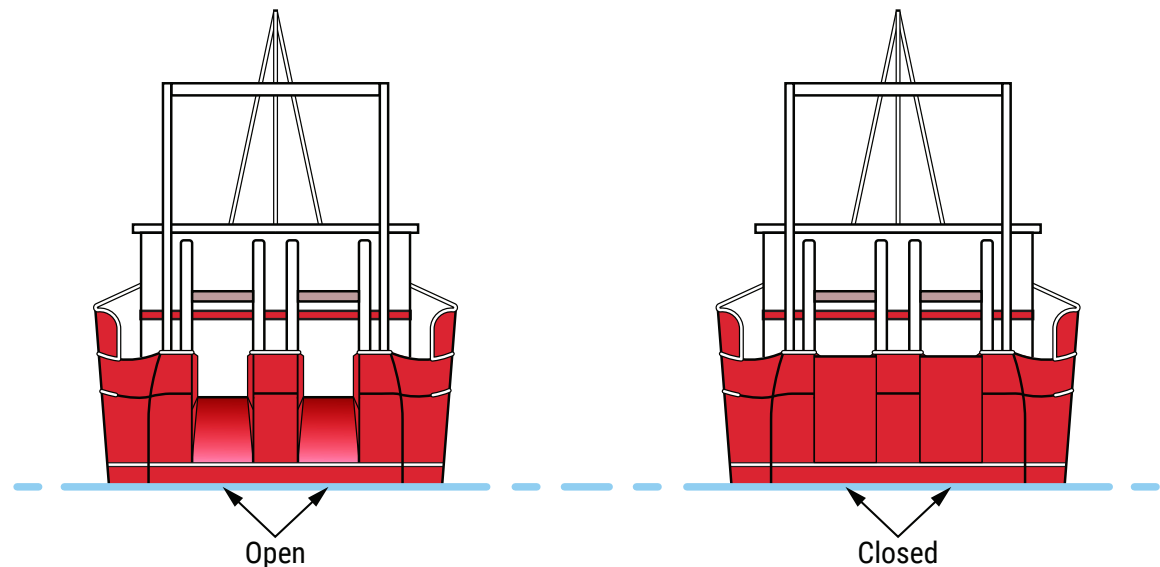
Figure 126. A diagram of the stern ramp gates in the open (at left) and closed (at right) positions.

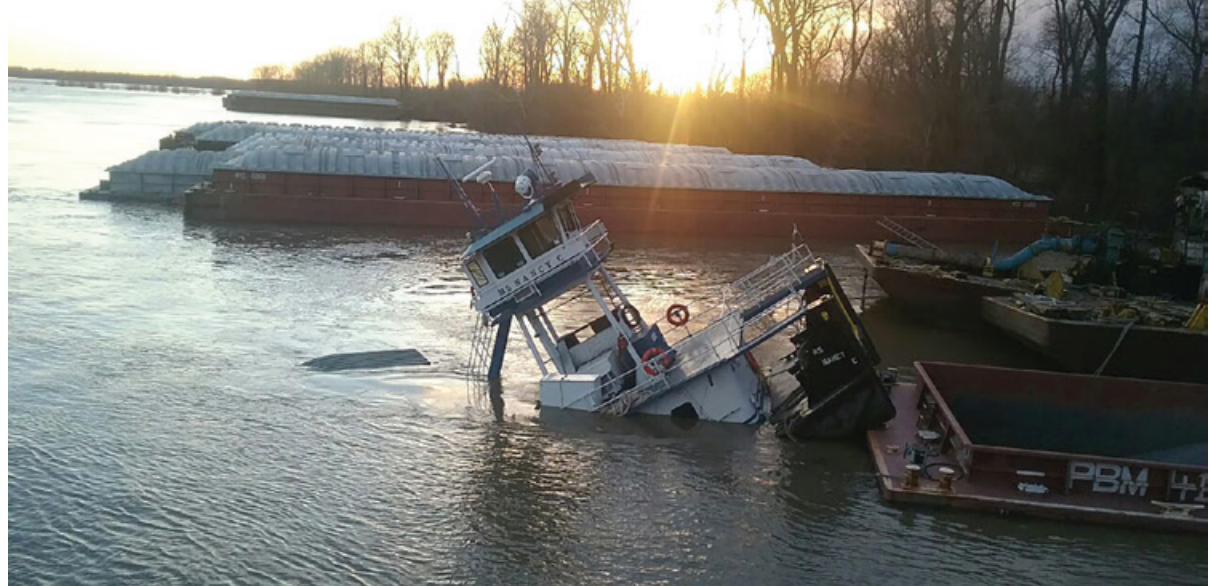
Figure 128. Postaccident photo of *Ms Nancy C*.

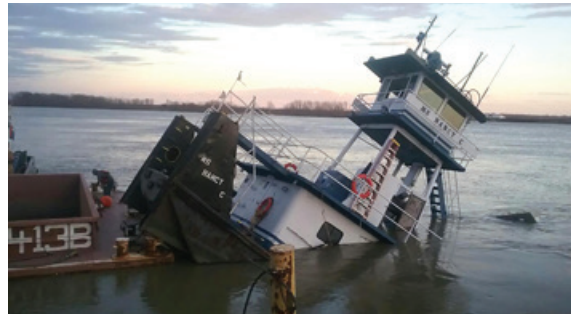
Figure 129. *Ms Nancy C* prior to salvage.

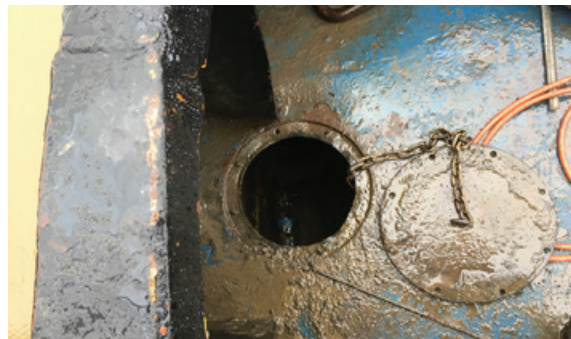
Waves as high as 3–4 feet with whitecaps that day likely splashed against the port and starboard sides of the vessel. Rain and water from the waves could have then entered the voids through the loose access covers or wastage at the aft portion of the deckhouse.

The probable cause of the flooding and sinking of the towing vessel *Ms Nancy C* was inadequate maintenance of the vessel by Chocktaw Transportation Company, resulting in corrosion and the loss of watertight integrity on the main deck, which allowed uncontrolled water ingress into the vessel's stern voids.

Figure 130. Starboard deck access to aft stern void found open during salvage, with broken and missing access cover screws.

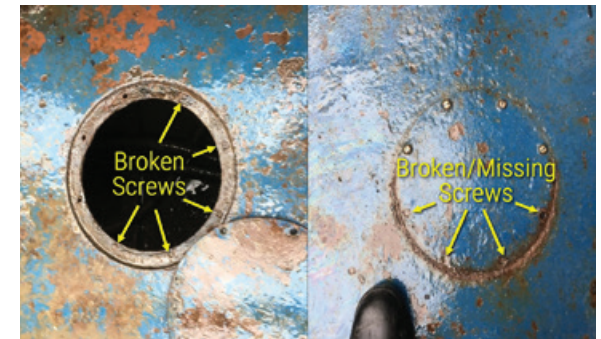
The amount of water entering the vessel exceeded the capability of the two portable pumps. This quantity of water increased the stern trim and decreased the aft freeboard so that water was able to freely enter the three open access covers to the stern voids, as well as through several other loose access hatches and poorly fitted doubler plates. As the vessel sank further, water would then have entered the engine room through wastage on the aft side of the deckhouse and over the sills of the open engine room doors.

Figure 132. Starboard deck access to forward stern void found open during salvage. At right, port deck access to aft stern void, with broken and missing access cover screws.

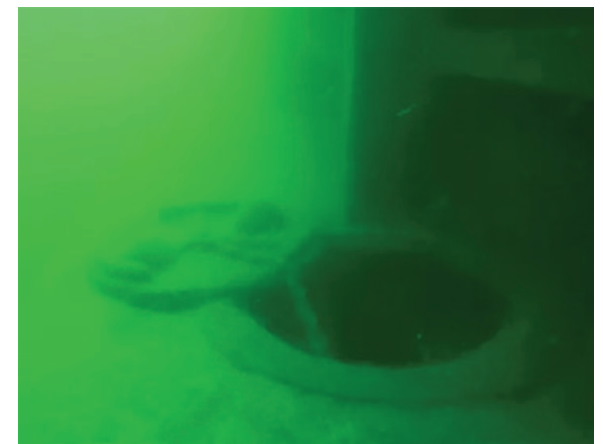
The probable cause of the sinking of barge *PTC 598* was flooding of the barge's voids through improperly secured manhole covers due to the charterer's failure to ensure adherence to its procedures for barge watertight integrity and draft limits.

Figure 138. The open starboard manhole to void no. 3 on the *PTC 598*.

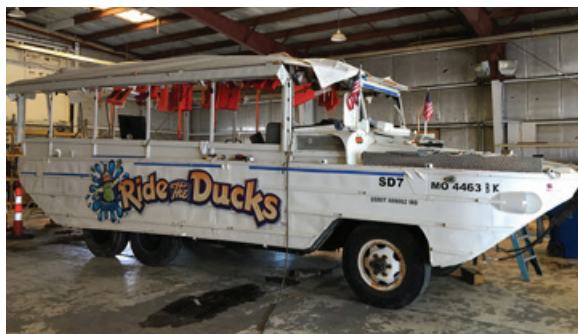
Figure 139. *Stretch Duck 7* after being recovered from Table Rock Lake following the sinking.

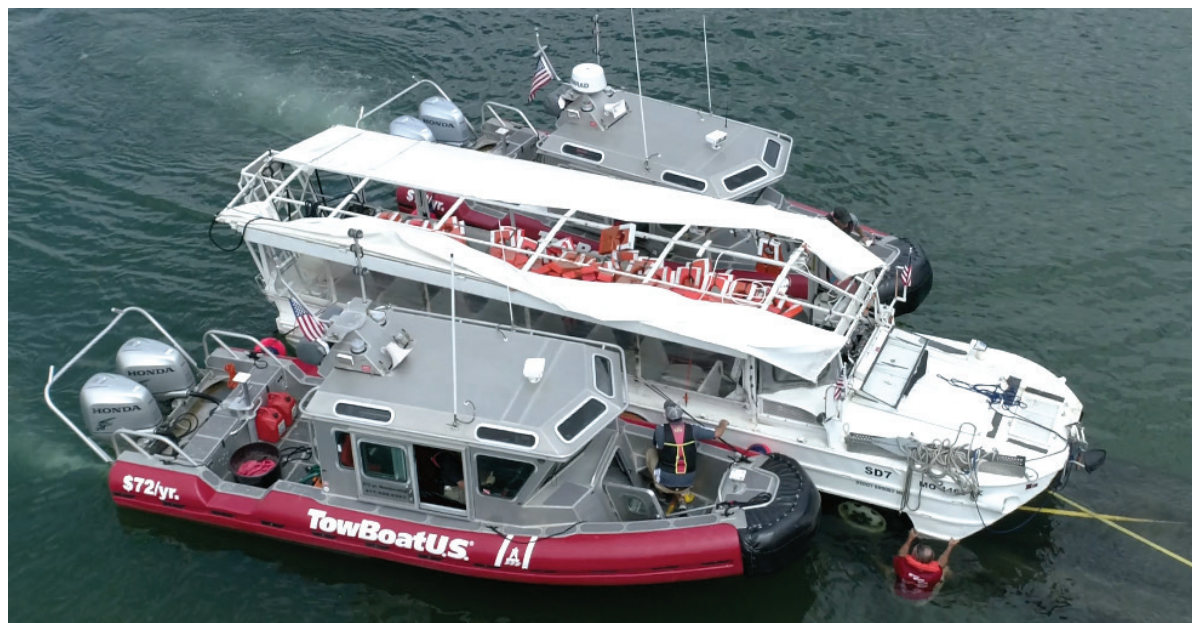
Figure 140. Torn canopy on the *Stretch Duck 7* during recovery at Table Rock Lake.

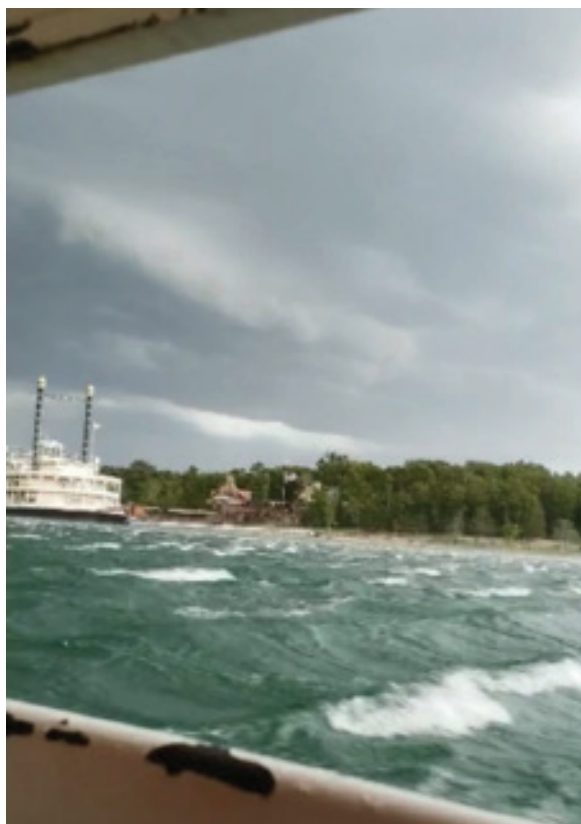
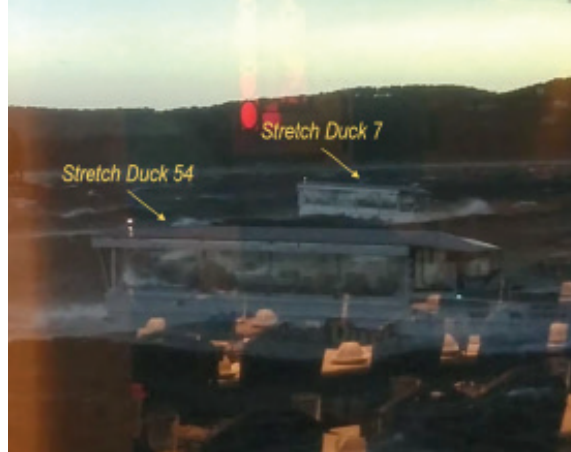
Figure 142. Below: About 1900, screenshot from passenger video shows whitecaps building on the lake seconds before the starboard-side curtain (top left) was closed on the *Stretch Duck 7*. In the background is the moored passenger vessel *Showboat Branson Belle*.

Figure 143. At 19:05:03, screenshot from video taken by a passenger inside the *Showboat Branson Belle* captures the *Stretch Duck 54* passing the *Stretch Duck 7* as they attempt to reach the exit ramp. Furnishing from the showboat's dining area is reflected in the glass.

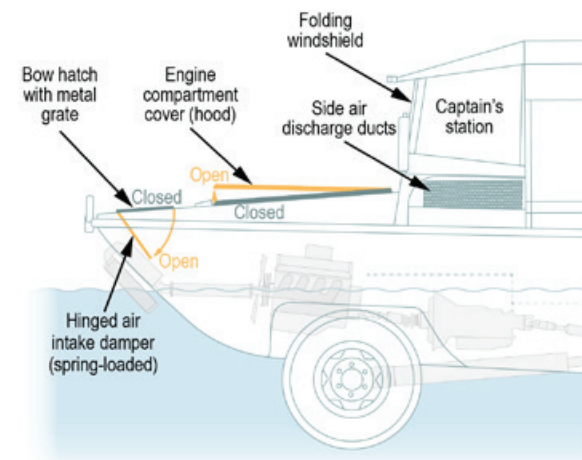
Engine compartment openings. As wind-driven waves washed over the *Stretch Duck 7*'s bow several times, water likely entered the vessel through the air intake hatch located on the forwardmost point of the bow. The

purpose of the hatch, when opened, was to allow air in the engine compartment for cooling the space during normal operations. Waves likely rolled over the bow hatch's spring-loaded damper and intermittently opened it, thereby allowing water into the engine compartment. As the water accumulated in the engine space, the *Stretch Duck 7*'s bow sank lower, and as relatively higher waves rolled across the hatch, the rate of flooding would have increased.

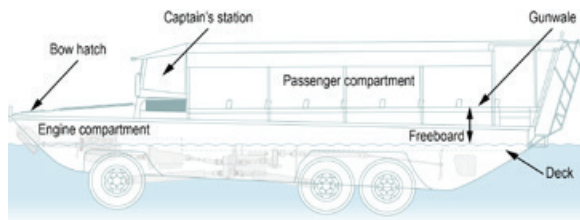
Figure 144. Profile drawing of *Stretch Duck 7* also showing engine, drive train, and propeller.

Reserve buoyancy. The *Stretch Duck 7* did not have any compartmentalization or subdivision that would have contained the floodwater entering the engine compartment. As the vessel headed into the wind and waves, its pitching motion increased, allowing floodwater to travel throughout the vessel, eventually filling the passenger compartment. Without any built-in flotation or other reserve buoyancy to counter the flooding, the *Stretch Duck 7* started sinking. As the vessel's reserve buoyancy was overcome, its freeboard was reduced to zero.

The *Stretch Duck 7* likely would not have sunk, had the Coast Guard implemented the NTSB's recommendation requiring sufficient reserve buoyancy on amphibious passenger vessels through "passive means, such as watertight compartmentalization, built-in flotation, or equivalent measures" issued 17 years earlier as a result of the fatal sinking of another DUKW, the *Miss Majestic*, which flooded progressively from a relatively small gap at the driveshaft below the waterline.

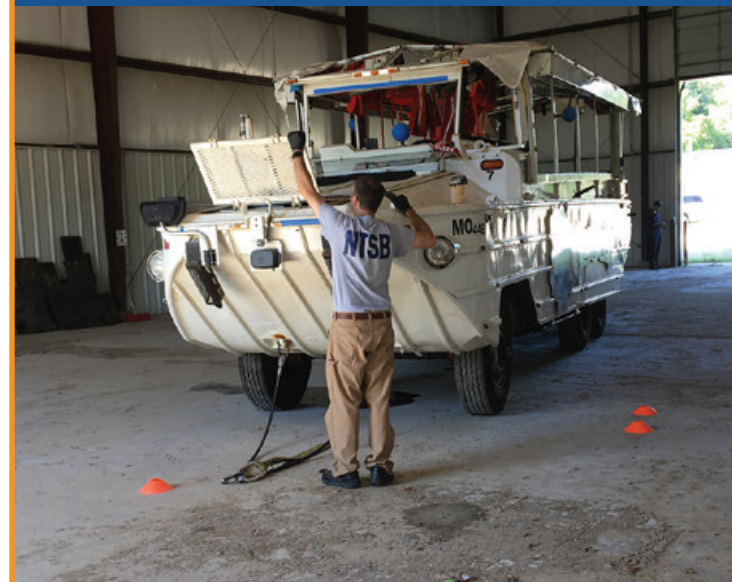
Figure 146. NTSB investigator inspecting the accident vessel's bow hatch.

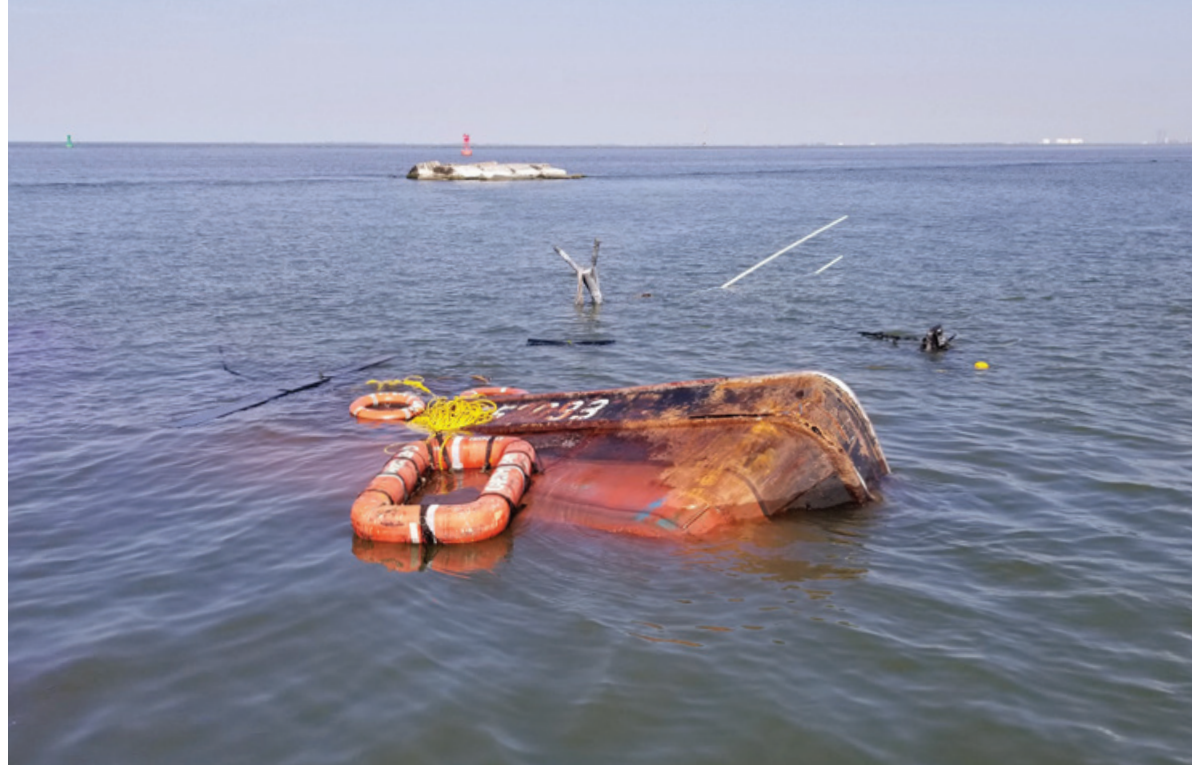
Figure 148. Starboard quarter of the *Capt. M&M* wreckage. Sabine Pass Jetty Channel buoys "19" (green) and "20" (red) appear in the background.

Progressive flooding into the engine room occurred via a cutout in the collision bulkhead. This bulkhead had been modified with a cutout to allow crew access between the engine room and forepeak, which is common in this industry according to Coast Guard personnel. However, the modification defeated the purpose of a watertight collision bulkhead, which is to limit flooding to the forward compartment of a vessel following a collision. Once flooding reached the engine room, the vessel likely lost stability and capsized.

The probable cause of the grounding of the fishing vessel *Capt. M&M* was the failure of the wheelhouse watchstander to keep a proper navigation watch. Contributing to the sinking was a modification to the watertight collision bulkhead that allowed progressive flooding.

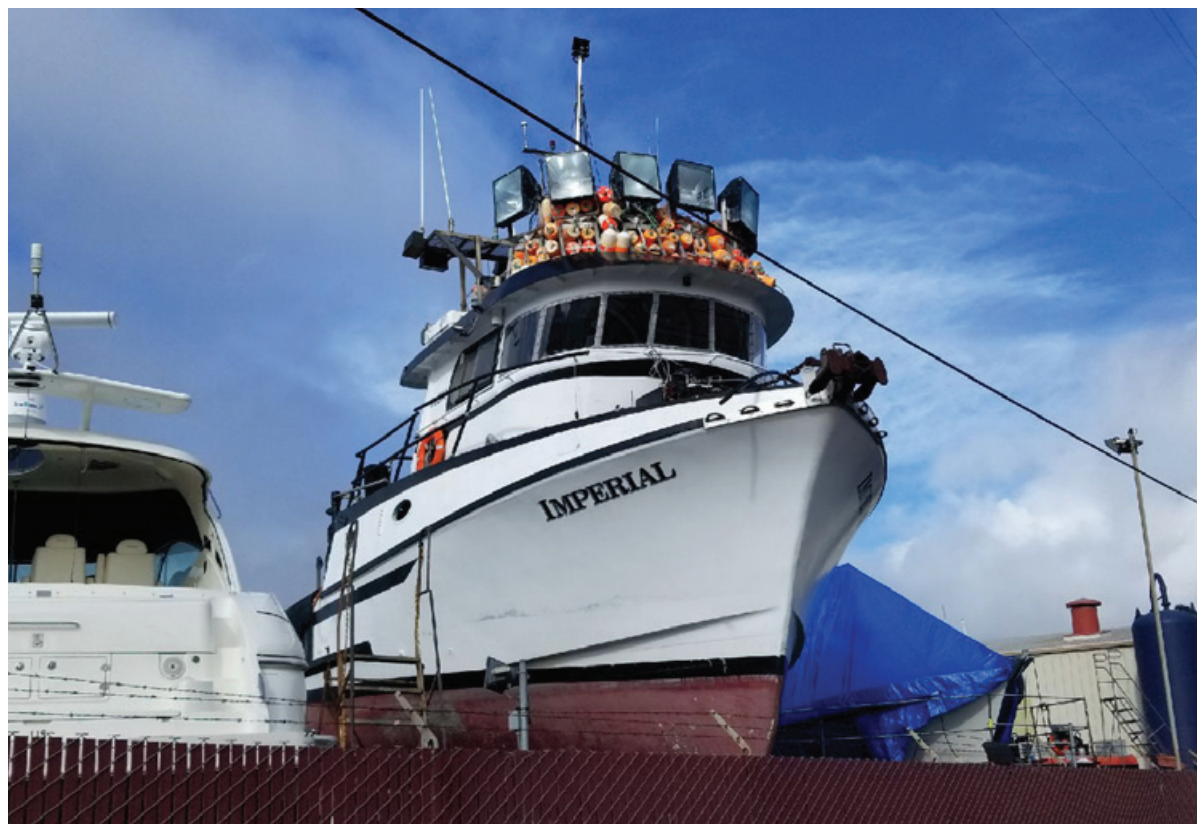
At 0445, he was awakened by the vessel shaking. He saw the cliffs of Point Reyes in front of him and rocks and white water from the breaking surf around him. The crew awakened—they found water in the engine compartment and could not stop the incoming water. With the engine still running, the captain steered the vessel further out from the surf. He shut down the engine to prevent damaging it and made a mayday call to the Coast Guard at 0508. The vessel received two portable pumps from a Good Samaritan vessel and crewmembers from a responding Coast Guard motor lifeboat assisted with continuous dewatering of the engine room. The Coast Guard motor lifeboat towed the *Imperial* to San Francisco.

Figure 150. *Imperial* on blocks after the accident.

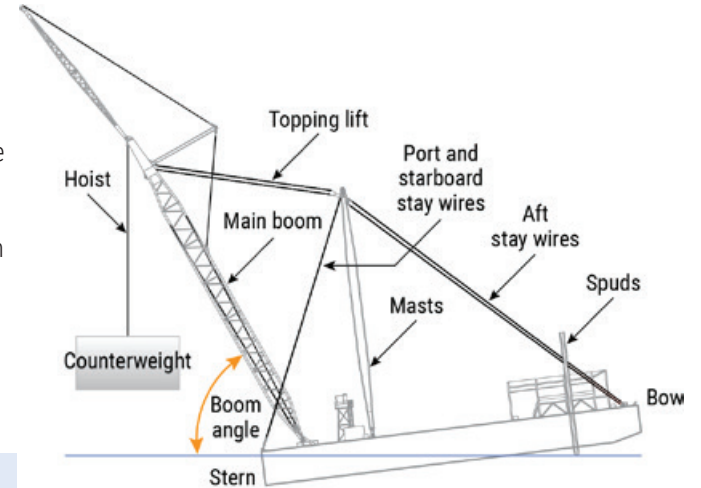
A crane that is not level due to a list causes sideloading of the boom, thus reducing the rated capacity. The crane operator stated that he boomed up to 69 or 70 degrees; the Keppel AmFELS' incident report stated 68 degrees. Therefore, the vessel would have trimmed at least 7 degrees by the stern for the boom angle to read 60.7 degrees when the weight was suspended. At 60.7 degrees of boom angle, the crane's maximum capacity was 645 tons; the actual 671-ton lift exceeded the capacity by 26 tons. The trim likely contributed to the crane being overloaded by reducing the boom angle relative to the water.

Figure 155. Simplified diagram of *Atlantic Giant II* illustrates barge's trim and boom angle relative to sea surface, as crane hoists *TOPS DB1*'s counterweight. (Dimensions and angles not drawn to scale.)

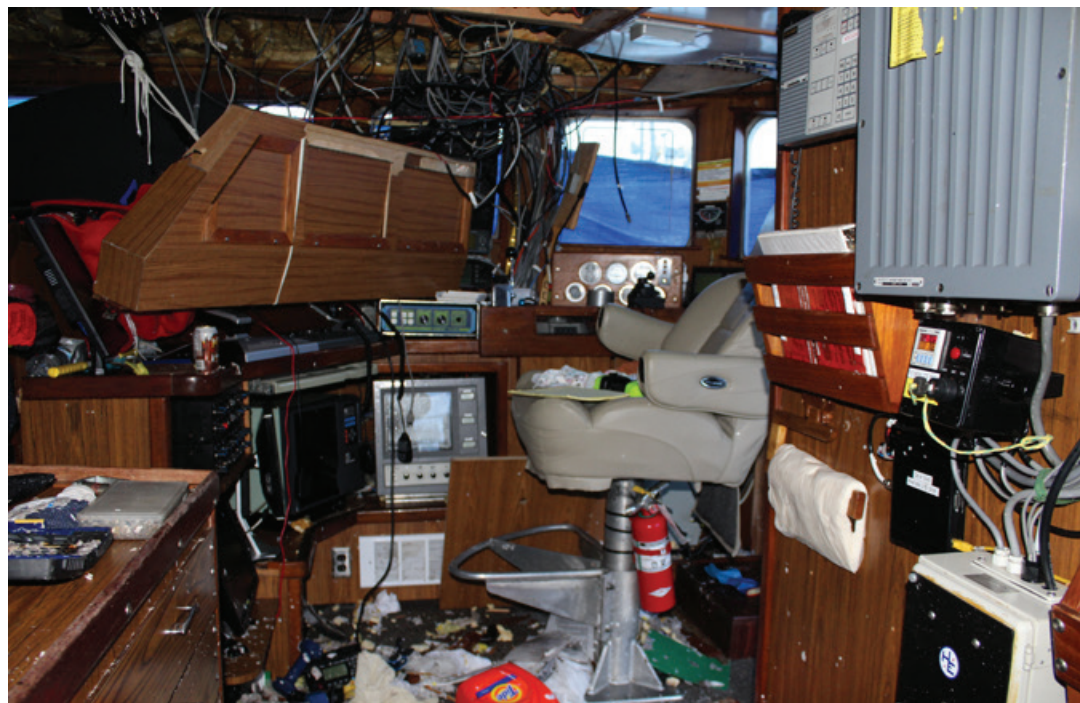
The wheelhouse ceiling “had been ripped off and our radios were torn away,” and there was “a river of water rushing down the [wheelhouse] stairs into the galley.” The crew immediately began to assess and react to the situation to secure the vessel. About 30 minutes after the wave struck the *Progress*, damage control was completed. The crew donned survival suits and then the captain, assessing that the vessel had lost all communications and navigation equipment, decided to activate the EPIRB and shoot flares, hoping vessels would respond. Shortly thereafter, one of the radios was repaired, and the captain called the Coast Guard and nearby vessels. At 0849, the Coast Guard received the EPIRB signals from the *Progress*.

The probable cause of the damage to fishing vessel *Progress* was an encounter with a considerably larger wave than those the vessel had been experiencing while hove to in gale-force conditions.

Figure 160. Below: Interior wheelhouse damage.

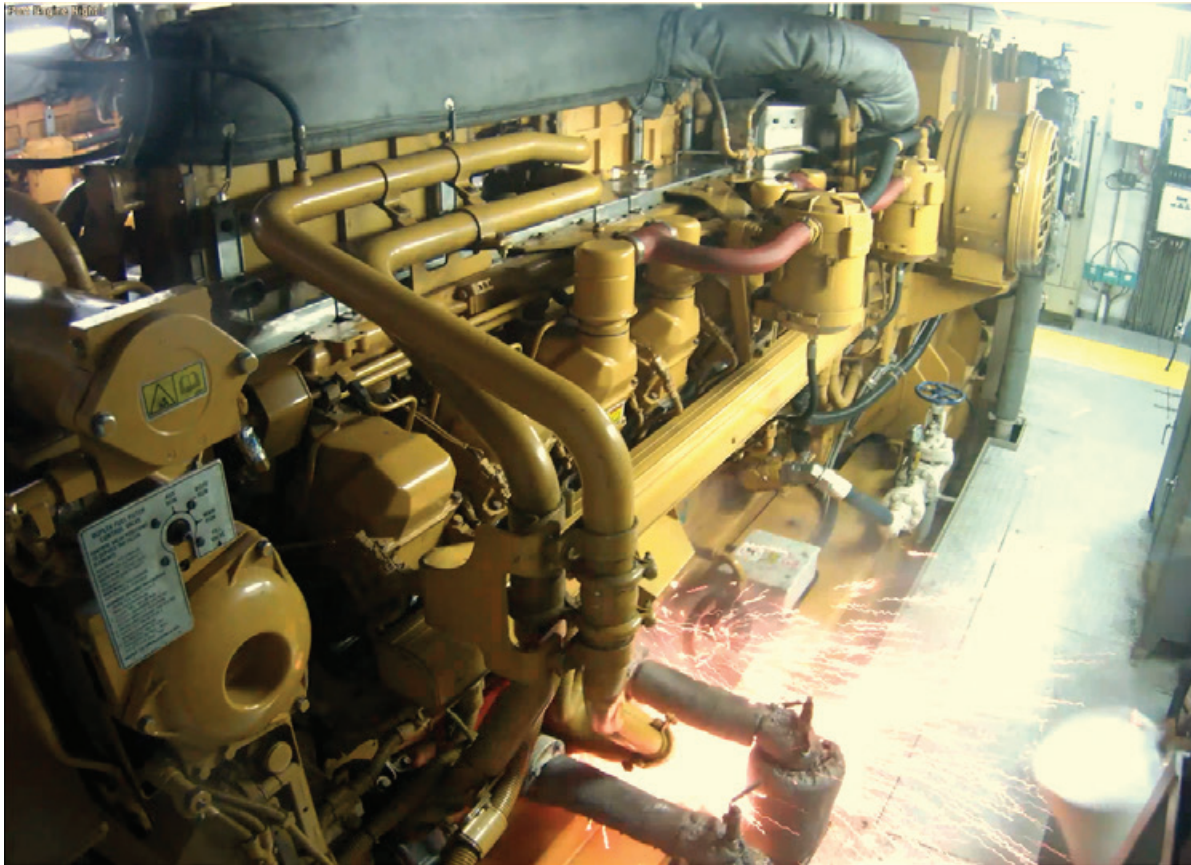
Figure 162. Screenshot from closed-circuit television at the time of the failure, looking aft from the inboard side of MDG no. 2.

During a forensic teardown of MDG no. 2, investigators and technical experts developed an engine failure timeline. They determined that the engine was running at rated speed when the joint between cylinder no. 8's connecting rod and rod cap loosened. The connecting rod cap hinged open and detached from the crankshaft rod journal, impacting the cylinder block and causing massive damage to the engine. The connecting rods on cylinder nos. 7 and 8 disengaged from the crankshaft and collided with the rotating assembly. A series of high-energy collisions created secondary damage to the engine.

Based on the forensic teardown of MDG no. 2 and the appearance of cylinder no. 8's connection rod bolts, cap and bearing assembly, investigators determined that one of the four connecting rod bolts on cylinder no. 8 backed out of the internal thread of the connecting rod. Once this bolt backed out, the remaining three bolts became overloaded. It appeared that repetitive impact occurred as the connecting rod cap loosened, resulting in the remaining three bolts shearing off.

The probable cause of the mechanical failure on board offshore supply vessel *Red Dawn* was a connecting rod assembly on the no. 2 diesel engine that came loose and separated from the crankshaft due to improper tightening (torquing) of the connecting rod bolts during the previous engine overhaul.

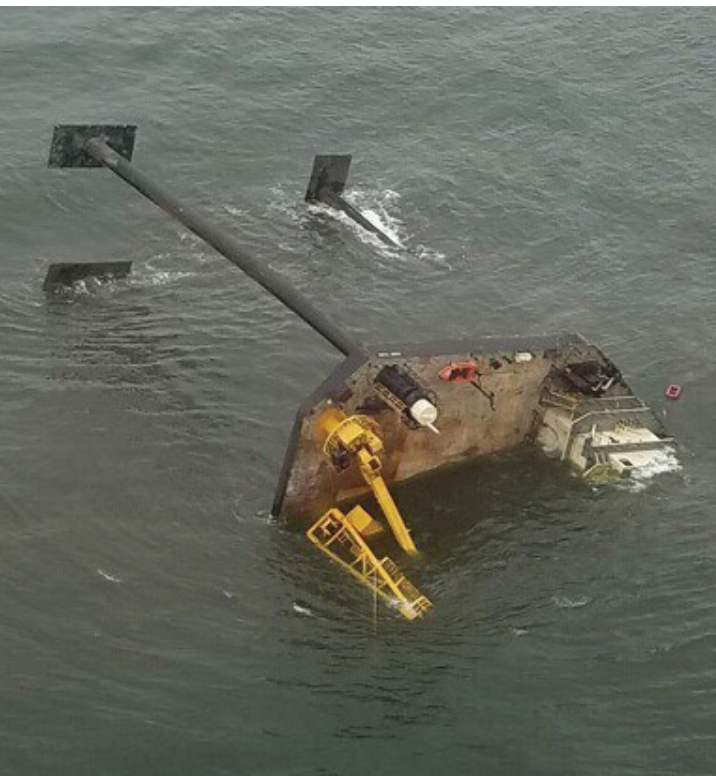
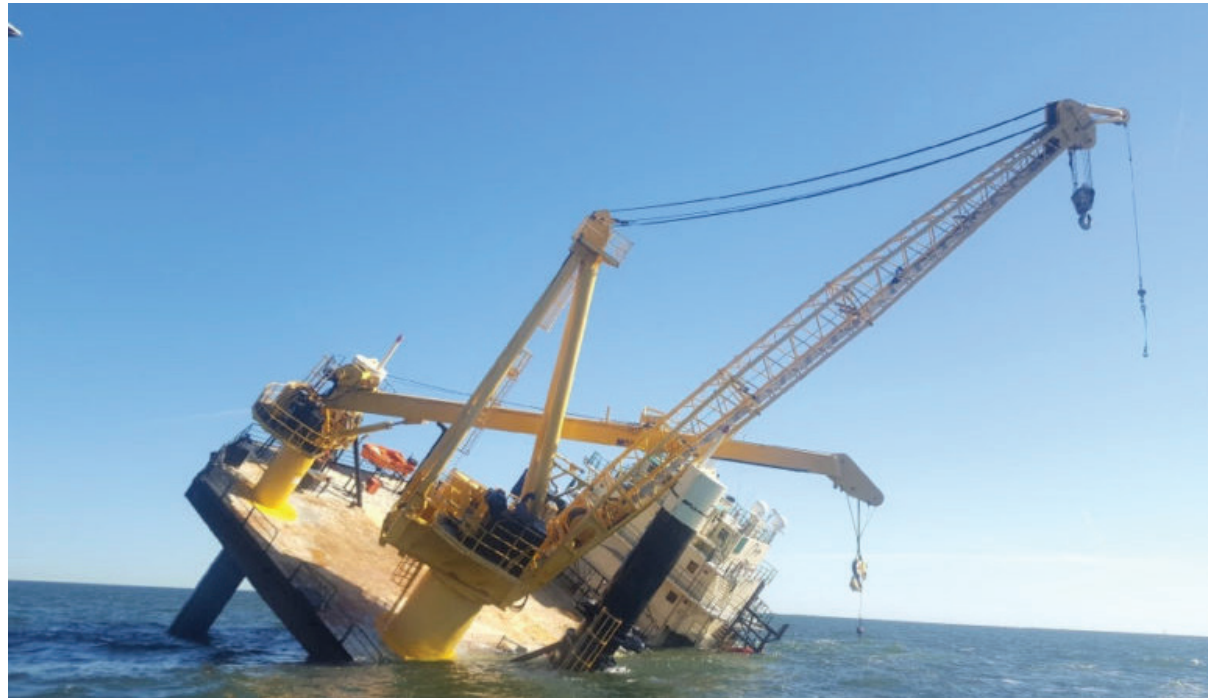
Figure 164. *Ram XVIII* six days after the accident, on November 24. Note the life float adrift astern of the vessel.

Figure 165. *Ram XVIII* after the vessel was abandoned, showing a significant angle of inclination to port.

The probable cause of the overturning of the elevated liftboat *Ram XVIII* was the industry practice of not regularly providing liftboat operators with adequate information about the seafloor composition, which resulted in the instability of the port leg due to unidentified conditions/hazards in seabed composition near the port leg landing site.

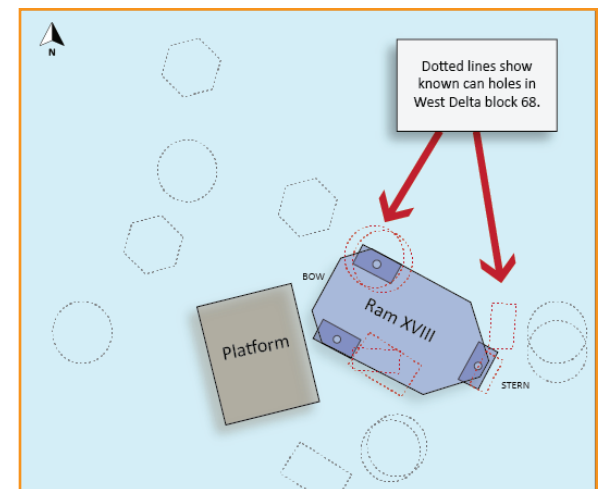
Figure 167. The WD-68-U platform and surrounding seafloor, including outlines of documented can holes. The *Ram XVIII*'s position is shown in relation to the platform, with its starboard leg in a can hole.

Insufficiently accounting for known seafloor hazards was a factor in the *Ram XVIII* and *Jonathon King Boyd-Bayou Chevron* accidents.

During undersea operations such as dredging of liftboat operations, seafloor conditions, including the presences of pipelines, cables, or can holes; bottom changes due to storm passages; proximity to major rivers; and soil composition can pose significant hazards to safe operations. Owners, operators, and charterers should use all available information for safe operations, including, but not limited to, available charts, maps, and sounding data; soil analysis, penetration history for the site, and/or core samples, before commencing operations.
