NATIONAL TRANSPORTATION
SAFETY BOARD

NTSB/SPC-16-01

SAFER SEAS DIGEST

LESSONS LEARNED FROM MARINE ACCIDENT INVESTIGATIONS

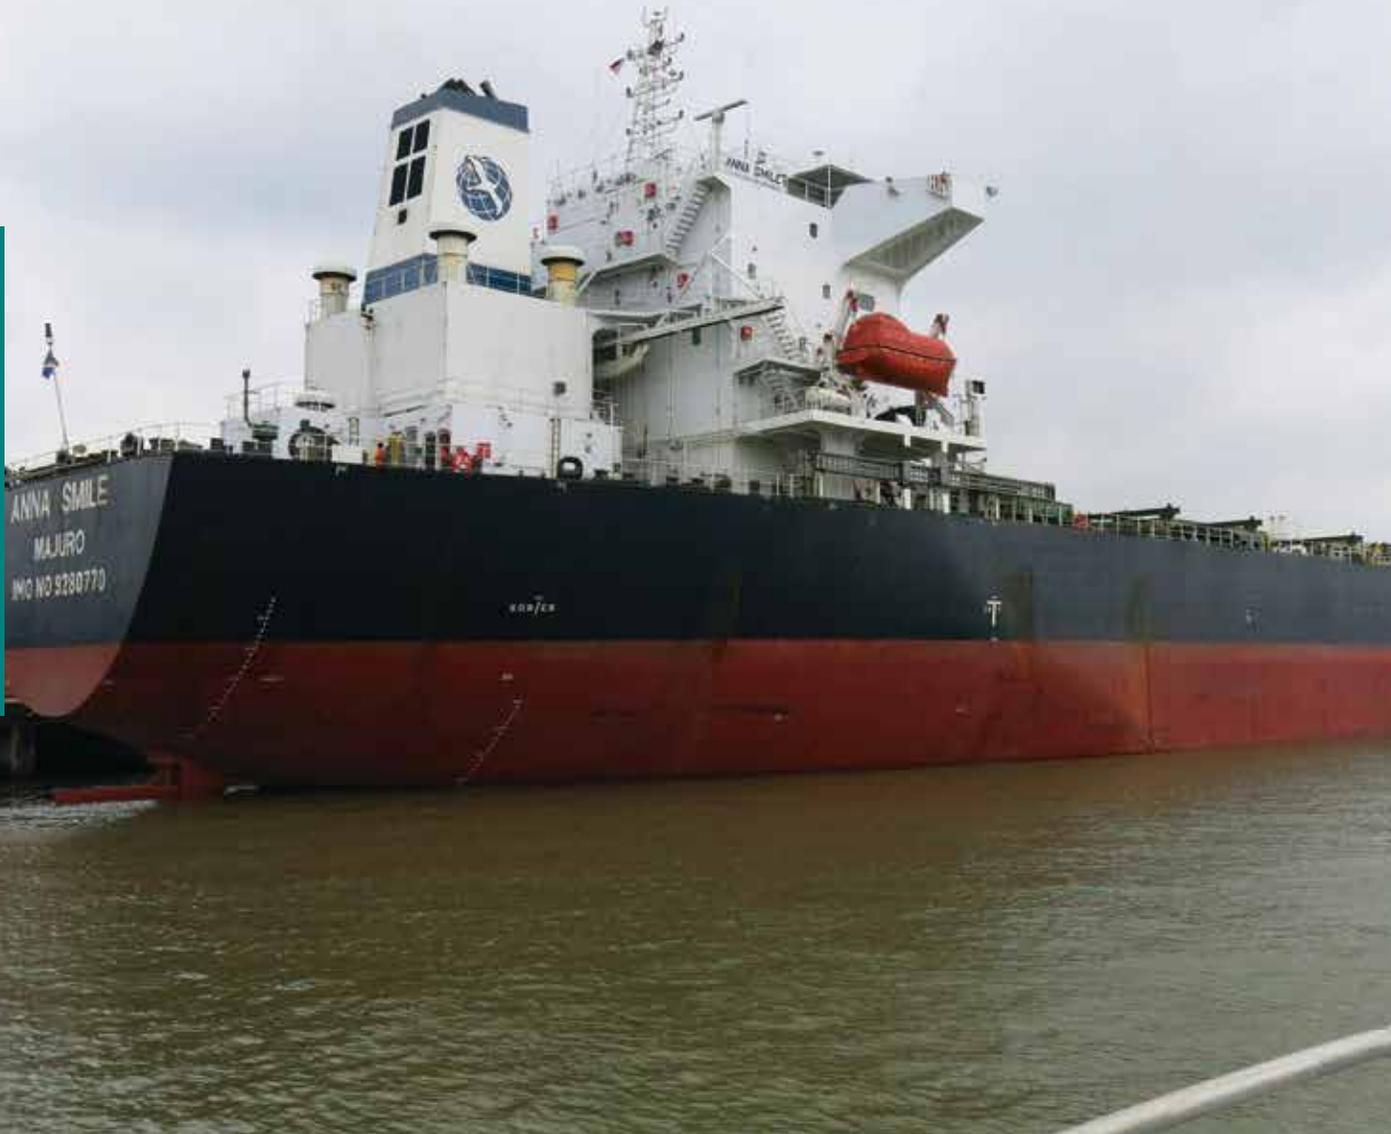
Damaged area of Anna Smile's hull. OPPOSITE PAGE, east tower of Louis Dreyfus grain elevator, which was damaged in the allision.

The bulk carrier *Anna Smile* allided with the Louis Dreyfus grain elevator in Houston, Texas, at 0504 on July 14, 2014, while maneuvering during docking operations. Damage to the grain elevator and its foundation was estimated at \$2.5 million. The *Anna Smile* suffered minor insets on the hull plating for a length of about 30 feet, but a damage estimate was not provided.

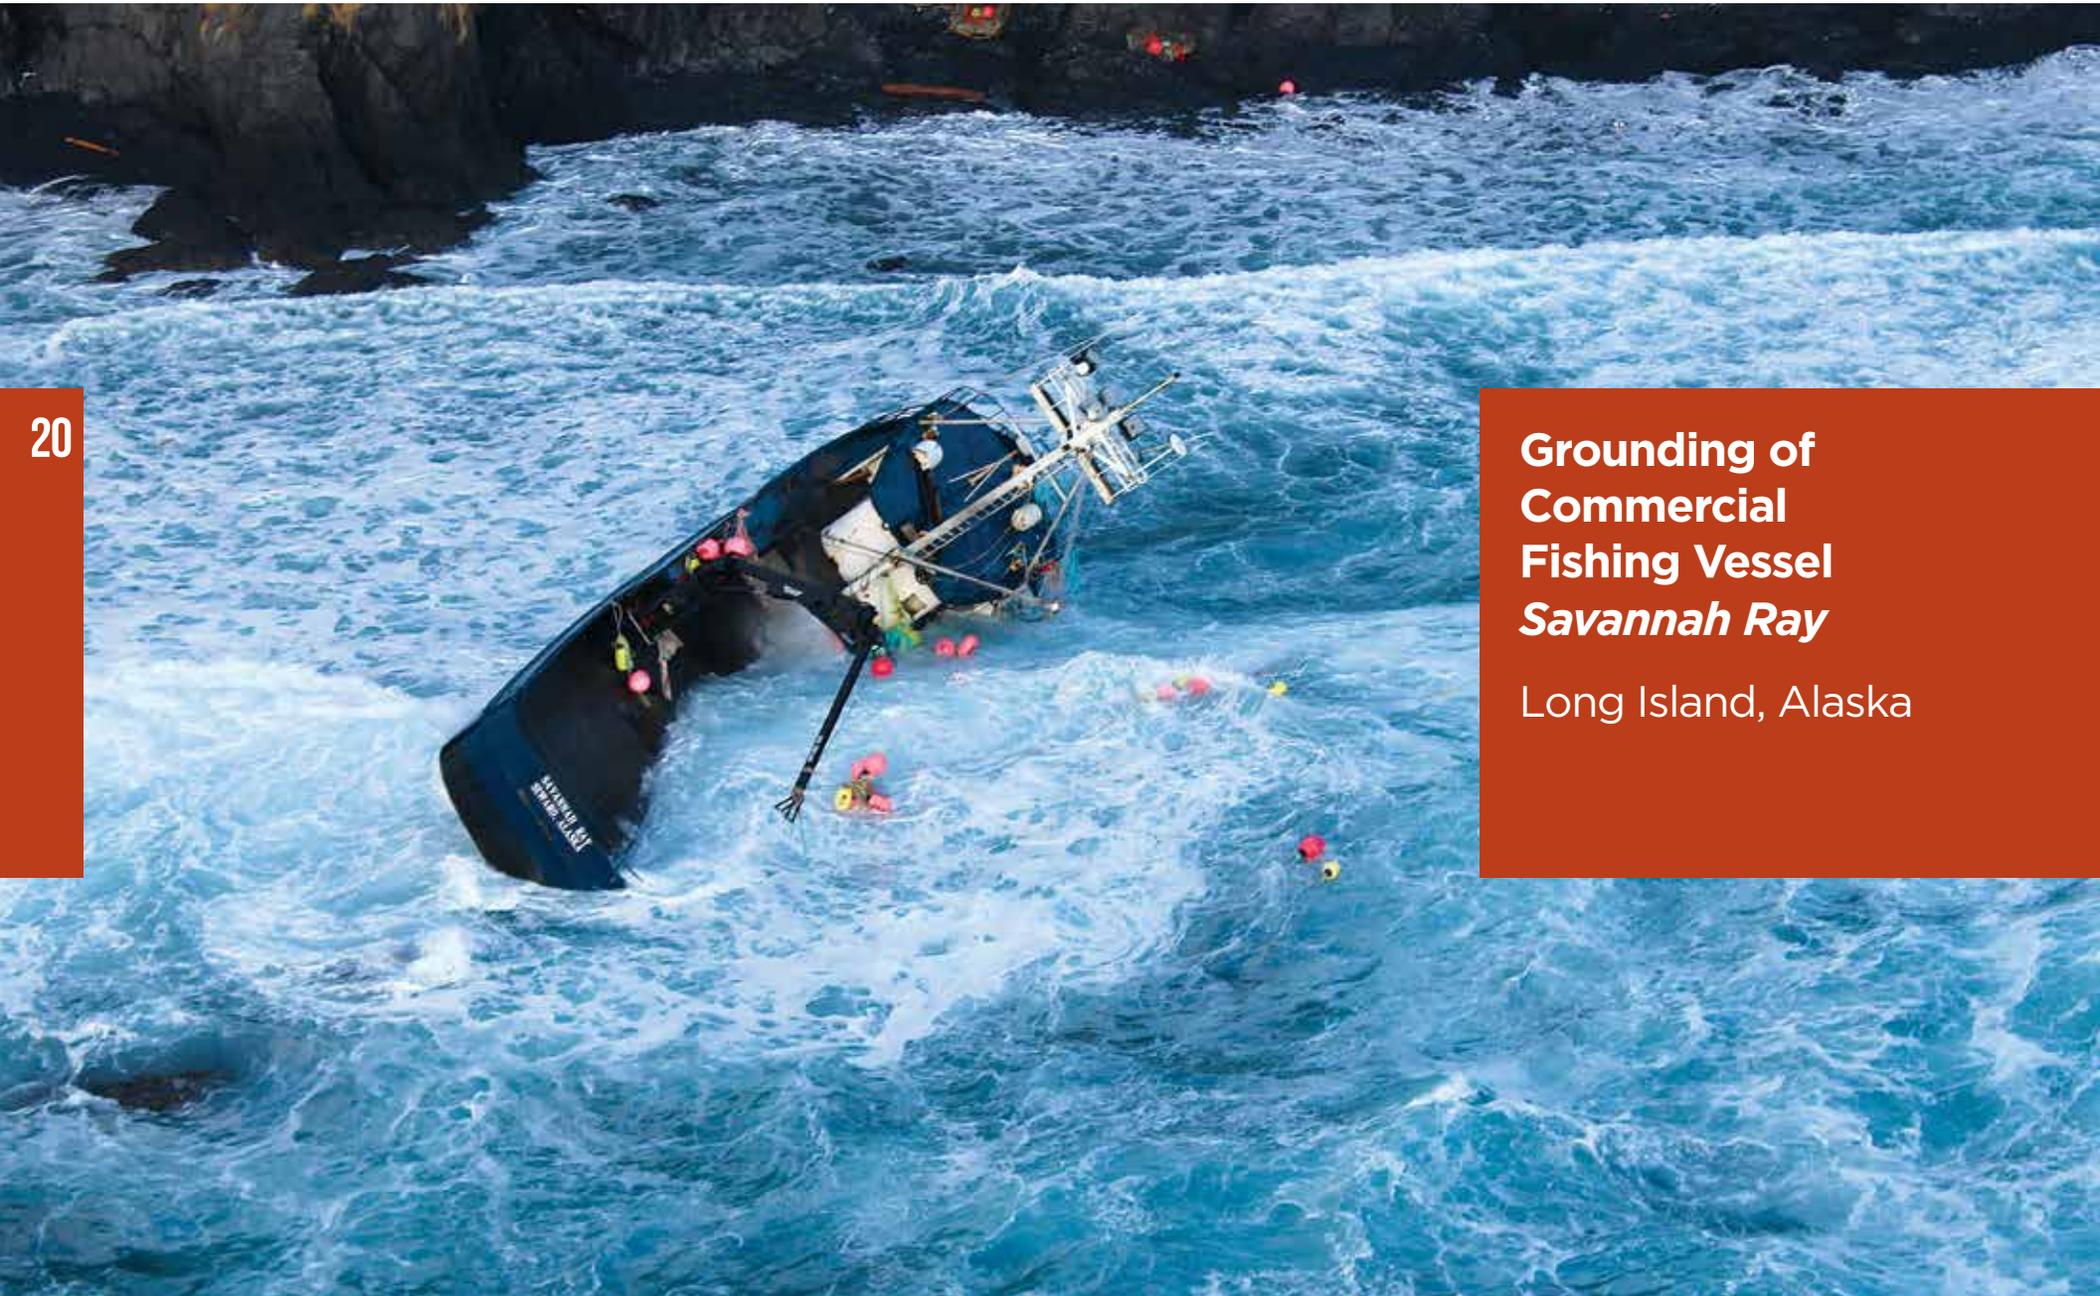
Savannah Ray after running aground (photo by Coast Guard). **OPPOSITE PAGE**, the vessel at its spring 2014 survey prior to the accident (photo by Resurrection Technologies).

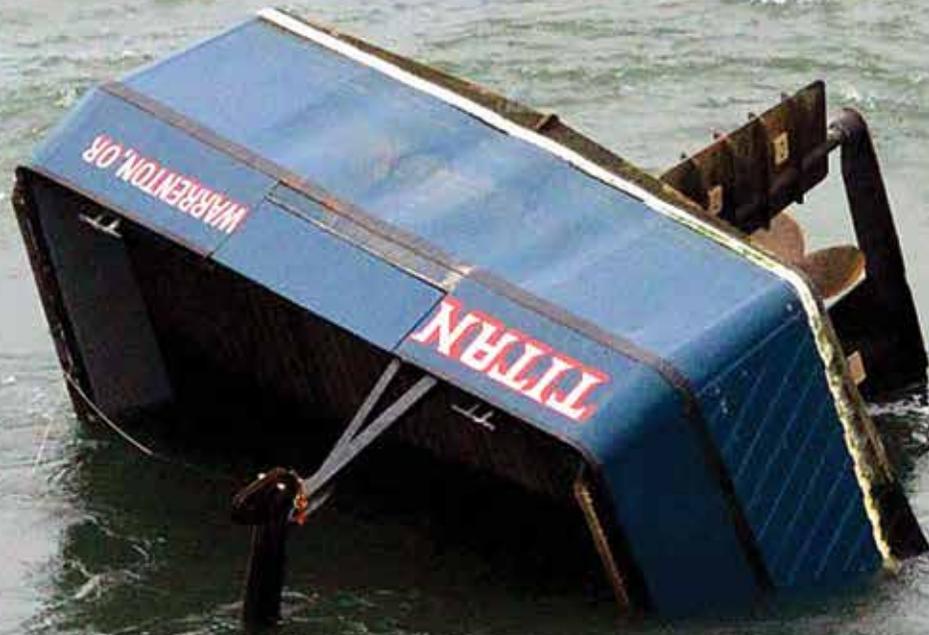
Titan's stern on the day of the grounding (photo by Coast Guard). OPPOSITE PAGE, the vessel under way before the accident (photo by HD Fisheries).

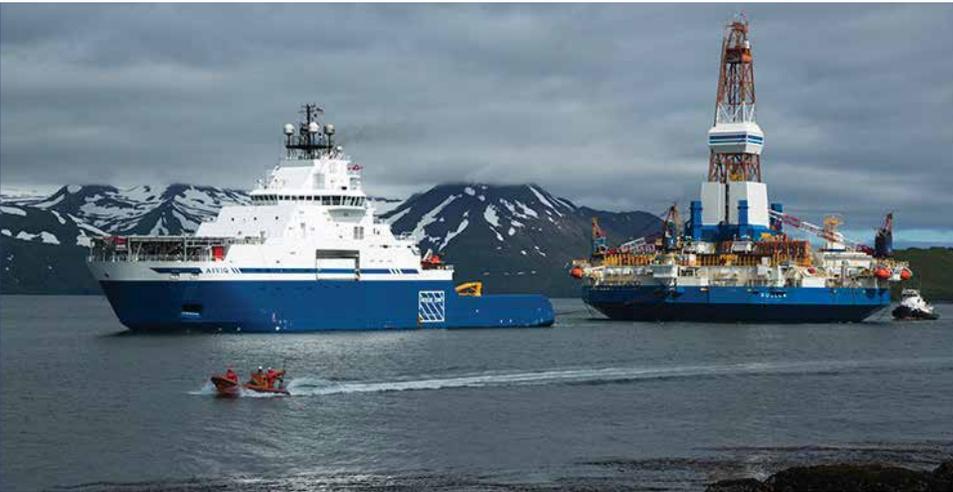
A Coast Guard helicopter approaches Kulluk to airlift crewmembers to safety (photo by Coast Guard). OPPOSITE PAGE, Aiviq towing the drilling unit before the grounding (photo from www.pbase.com).

The mobile offshore drilling unit *Kulluk*, owned by Shell Offshore Inc., grounded in heavy weather near Ocean Bay on the eastern coast of Sitkalidak Island off Kodiak Island, Alaska, about 2040 on December 31, 2012. The *Kulluk*, under tow by the anchor-handling tug *Aiviq*, departed Captains Bay near Unalaska, Alaska, 10 days earlier bound for Seattle, Washington. Four crewmembers on the *Aiviq* suffered minor injuries. The *Kulluk* sustained substantial damage,

including portions of the underwater hull; however, no damage estimate was provided.

The National Transportation Safety Board determined that the probable cause of the grounding of the mobile offshore drilling unit *Kulluk* was Shell's inadequate assessment of the risk for its planned tow of the *Kulluk*, resulting in implementation of a tow plan insufficient to mitigate that risk.

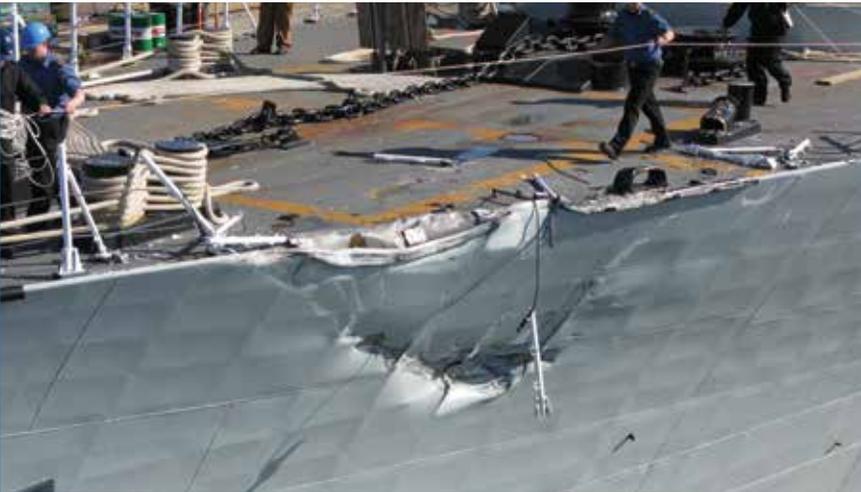
*Winnipeg and American Dynasty, which sustained significant damage to its bow, shortly after the collision (photo by The Canadian Press).
OPPOSITE PAGE, damage to Winnipeg's port side at the point of impact (photo by Transportation Safety Board Canada).*

On April 23, 2013, at 0817, while preparing to enter a graving dock in Esquimalt, British Columbia, Canada, the US-flagged fishing vessel *American Dynasty* collided with the Canadian Navy frigate HMCS *Winnipeg* moored nearby, after veering off course following a loss of electrical power and propulsion control. Both vessels and the naval pier sustained extensive structural damage totaling more than \$500,000 in repair costs. Six shipyard

Although the CP control system was designed to maintain the last ordered pitch due to power loss, a leak in the system's hydraulic oil distribution box enabled the propeller pitch to move to the ahead direction. With the main engines still turning the propeller shaft, the vessel began to move ahead.

The *American Dynasty's* emergency batteries should have provided power to the CP control system in the event of a power loss. However, investigators found that the batteries, which were supposed to supply power to the vessel's essential systems, were incapable of holding a sufficient charge. All of the batteries were last replaced in 2009.

The National Transportation Safety Board determined that the probable cause of the collision between the *American Dynasty* and the *Winnipeg* was the insufficient planning between the *American Dynasty's* master and chief engineer regarding vessel arrival procedures and emergency maneuvering and the poor crisis communications between the bridge and the engine room. Contributing to the accident was the status and condition of the *American Dynasty's* emergency generator and emergency batteries, which were not prepared to supply power at a critical time.

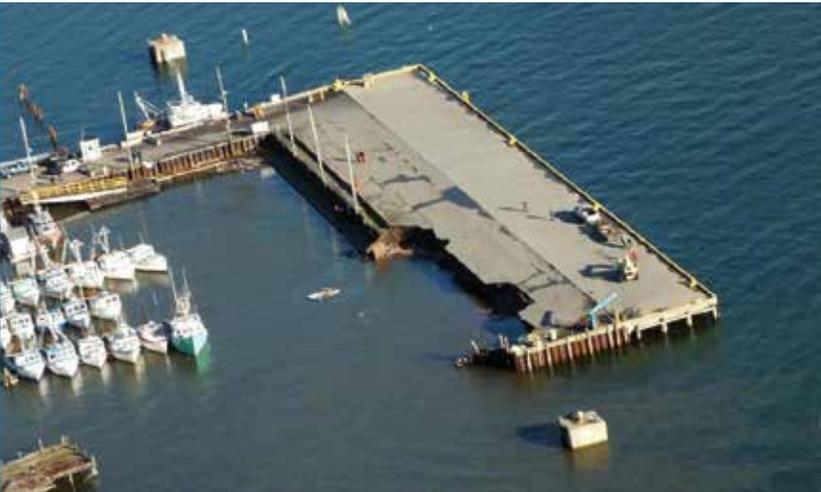
The pickup truck that struck Medic II rests near the vessel at the bottom of the Eastport pier (photo by Coast Guard). OPPOSITE PAGE, aerial view of the damaged pier (photo by Jim Lowe).

A 200-foot section on the western side of the Eastport breakwater pier in Eastport, Maine, collapsed about 0200 on December 4, 2014, damaging several vessels that were moored alongside. Damages to the *Ada C. Lore*, the *Double Trouble 2*, and the *Medric II* totaled an estimated \$700,000. Minor pollution was reported.

inspections conducted after a structural failure on the north side of the pier revealed significant deterioration of the sheet piling. In August 2013, the Maine Department of Transportation contracted an engineering firm to design a replacement structure for the original pier. Reconstruction plans included demolishing the original section and replacing it with a new 400-foot-by-50-foot section to be built on concrete-filled steel pilings located outside the 1985 section; a single layer of sheet pile was designed to form a new breakwater inside.

As a result of the collapse, the wooden-hulled *Ada C. Lore* suffered extensive damage to its masts, rigging, and structural components of accommodation spaces. Two holes were found on the main deck, which was reported to be leaking significantly. The *Double Trouble 2*, a privately owned fiberglass fishing vessel, sank to the windows of the shelter deck, resulting in the flooding of the engine room. Fishing rigging, portions of the deckhouse, and the hull were damaged beyond repair. The *Medric II*, a multipurpose workboat constructed of high-density polyethylene, was hit by the pickup truck and large sections of the collapsing pier. The vessel suffered significant hull damage, the wheelhouse was completely destroyed, and two outboard engines were submerged for hours. Gasoline from the tanks below deck leaked out and damaged the Styrofoam flotation located inside the hull. After the incident, an engineering firm assessing the pier concluded, "The collapse was a result of failure of the lateral restraint system which consists of 2 levels of tie rods arranged to resist lateral earth pressure. The exact failure mode could not be determined."

The National Transportation Safety Board determined that the probable cause of the collapse of the Eastport Port Authority breakwater pier was the failure of the lateral restraint system due to the structure's long-term deterioration.

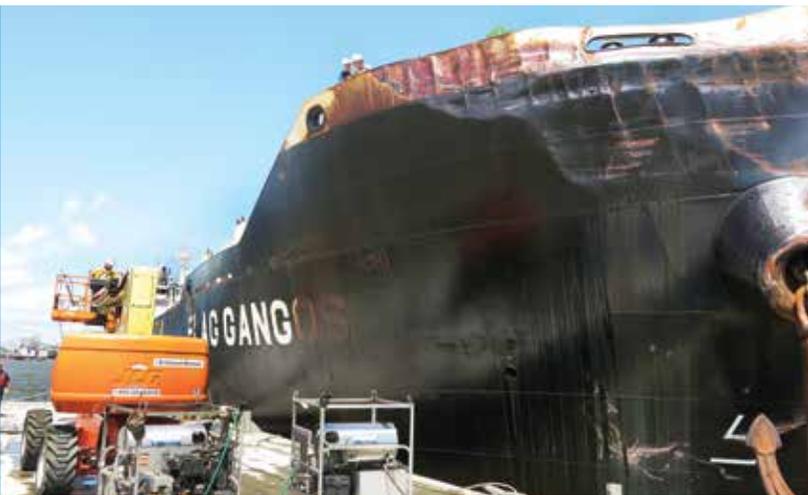
Damage to the starboard quarter of Pamisos. OPPOSITE PAGE, damage to the upper starboard side and bulwark of Flag Gangos near the bow.

At 2215 on August 12, 2014, the outbound bulk carrier *Flag Gangos* collided with the berthed oil tanker *Pamisos* on the Lower Mississippi River at Gretna, Louisiana, before alliding with a floating pier, which then struck and damaged a fuel barge berthed behind the *Pamisos*. No one was injured, but about 1,200 gallons of slurry oil were spilled while being transferred, with some entering the river. The total estimated damage was more than \$17.5 million.

Investigators discovered that a hydraulic solenoid valve and coil had failed in the *Flag Gangos*' port steering system. Nearly 1 year earlier, the steering system manufacturer emailed a service letter to the vessel's operating company warning about possible failures of this model of coil. The service letter stated, "MANDATED

The National Transportation Safety Board determined that the probable cause of the accident was the delay by the *Flag Gangos*' operating company in completing a mandatory upgrade to the vessel's steering system and failure to routinely test the steering system's hydraulic fluid for debris as required by the manufacturer. Contributing was the failure of the steering system manufacturer to schedule and complete the mandatory upgrade.

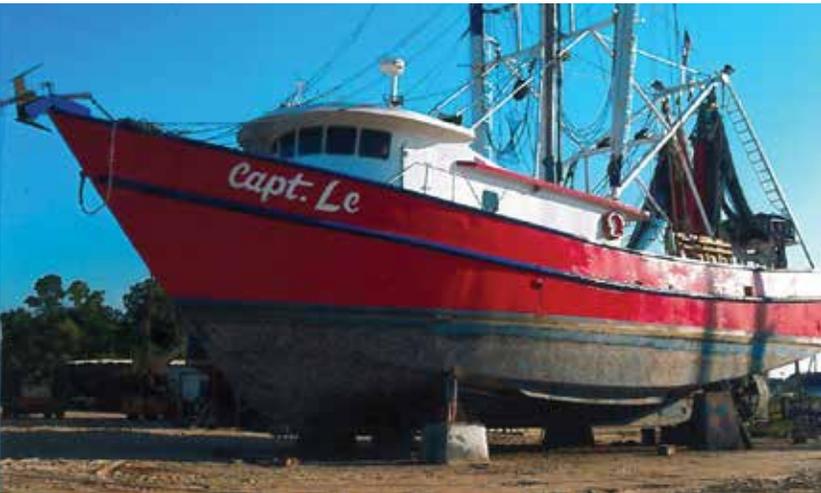
Scraping and denting damage to the bow of *Gloria May*. OPPOSITE PAGE, *Capt Le* before the accident (photo by owner).

The offshore supply vessel *Gloria May* collided with the uninspected fishing vessel *Capt Le* in the Gulf of Mexico about 2240 on the evening of August 24, 2014. As a result of the collision, the *Capt Le* flooded and sank, while the bow of the *Gloria May* suffered minor damage estimated at \$225,000.

The National Transportation Safety Board determined that the probable cause of the collision between the offshore supply vessel *Gloria May* and the fishing vessel *Capt Le* was the failure of both vessels' operators to maintain a proper lookout.

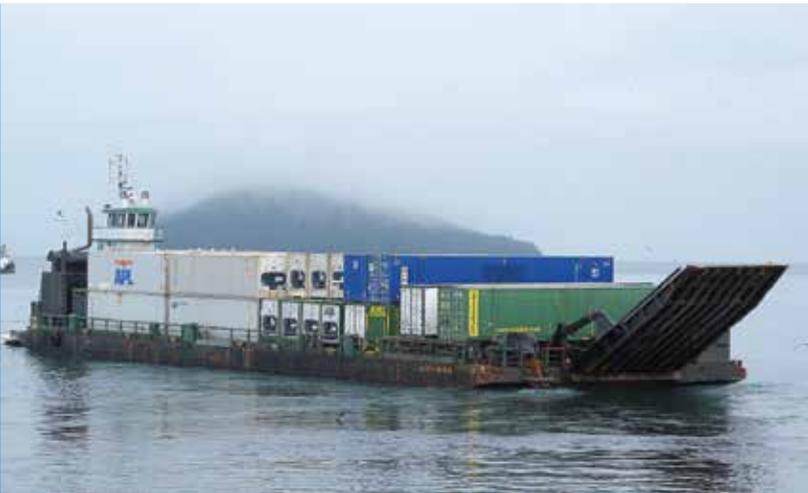
Damaged port bulwark plating and frames of Sycamore. OPPOSITE PAGE, Krystal Sea/Cordova Provider departing Cordova a few days after the accident.

The integrated tug and barge *Krystal Sea/Cordova Provider* was maneuvering to dock in Cordova, Alaska, when the bow ramp of the barge struck the moored Coast Guard cutter *Sycamore* just after sunrise on Sunday, July 28, 2013. Damages were estimated at \$248,884 for both vessels.

The captain attempted to maneuver to avoid impact with the cutter, but the ITB's bow ramp struck the moored *Sycamore* and slid down the cutter's bulwark. The mate, who entered the wheelhouse shortly after impact, noted that

The National Transportation Safety Board determined that the probable cause of the allision of the integrated tug and barge *Krystal Sea/Cordova Provider* with the US Coast Guard cutter *Sycamore* was the loss of directional control of one of two azimuthing stern drive propulsion units during an unsuccessful attempt by the *Krystal Sea*'s new captain to transfer from autopilot to manual control while approaching the intended dock. Contributing to the accident was the lack of function-testing of manual steering and propulsion control after disengaging the autopilot at a distance from the dock sufficient to allow time for corrective action.

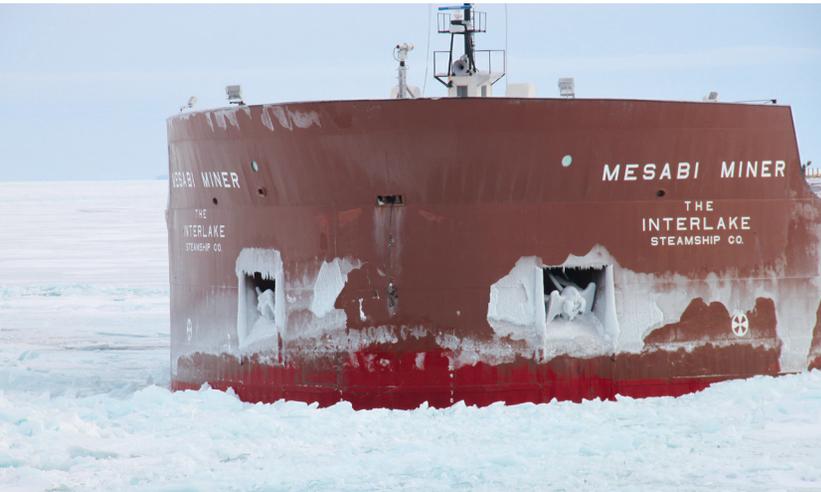
Damage to the port quarter of Hollyhock. OPPOSITE PAGE, Mesabi Miner shortly after the collision (photo by Coast Guard).

On the morning of January 5, 2014, the Coast Guard cutter *Hollyhock* was breaking through ice west of the Straits of Mackinac to establish a path for six merchant vessels heading into Lake Michigan when it ran into thicker ice and had difficulty continuing ahead. The first merchant vessel in the convoy, the *Mesabi Miner*, was unable to slow down quickly enough and, at 1042, struck the stern of the *Hollyhock*. Both vessels sustained significant

damage, an estimated \$494,145 in total repair costs, but remained operational.

The National Transportation Safety Board determined that the probable cause of the collision between the United States Coast Guard cutter *Hollyhock* and the bulk carrier *Mesabi Miner* was the lack of effective communications between the two vessels' bridge teams during icebreaking operations, which resulted in an insufficient amount of time to take action to avoid a collision.

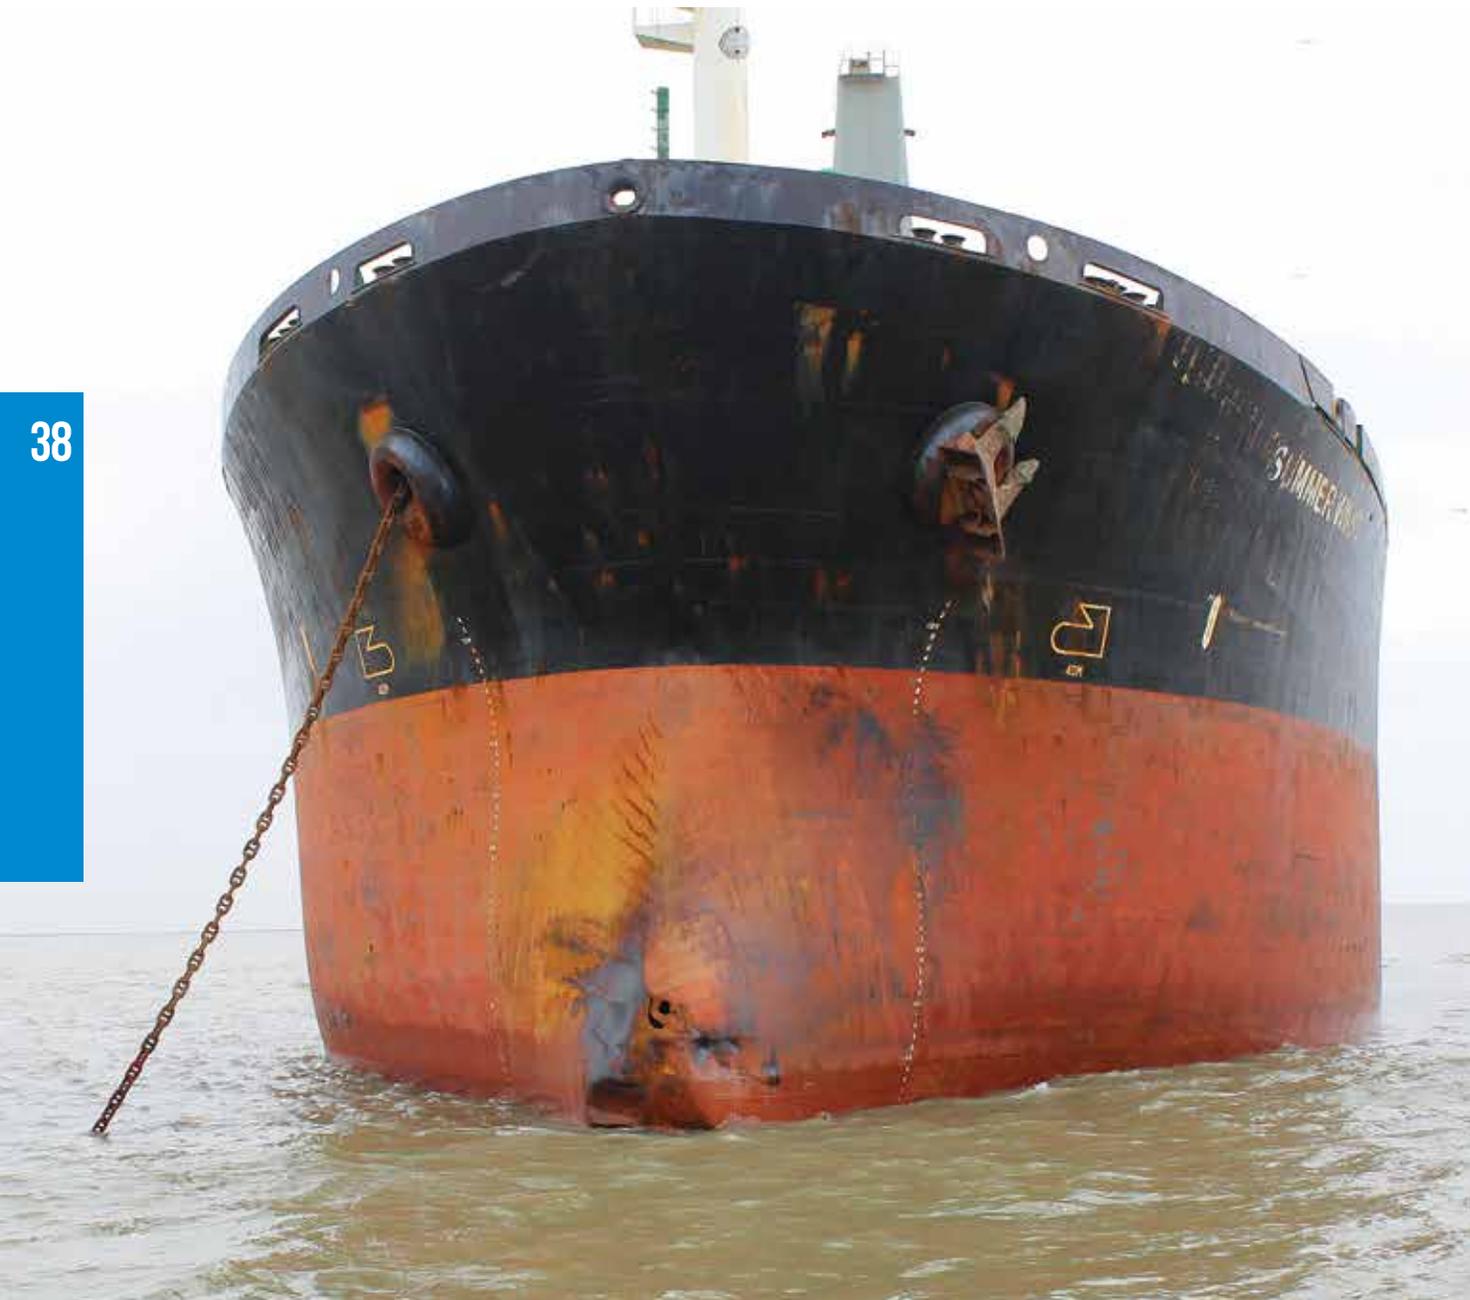
Bow damage of Summer Wind. ABOVE RIGHT, punctured hull on the starboard side of the lead barge in Miss Susan tow (photo by Coast Guard).

During heavy fog about 1235 on March 22, 2014, the bulk carrier *Summer Wind* collided with the *Miss Susan* tow in the Houston Ship Channel in Lower Galveston Bay, Texas. The collision breached the hull of the forward tank barge in the tow, allowing about 168,000 gallons of fuel oil to spill into the waterway. Two crewmembers on the *Miss Susan* sustained minor injuries related to inhalation of fuel vapor. Damage to all vessels totaled over \$1.378 million.

The National Transportation Safety Board determined that the probable cause of the collision was the *Miss Susan* captain’s attempt to cross the Houston Ship Channel ahead of the *Summer Wind*, thereby impeding the passage of the bulk carrier, which could transit only within the confines of the channel. Contributing to the accident was the failure of the Houston pilot and the *Summer Wind* master to set a safe speed given the restricted visibility and nearby towing vessel traffic, and the failure of the *Miss Susan* captain and the Houston pilot to establish early radio communication with one another. Also contributing to the accident was the failure of Vessel Traffic Service Houston/Galveston to interact with the two vessels in a developing risk of collision, and the lack of a Coast Guard vessel separation policy for the Bolivar Roads Precautionary Area.

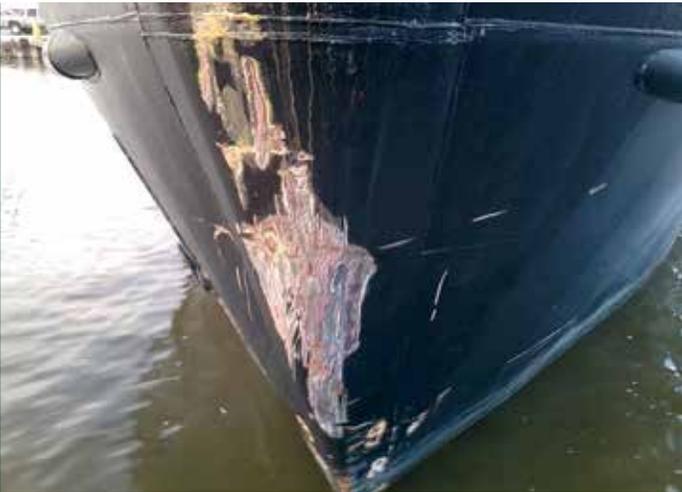
About 0712 on February 18, 2014, the offshore supply vessel *Tristan Janice* allided with an unmanned natural gas production platform in the northern Gulf of Mexico about 54 miles south-southwest of Houma, Louisiana. Damages amounted to \$545,000 for both the vessel and platform, and a substantial amount of natural gas escaped into the atmosphere from a ruptured supply pipe.

engines, each driving a propeller. Before dawn the mate, who had the conn (navigational control), believed that the starboard engine was not maintaining full speed. He directed a deckhand to use a line to tie off the starboard engine throttle in the machinery space so that it would remain in the full ahead position.

The National Transportation Safety Board determined that the probable cause of the allision of offshore supply vessel *Tristan Janice* with a natural gas production platform was the poor watchkeeping and operational practices of the captain and the mate to ensure that the vessel was safely navigated, and the vessel owner's inadequate procedures and oversight of the vessel's safety management system.

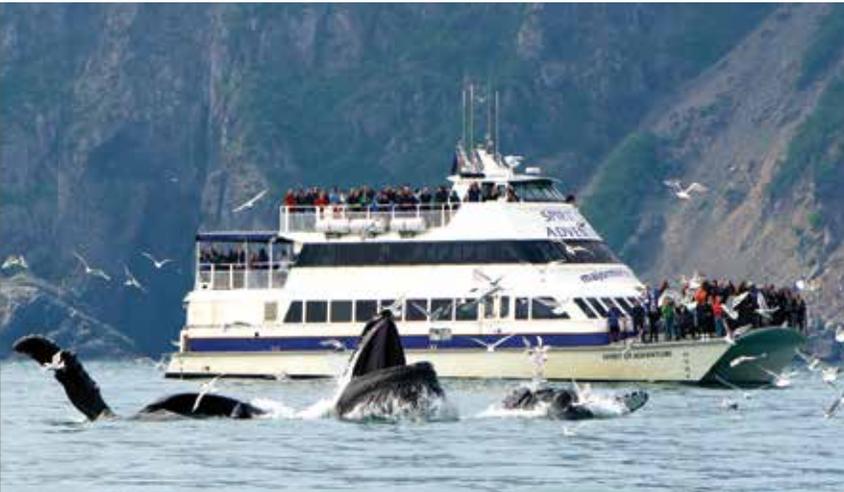
The *Spirit of Adventure*, a catamaran small passenger vessel, flooded and partially sank before dawn on December 6, 2014, while alongside its pier in Seward Boat Harbor, Alaska. Given that the vessel was out of service for the winter, no one was on board. Damage to both the pier and the vessel, which was declared a constructive total loss, totaled an estimated \$2 million.

layup period, during which company personnel conducted end-of-season maintenance and performed various repairs and upgrades. In October 2014, maintenance personnel removed a section of elbow piping from the exhaust systems of both propulsion engines because of leaks that could not be repaired by welding or patching. When the exhaust piping elbows were removed, the flanged end of the vertical section of exhaust piping was open to the sea. The mechanics covered the opening with a plywood blank bolted to the flange but did not install a gasket to prevent leakage. Also, 3/4-inch-diameter seawater cooling

lines to the exhaust piping were disconnected when the exhaust elbows were removed. The disconnected seawater lines, which were neither capped nor plugged, were left loosely supported at an elevation above the waterline.

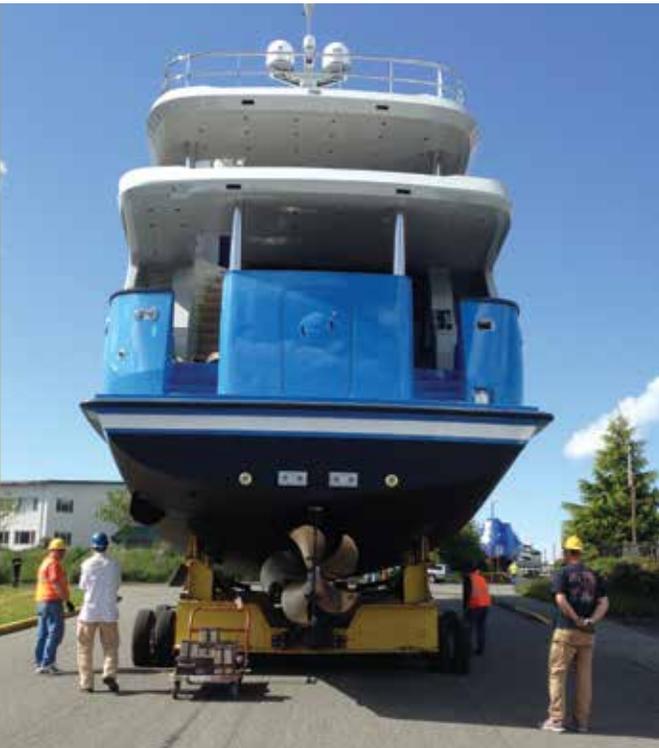
The newly built yacht *Baaden* capsized at 2050 on May 18, 2014, while being launched down the Fidalgo Marina boat ramp in Anacortes, Washington. Although salvaged, the yacht was declared a constructive total loss estimated at \$10 million. Three shipyard employees were treated for minor cuts and injuries at local hospitals.

The National Transportation Safety Board determined that the probable cause of the capsizing of the yacht *Baaden* during its initial launch was the vessel's low margin of stability due to the combined effects of a recording error during the final vessel weigh, which resulted in an incorrect assessment of the vessel's center of gravity and an overestimation of the weight of installed ballast.

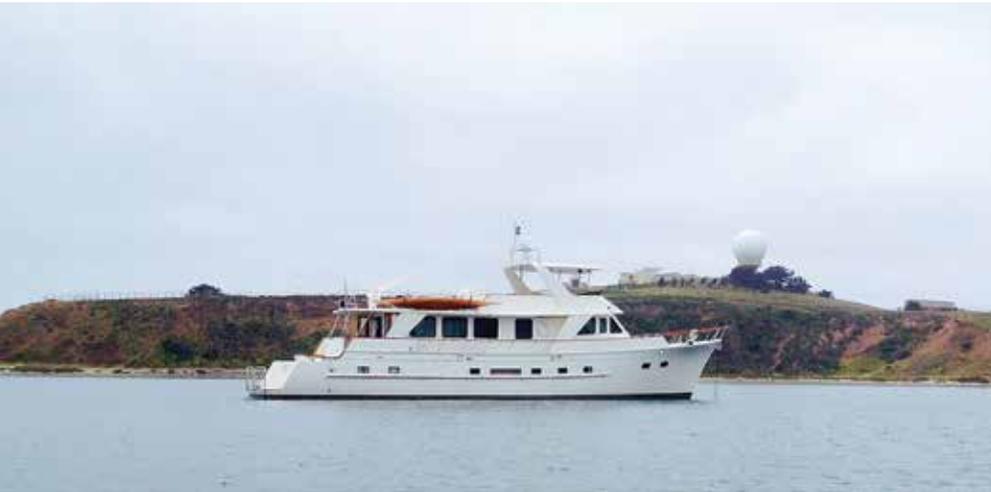
La Pietra ablaze. OPPOSITE PAGE, the vessel before the accident. (Photos by Coast Guard)

On July 4, 2014, at 1058, a fire broke out in the engine room on board the recreational vessel *La Pietra* when the vessel was near Destruction Island, Washington. The onboard vessel owners (husband and wife) were rescued by the Coast Guard; the husband was treated for smoke inhalation and minor burns. *La Pietra* burned to the waterline and sank with 600 gallons of diesel fuel on board, a total loss estimated at \$360,000.

The National Transportation Safety Board determined that the probable cause of the *La Pietra* accident was an engine room fire of unknown origin. Contributing to the loss of the vessel was the owners' inability to access and shut off the engine room ventilation system, which diminished the effectiveness of the fire suppression system and extinguishing efforts.

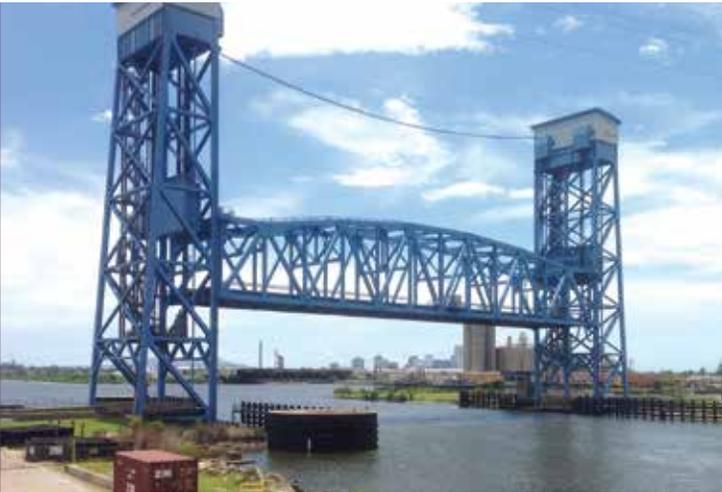
About 2355 on August 13, 2014, a crane barge transported by the towing vessel *Cory Michael* struck the raised lift span of the Florida Avenue Bridge while transiting on the Industrial Canal in New Orleans, Louisiana. The crane boom fell onto the towing vessel's upper wheelhouse fatally injuring the captain. Damage to the crane and the vessel was estimated at \$2.3 million.

As the stern of the barge passed under the bridge, the crane mast struck the steel framing of the lift span. The impact caused a series of failures on the crane that resulted in 322,000 pounds of the crane's counterweight falling into the waterway and the crane boom dropping onto the *Cory Michael's* upper wheelhouse. The overhead and supporting structural framing of the upper wheelhouse collapsed from the impact fatally injuring the captain.

The National Transportation Safety Board determined that the probable cause of the allision of the *Cory Michael* tow with the Florida Avenue Bridge was the captain's failure to establish the correct air draft of his tow and ensure that the bridge was raised to an adequate height before attempting the passage, and the failure of the bridge operator for the Port of New Orleans to raise the lift span to the fullest extent as required by regulations and port policy.

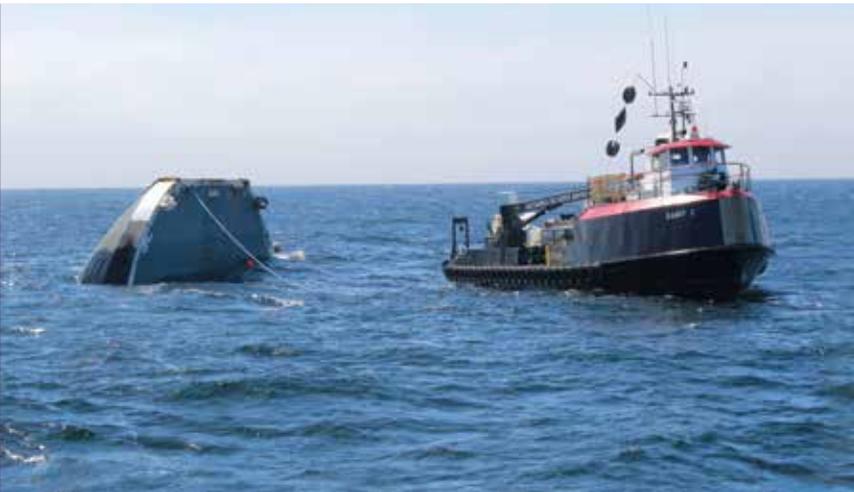
Calvin after the accident. OPPOSITE PAGE, a diving boat engaged in salvage operations of Nash, whose bow protrudes 15 feet above the surface.

The National Transportation Safety Board determined that the probable cause of the sinking of tank barge *Nash* was flooding of the aft starboard side void tank. The mechanism for entry of flooding water to this tank could not be determined because the barge was not salvaged and was not available for examination after it sank.

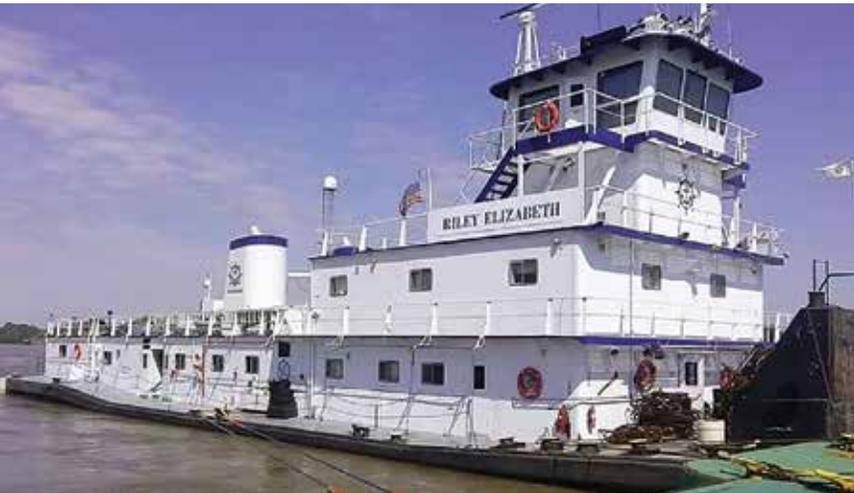
Damage to the inshore end of a Corps of Engineers spar barge (photo by Corps of Engineers). OPPOSITE PAGE, Riley Elizabeth on the Mississippi River postaccident (photo by Western Rivers Boat Management).

The National Transportation Safety Board determined that the probable cause of the collision of the *Riley Elizabeth* tow with the US Army Corps of Engineers barge plant was the incomplete information provided by the Corps of Engineers about the extent of the obstruction in the waterway, and the failure of the *Riley Elizabeth* mate to determine the extent of the obstruction before starting the turn at Kempe Bend.

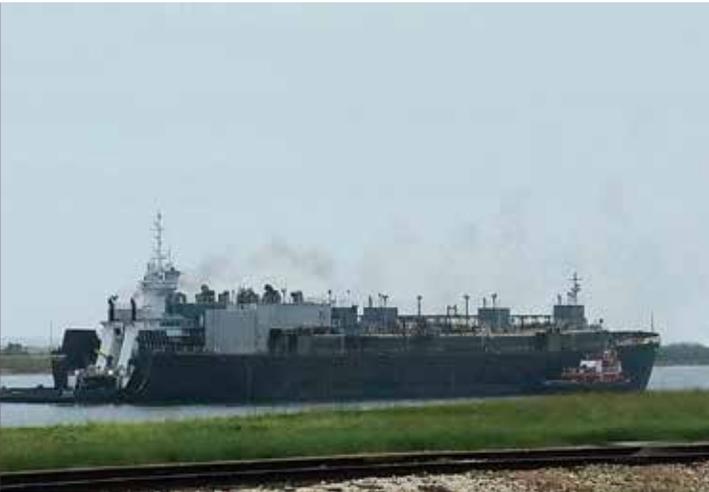
*Production platform EC321A, where the Coast Guard helicopter responds on deck (photo by crew on responding vessel Penny F).
OPPOSITE PAGE, Valiant/Everglades under way (photo by Kirby).*

A survey carried out by the pipeline owner stated that the anchor dragged across six subsea pipelines and completely severed one 16-inch natural gas pipeline. The pipeline owner reported that 223,000 mcf of natural gas was released as a result of the rupture. An additional 26,800 mcf was later released in a controlled manner to clear the line.

The National Transportation Safety Board determined that the probable cause of the damage to the subsea natural gas pipeline was the anchor from the *Valiant/Everglades* dragging across the pipeline after the vessel lost starting air pressure and propulsion due to the opening of an unprotected air system valve on deck.
