NATIONAL TRANSPORTATION SAFETY BOARD

# SAFER SEAS

# Digest

Lessons Learned from  
Marine Investigations

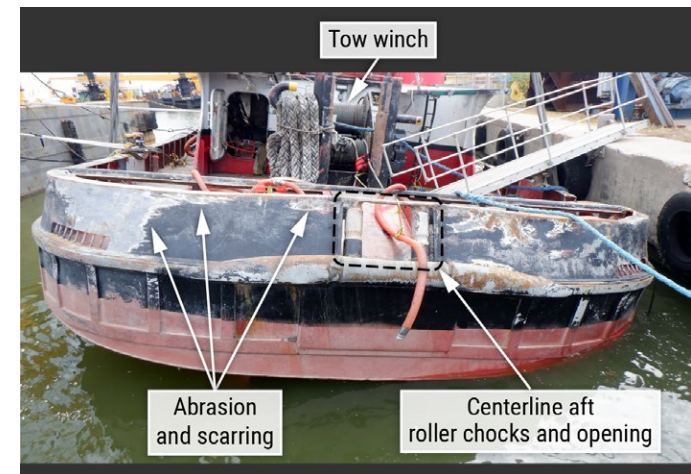
**Abrasion markings and scarring on the vessel's port quarter bulwarks.**

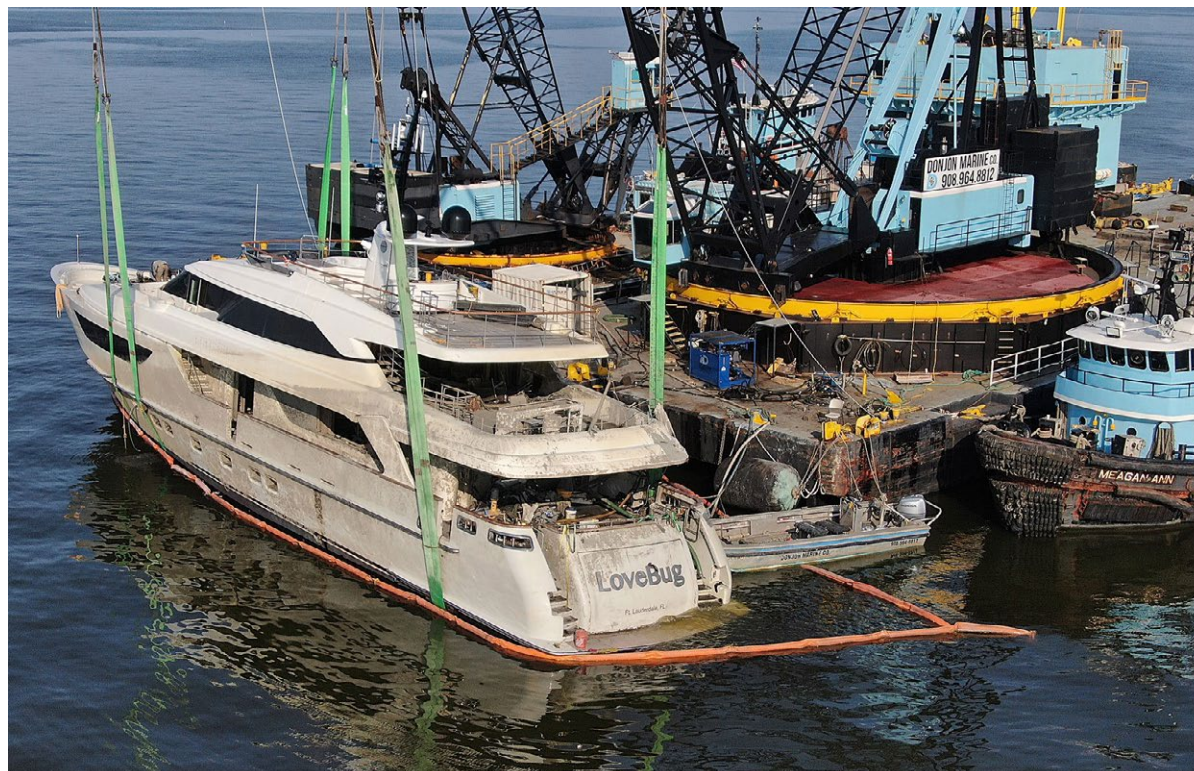
**The Lovebug, with garage door visible at the stern, as it was raised out of the water after it partially sank.**

Salvors also found the watertight door between the garage and engine room compartment open. Water in the garage would have decreased the yacht's draft aft, accelerating water ingress. If the water level in the garage space reached the lower edge of the open watertight door, seawater would have flooded into the engine room compartment.

**THE PROBABLE CAUSE** of the listing and partial sinking of the yacht *Lovebug* was undetected flooding through an open watertight door, resulting in the vessel losing stability.

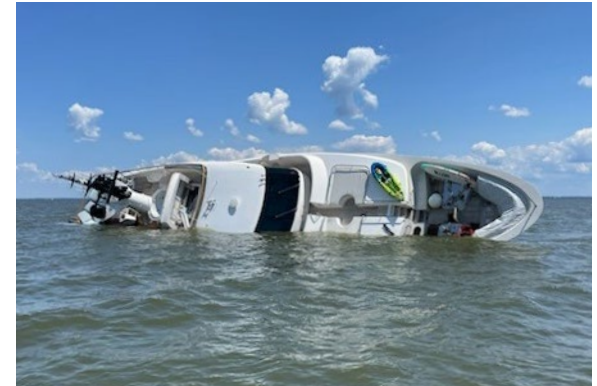
**The partially sunken *Lovebug* at 1342.**

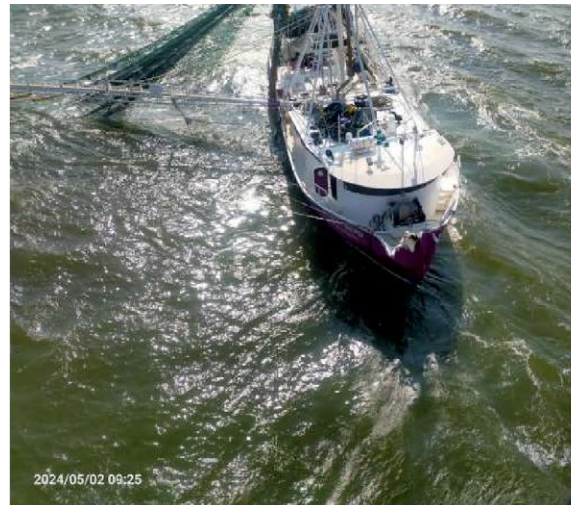
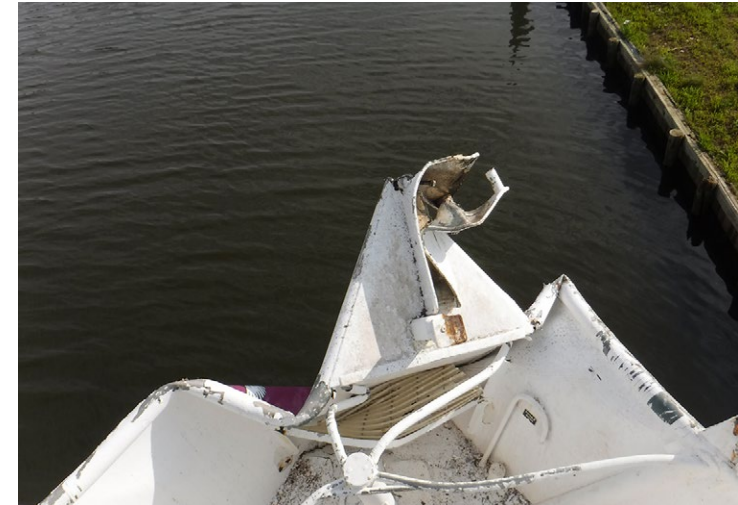
Damage to *Papa Rod*'s bow. SOURCE: COAST GUARD.

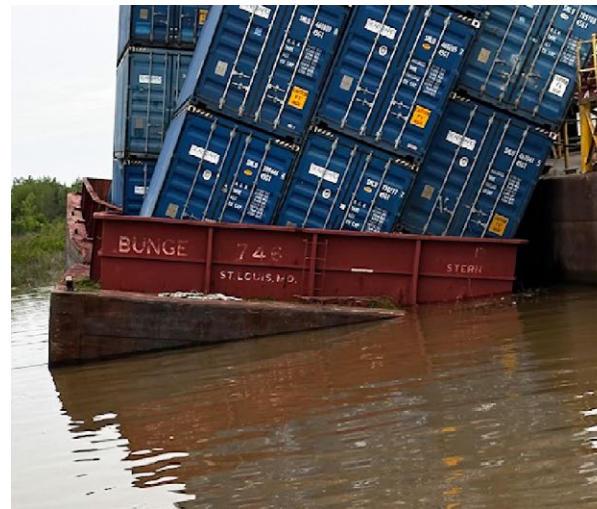
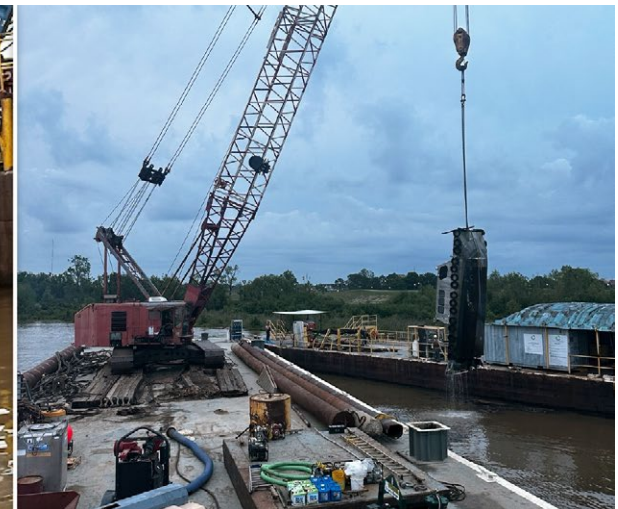
Fleeting area container barge **BUNGE 746** listing after the collision and fleeting area crew boat **Mr. Bubba** being recovered after it sank. SOURCE: COAST GUARD.

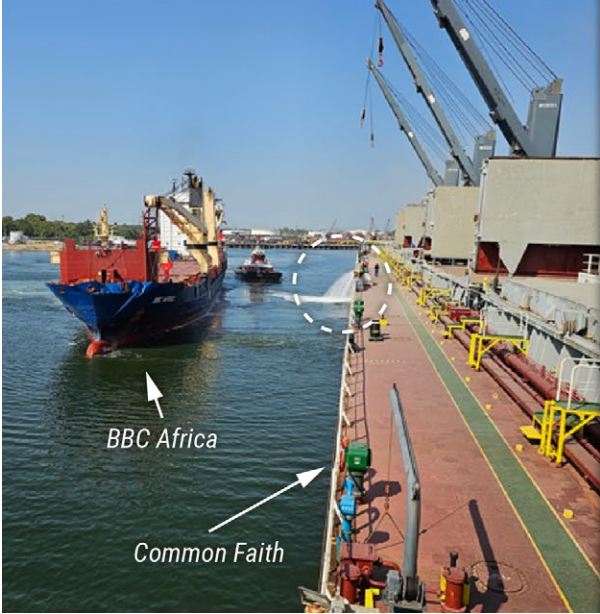
BBC Africa and Common Faith after the collision and ballast water spilling from Common Faith punctured port ballast tank (circled at left). SOURCE: COMMON FAITH MASTER.

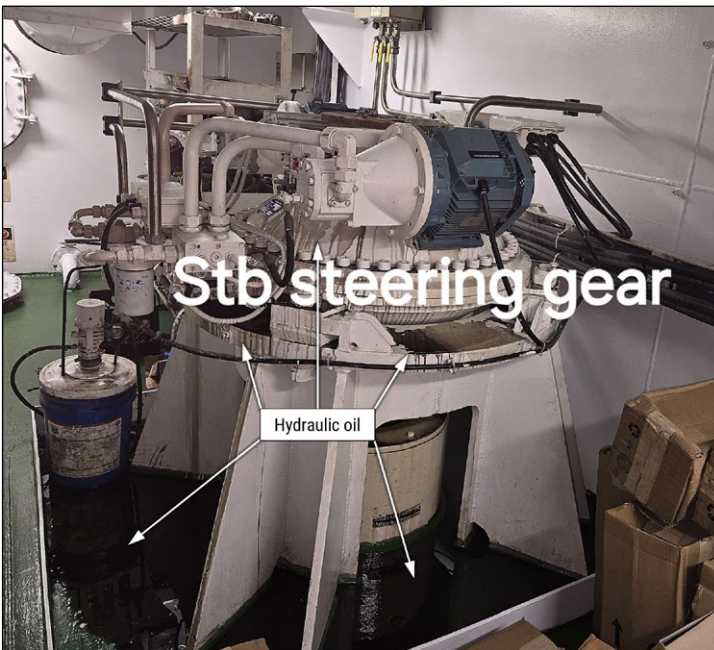
autopilot was “working harder” than he expected it to. In the watch turnover checklist for that day, the chief mate logged that “the vessel’s steering system seems to be off” and that it required 8° of starboard rudder to maintain course. However, no action was taken to address the steering problems because the degradation to the system had become normalized. Had the discrepancies observed with the steering system been reported to the chief engineer, the system could have been examined and repaired before the collision occurred.

**Jack Edwards starboard steering gear as found immediately after collision.**

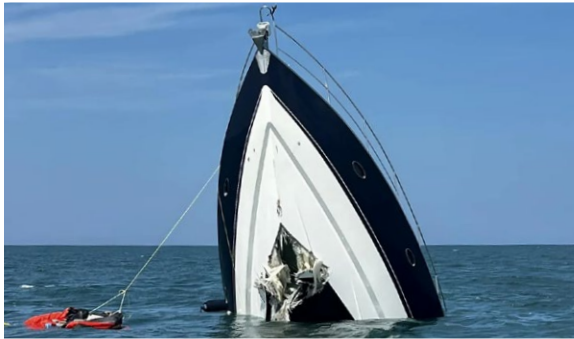
### Hull damage to the *Atlantis*.

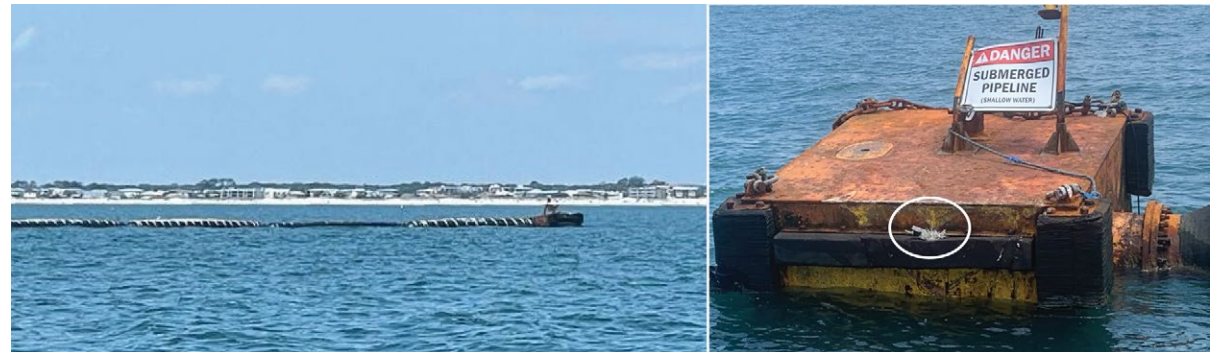
**From left: The dredge pipeline pump-out cube and floating hose from a distance, after the casualty. The pump-out cube with damaged sign and the area where the *Atlantis* made contact (circled).**

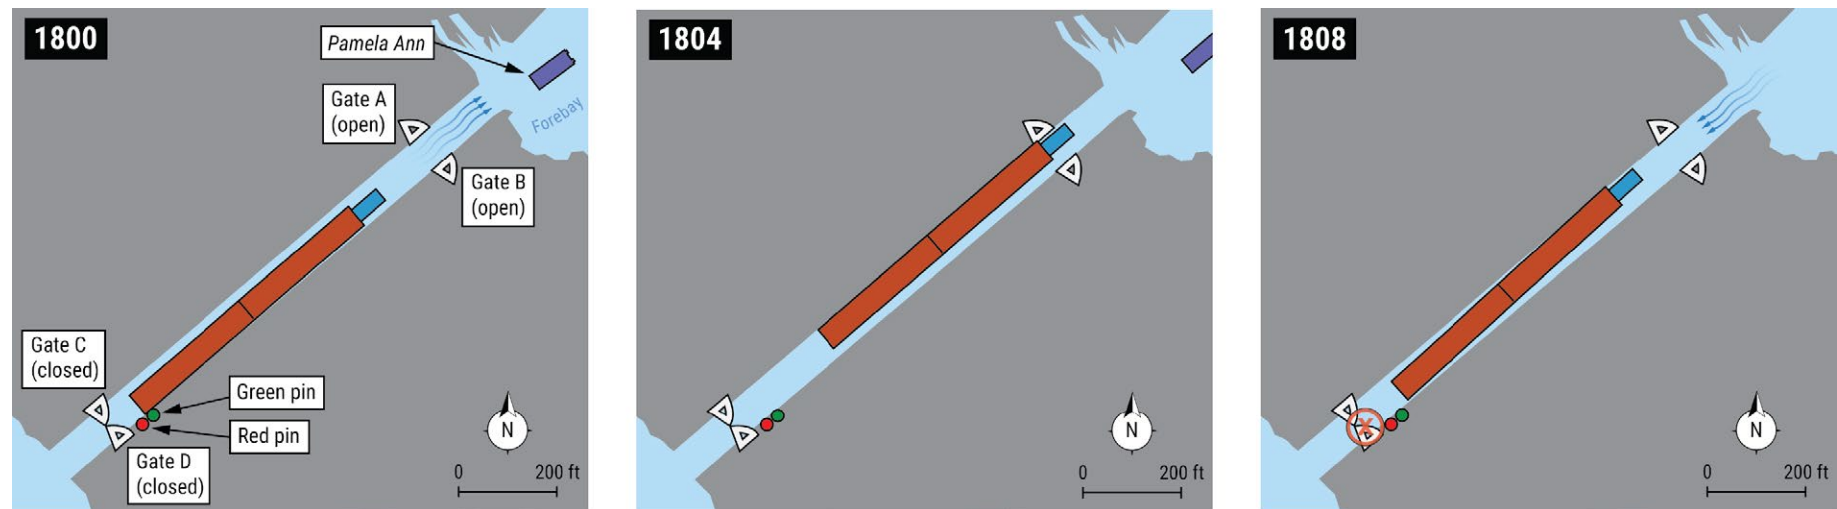
**THE PROBABLE CAUSE** of the contact of the barge *EMS 317* with Algiers Lock Gate D was surging water within the lock chamber, which was likely caused by the wakes from three deep-draft ships passing the lock forebay in quick succession during extreme low water conditions on the Mississippi River.

The positions of the *Kitty* tow at 1800, 1804, and 1808. Direction of water movement in and out of the lock is indicated by wavy arrows, and the contact area is indicated by a red X.

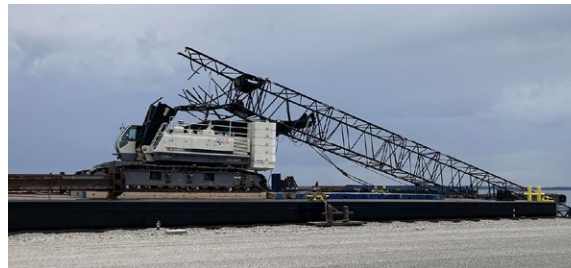
An NTSB study used video of the crane barge on the day of contact to determine that a boom elevation angle for the crawler crane over about 55° would contact the truss bottom cord of the bridge with the barge near the center of the channel. The study determined that the boom angle during the voyage and before contact with the bridge was about 62°, corresponding to a boom height of 162.3 feet above the water. Similarly, a postcasualty Coast Guard analysis determined that if the boom angle was 60° (the high end of the towing company managers' estimate), the end of the 160-foot-long boom with an attached 5-foot rooster sheave would have been about 165 feet above the water level. Given the vertical clearance of 153 feet for the Mackinac Bridge at the time of the contact, the crane was about 10 feet too high to transit under the bridge (not including an additional safety margin).

**The boom bent backwards over the cabin after striking the bridge.**

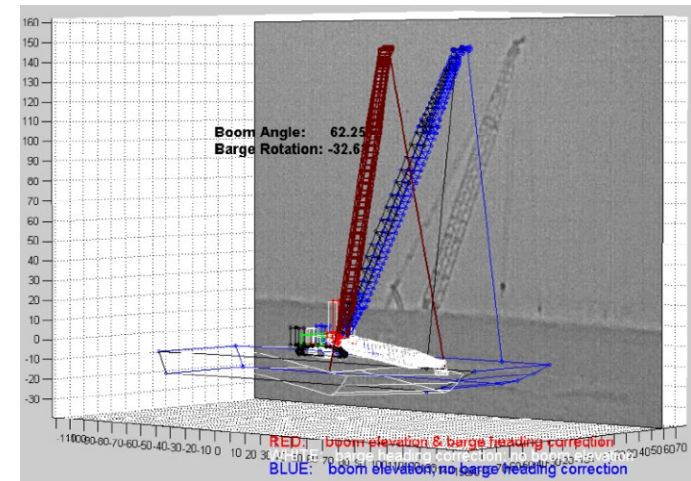
The damage to the Mackinac Bridge structure indicated that the first contact was to the stiffening truss below the roadway, at the top of the truss's bottom chord (about 155 feet above the water). Given the configuration of the crane, the wires securing the crane boom would have hit first, and when they parted, the boom would have contacted the top of the chord. As the barge continued forward, the boom would have been pushed backwards and its angle and height above the water would have increased, leading to damage higher up on the bridge. At some point, the boom contacted the upper diagonal truss, about

**Infrared footage of the crane on board the deck barge *BMI 209* at 1226, with the NTSB simulation overlay of the boom angle at 62.2°. BACKGROUND SOURCE: ENBRIDGE STRAITS MARITIME OPERATIONS CENTER.**

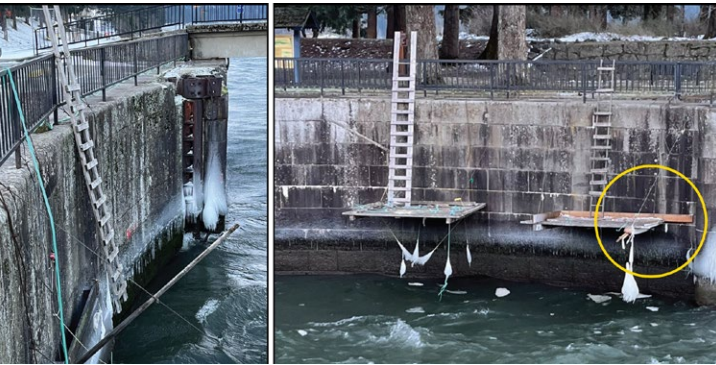
The area where the destroyed fishing platform had been mounted and damage to one of the platforms on the opposite side of the lock (circled).

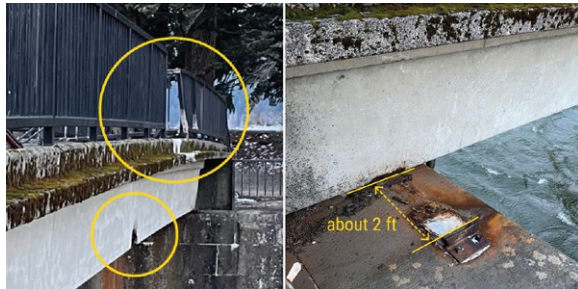
Damage to the pedestrian bridge deck and railing (circled) and displacement of the deck. BACKGROUND SOURCE: PORT OF CASCADE LOCKS PORT COMMISSION.

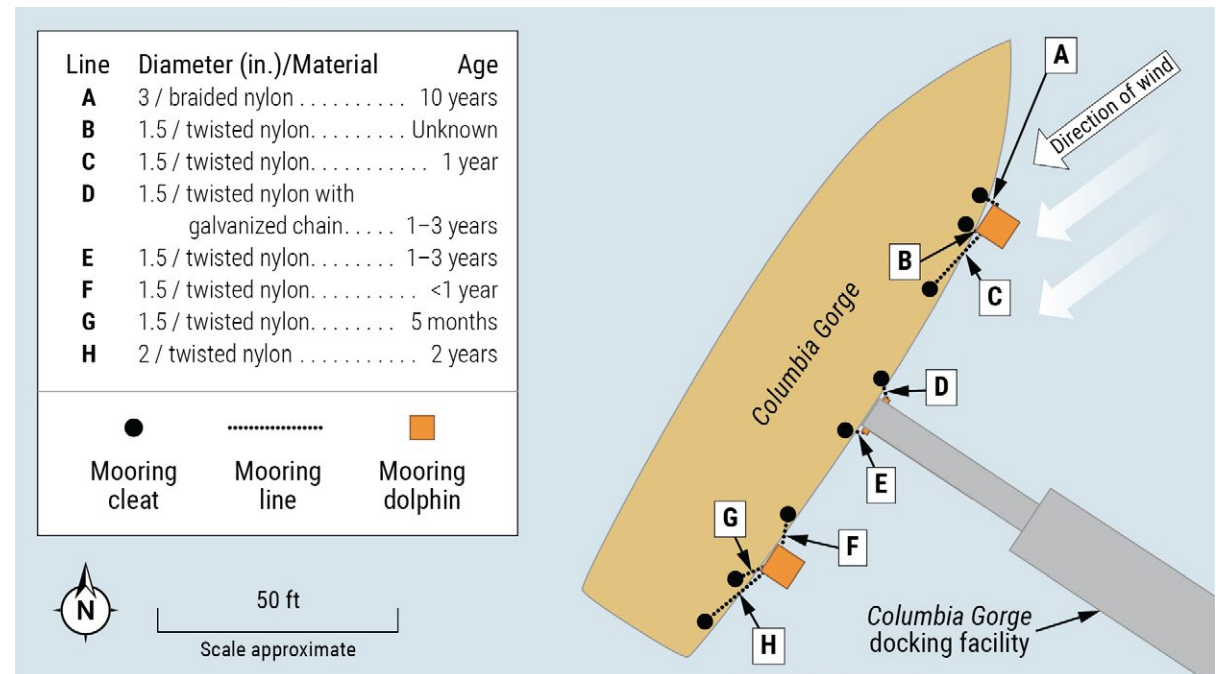
While the vessel was moored, the winds picked up to more than twice what was forecasted, increasing the wind load (force) acting on the *Columbia Gorge*. This force, just off the starboard bow, would have strained the mooring lines and chain holding the ship to its dock. As a result, all eight mooring lines and the chain failed. The *Columbia Gorge*, with no one aboard, broke free from its mooring and drifted about 475 yards downriver into a historic lock. The vessel damaged tribal fishing platforms mounted on the lock walls before its stern became wedged beneath the Thunder Island pedestrian bridge, which spanned the lock. Once notified of the breakaway, the crew responded quickly and secured the vessel.

The vessel operator had no plan in place for regularly examining the vessel's mooring lines or replacing them before failure, and the ages of the *Columbia Gorge*'s mooring lines ranged from less than 1 year to 10 years, with the age of some lines either unknown or not definitively known. The Port of Cascade Locks Port Commission Root Cause Analysis Team, which was formed 3 days after the casualty to investigate the breakaway, found that the mooring arrangement and nylon lines used would have been adequate to keep the vessel moored during the adverse weather conditions the morning of the casualty if the lines had been new or in good condition.

Because none of the lines were new and the vessel operator did not have a life cycle management program to regularly examine the condition of the lines, it is possible that some of the mooring lines used to secure the *Columbia Gorge* during the adverse weather event had become degraded, which led to the mooring lines breaking. As a result of the casualty, the operating company required mooring lines to be replaced annually.

*Columbia Gorge* mooring arrangement on January 13, 2024, including the diameters of and materials comprising each mooring line.

Conducting regular visual assessments to verify the condition of mooring lines and identify issues or defects is a prudent practice that is useful as a part of a vessel's preventative maintenance plan. In addition to a line's age, multiple factors affect the service life of a mooring line, including mooring design and the usual line arrangement, position of the line, mooring frequency, and environment. Mooring lines should be examined regularly for damage or excessive wear—regardless of a line's age.

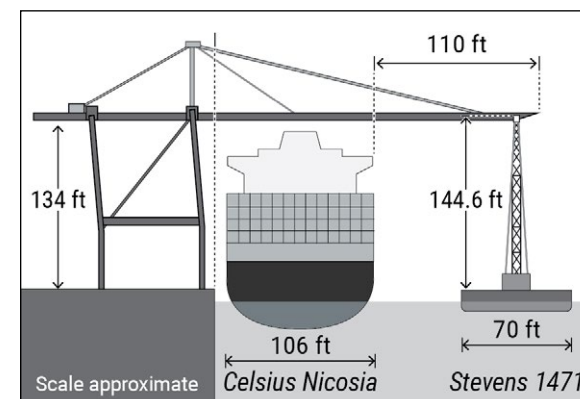
The *Royal Engineer* and tow were making about 3.5 knots when the top of the *Stevens 1471* crane mast struck the boom tip of the STS crane, resulting in extensive damage to the STS crane.

**The horizontal extent of the North Charleston Terminal STS crane.**

STS cranes, when conducting cargo operations on a vessel and in the lowered position, may extend considerably beyond the side of the vessel and become a hazard to vessels with high air drafts transiting nearby. Mariners should always consider their vessel and tow's air draft when identifying hazards to navigation.

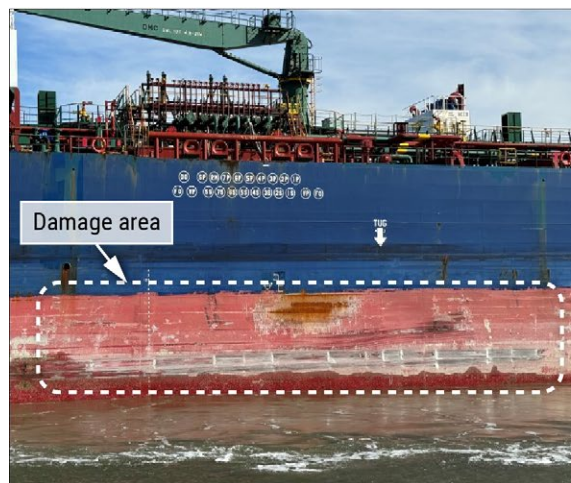
**Left to right: *Hafnia Amessi* starboard side after the contact, showing inset plating and scraped paint within outlined area, and Naval Weapons Station Pier B, showing damage to the platform and protective dolphin.**

On January 14, 2024, at 1019 local time, the 604-foot-long tanker *Hafnia Amessi* was transiting outbound on the Cooper River near Naval Weapons Station, Joint Base Charleston, South Carolina, when the vessel struck the Naval Weapons Station Pier B. Hull plating on the vessel's starboard side, a cement platform on the end of the pier, and a protective dolphin were damaged. There were no injuries, and no pollution was reported. Damage to the vessel and pier was estimated at \$8.1 million.

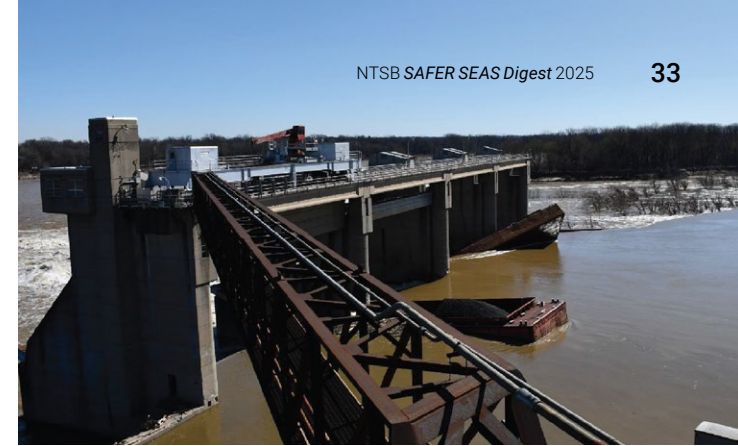
On March 8, 2024, about 1550 local time, the towing vessel *Amber Brittany* was transiting upbound on the Ohio River, pushing a 15-barge tow, when the tow struck the vane dike at the upstream end of the McAlpine Locks and Dam in Louisville, Kentucky, and broke apart. There were no injuries, and no pollution was reported. Total damages to the barges, cargo, and dam gates were estimated at \$1.3 million.

Barges from the *Amber Brittany* tow lodged in the Lower McAlpine Dam Gate after the tow broke apart.

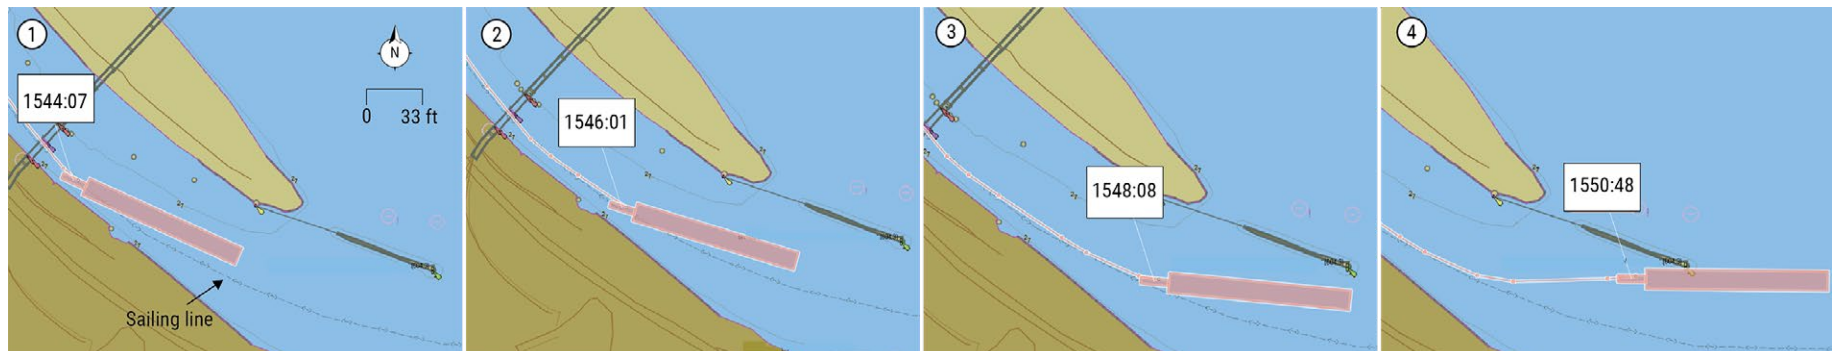
**THE PROBABLE CAUSE** of the contact of the *Amber Brittany* tow with the vane dike was the pilot not effectively compensating for the outdraft current while navigating out of the lock channel entrance, likely due to the pilot's inexperience in transiting the Portland Channel on the *Amber Brittany* and his distraction due to cell phone use.

The *Amber Brittany* tow as it came through the Louisville and Indiana Railroad Bridge, its heading altered to port, it was set off the sailing line, and it contacted the vane dike mooring cell.

Lock canal entrances require heightened situational awareness from vessel operators. Using cell phones and other wireless electronic devices has been demonstrated to be visually, manually, and cognitively distracting. Talking on cell phones can have serious consequences in safety-critical situations, and sending or reading text messages is potentially even more distracting than talking because texting requires visual attention to the display screen of the device. Mariners should avoid using mobile devices, especially while maneuvering in unfamiliar areas of restricted navigation.

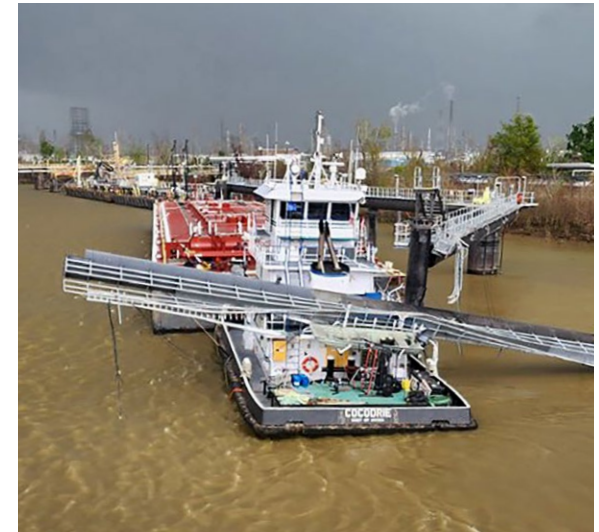
In an attempt to "twist" the head of the tow to port (away from the dock and its walkway), the pilot came full ahead on the starboard engine, moved the flanking rudder to starboard, and moved the main rudders to port. However, given the *Cocodrie*'s proximity to the dock no. 6 walkway, the pilot's action was too late to arrest the vessel's astern momentum, and the aft corner of the *Cocodrie* wheelhouse struck the walkway, causing it to come away from its mountings and fall onto the *Cocodrie*.

**Cocodrie with the walkway resting across the deck of the aft main deck structure.** SOURCE: COAST GUARD.

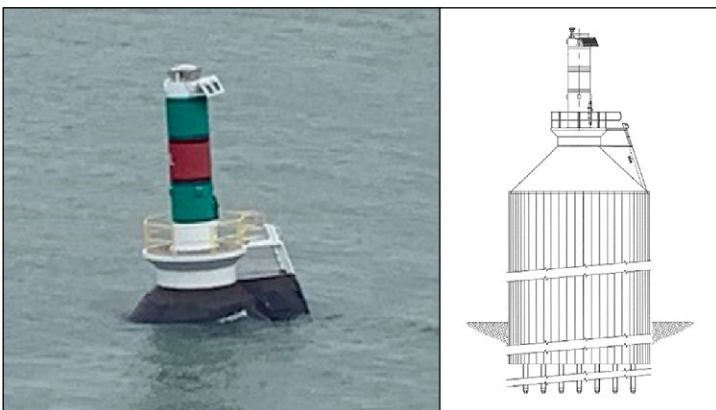
the wheelsman alerted the captain and second mate that the rudder was stuck about 20° left and he had lost steering control. The vessel swung to port and, despite crew efforts to respond to the casualty, the port bow of the *American Mariner*, moving about 12 mph, struck the Munuscong Channel Junction Light.

**Upper portion of the Munuscong Channel Junction Light after being struck by the *American Mariner* and a rendering of the 31-foot-diameter concrete navigation aid.** SOURCE: COAST GUARD.

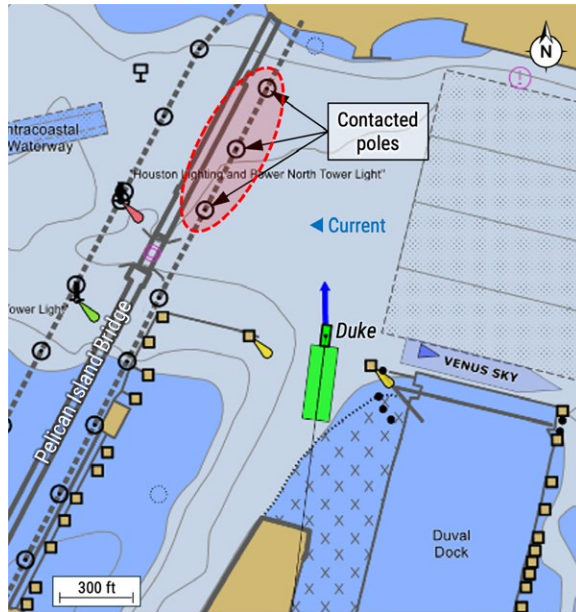
At the time, the flood current, as noted by the captain, was about 0.8 knots, which would have pushed the tow toward the bridge as he backed into the channel. Given the captain's focus on the moored vessel to the east, he likely did not recognize that the current was pushing the tow faster than he anticipated and toward the power poles and bridge until the tow struck them.

**THE PROBABLE CAUSE** of the contact of the *Duke* tow with power transmission poles and the Pelican Island Bridge was the captain's focus on staying clear of a nearby moored cargo vessel and not recognizing how close the tow was getting to the power poles and bridge.

**Duke tow departing the basin at 0120. The poles and section of the bridge contacted by the tow are circled.** BACKGROUND SOURCE: MAGNOLIA DATA AS VIEWED ON ROSE POINT.

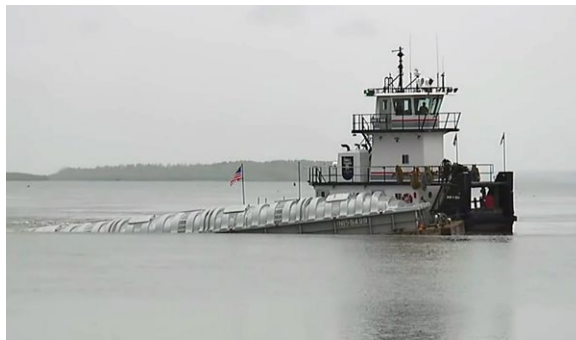
The pilot increased the engine rpm to attempt to maneuver the head of the tow back toward the center of the channel. However, the vessel’s speed and proximity to the protection cell, as well as the following current, prevented the pilot from maneuvering the tow sufficiently to avoid striking the protection cell. The third barge in the starboard string contacted the protection cell, and the tow subsequently broke apart, with 13 of the 15 barges drifting downriver. Assist boats recovered 14 of the 15 barges; the remaining barge sank along the shoreline and was later salvaged.

**The sinking barge IN155499 being held in place by an assist boat.**

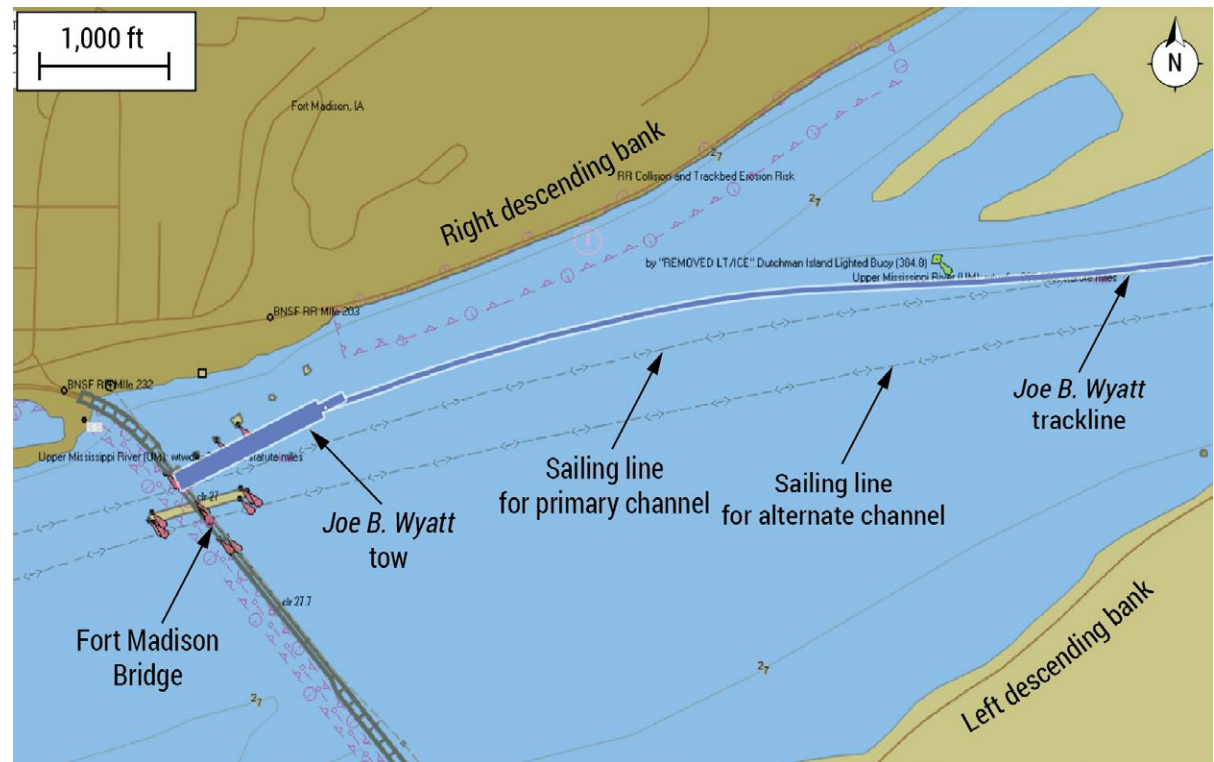
At 1306, with the pilot at the helm, the **Joe B. Wyatt** tow passed the southwest end of Dutchman Island, about a mile upriver from the Fort Madison Bridge, at 8.2 mph. The tow was about 65 feet right (toward the right descending bank) of the charted primary sailing line (recommended track). (The bridge's central fendering system separated the

**THE PROBABLE CAUSE** of the contact of the *Joe B. Wyatt* tow with a protection cell and the fendering system of the Fort Madison Bridge was the pilot overcompensating for anticipated river crosscurrents during the tow’s approach to a bridge.

**Track of the *Joe B. Wyatt* tow as it approached the Fort Madison Bridge at 1311 on May 9.**

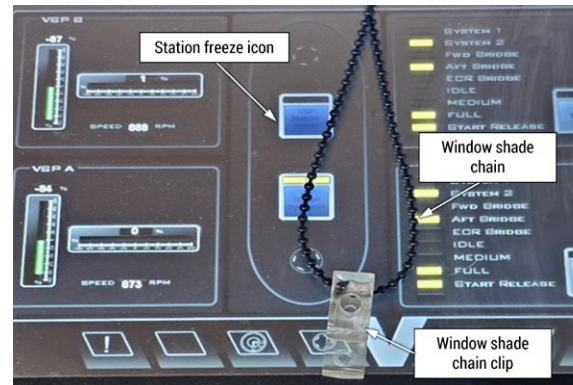
between Bolivar and Galveston, the shade chain could have been adjusted at some point due to the ferry's position relative to the sun. According to one deckhand, they typically adjusted the shade if the sun was "too bright" or going down. Adjusting the shade increased the potential that the chain and its plastic clip, once released after adjustment by the operator, would lay atop the touch panel. However, crewmembers in the wheelhouse did not recall adjusting the window shade during the transit. If the shade chain and its plastic clip had been left lying across the touch panel, the clip could have activated the station freeze function during the transit, unbeknownst to the operator, resulting in the loss of cycloidal propulsion system control.

**THE PROBABLE CAUSE** of the contact of the ferry *Ray Stoker, Jr.* with a floating dock was likely a wheelhouse window shade chain clip activating the station freeze function on a propulsion control touch panel, resulting in a temporary loss of propulsion control.

**Touch panel with plastic chain during postcasualty testing.** SOURCE: VOITH SERVICE REPORT PROVIDED BY TXDOT.

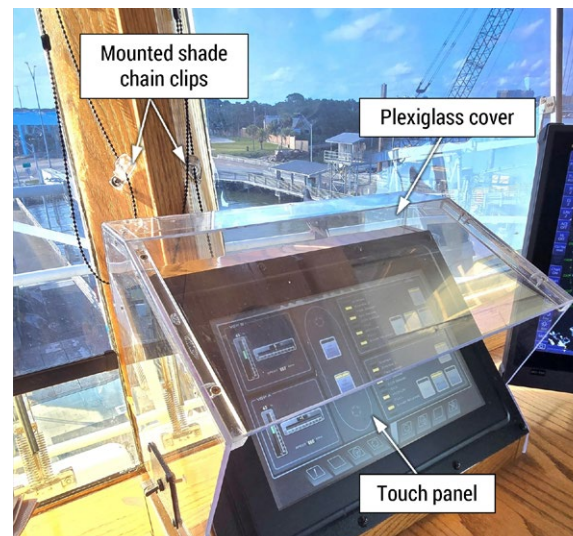
**Touch panel with plexiglass cover installed after the casualty.** BACKGROUND SOURCE: TXDOT.

Following the accident, the operating company installed transparent plexiglass covers over the control touch panels on the *Ray Stoker, Jr.* and instructed ferry crewmembers to install fittings to secure window shade chains so that they would not come into contact with the panels.

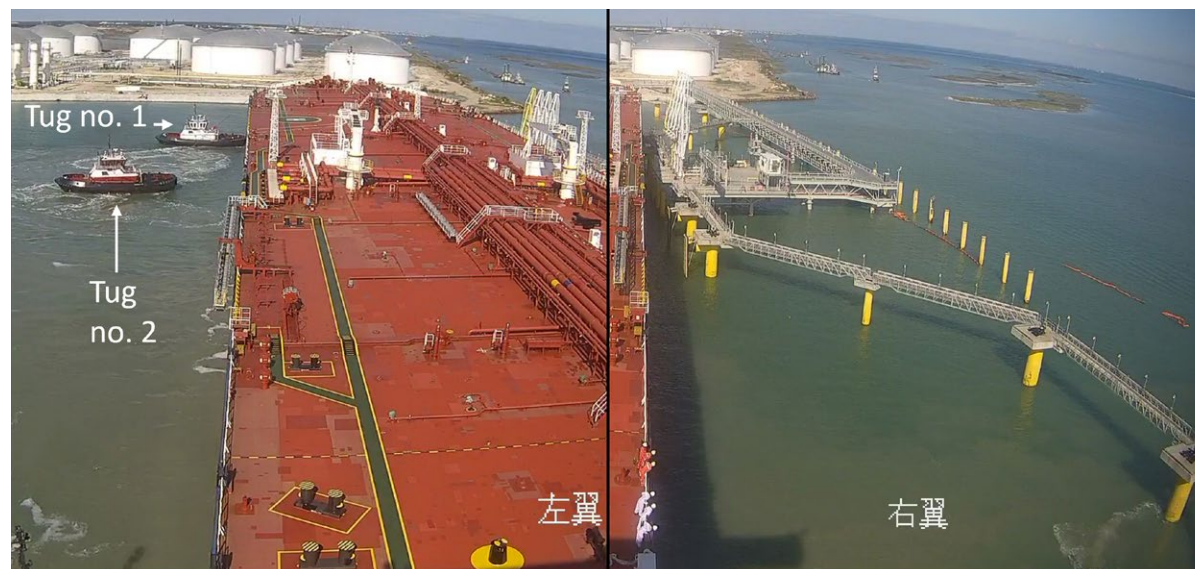
Image recording system screenshot at 1415, the time of contact with the east dock breasting dolphins, from the port and starboard side of the **Cosflourish Lake**, looking forward.

On November 14, 2023, about 1415 local time, the tanker **Cosflourish Lake** struck protective pilings and two breasting dolphins while docking at the east dock of South Texas Gateway Terminal (STGT) in Ingleside, Texas. There were no injuries, and no pollution was reported. Damage to the terminal was estimated at \$18 million.

**THE PROBABLE CAUSE** of the contact of the tanker *Cosflourish Lake* with the STGT dock was the pilot at the conn not effectively using the tugs at the vessel's bow while docking.

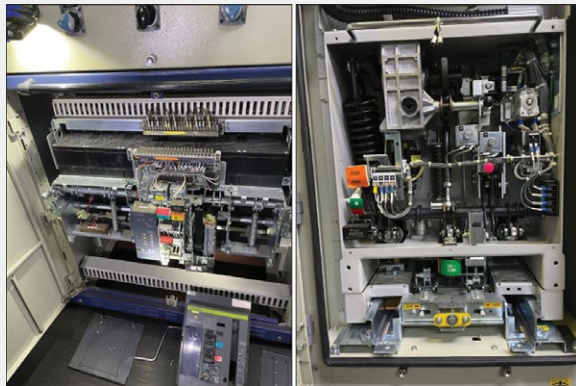
Left to right: The LR1 breaker (face cover removed) during examination, and the HR1 circuit breaker racked out in the test position during examination.

NTSB investigators discovered a loose signal wire (Wire 1) on a terminal block within the HV switchboard. The wire-label banding on the signal wire covered the wire's ferrule collar so that the ferrule could not be fully inserted into the terminal block's spring clamp gate, causing an inadequate connection. This left the wire vulnerable to becoming electrically disconnected. As the *Dali* approached the Francis Scott Key Bridge, Wire 1 disconnected from its terminal block and HR1 opened, interrupting power to TR1 and the LV switchboard and causing the blackout.

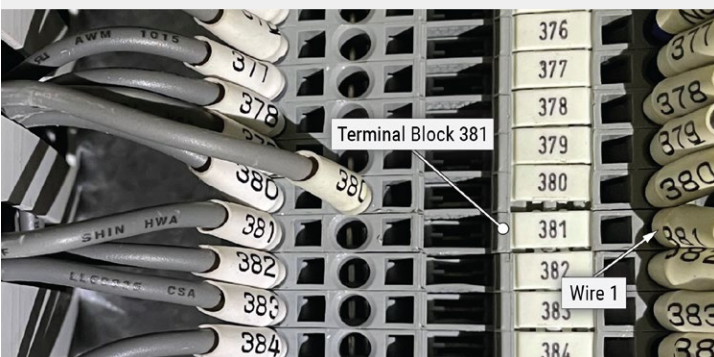
**Signal wires Wire 1 and Wire 3 identified in Terminal Block 381.**

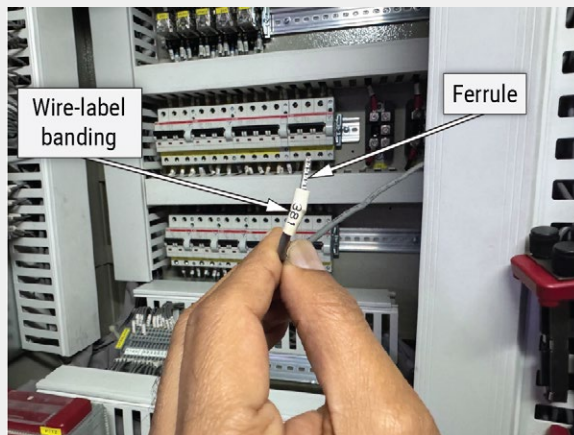
**Wire 1 disconnected from Terminal Block 381.**

**THE PROBABLE CAUSE** of the contact of the containership *Dali* with the Francis Scott Key Bridge was a loss of electrical power (blackout), due to a loose signal wire connection to a terminal block stemming from the improper installation of wire-label banding, resulting in the vessel's loss of propulsion and steering close to the bridge. **CONTRIBUTING** to the crew's inability to recover propulsion from the loss of electrical power was the limited time available due to the *Dali*'s proximity to the bridge. **CONTRIBUTING** to the collapse of the Francis Scott Key Bridge and the loss of life was the lack of countermeasures to reduce the bridge's vulnerability to collapse due to impact by ocean-going vessels, which could have been implemented if a vulnerability assessment had been conducted by the Maryland Transportation Authority as recommended by the American Association of State Highway and Transportation Officials. **ALSO CONTRIBUTING** to the loss of life was the lack of effective and immediate communications to notify the highway workers to evacuate the bridge.

We issued **recommendations** relating to detecting inadequate signal wire connections and preventing improperly placed wire-label banding on terminal blocks to Synergy, the vessel manager; WAGO, the manufacturer of the terminal block with the loose signal wire connection; and HD Hyundai Heavy Industries, the vessel's builder.

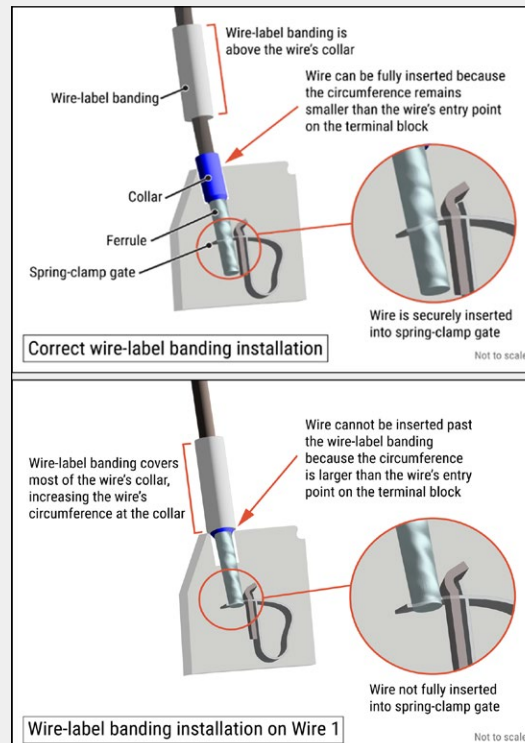
**From top: Correctly installed wire-label banding compared to Wire 1's wire label banding installation, showing how placement of wire-label banding affects the way wires are seated in their terminal blocks.**

The initial underway blackout was caused by a series of electrical-related events that began when a signal wire (Wire 1), one of many in the main switchboard, electrically disconnected from its terminal block. Installed on each signal wire, including Wire 1, were labeling bands (wire-label banding), which were small silicone sheaths made of thermoplastic material that was heat-shrunk around the wire and had its associated terminal block identification number printed on it. The wire-label banding for Wire 1 covered all of the ferrule's blue insulated collar, increasing the ferrule's overall circumference, preventing the wire from being fully inserted into its terminal block—leaving Wire 1 vulnerable to becoming electrically disconnected.

Synergy (the vessel's operator) required main switchboard inspections aboard the *Dali*, but the inspection guidance did not specify how to complete these checks, nor did it specify that all control (signal) wires in the HV switchboard had to be reviewed. Infrared thermal imaging is an inspection technique that allows inspectors to identify possible points of failure in electrical components not readily visible to the human eye. Had the technique been used to inspect the *Dali*'s HV switchboard connections as part of the vessel's preventative maintenance program, the loose Wire 1 may have been identified.

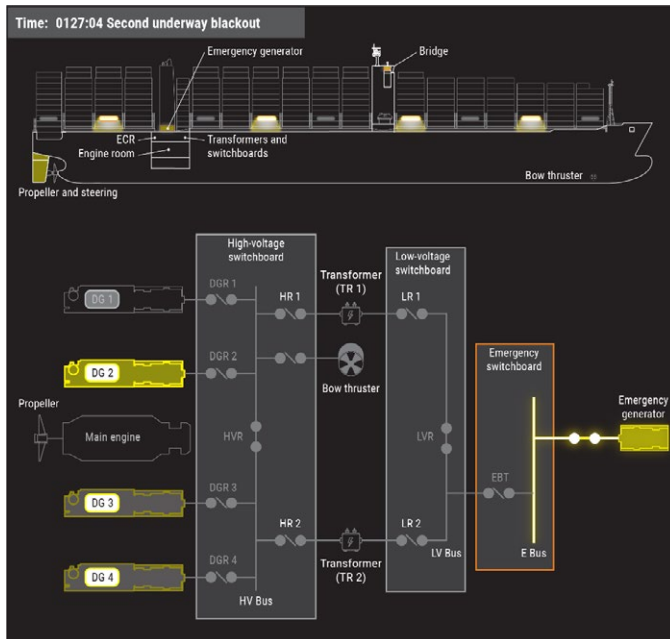
At 0126:10, 70 seconds after the blackout, the EDG connected to the emergency bus, supplying power to the emergency switchboard, including steering gear pump no. 3. However, about 0127:02, the vessel experienced another blackout; both the HV and LV switchboards lost power. This occurred because the fuel pressure for DG3 and DG4 dropped, leaving the generators unable to maintain speed at their electric load and resulting in an underfrequency condition. The vessel's PMS, which monitored the generators, detected the low frequency and automatically started DG2 as designed. However, before DG2 could synchronize to the HV bus, the PMS automatically disconnected DG3 and DG4 from the HV bus due to their underperformance, leading to both HR1 and LR1 opening automatically.

**Configuration of *Dali* plant at 0127:04 when the vessel lost power (blackout) for a second time while underway.**

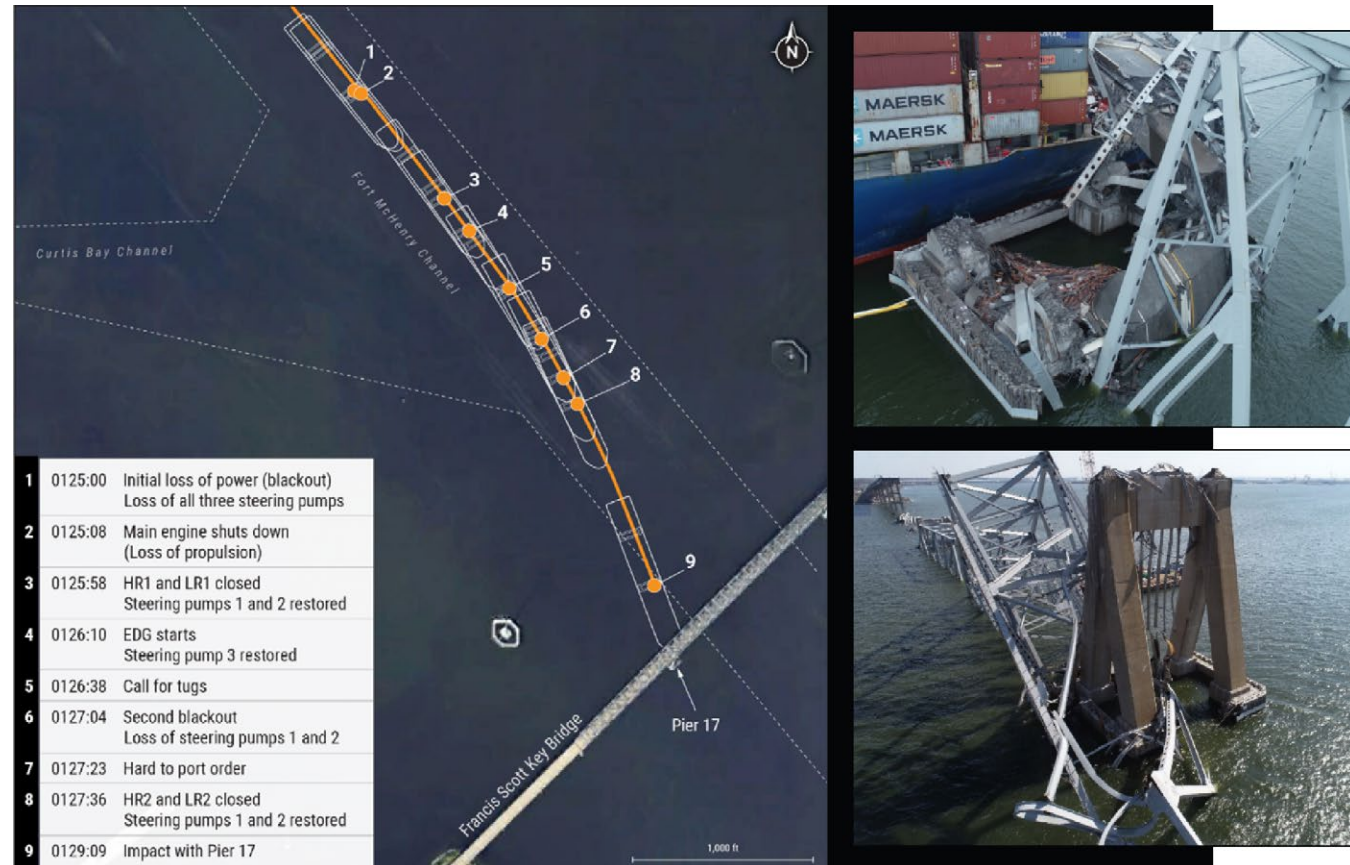
Despite the *Dali* crew and pilot's continued efforts to slow the vessel or change its course, the *Dali* continued toward Pier 17. Before the MDTA officers could alert the highway workers on the bridge, the *Dali*'s bow struck Pier 17 at a speed of 6.4 knots (7.4 mph). The pier collapsed, followed by the main spans (17, 18, and 19); Piers 19, 20, and 21; and Spans 20, 21, and 22.

**Trackline of the *Dali* as it approached the Key Bridge. Each dot marks the location of the vessel's AIS antenna (above the vessel's bridge) at a given time. Insets show damage to fendering surrounding Pier 17 and Pier 18.**

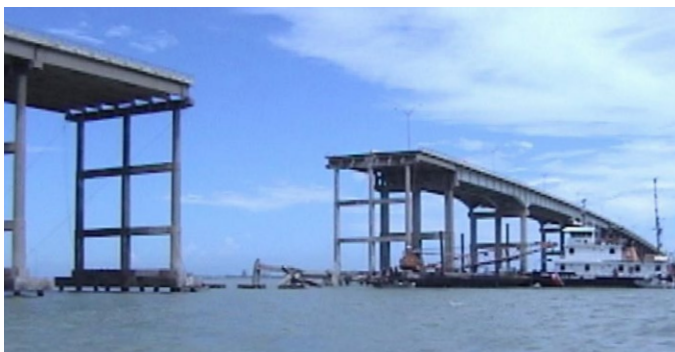
**Collapsed section of Queen Isabella Causeway in Port Isabel, Texas. On September 15, 2001, four loaded barges crashed into one of the bridge's support columns. The collision caused two 80-foot spans to fall into the water. Eight people were killed as their cars fell 85 feet into the water. Five vehicles were recovered from the water along with three survivors.**

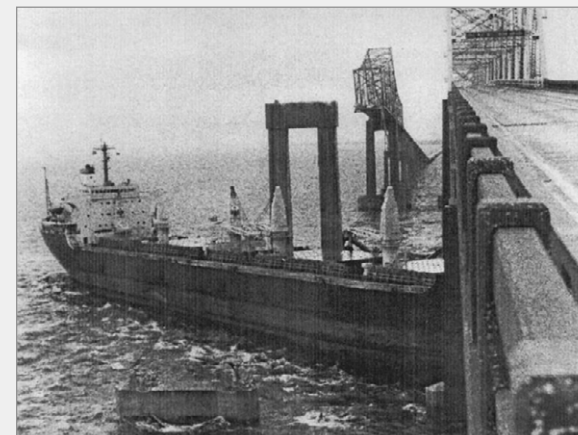
View of the collapsed western span of the Sunshine Skyway Bridge in Tampa Bay, Florida, after the Liberian-flagged bulk carrier *Summit Venture* rammed a support pier on May 9, 1980. The NTSB investigated the accident and issued recommendations to FHWA and the Coast Guard that ultimately resulted in AASHTO's adoption of its 1991 *Guide Specification and Commentary for Vessel Collision Design of Highway Bridges*, which introduced a vulnerability assessment calculation for bridges.

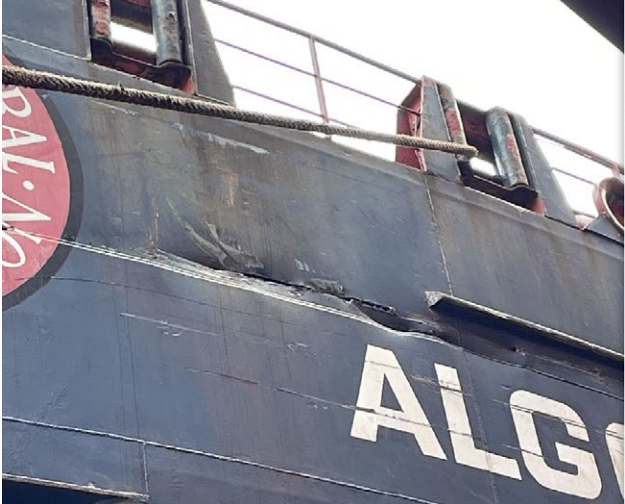
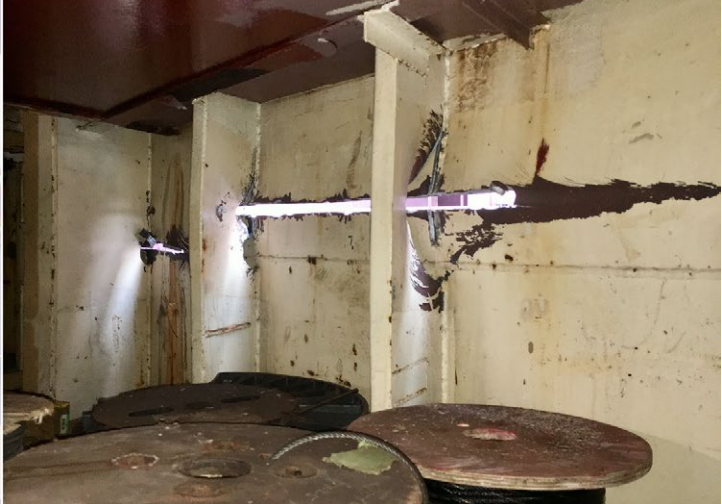
**Exterior and interior damage to the Algoma Discovery following the casualty.** SOURCE: COAST GUARD.

On July 20, 2024, about 2215 local time, the Canada-flagged cargo vessel **Algoma Discovery** struck five of the loading shuttles at the BNSF Allouez Taconite Facility, in Superior, Wisconsin, after losing electrical power and main propulsion while docking. There were no injuries, and no pollution was reported. Damage to the facility was estimated at \$950,000, and damage to the **Algoma Discovery** was estimated at \$130,000.

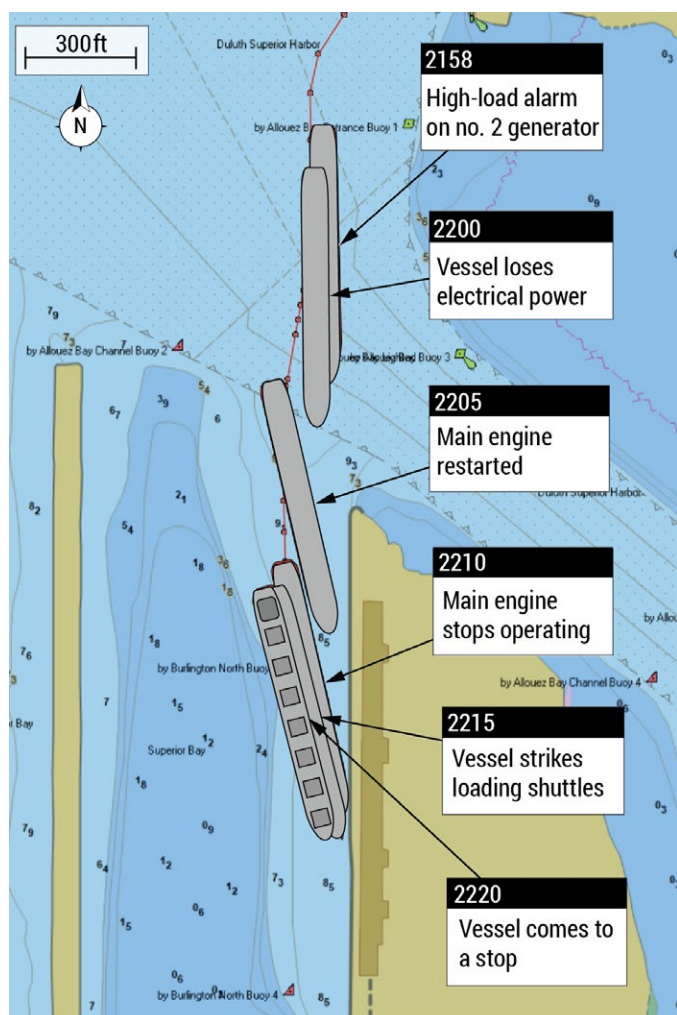
**Trackline of *Algoma Discovery* as it approached the dock to the time it came to a stop after striking the loading shuttles.** BACKGROUND SOURCE: NOAA ENC US5DLHCG AS VIEWED ON MADE SMART.

Without main propulsion and a bow thruster, the master could not effectively maneuver the vessel to avoid striking the facility's loading shuttles. Had the chief engineer or operating company required further testing of the no. 2 generator at a significant load before the vessel's docking, they may have identified that the malfunction with the no. 2 generator had not been corrected. With the knowledge that the vessel did not have three operational generators, which were required to operate the bow thruster, the crew and operating company then could have implemented measures to ensure a safe docking without the use of the bow thruster.
