NATIONAL TRANSPORTATION SAFETY BOARD

# SAFER SEAS

# Digest

Lessons Learned from  
Marine Investigations

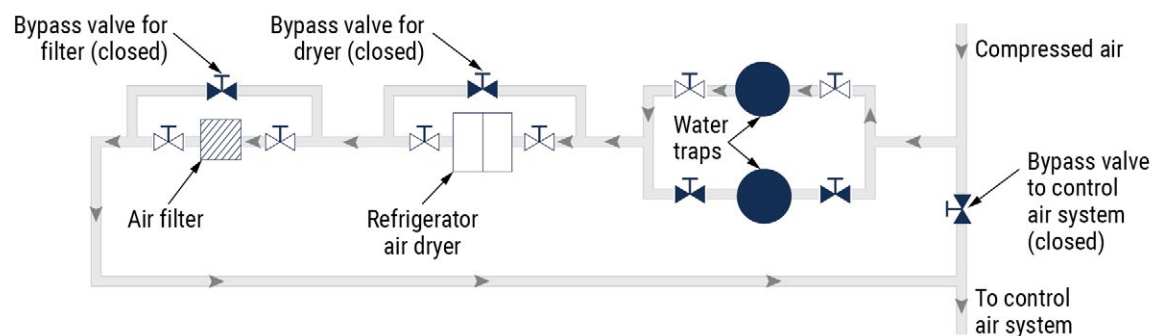
The low start air pressure was likely due to the vessel's compressed air bottle system pressure being depleted from the multiple attempts to restart the engine the second time. When the vessel lost power, the refrigeration air dryer for the control air system shut down, most likely due to the loss of electrical power to the fan motor. This prevented the supply of compressed air to the control air system. The refrigeration air dryer system was not configured to restart automatically; instead, the crew would have to manually restart it after main electrical power was restored. Therefore, the air used for multiple maneuvering commands (from the bridge engine controls to the control air system for

**Typical flow of compressed air through the water traps, refrigerator air dryer, and air filter before reaching the control air system.** BACKGROUND SOURCE: ALGOMA CENTRAL CORPORATION.

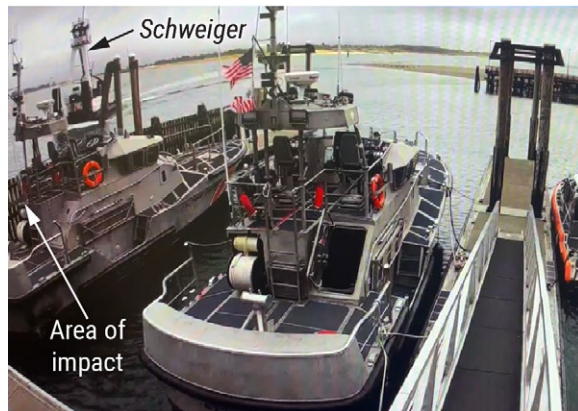
The captain reported that he fell asleep before the contact. Based on the time the vessel began turning to port, the captain likely fell asleep about 1 to 3 minutes before the contact, sometime between 12:35:12 and 12:36:25.

**CCTV captured the *Schweiger* underway moments before contacting the wave barrier and floating dock.**

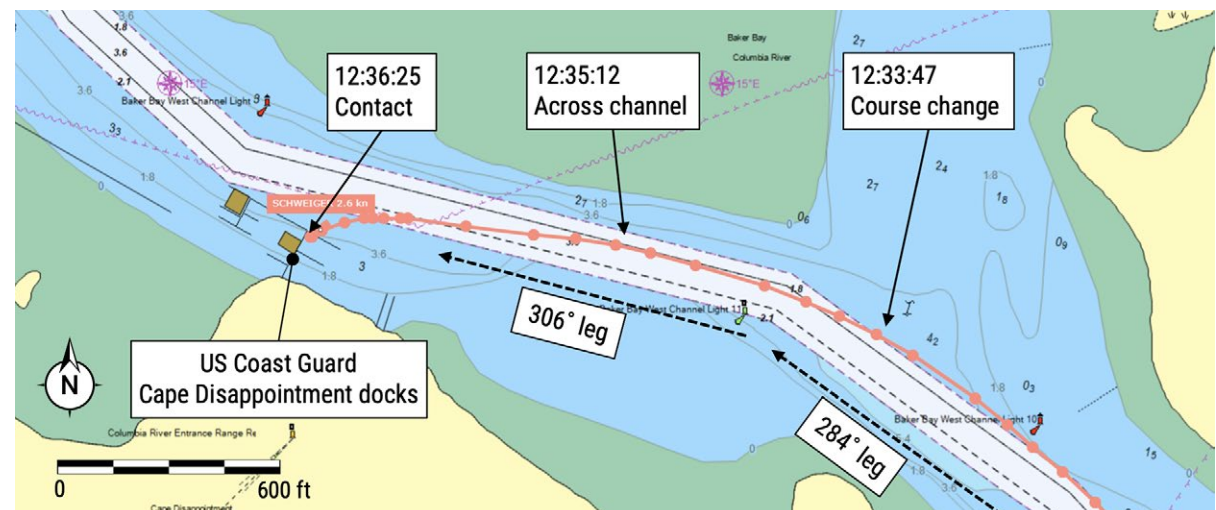
**Trackline of the *Schweiger* as it transited the Baker Bay West Channel on September 11.**

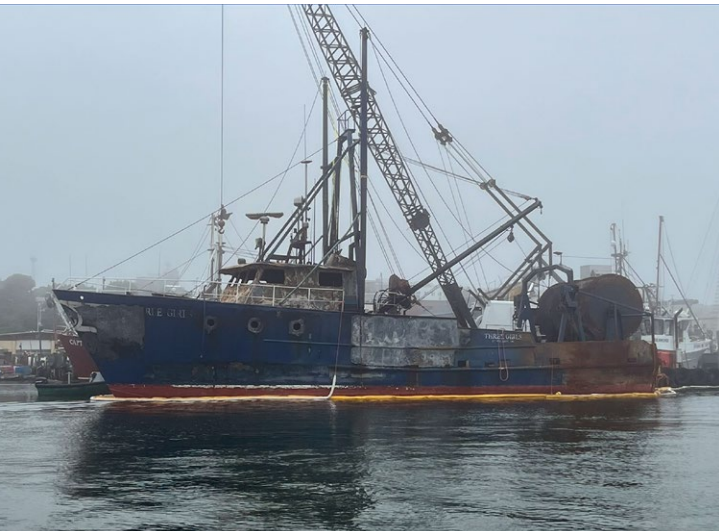
**Three Girls docked in Portland, Maine, on August 14, 2024, after the fire.**

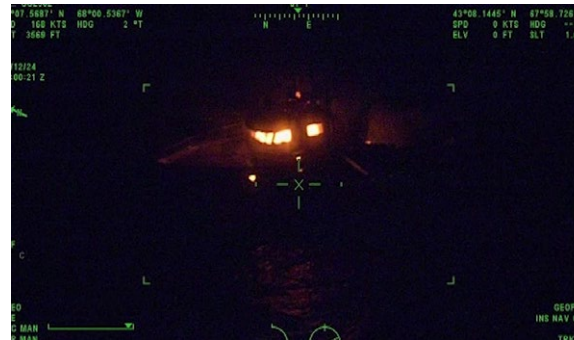
**View of the burning *Three Girls* from the rescue helicopter, with fire in the wheelhouse.**

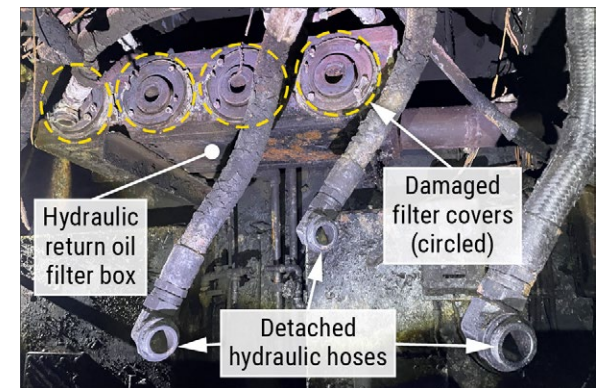
After the fire, all hydraulic hoses from the hydraulic return oil filter box were found detached from their aluminum filter housing covers, which had

been melted away by the fire, indicating the hoses, their fittings, or another component of the steel filter box had failed. Due to the extent of the fire damage throughout the engine room, investigators were unable to determine which hydraulic hose, fitting, or component may have initially failed. If the filter box or a component of the filter box failed, pressurized hydraulic oil would have sprayed into the engine room onto nearby operating machinery.

**Hydraulic system return oil filter box in the *Three Girls* engine room after the fire.**

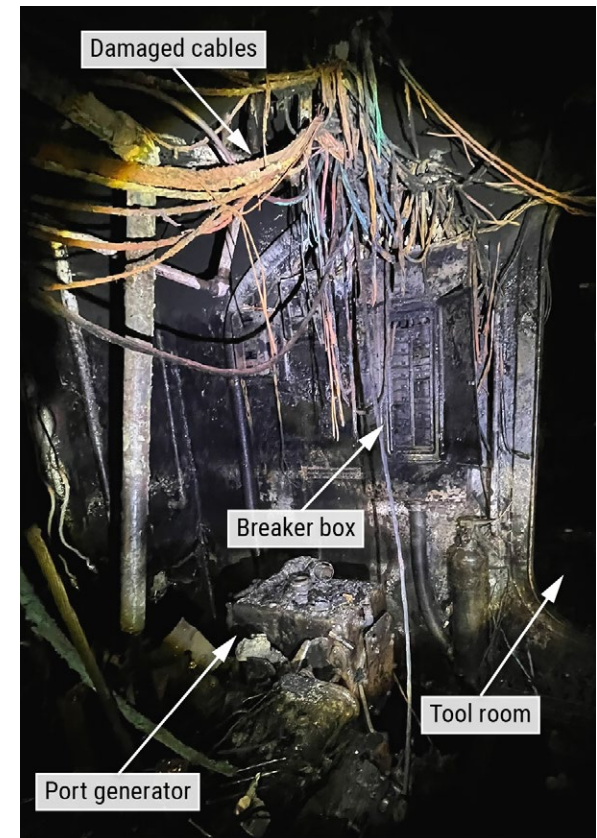
A postcasualty examination of the engine room found the most extensive fire damage was in the forward, port side and a few areas of “clean burn” present between the hydraulic return oil filter housing and the winch engine that was operating at the time, indicating the fire had burned hottest there. Therefore, the fire area of origin was likely in the port, forward corner of the engine room between the hydraulic return oil filter housing and the winch engine.

**Fire damage in the port forward corner of the *Three Girls* engine room.**

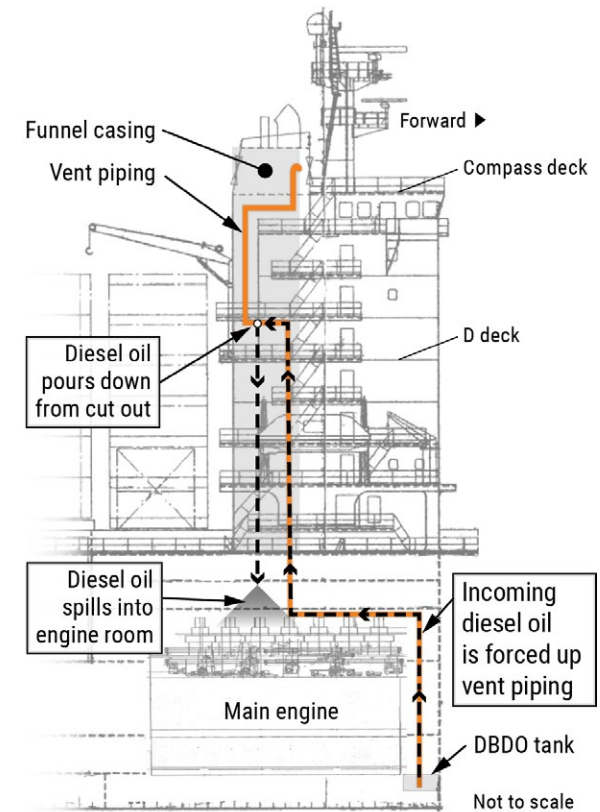
Diesel oil then poured out of the opening in the vent pipe and cascaded down through the engine room, igniting and resulting in a fire. Had the cut out not been present, the diesel oil would have likely exited the vent pipe on the compass deck and spilled onto the vessel exterior and into the water, rather than directly into the engine room, which contained operating machinery and other ignition sources.

Side profile view of engine room and funnel casing area with the combined fuel tanks vent pipe, annotated in orange, up to compass deck.

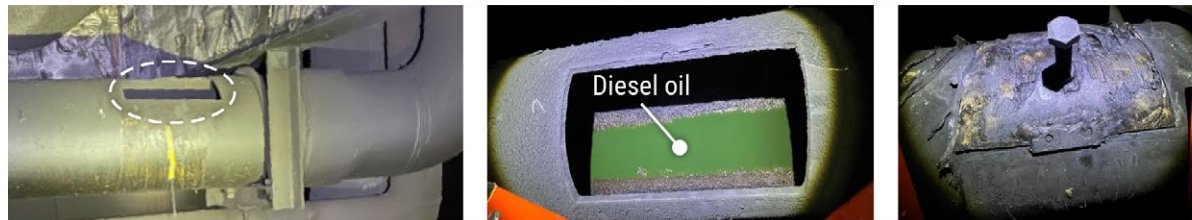
At some unknown time, a 7-inch-by-11-inch section of pipe had been cut into the top of a horizontal section of the 12-inch vent pipe on the D deck. There were no records of this unauthorized alteration. The cut out section of pipe had been replaced with a flexible sealant and then wrapped in tape. Once the diesel oil reached this area of the vent piping, the

Left to right: Circled area identifying the open section of fuel vent piping on D deck; diesel oil observed in vent piping, seen from above, through cut out section; and cut out placed back in position.

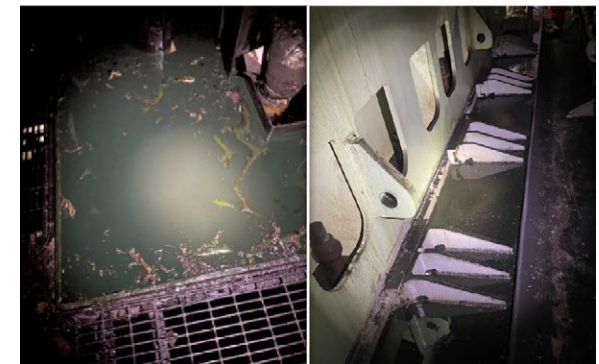
Diesel oil puddled in deck containment D deck and alongside base of main engine on tanktop.

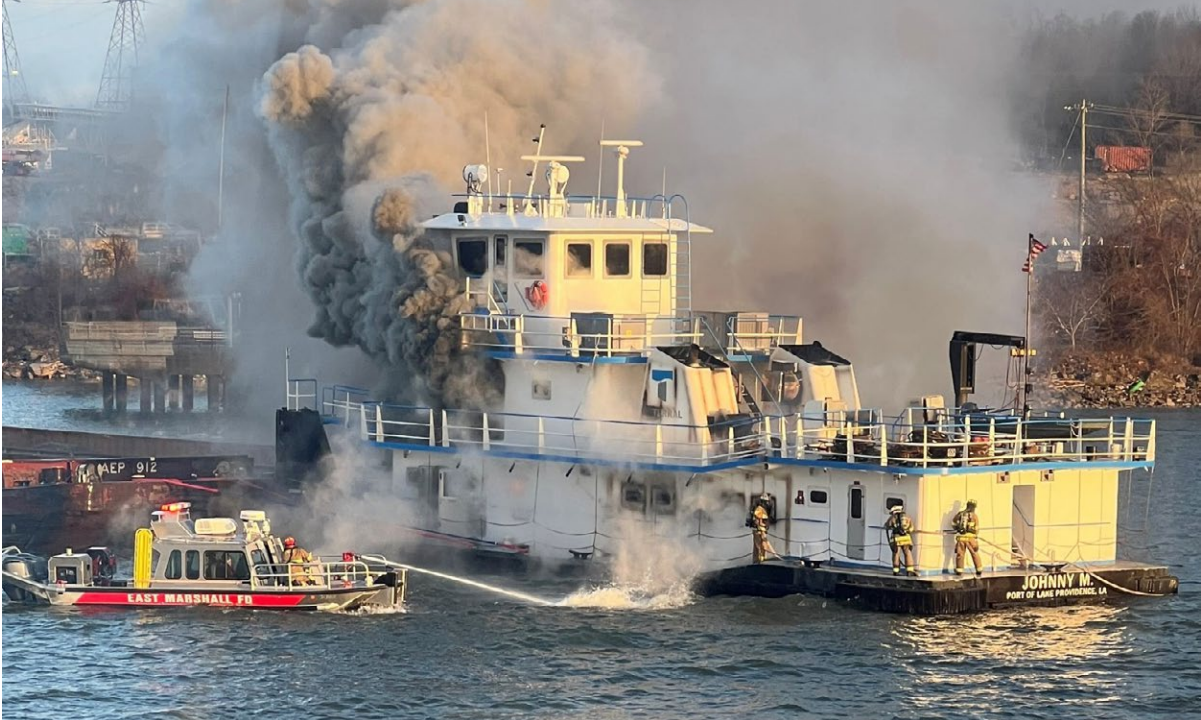
**Local firefighters fighting the fire aboard Johnny M.** SOURCE: EAST MARSHALL FIRE DEPARTMENT.

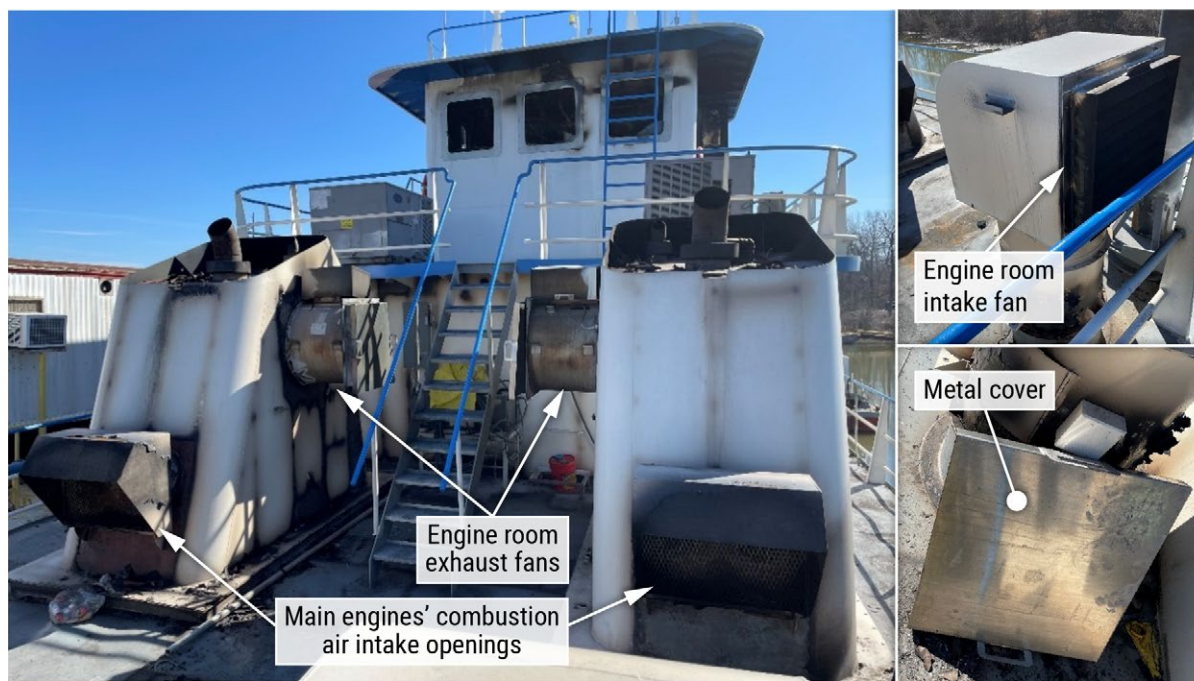
**Johnny M exhaust stacks showing covered engine room exhaust fans and engine air intake openings (two openings under each hood). Insets, from top: Engine room intake fan (there were two intake fans—one port and one starboard) and metal cover, all located on upper deck.**

**THE PROBABLE CAUSE** of the engine room fire on the towing vessel *Johnny M* was a catastrophic main engine failure that caused the venting and ignition of hot atomized lube oil. **CONTRIBUTING** to the ineffectiveness of the CO<sub>2</sub> fixed fire extinguishing system was the lack of structural fire protection for the main engines' combustion air intake ducting, which allowed oxygen to enter the engine room once the fire consumed the ducting.

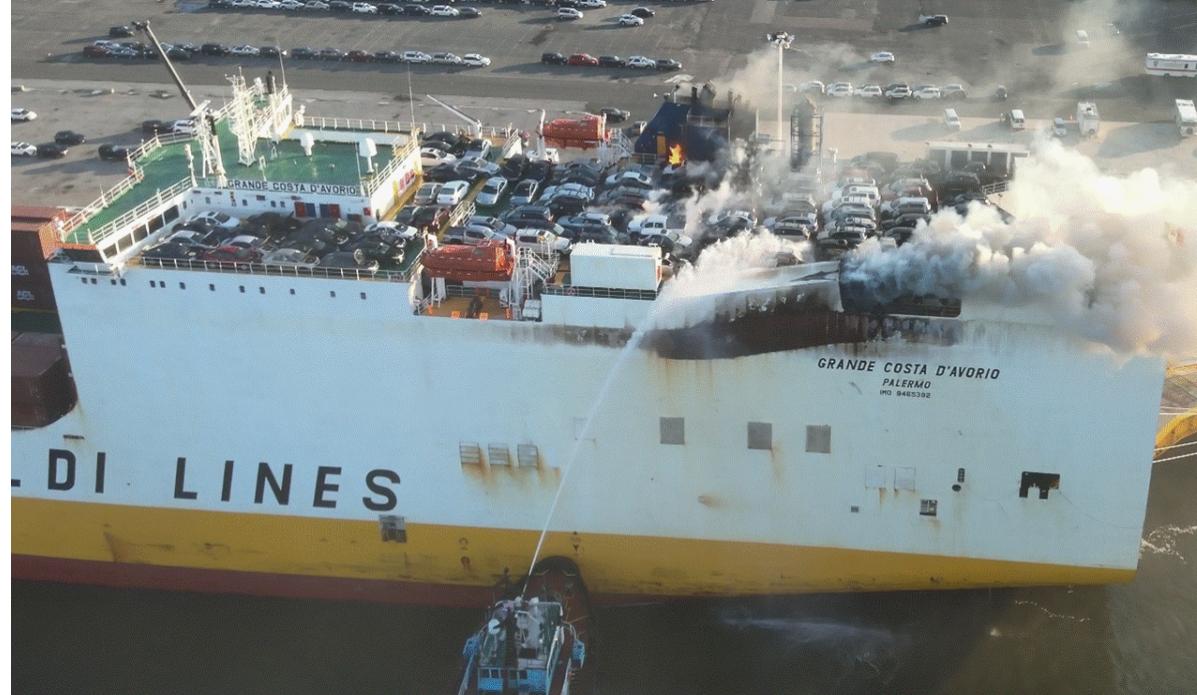
**A fire boat directing water onto the *Grande Costa D'Avario*.** SOURCE: ATF.

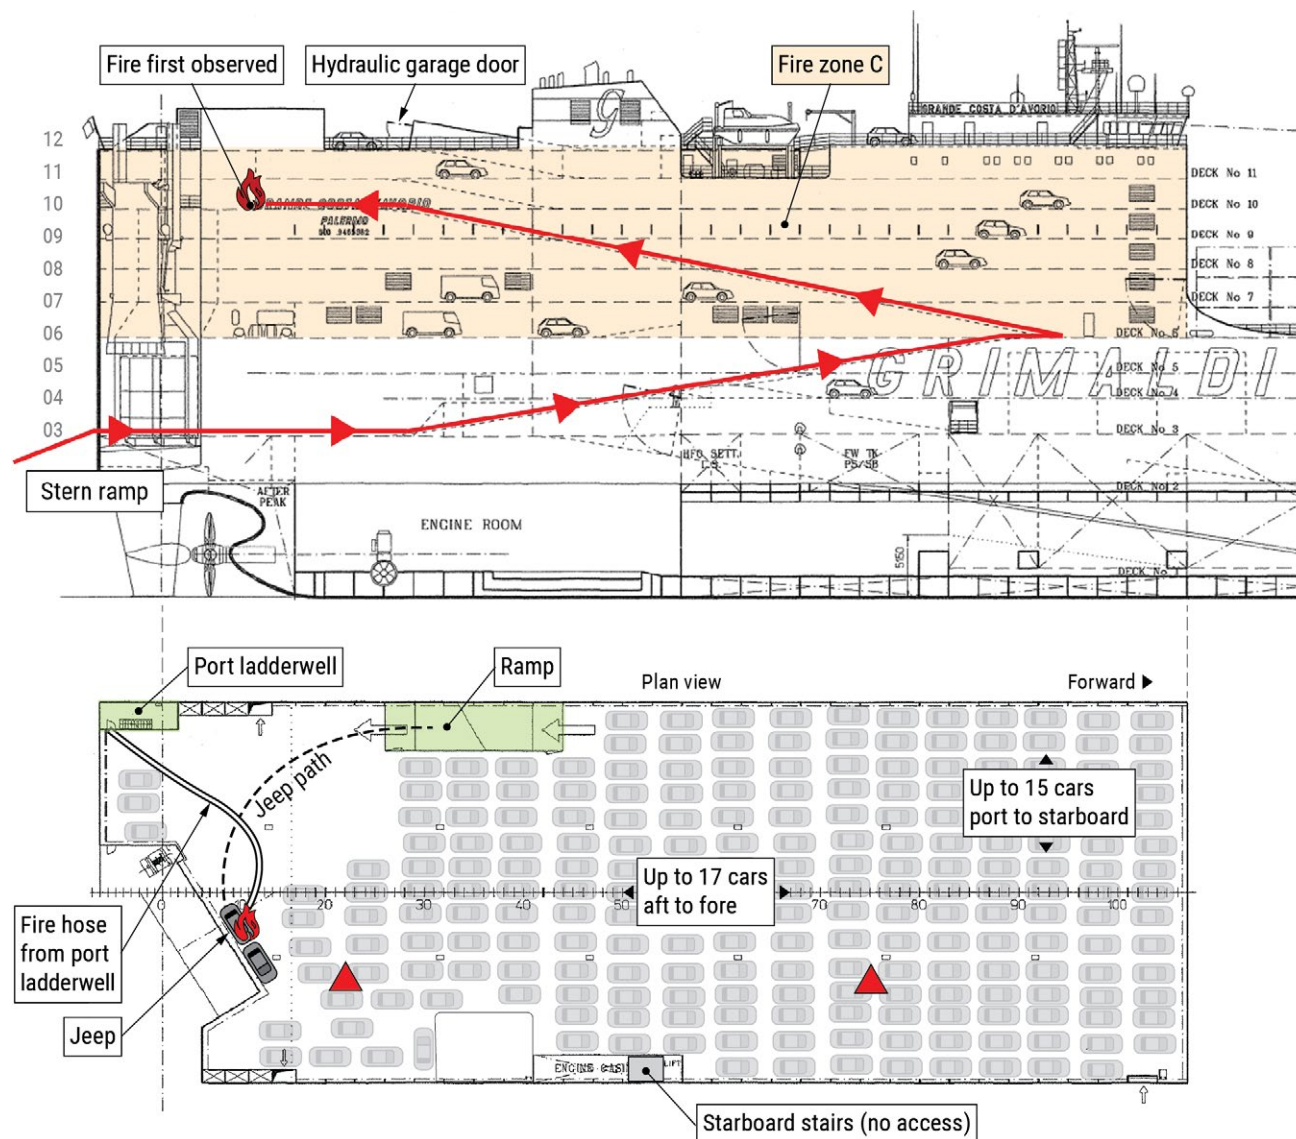
Above: Partial profile of the *Grande Costa D'Avorio*, showing the garage decks, the Jeep's approximate route to deck 10 and location of the fire, and plan view of deck 10 layout, showing an approximation of the deck's loaded condition (based on the estimated 200 cars loaded on that deck at the time). The locations where the two missing firefighters were found are indicated by triangles. BACKGROUND SOURCE: GRIMALDI DEEP SEA SPA.

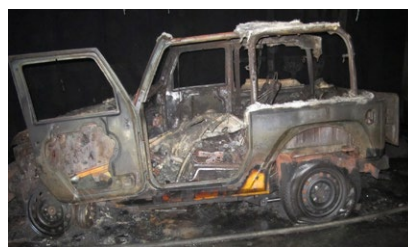
We found the vessel fire resulted from the overheated transmission fluid of a Jeep pusher vehicle, which boiled over and ignited on a hot engine surface. The Jeep was a passenger vehicle that Ports America (the operator of Port Newark Terminal and employer of longshoremen) had retrofitted with a large steel front bumper for use in an industrial, cargo-loading setting (pushing nonrunning vehicles onto vessels and up multiple ramps). As a passenger vehicle, the Jeep's transmission was not designed to handle this type of heavy vehicle use; as a pusher vehicle, it was used in an industrial manner and routinely subjected to rigorous conditions. According to OSHA, a mobile, power-driven vehicle used to push nonrunning vehicles aboard a vessel was subject to OSHA PIT standards, including capacity ratings, maintenance, and modifications being approved by the manufacturer or an accredited testing laboratory. The Jeep was not suitable for use as a PIT because it did not meet OSHA's PIT standards, including the requirement for modifications to be approved by the manufacturer or an accredited testing laboratory.

Left: Damage to Jeep after the fire.

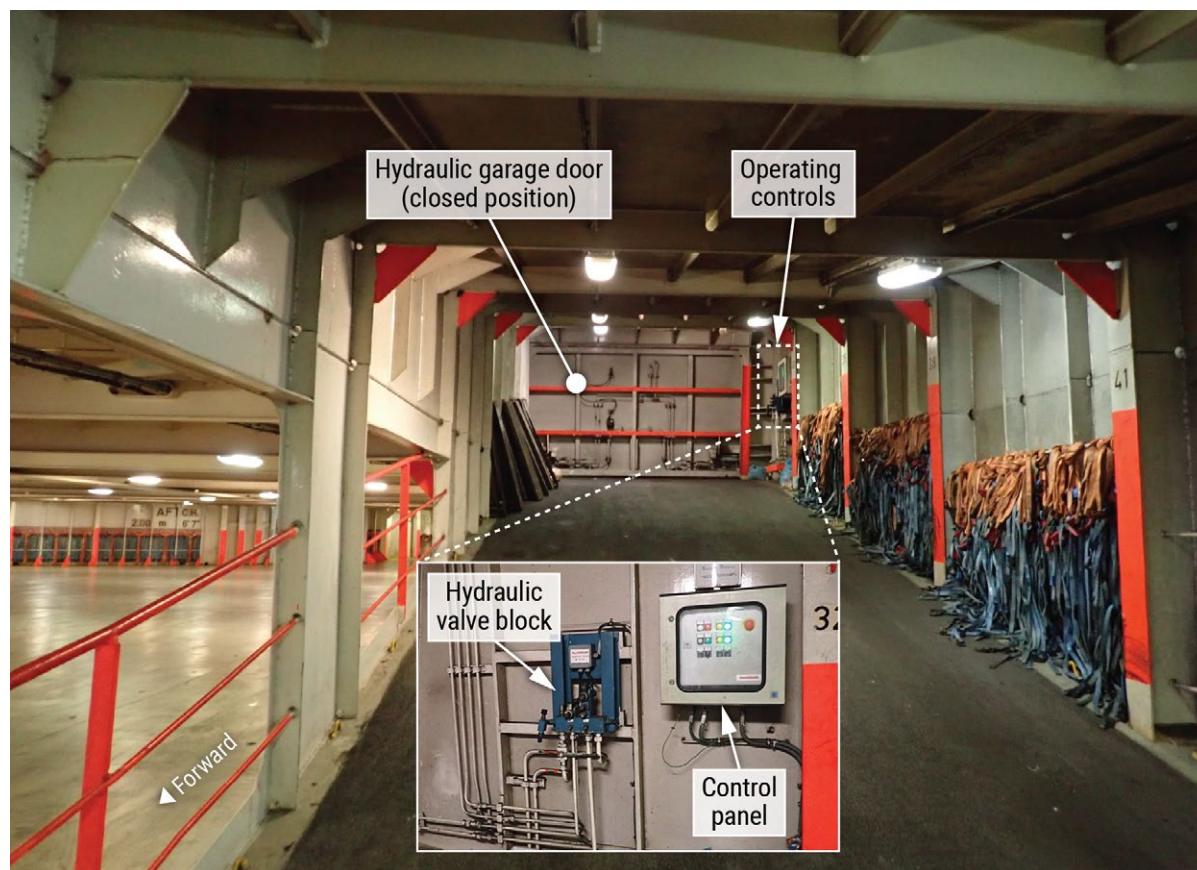
◆ **Absence of operating controls on the outside of a garage deck door that was part of a fire boundary zone for a space protected by a fixed gas fire extinguishing system.** Before ordering the release of the vessel's fixed CO<sub>2</sub> fire extinguishing system, the captain ordered the crew to seal the space. However, the crew could not close the deck 12 hydraulic garage door because the door controls were located *inside* the door. For a crewmember to close the door, they would have had to hold a button down (or operate the manual valves or hand pump) inside the fire protection zone until the door was completely closed, and then travel down the ramp and about 120 feet through a smoky garage deck partially loaded with cargo vehicles to exit into the port ladderwell—a dangerous egress even for a crewmember equipped with an SCBA. We found that, although the vessel captain's decision to release CO<sub>2</sub> into the fire protection zone that included the deck with the fire was appropriate, the deck 12 hydraulic garage door lacked operating controls outside the fire protection zone, which prevented the crew from safely closing the door and thus led to the ineffectiveness of the CO<sub>2</sub> in extinguishing the fire.

Deck 12 hydraulic garage door looking aft up the vehicle ramp, from the interior of the garage space on deck 11. Inset shows the door's control panel to the right of the valves used for manual operation. Photos taken on the Grimaldi vessel *Grande Senegal*, a sister vessel to the *Grande Costa D'Avorio*. BACKGROUND SOURCE: COAST GUARD.

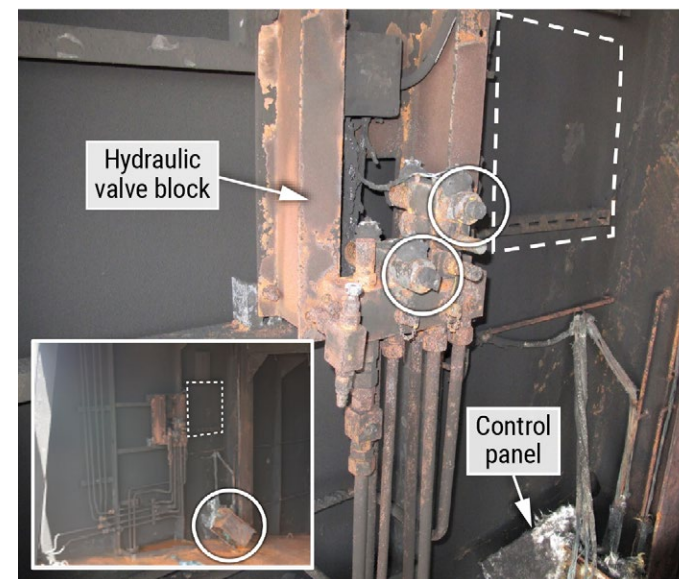
Deck 12 garage door hydraulic valve block after the fire, with manual operating control valves circled. The location of the door's control panel, which burned and fell off the bulkhead, is outlined in the dotted line. Inset shows a wide view of the area and the control panel (circled) on the floor. INSET SOURCE: ATF.

In addition, we made a **recommendation** to Grimaldi Deep Sea, the ship owner, to inventory all its vessels to identify all openings that are part of a fire boundary and modify its vessels so that the openings are capable of being closed from outside the protected space. We also **recommended** that RINA Services, the vessel's classification society, revise its procedures for review and approval of vessel plans to ensure compliance with all applicable international regulations. Lastly, we **recommended** that the Coast Guard submit a proposal to IMO to clarify the *SOLAS* regulation requiring that all openings capable of admitting air into or allowing gas to escape from a protected space can be closed from outside the protected space applies, regardless of their expected operational condition when in port or at sea.

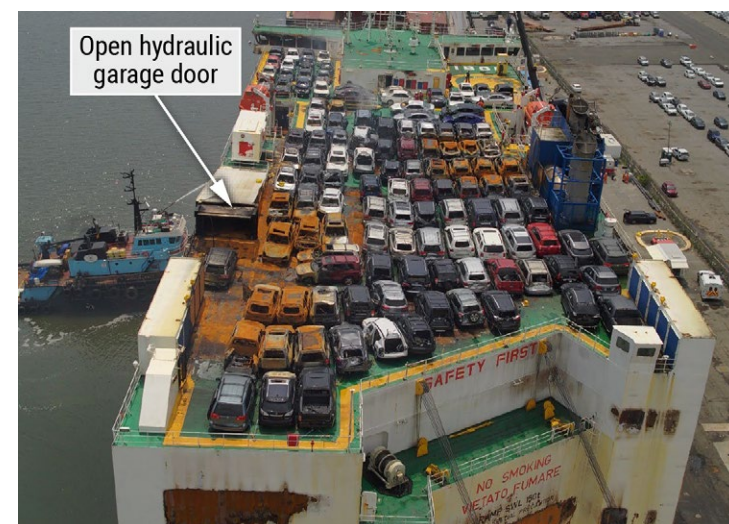
Overall damage to deck 12 (looking forward).

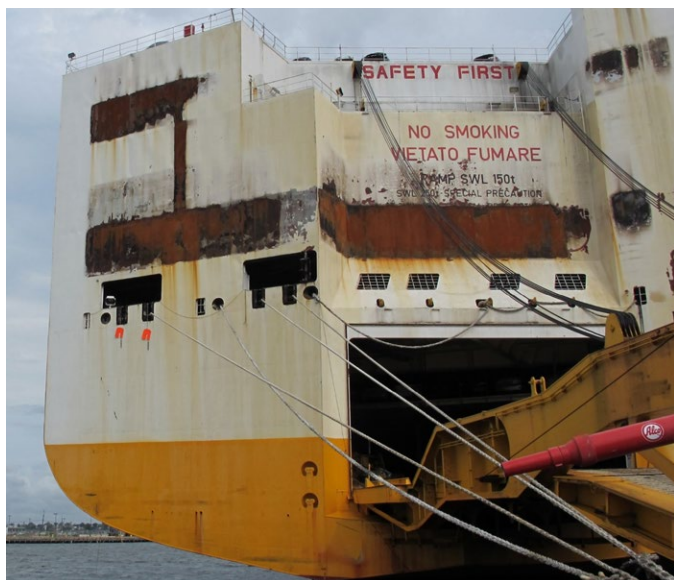
**Damage to the vessel's stern.**

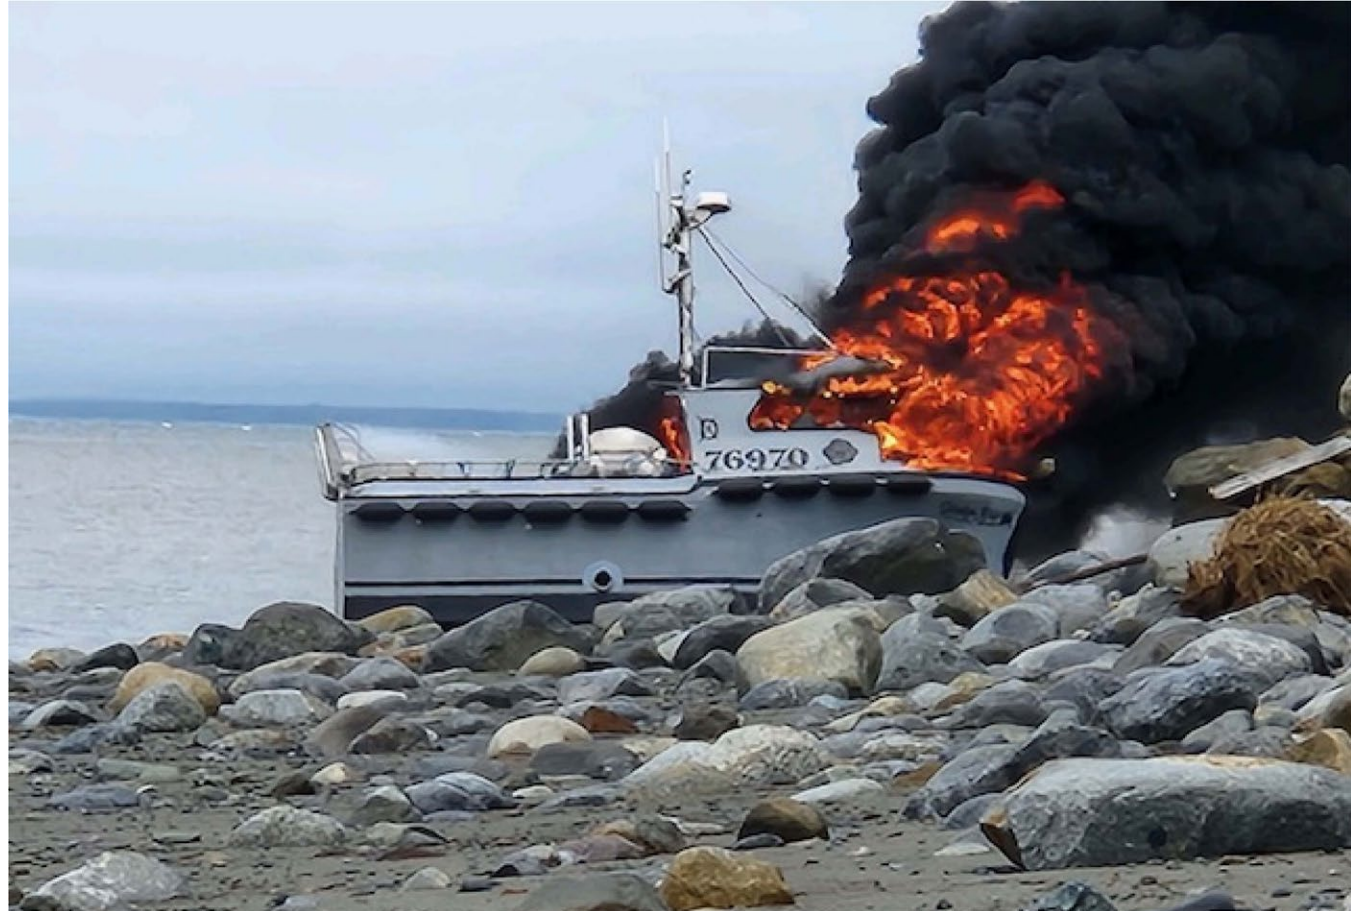
***Jordyn Rose* on the day of fire.** SOURCE: *JORDYN ROSE* CAPTAIN.

On June 24, 2024, about 1030 local time, the fishing vessel *Jordyn Rose* caught fire while it was beached near the mouth of the Naknek River near Naknek, Alaska. The captain, the only person on board at the time, abandoned the vessel onto the beach. There were no injuries, and no pollution was reported. The vessel was a total loss, valued at \$910,000.

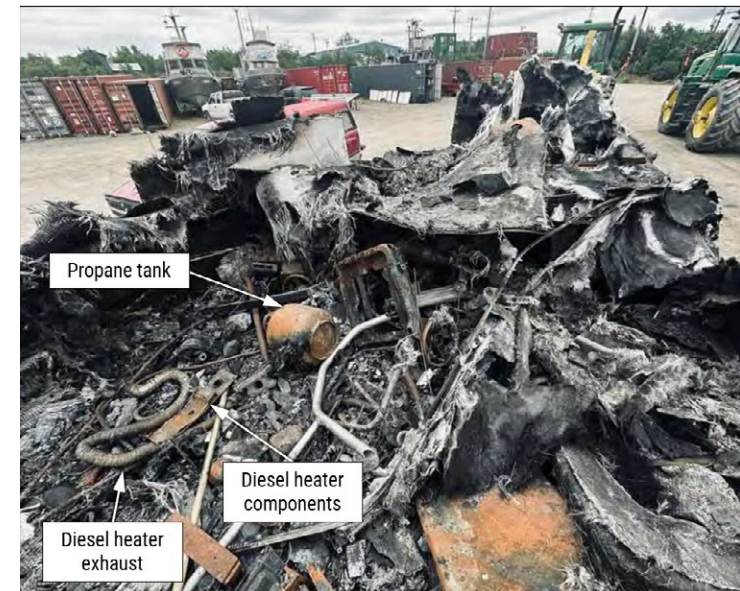
After abandoning the vessel, the captain observed flames spreading into the main cabin from the bunk area. The captain's observations were consistent with the post-fire survey report, which indicated that the greatest amount of fire damage, and likely area of origin, was near the port bow. Additionally, photos taken by the captain immediately after abandoning the vessel showed the fire near the port bow before it spread to the rest of the vessel.

**THE PROBABLE CAUSE** of the fire aboard the fishing vessel *Jordyn Rose* was an undetermined interior source near the port bow of the vessel.

**Fire damage to the *Jordyn Rose* bow (facing forward).**

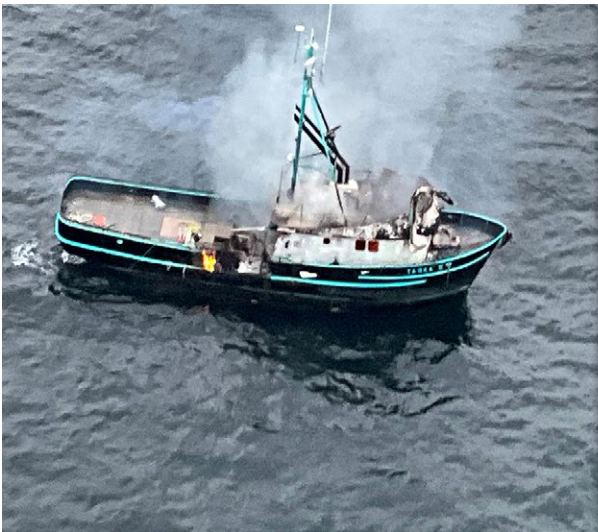
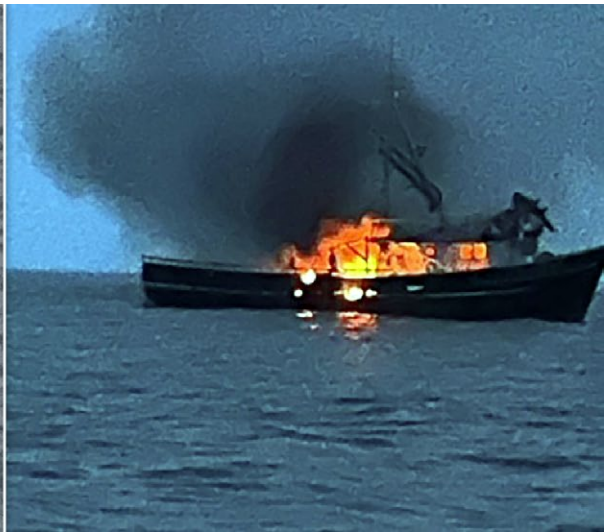
The *Tarka II* as seen on the Coast Guard overflight and the *Tarka II* as seen by the captain upon returning to the vessel, both on the night of the fire. SOURCES: COAST GUARD (LEFT), *TARKA II* CAPTAIN (RIGHT).

On September 10, 2024, about 1600 local time, the commercial fishing vessel *Tarka II* was transiting in the Pacific Ocean about 4 nautical miles southwest of Tatoosh Island, Washington, when the captain discovered a fire in the engine room. The two crewmembers on board did not attempt to fight the fire. They abandoned the *Tarka II* into a liferaft and were rescued by the Coast Guard. The fishing vessel later sank with an estimated 1,000 gallons of diesel fuel on board. There were no injuries. The vessel was not recovered and considered a total loss, valued at \$460,000.

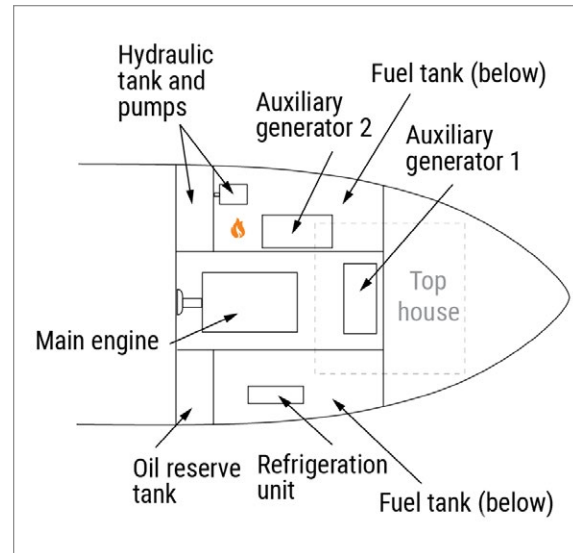
lines ran “inches” from the engine exhaust pipes, which were protected by fiberglass lagging. Investigators were unable to verify the condition or arrangement of the exhaust lagging in the engine room because the vessel sank and there were no photos available of the engine room before the fire. The captain reported that the smoke initially looked and smelled like engine exhaust. It is possible that exhaust pipe heat, or an exhaust leak, either from the main engine or the running no. 1 auxiliary generator, ruptured one of the pressurized hydraulic lines, causing the hydraulic fluid to spray and ignite on a nearby, unprotected hot surface, and spread to nearby combustibles. However, because the *Tarka II* sank and was not recovered, the exact source of the fire could not be determined.

**General layout of the *Tarka II* engine room (not to scale) with the location of the fire indicated by the flame symbol.** BACKGROUND SOURCE: *TARKA II* CAPTAIN.

**THE PROBABLE CAUSE** of the fire aboard the fishing vessel *Tarka II* was an unknown source within the engine room.

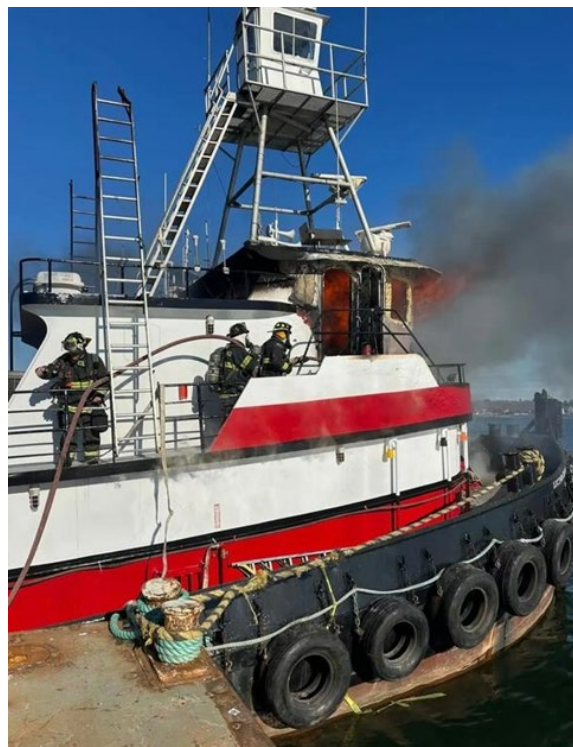
**Land-based firefighters on Lucinda Smith.**

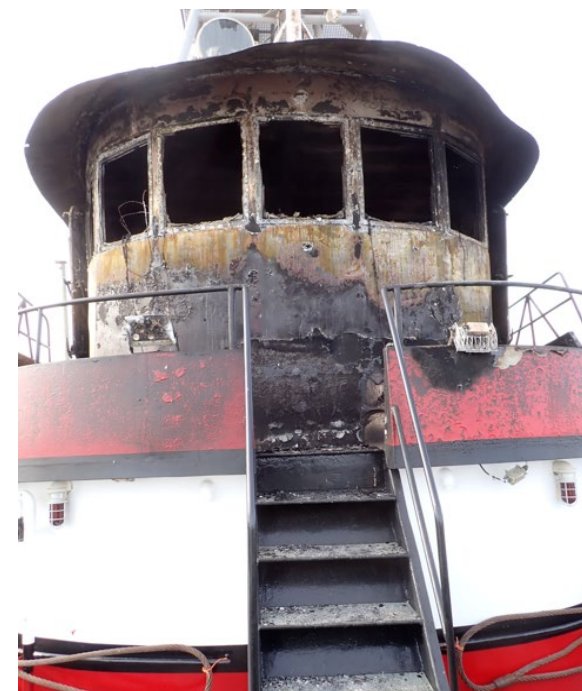
**Damaged wheelhouse.** SOURCE: COAST GUARD.

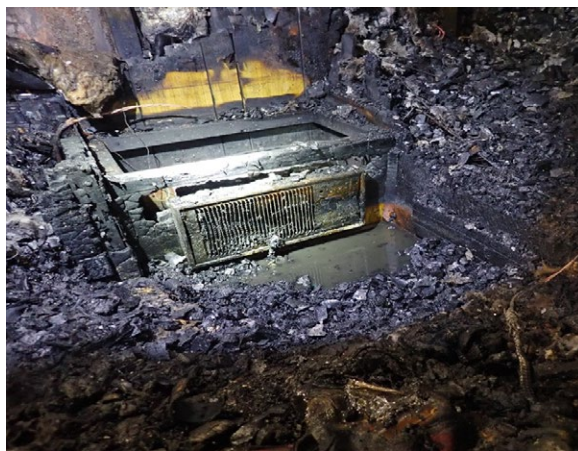
After the fire, ATF investigators determined that the fire originated in the first mate's stateroom, aft of the wheelhouse, near the end of the bunk (by the electric heater). Electrical sources near the bunk included an electric heater, an oscillating fan, and an electrical wall receptacle. Crew interviews revealed that the heater and fan were not in use before the fire and thus likely were not an ignition source. The receptacle and associated vessel wiring were original to the vessel's construction and nearly 50 years old. If there was an electrical fault—such as a loose, broken, or frayed wire, or broken receptacle hardware—within the receptacle or nearby circuitry, it could have created excessive resistance heating. Resistance heating from electrical conductors within receptacles can produce sufficient heat to ignite nearby combustibles. However, due to the extent of the fire damage, the exact ignition source and cause of the fire could not be determined.

**THE PROBABLE CAUSE** of the fire aboard the towing vessel *Lucinda Smith* was an undetermined ignition source in one of the vessel's staterooms.

**Electric heater in first mate's stateroom after the fire.**

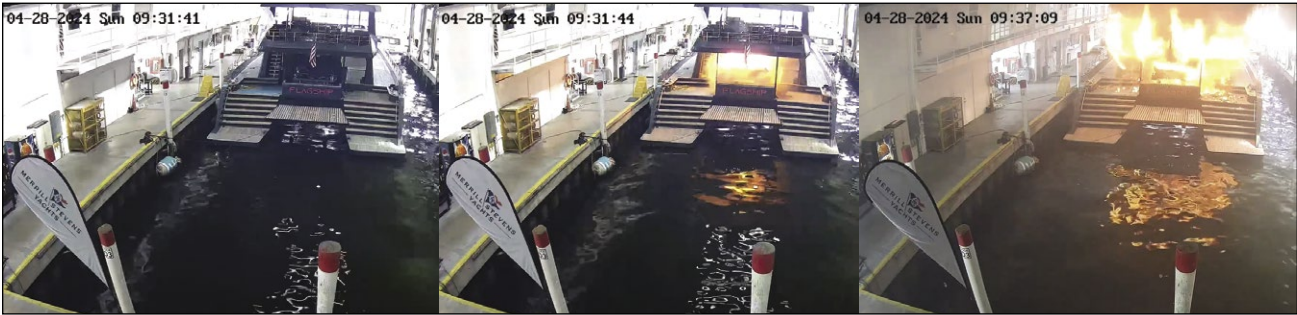
Left to right: Video still images from the shipyard’s internal security camera showing (1) the *Flagship* moored within the facility before the fire; (2) an explosion from the aft area of the vessel at 1031; and (3) progression of the fire within the vessel. (Timestamps are 1 hour behind the actual time because the shipyard clocks were not set for daylight savings time.) SOURCE: RMK MERRILL STEVENS.

At the time of the casualty, the shipyard security cameras recorded an explosion aboard the 82-foot-long *Flagship*, originating from a hatch that led to a 24-volt lithium-ion battery bank. After the explosion, smoke was visible, followed by fire. Shortly thereafter, the fire grew rapidly, engulfing the vessel. Investigators later identified extensive damage to the aluminum deck and hull structure in the area around and above the location of the 24-volt lithium-ion battery bank. Based on the security video and the location of the most extensive fire damage, a lithium-ion battery cell within the 24-volt battery bank was most likely the initiating source of the explosion and fire.

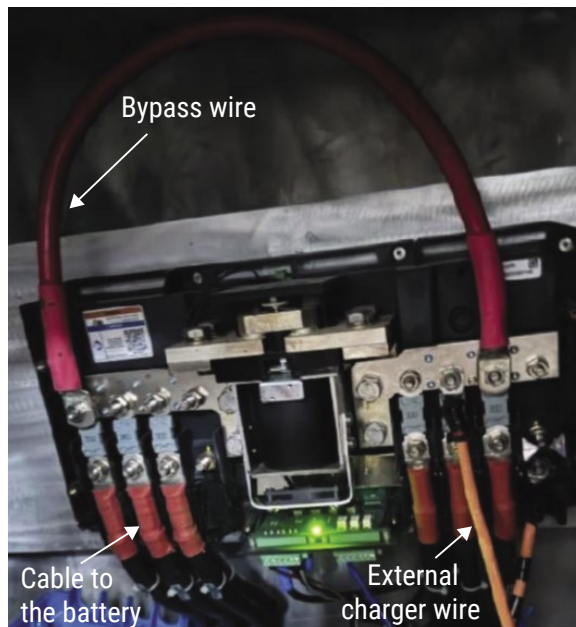
the vessel owner's representative developed a new procedure to increase the charging speed of the lithium-ion batteries by bypassing the BMS of each battery bank. A wire was attached to bypass each BMS so the batteries could be manually charged at a faster pace by an external charger. As a result, the charge level within the vessel battery banks was not automatically maintained by the BMSs, and, due to an unidentified electrical drain within the vessel, the batteries became fully discharged on several occasions for extended periods. In addition, routinely charging the batteries using a portable battery charger could have resulted in overcharging, since the external battery charger was not connected to and monitored by a BMS, and the battery charge level was instead monitored by personnel at the shipyard. Therefore, the practice of externally charging the lithium-ion batteries without resolving the BMS issues resulted in fluctuations in the level of charge on the battery bank.

**The installed bypass wire and the wire from the external charger on one of the 48-volt BMSs on board the *Flagship*.**

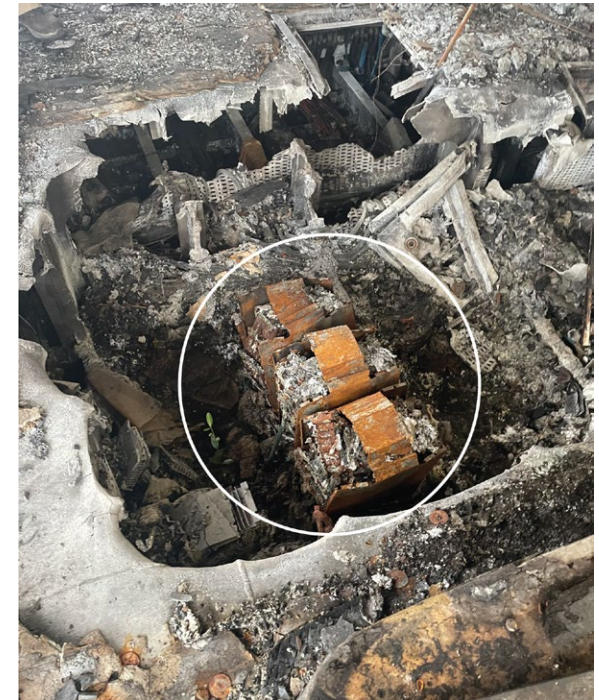
Extensive fluctuation in the level of charge within the batteries may have caused one of the cells to become unstable, eventually resulting in thermal runaway. A thermal runaway occurs when a battery cell overheats and combusts; it is a chemical reaction that can occur to any type of battery cell if it is damaged, shorted, overheated, defective, deep discharged, or overcharged. The heat produced from a thermal runaway of a lithium-ion battery cell can exceed 1,100°F, which can easily cause the adjoining cells of the same battery bank to ignite, as well as cause significant damage to aluminum structures. Lithium-ion battery cell explosions are typically caused by a thermal runaway.

**THE PROBABLE CAUSE** of the fire on the yacht *Flagship* was the thermal runaway and explosion of the 24-volt lithium-ion battery bank due to the inoperable BMSs, resulting in the practice of manually charging the lithium-ion batteries with a portable battery charger, which compromised the safe monitoring of the vessel's lithium-ion battery systems.

**The 24-volt lithium-ion battery bank (circled), after the fire.**

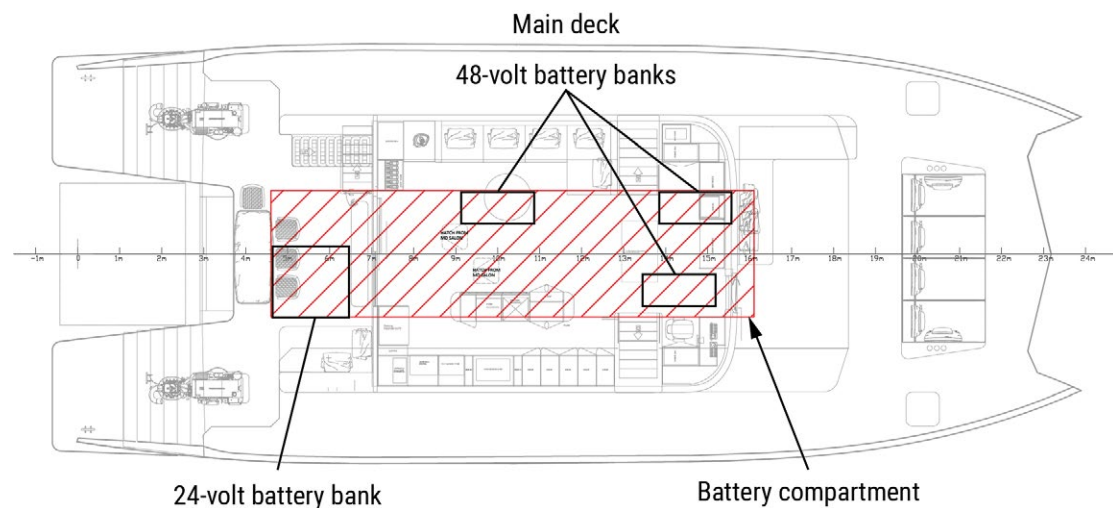
**Diagram of the main deck of the *Flagship* showing the approximate locations of the 24-volt and 48-volt lithium-ion battery banks.** BACKGROUND SOURCE: RMK MERRILL STEVENS.

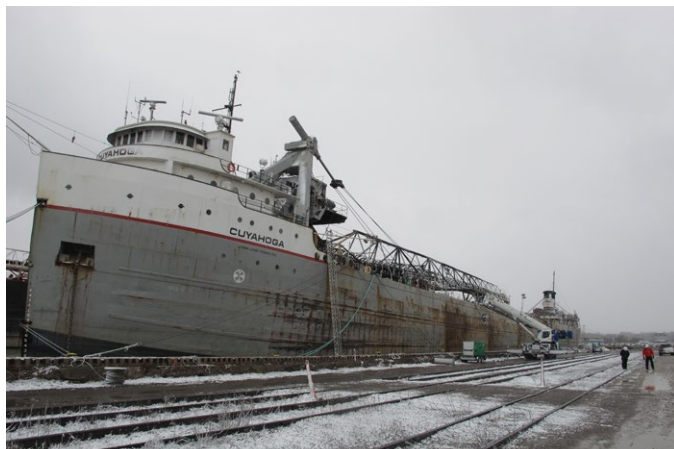
*Cuyahoga* after the fire, on March 20, 2024.

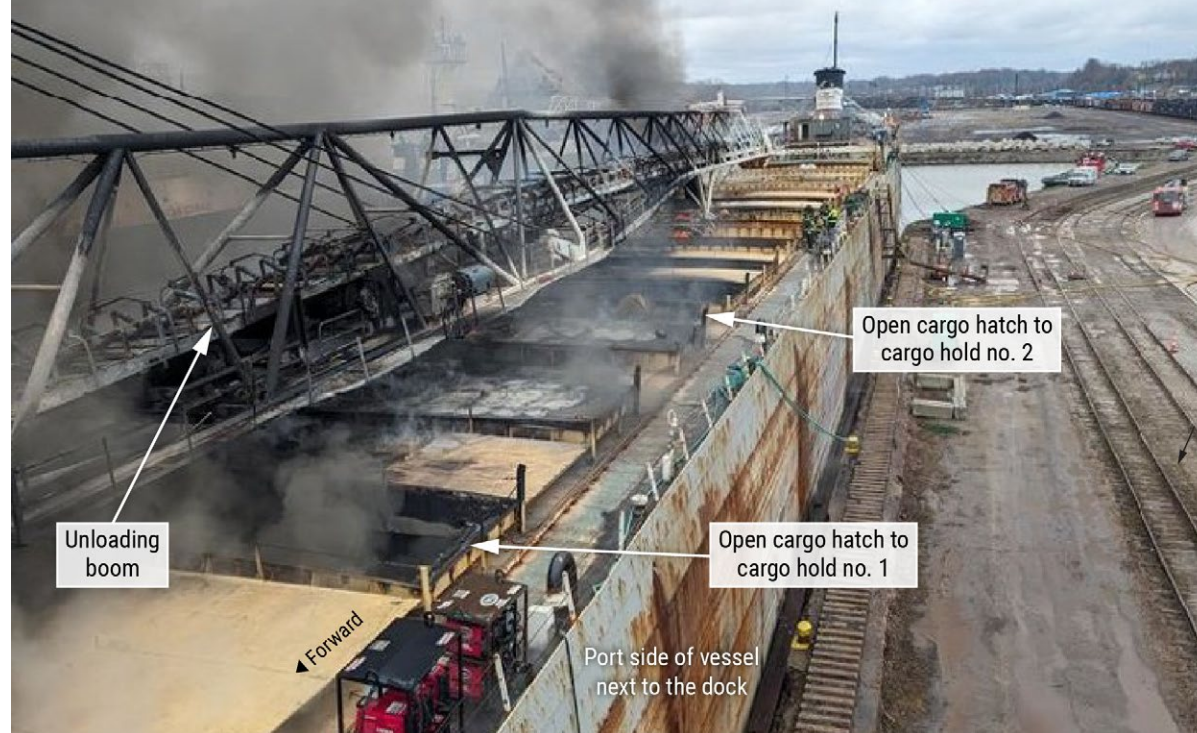
*Cuyahoga* during the fire. BACKGROUND SOURCE: ASHTABULA FIRE DEPARTMENT.

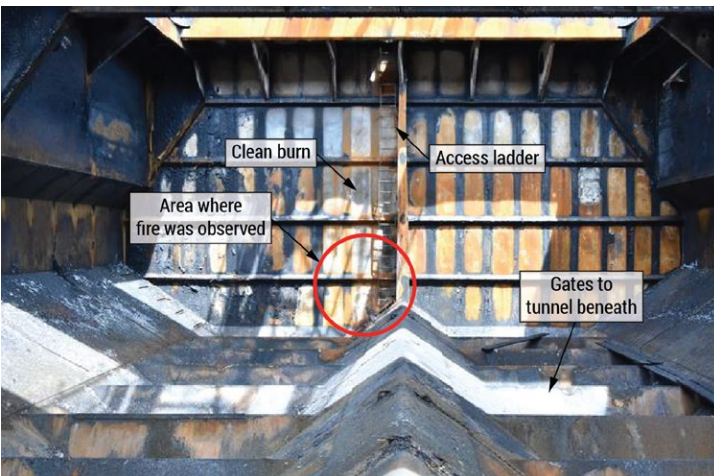
longer period of time to burn and consume the source of fuel. Given the location of the clean burn, it is likely that the fire's origin was on the forward bulkhead of cargo hold no. 2.

Based on interviews of maintenance personnel and crewmembers and data collected after the fire, the bulkhead's coating in cargo hold no. 2 caught fire. All of the cargo holds had been painted with an epoxy coating that had an ignition temperature between 600°F to 1,100°F and could ignite when exposed to direct flame or to the heat generated during welding. Therefore, the fuel source for the fire was the epoxy coating on the vessel's cargo holds.

**Fire damage to the forward bulkhead of cargo hold no. 2, showing the location (circled) where the welder, fitter, and fire watch saw the initial fire.**

**THE PROBABLE CAUSE** of the fire on the bulk carrier *Cuyahoga* was the ignition of the epoxy coating on the forward bulkhead within cargo hold no. 2, possibly from a smoldering fire from an undetermined source associated with earlier hot work in the hold.

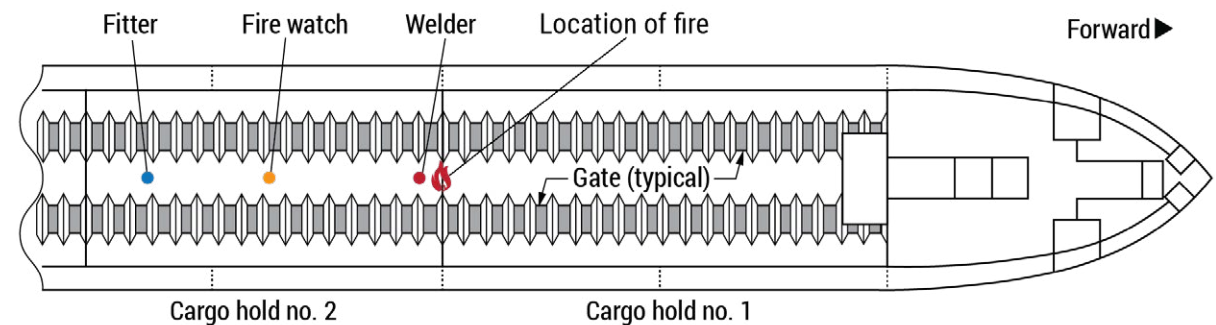
**Layout of the cargo hold no. 2 with location of fire and approximate locations of fitter, fire watch, and welder (not to scale).**
