NATIONAL TRANSPORTATION SAFETY BOARD

# SAFER SEAS

# Digest

Lessons Learned from  
Marine Investigations

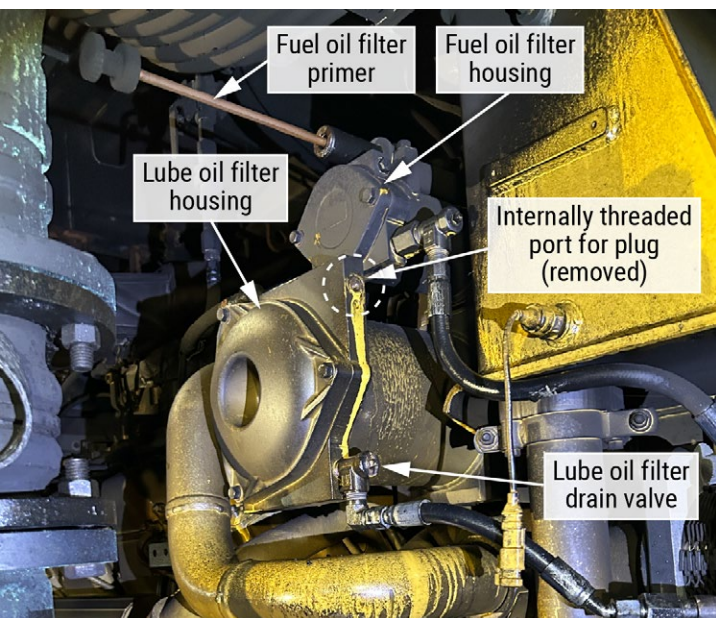
Less than a minute after starting the engine, about 1435, engineering crewmembers saw flames in the engine room. Given the orientation of the port auxiliary engine in relation to the operating port main engine, the fire started when pressurized lube oil from the port auxiliary engine sprayed onto a hot surface of the port main engine.

**Port auxiliary engine lube oil filter housing aboard *Stuyvesant* after the fire. The internally threaded port with the missing plug is circled at the top of the lube oil filter housing.**

**THE PROBABLE CAUSE** of the engine room fire on the dredging vessel *Stuyvesant* was lube oil spraying from an auxiliary diesel engine (generator) and igniting off a nearby running diesel engine, due to engine crewmembers not reinstalling a plug after routine maintenance in accordance with the engine manufacturer’s instructions and not thoroughly inspecting the port auxiliary engine before initially starting it.

it is likely they would have discovered the missing plug during an inspection and taken steps to reinstall components before starting the engine and prevented the fire. The operating company has since updated its maintenance procedures to mandate that, following maintenance on an engine, two crewmembers inspect the equipment before starting the engine.

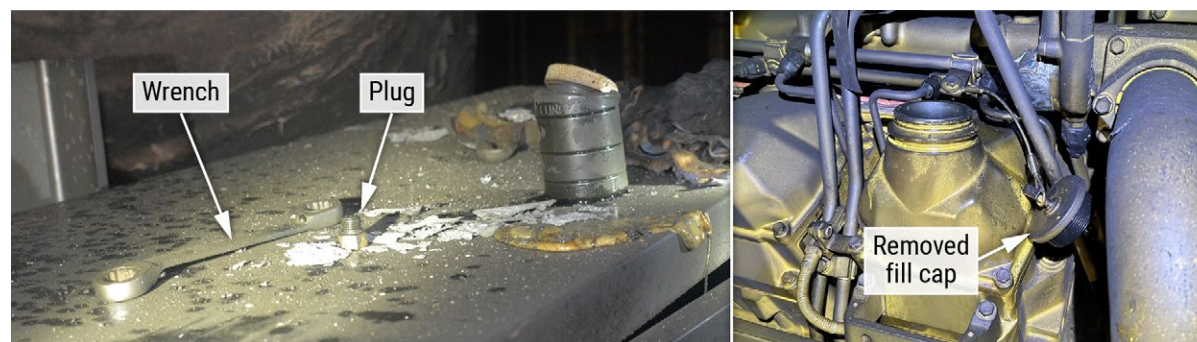
**Removed plug on top of a storage cabinet and the removed fill cap from the port auxiliary engine.**

After maintenance has been conducted on engine room machinery, diligent inspection of the machinery is critical to ensure it functions as expected and all components have been reinstalled properly. Starting up engines locally, rather than remotely, gives crewmembers the opportunity to immediately verify that the engine is operating satisfactorily (to manufacturer’s specifications) with no visible fuel, lube oil, or water leaks, and has no atypical noises or vibrations that require it to be stopped.

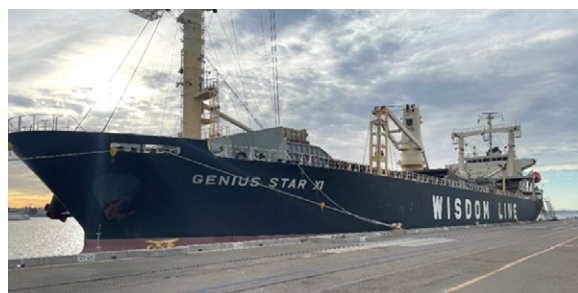
**Cargo vessel *Genius Star XI* on February 24, 2024, after the fires.**

After the vessel arrived in Dutch Harbor, the Coast Guard determined that 43 of the 160 BESS units on the tween deck in cargo holds no. 1 and no. 2 had been damaged (none of the 32 BESS units stored on the lower deck in the holds were damaged). In addition, 41 of the units had become loose. They found that the fires originated from three of the BESS units that had broken loose (two on the tween deck of hold no. 1 and a single unit on the tween deck of hold no. 2).

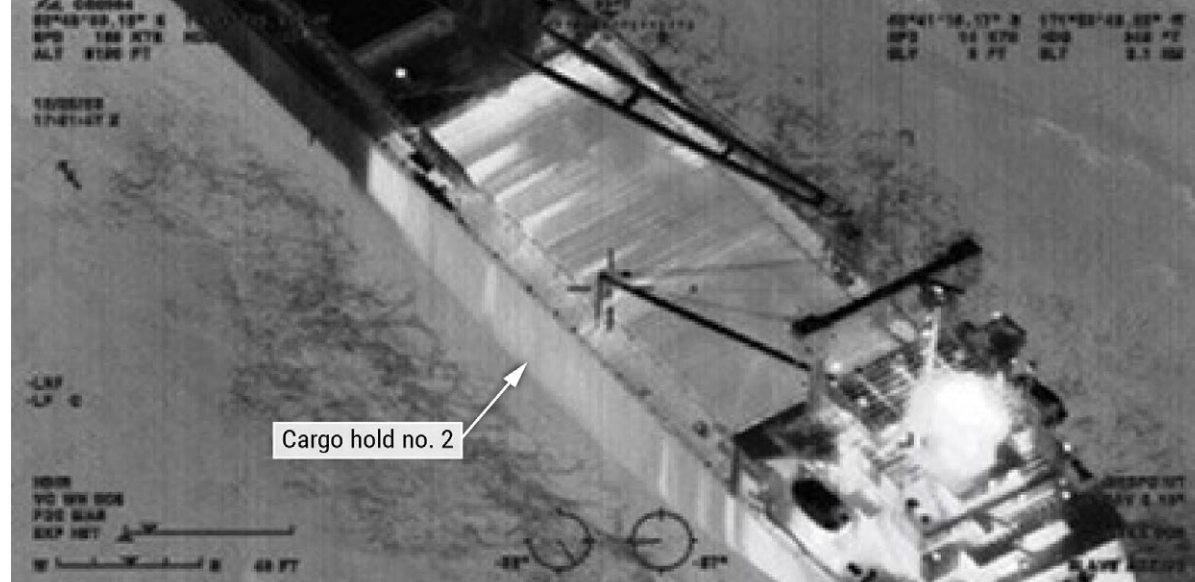
**Infrared photo of the *Genius Star XI* en route to Dutch Harbor, showing an indication of heat (in white) within cargo hold no. 2 on December 28.** BACKGROUND SOURCE: COAST GUARD.

On December 25, 2023, at 0830, while the cargo vessel *Genius Star XI* was transiting the North Pacific Ocean in heavy weather with a cargo of lithium-ion BESS units on board, a fire was discovered in a cargo hold. The crew discharged the vessel's CO<sub>2</sub> fixed fire extinguishing system into the hold, and the vessel proceeded to the nearest port, Dutch Harbor, Alaska, for assistance. On December 28, about 0215, while the vessel was en route to Dutch Harbor, a fire started in a second cargo hold. The crew externally cooled the cargo hold using fire hoses, and, after the vessel anchored in Dutch Harbor on December 29, the fire was determined to be extinguished. There were no injuries, and no pollution was reported. Damage from both fires was estimated at \$3.8 million.

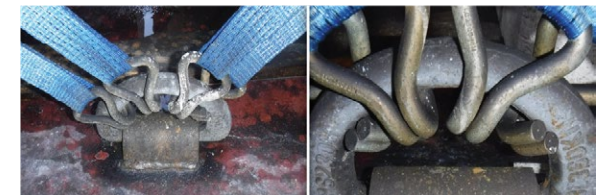
but, during the voyage, numerous lashing belt hooks fractured. Investigators discovered that the diameter of the D-ring and the inner diameter of the hook (throat opening) were not compatible. Essentially, the hook was not able to fully seat on the D-ring, so only the tip of the hook was securing the lashing belt to with the D-ring. This concentrated the securing load at the turn, or bend, of the hook, instead of having that load properly transmitted across the full throat of the hook, resulting in the hook's fracture and separation. Since each BESS unit was secured by four lashing belts, the fracturing of one lashing belt hook placed additional stress on the unit's remaining hooks. Because the hooks were not properly seated on the D-ring, it is more likely that they would subsequently fracture and separate. These lashing belt hook failures would have resulted in loose and shifting BESS units. Additionally, numerous welded brackets securing D-rings separated or partially separated from the tween decks. It is likely that, in addition to shifting cargo from lashing hook failures, the separation of the D-ring securing brackets from the tween deck also contributed to the BESS units becoming loose and shifting within the cargo holds. The crew implementing the storage and lashing plan did not identify the incompatibility of the hooks with the D-rings, which compromised the effectiveness of the plan.

Postcasualty photos showing a D-ring held by a bracket that is attached to the tween deck, with hooks and lashing belts holding BESS units, and a close-up view showing only the tip of the hook in contact with the D-ring. SOURCE: COAST GUARD.

In addition to following a vessel's cargo securing manual and implementing the approved vessel storage and lashing plan, a vessel's crew must also conduct a thorough inspection of all the cargo-securing arrangements both during and after cargo loading. Such inspections are critical to identifying improper attachments or other concerns with cargo securement that could compromise the assumptions planners make in implementation of the plan. Not ensuring cargo is properly secured can result in cargo breakaway. Special attention should be placed on examining fitment of components, such as lashing belt hooks, wires, or chain falls used to secure the cargo to ensure they are properly seated (fully engaged) on the D-rings or other points of securement.

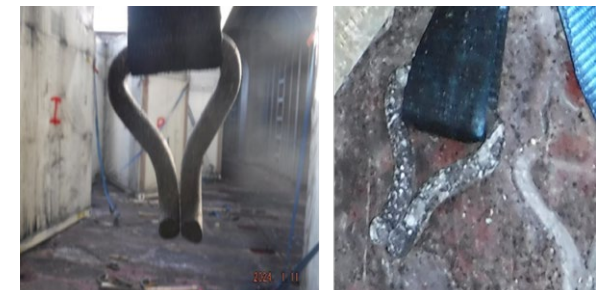
Two separate hooks that fractured and separated from a D-ring. SOURCE: COAST GUARD.

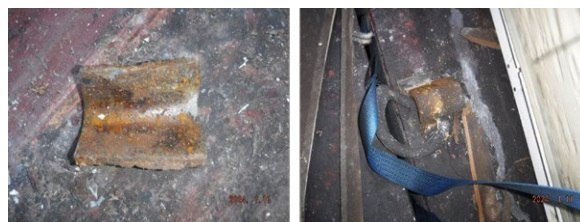
**Bracket found separated from the deck, and a D-ring partially pulled from a deformed bracket that was still connected to the deck.** SOURCE: COAST GUARD.

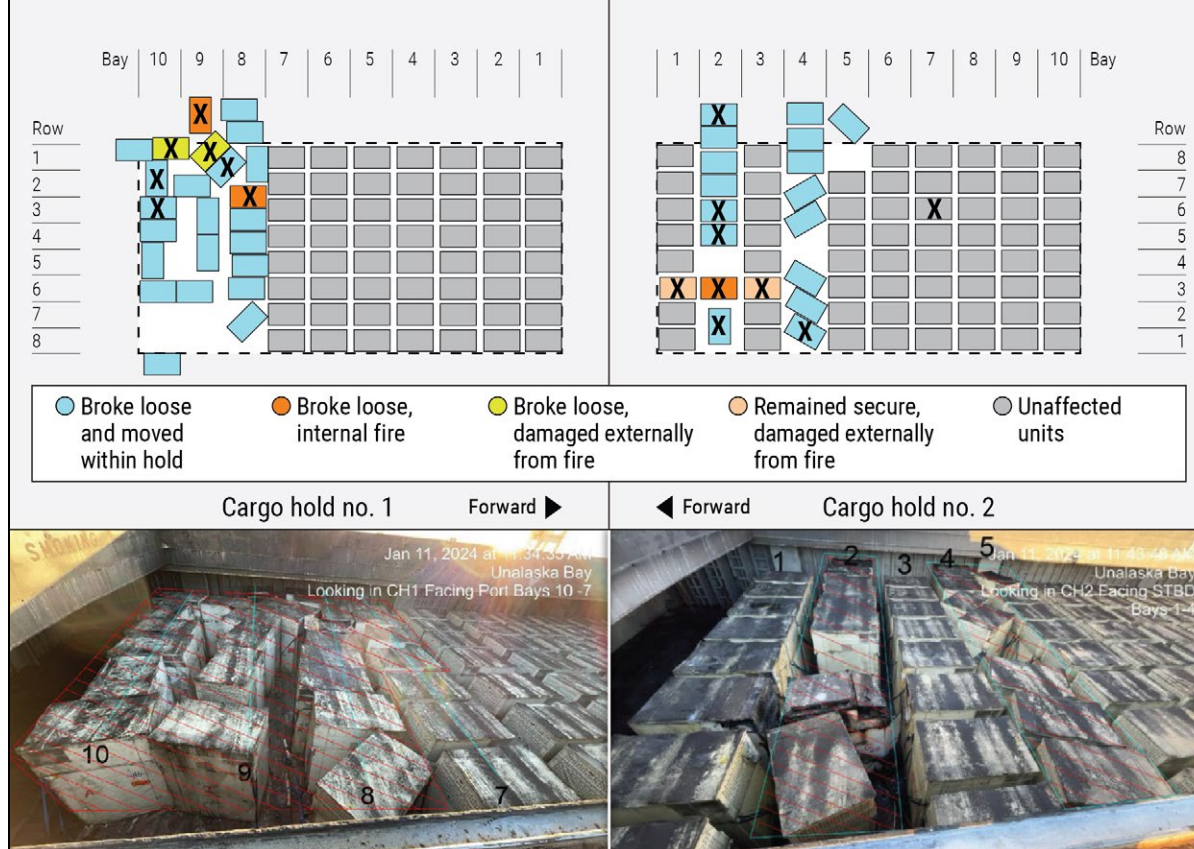
**THE PROBABLE CAUSE** of the two (December 25 and December 28, 2023) fires aboard the *Genius Star XI* was the breakaway of 41 BESS units in the cargo holds during heavy weather conditions due to improperly secured lashing belts, which resulted in internal structural deformation of these units and thermal runaway of lithium-ion battery packs in 3 of the BESS units.

**Shifted BESS units in tween deck cargo holds no. 1 and no. 2. BESS units marked with an X in the plan view were examined by investigators on February 25, 2024.** BACKGROUND SOURCE: ENERGY SECURITY AGENCY (ESA).

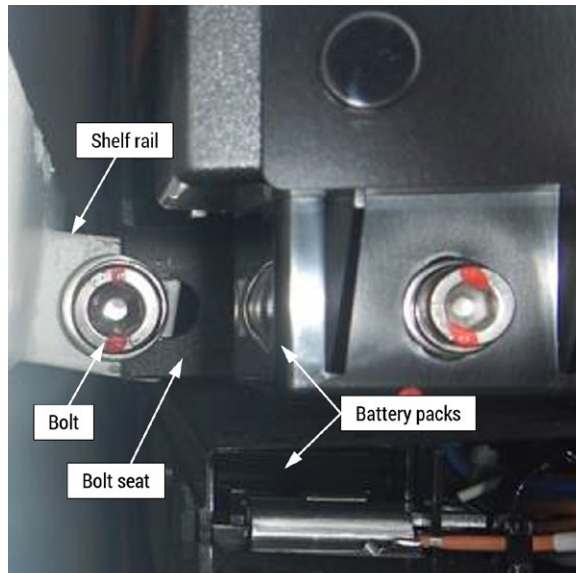
The 41 BESS units that had broken from their lashing belts and shifted had some level of internal shelf deformation. Additionally, 13 units that had broken from their lashing belts had one or more shelves that had detached from the deformed shelf rail, resulting in shelf collapses within the unit. When a shelf detached from its rail and collapsed, its two 136-kilogram (300-pound) lithium-ion battery packs could move freely and impact the interior structure of the BESS unit. Arcing and scorch marks were found within those same 13 units, which likely occurred when the exposed battery pack busbar impacted the inside of the unit and caused the batteries to short circuit and create an electrical discharge. The electrical discharge likely caused the lithium-ion batteries to short circuit, which damaged the cells and caused them to overheat, initiating a thermal runaway in three of the BESS units. The heat produced from a thermal runaway of a lithium-ion battery cell can exceed 572°F (300°C), which could have easily caused the adjoining cells of the same battery bank, as well as nearby combustible materials, to ignite, further spreading the fire.

**Postcasualty photo of a BESS unit that had not broken loose from its lashing belts but had deformed shelf rails and battery pack shelf separation.** BACKGROUND SOURCE: ESA.

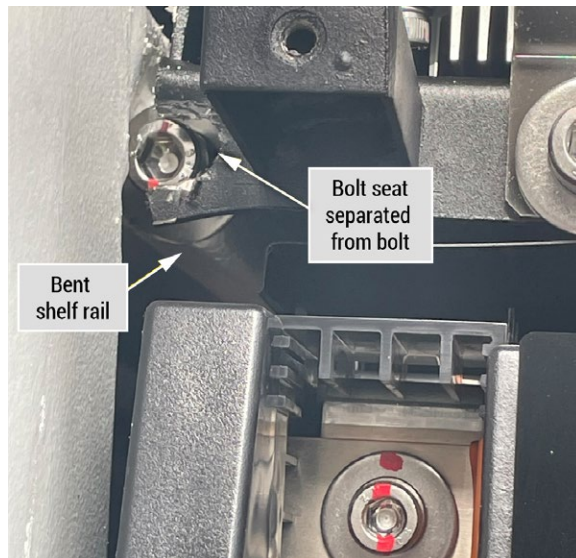
**An example of a shelf rail deformation showing a bent shelf rail with a bolt seat for the shelf separated from the bolt.**

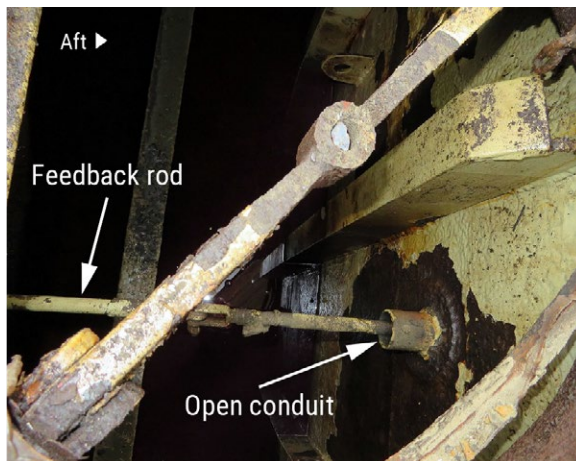
Pipe runs (conduits) inside the hull, which had previously been used to allow rods to run the length of the hull, were either corroded or missing where they passed through the voids. These openings allowed water from the lazarette to flood through two voids and, eventually, into the engine room. Thus, the conduits allowed for progressive flooding, which resulted in the partial sinking.

Feedback rod and conduit in the flooded void, between the lazarette and aftmost fuel tanks during salvage operations.

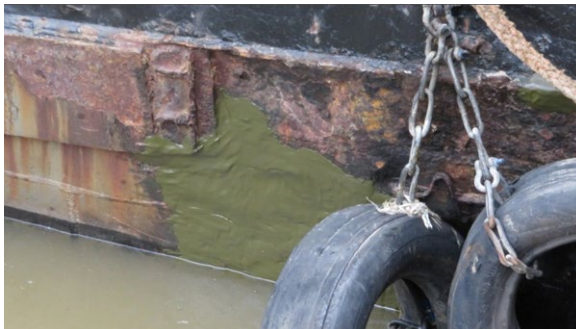
The *Uncle Blue* had been in service for almost 60 years. During salvage, investigators discovered numerous wastage holes in the hull on the port side of the lazarette. Given the vessel’s age and the holes found in the hull, the vessel’s hull had not been adequately maintained. Investigators did not identify

Temporary epoxy repair, applied during the postcasualty salvage, on the port quarter, near the lazarette.

Steel hulls are susceptible to corrosion, erosion, and damage over time. To avoid flooding or weakening of the hull, it is good marine practice for owners to conduct regular oversight and maintenance of hulls, including between drydock periods. An effective maintenance and hull inspection program should proactively address potential steel wastage, identify hull and watertight integrity deficiencies, and ensure corrosion issues are repaired in a timely manner by permanent means.

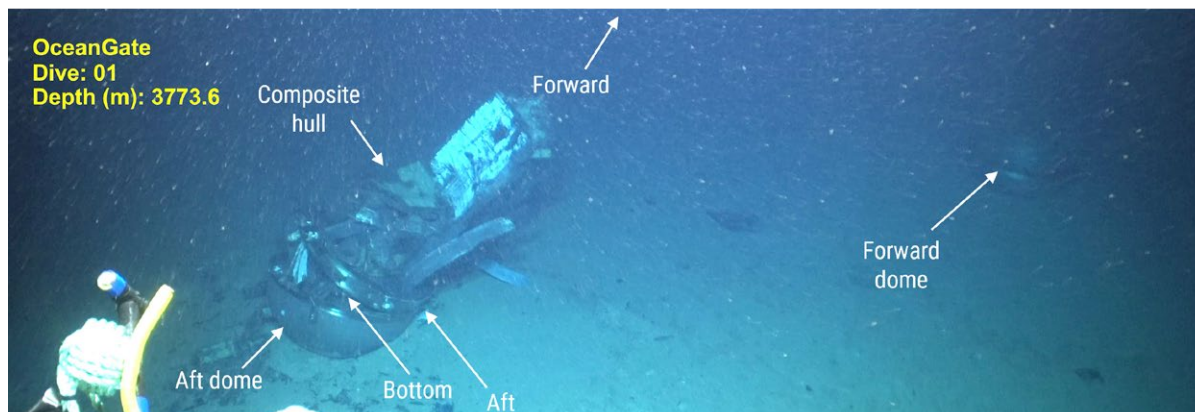
**Titan wreckage on ocean floor.** BACKGROUND SOURCE: PELAGIC RESEARCH SERVICES.

**THE PROBABLE CAUSE** of the hull failure and implosion of the submersible *Titan* was OceanGate's inadequate engineering process, which failed to establish the actual strength and durability of the *Titan* pressure vessel and resulted in the company operating a carbon fiber composite vessel that sustained delamination damage that was subsequently exacerbated by additional damage of unknown origin, resulting in a damaged internal structure that subsequently led to a local buckling failure of the pressure vessel. **CONTRIBUTING** were US and international voluntary guidance and US small passenger vessel regulations that were insufficient to ensure OceanGate adhered to established industry standards. **ALSO CONTRIBUTING** was OceanGate's flawed analysis of their pressure vessel monitoring system data, which led to their continued operation of a damaged pressure vessel.

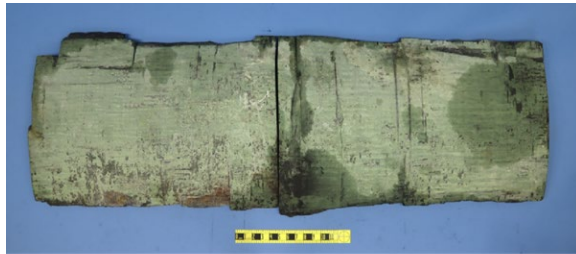
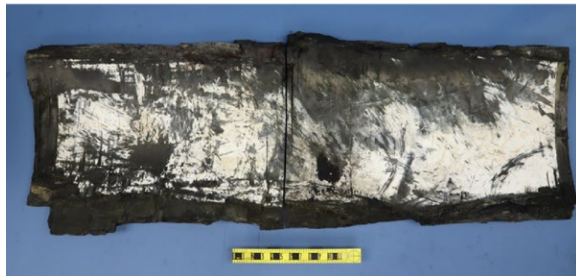
From top: Recovered carbon fiber composite pressure hull outer surface and inner surface.

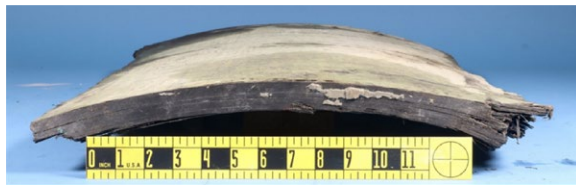
From top: Recovered carbon fiber composite cylinder machined end face, and mid-span fractured face.

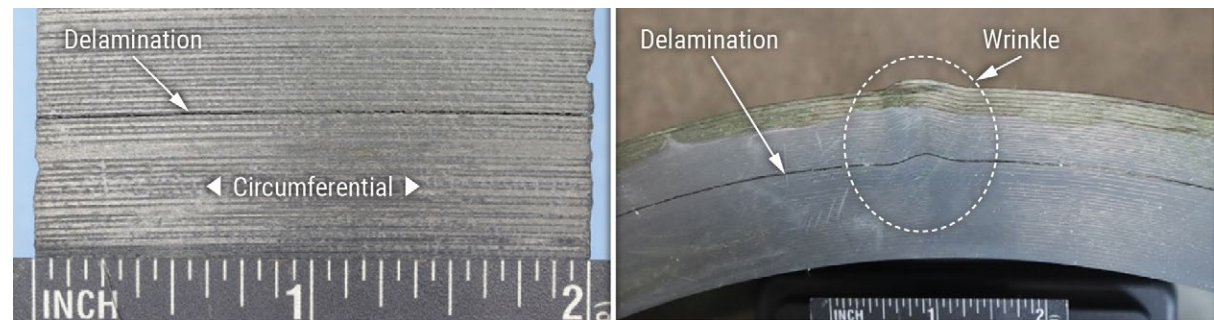
❖ **OceanGate's inadequate engineering process for the *Titan*.** A design and development program typically includes phases for design, testing, verification, and validation. However, OceanGate did not conduct adequate verification testing before deploying and operating the *Titan*. After the failure of the first full-scale pressure vessel, the company used a new manufacturing method to build a second version of the pressure vessel and did not build or test new sub-scale models using this process. OceanGate's engineering process for the *Titan* resulted in the construction of a carbon fiber composite pressure vessel that contained multiple anomalies and failed to meet necessary strength and durability requirements. The second version of the pressure vessel was used for dives during the 2021, 2022, and 2023 expeditions, including the casualty dive. Because OceanGate did not adequately test the *Titan*, the company was unaware of the pressure vessel's actual strength and durability, which was likely much lower than their target, as well as the implications of how certain operational changes, including storage condition and towing, could impact the integrity of the pressure vessel and overall safety of the vessel.

From left: Centerline delamination in trimmed end piece of first full-scale *Titan* pressure vessel, and wrinkle and delamination in trimmed end piece of one-third scale model.

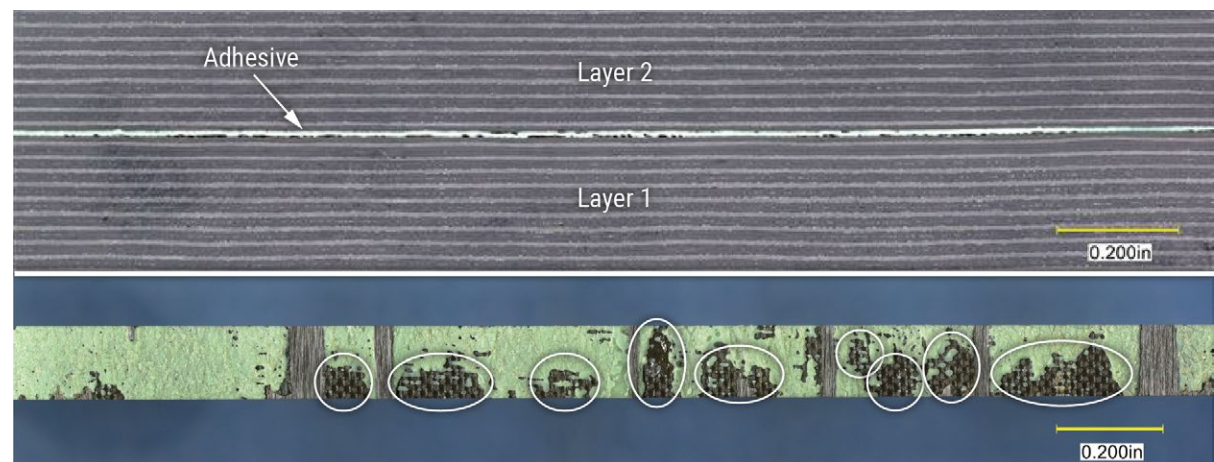
From top: Cross section of layers 1 and 2, showing adhesive between layers, and voids (circled) in the adhesive between layers 1 and 2.

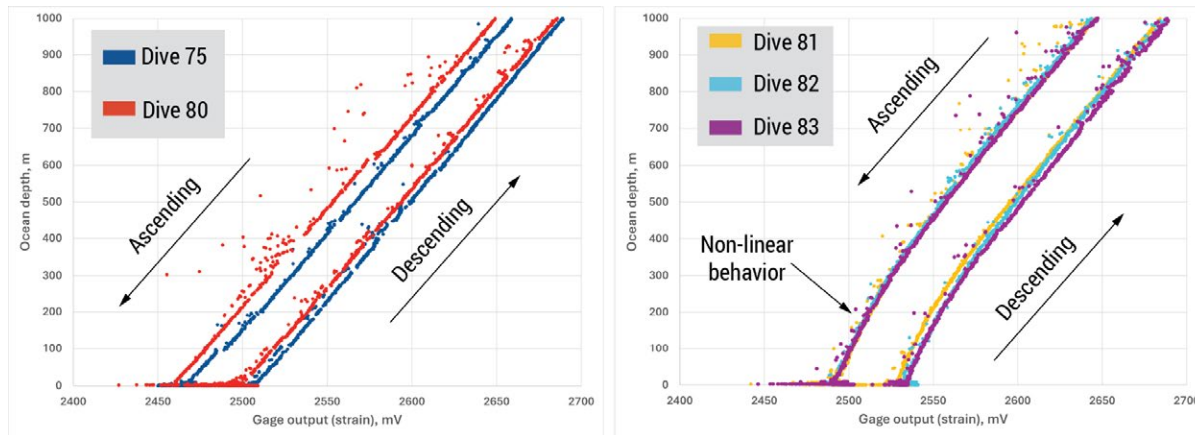
❖ **OceanGate's flawed analysis of *Titan* strain gage and acoustic emission (real-time monitoring system) data as a measure of pressure hull integrity.** OceanGate monitored the *Titan* pressure vessel's integrity using its real-time monitoring system. OceanGate analyzed data from the strain gages against time. However, analyzing strain data in this way was flawed because it was difficult for OceanGate to compare data between dives. A more appropriate means of evaluating strain data would have been to evaluate it against depth, since the external pressure acting on the pressure vessel was a direct result of the vessel's depth. Because OceanGate's analysis of the data was flawed, the company was unaware that the *Titan* was damaged and needed to be immediately removed from service after dive 80.

Strain gage output for the first and last 1,000 meters (3,281 feet) of dive depth for dives 75 and 80–83 (gage group 4 – hoop strain gage). The curves have been aligned using the linear portion of the descent phase of the trip. The strain for dives 81, 82, and 83 show non-linear behavior below 500 meters (1,640 feet) depth.

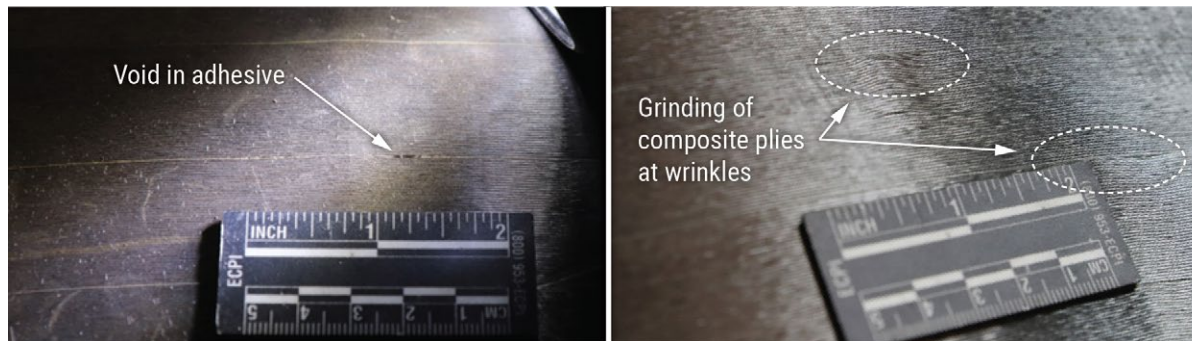
Void in the adhesive layer tenting around a wrinkle and grinding of outer carbon fiber plies at a wrinkle.

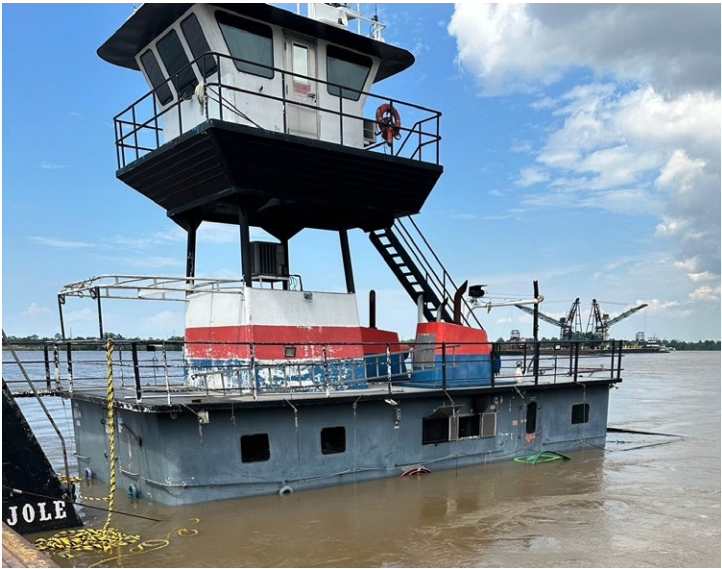
*Cajole* partially submerged and secured to a barge after all involved personnel safely disembarked the vessel. SOURCE: COAST GUARD.

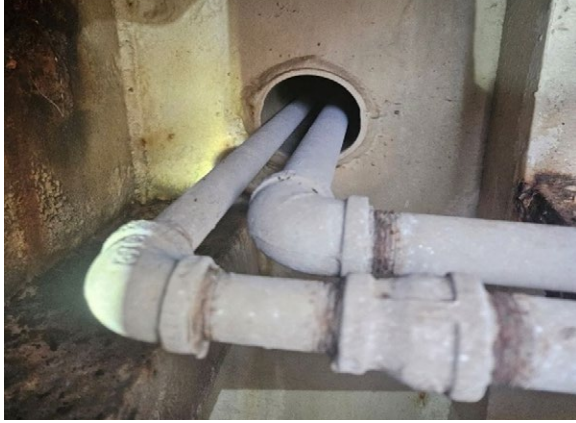
**View of unsealed piping conduit penetration between the engine room and auxiliary space from the auxiliary space on May 28, 2024.** SOURCE: COAST GUARD.

About 2 weeks before the casualty, a Coast Guard inspector found that piping and electrical wire conduits between the forward auxiliary void and engine room were not properly sealed to be watertight. Operating company personnel sealed the piping and electrical wire conduits, and the inspector signed off that the repairs were completed satisfactorily. However, based on the flooding that the captain saw coming through at least one of the conduits, the repairs the crew had made during the Coast Guard inspection were likely not completely effective. With the starboard-side conduit between the engine room and auxiliary void lacking watertight integrity, water was able to progressively flood between the spaces. Therefore, the water in the engine room was likely the result of progressive flooding, through the conduits, from the auxiliary void located directly forward of the engine room. The flooding added weight to the vessel, causing it to sink lower in the water and decreasing its freeboard, which may have allowed for flooding through other deck or house openings. The vessel's reserve buoyancy was then overcome, resulting in it sinking.

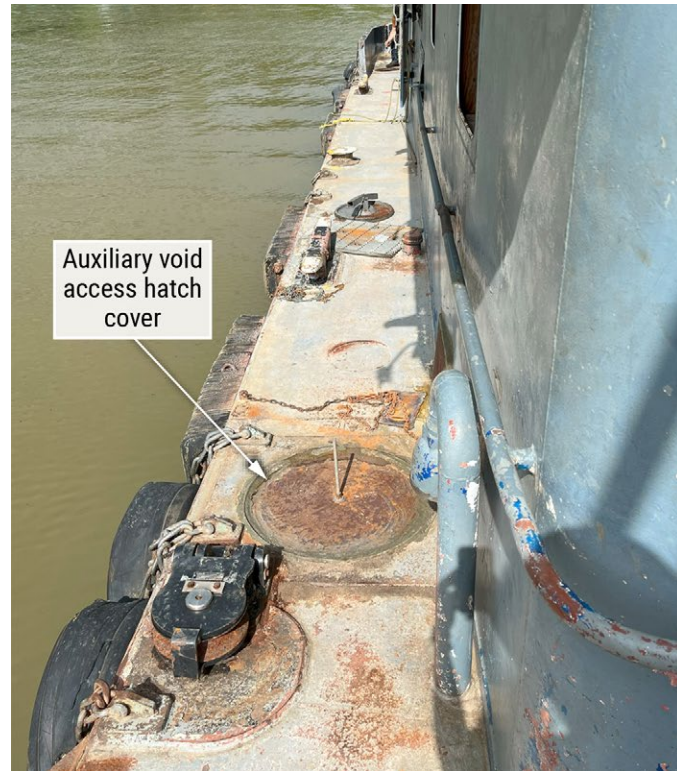
**THE PROBABLE CAUSE** of the flooding and sinking of the towing vessel *Cajole* was likely a compromised flush-mounted access hatch, which allowed water to flood into a forward void space, and unsealed penetrations in a transverse bulkhead, which allowed for progressive flooding aft into the engine room.

***Cajole* after the sinking, with starboard-side auxiliary void access hatch cover replaced and permanently sealed to the main deck for transit to shipyard.**

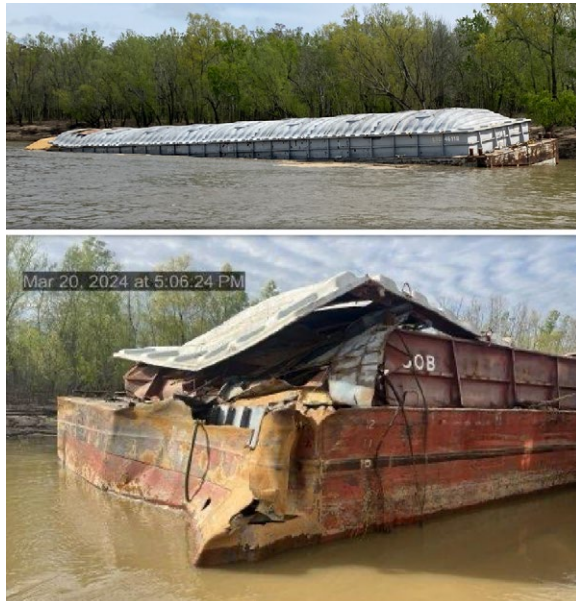
**From top: Covered barge LTD 4611 partially sunken by its bow to port, and damage to the stern area of MTC 500B, the barge that was immediately aft of the PTC 706.**

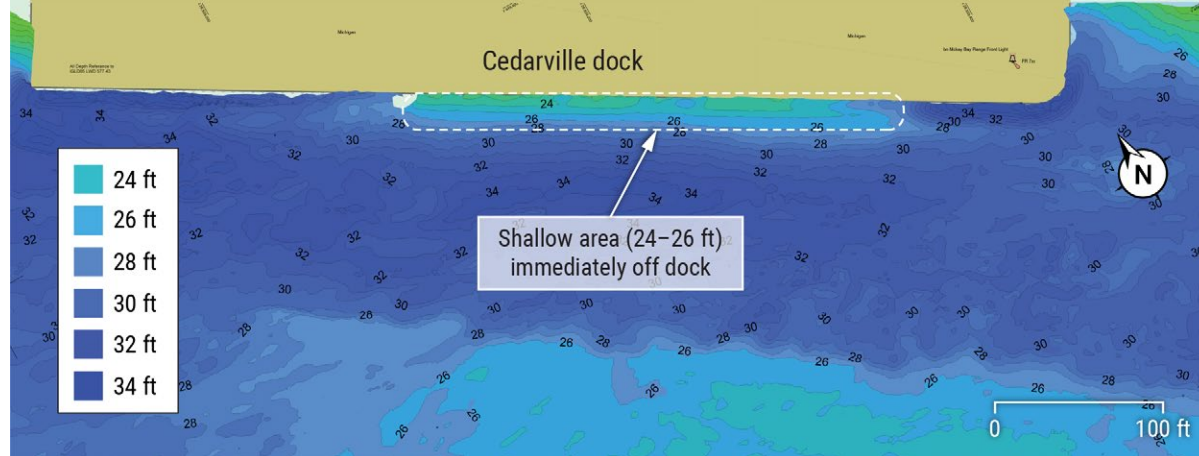
**May 8, 2023 (16 days after grounding) bathymetric survey of Cedarville dock (at International Great Lakes Datum).** BACKGROUND SOURCE: RYBA MARINE CONSTRUCTION CO.

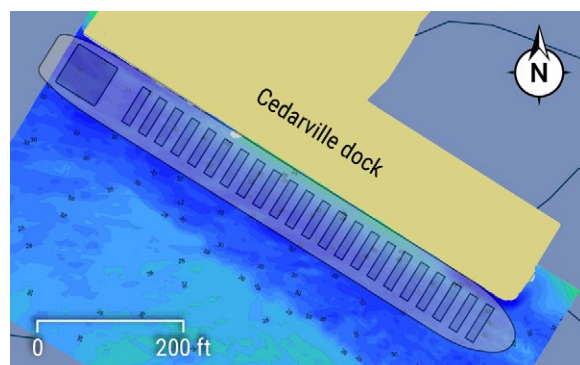
**Overlay of *John J Boland*'s position at 0946 after the vessel initially grounded over the 2019 bathymetric survey of the Cedarville dock, which was based on International Great Lakes Datum at low water datum.**

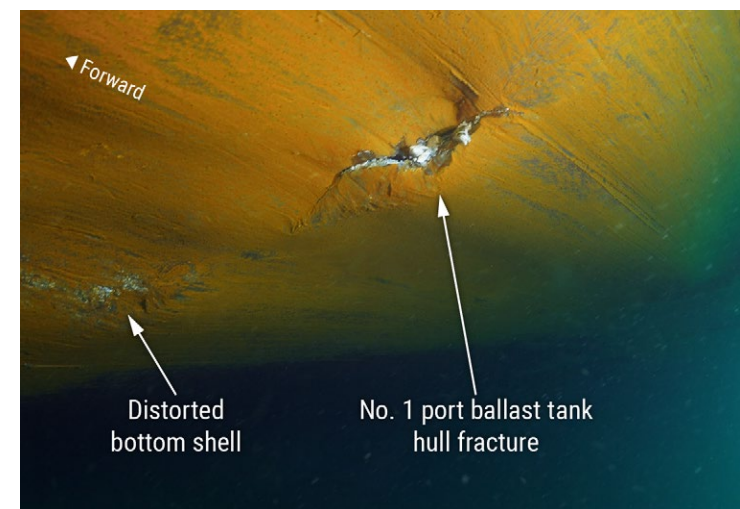
**No. 1 port ballast tank hull fracture and distorted bottom shell.** BACKGROUND SOURCE: BENEATH THE SURFACE.

**THE PROBABLE CAUSE** of, and resulting hull damage to, the self-unloading bulk carrier *John J Boland* was inadequate operating company guidance to create a load plan with sufficient underkeel clearance and the master's decision to use the main engine to free the vessel after it was aground. **CONTRIBUTING** was the master and first mate becoming desensitized to the risk of vessel damage associated with grounding during loading operations.

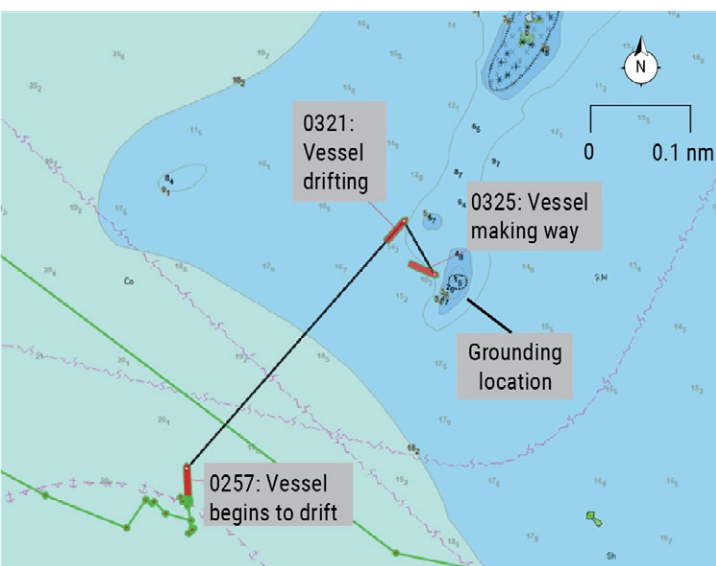
**The *Bonnie G*'s trackline after the captain began navigating the vessel toward the green buoy and the West Gregerie Channel, just before the vessel grounded.** BACKGROUND SOURCE: NOAA ENC 25649 AS VIEWED ON MADE SMART.

**THE PROBABLE CAUSE** of the grounding of the cargo vessel *Bonnie G* was the inadequate scope of chain deployed when anchoring, which likely led to the anchor chain parting, and the captain not identifying a charted rock and steering the vessel onto it when attempting to maneuver to safe water.

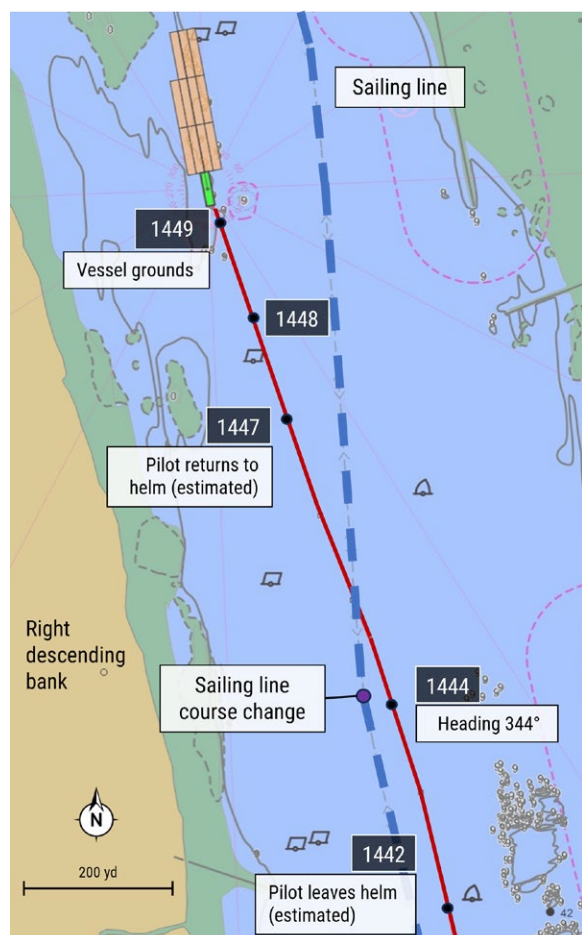
During the time the pilot said he was away from the helm, he missed a 9° course change to starboard on the sailing line (the recommended track). The pilot said that, before he left the helm, he checked the electronic charting system (ECS). However, the ECS would have displayed the upcoming change in course. Further, the pilot did not identify that the tow had begun to progress closer to the right descending bank while he was away from the helm, which should have been apparent from his reported position on the port side of the wheelhouse.

**ECS showing the positions of the *City of Louisville* for 7 minutes before the time of grounding.**

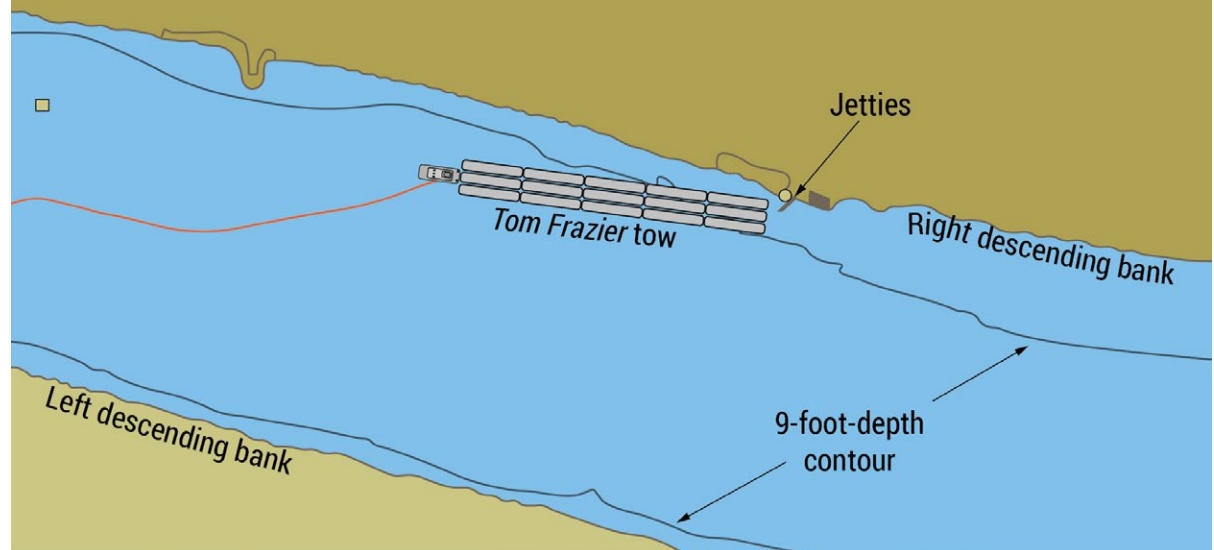
**THE PROBABLE CAUSE** of the grounding of the towing vessel *Tom Frazier* on submerged jetties was the captain maneuvering his tow too close to the bank in order to avoid a downbound tow, and not identifying the hazard posed by the charted jetties.

**Re-creation of ENC showing stone jetties, with *Tom Frazier* tow arrangement and trackline overlaid.**

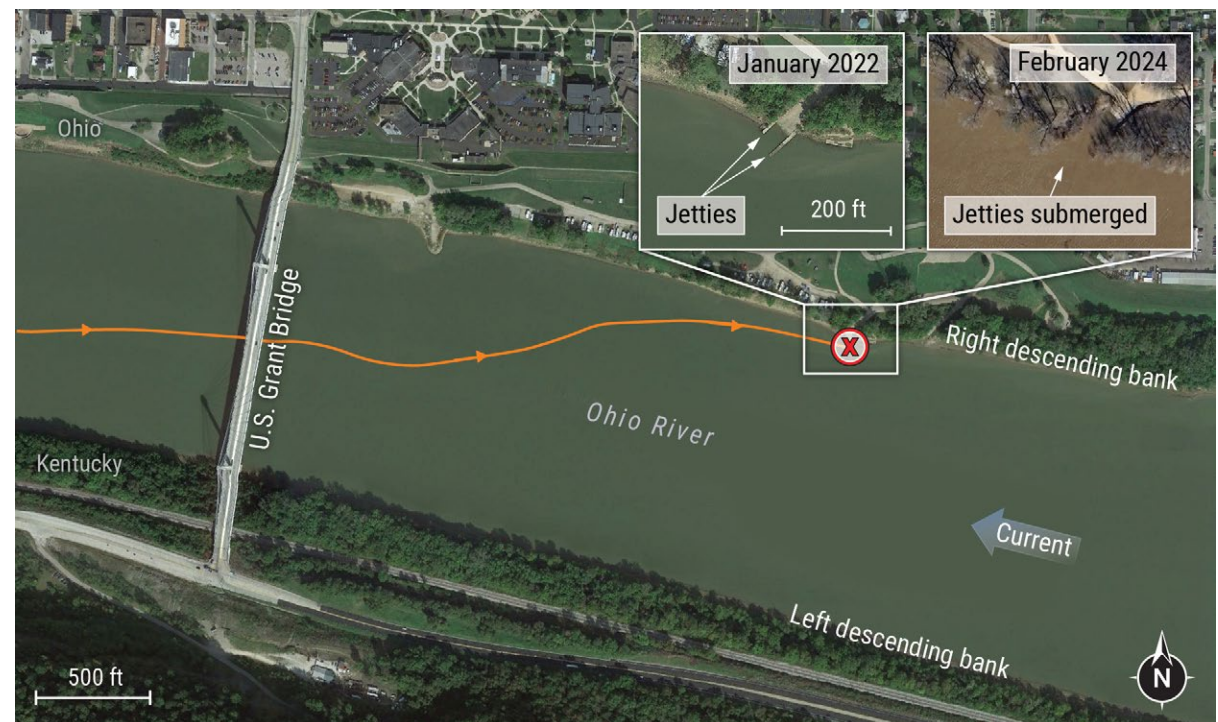
**Trackline of *Tom Frazier* tow as the vessel transited through the U.S. Grant Bridge and toward the right descending bank. Inset satellite photos show the jetties visible on January 26, 2022 (17.4 to 18.5 feet at the Portsmouth gage) and submerged on February 14, 2024 (28.7 to 31.6 feet at the Portsmouth gage).**

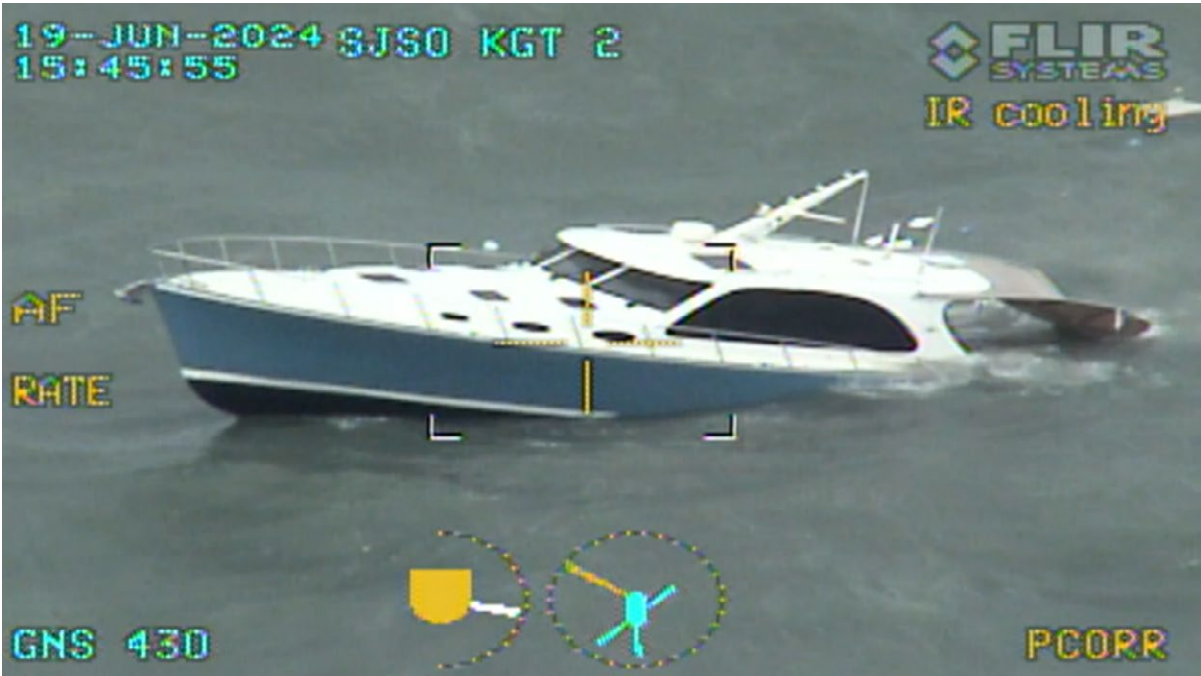
**The 6 Saturdays as viewed from the St. Johns County Sheriff’s Office helicopter at 1546.**  
SOURCE: ST. JOHNS COUNTY SHERIFF’S OFFICE.

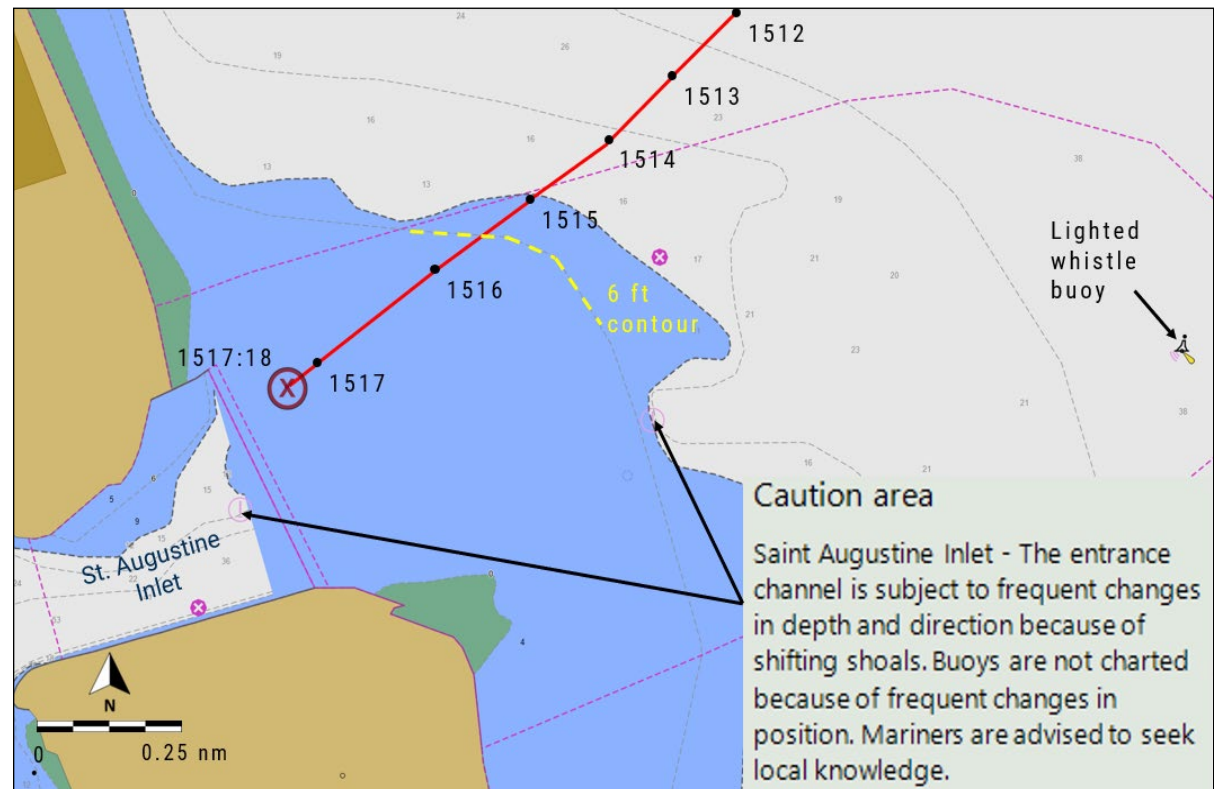
The navigation chart for the area where the grounding occurred contained a cautionary note warning of frequent changes in depth due to shifting shoals. Additionally, the *US Coast Pilot* warned of dangerous and shifting shoals extending 1 nautical mile seaward. Although the captain of the **6 Saturdays** said he had operated vessels many times through the St. Augustine Inlet, he was unaware of the shoaling and published cautions and warnings. The captain did not navigate the vessel to the lighted whistle buoy off the entrance of the inlet to follow the buoyed channel inward, which would have kept the vessel in safe water. Instead, he proceeded directly through the shoal water at a speed of about 15 knots. The captain's decision to navigate the vessel through shoal water with charted depths that were likely less than the vessel's draft led to the vessel's grounding.

**ENC with the positions and track of the 6 Saturdays up to the grounding location, and caution area inset.**

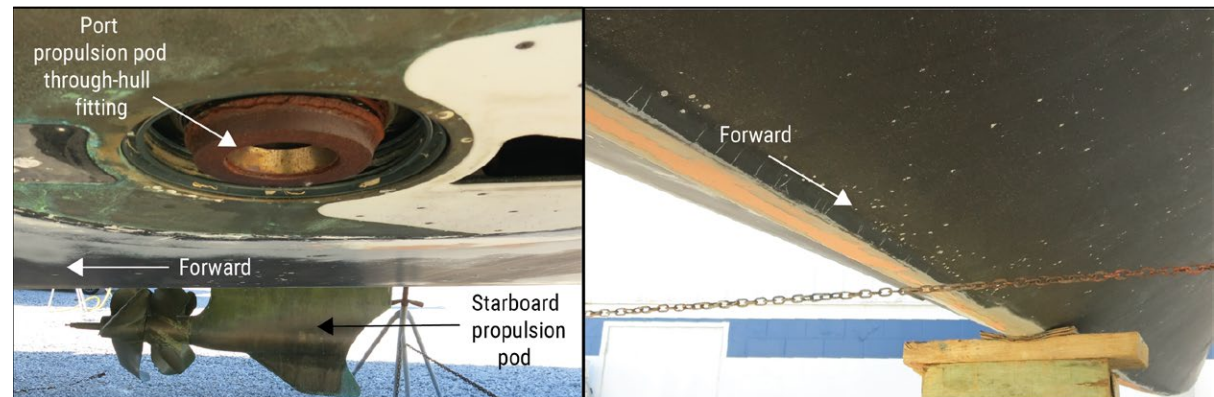
**THE PROBABLE CAUSE** of the grounding of the recreational vessel **6 Saturdays** was the captain's decision to navigate through an area known to have shoals instead of the buoyed entrance channel marking the safe navigation passage into the St. Augustine Inlet.

**From left: Aft bottom of the 6 Saturdays, including the through-hull fitting for the missing port propulsion pod and damage to the propeller blades of the starboard propulsion pod. Scratch mark damage to the keel.**

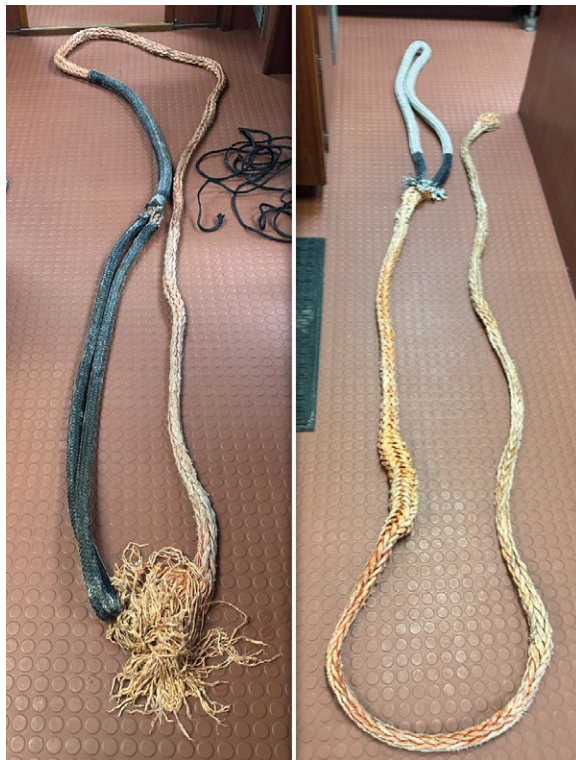
the soft shackle parted due to the lines exceeding their breaking strength, likely due to shock loading. Given that the ITB was in regularly encountered conditions and the lines were reported as properly rigged, it is undetermined how the first push line that parted was shock loaded. Once the first push line parted, this likely began a cascading failure as the remaining three push lines took up the additional strain.

**THE PROBABLE CAUSE** of the grounding of the barge *Cordova Provider* was due to shock loading that led to the parting of the push lines connecting the *Cordova Provider* to the tug *Krystal Sea*.

The recovered pennant section of the port outboard and starboard inboard push lines, postcasualty.

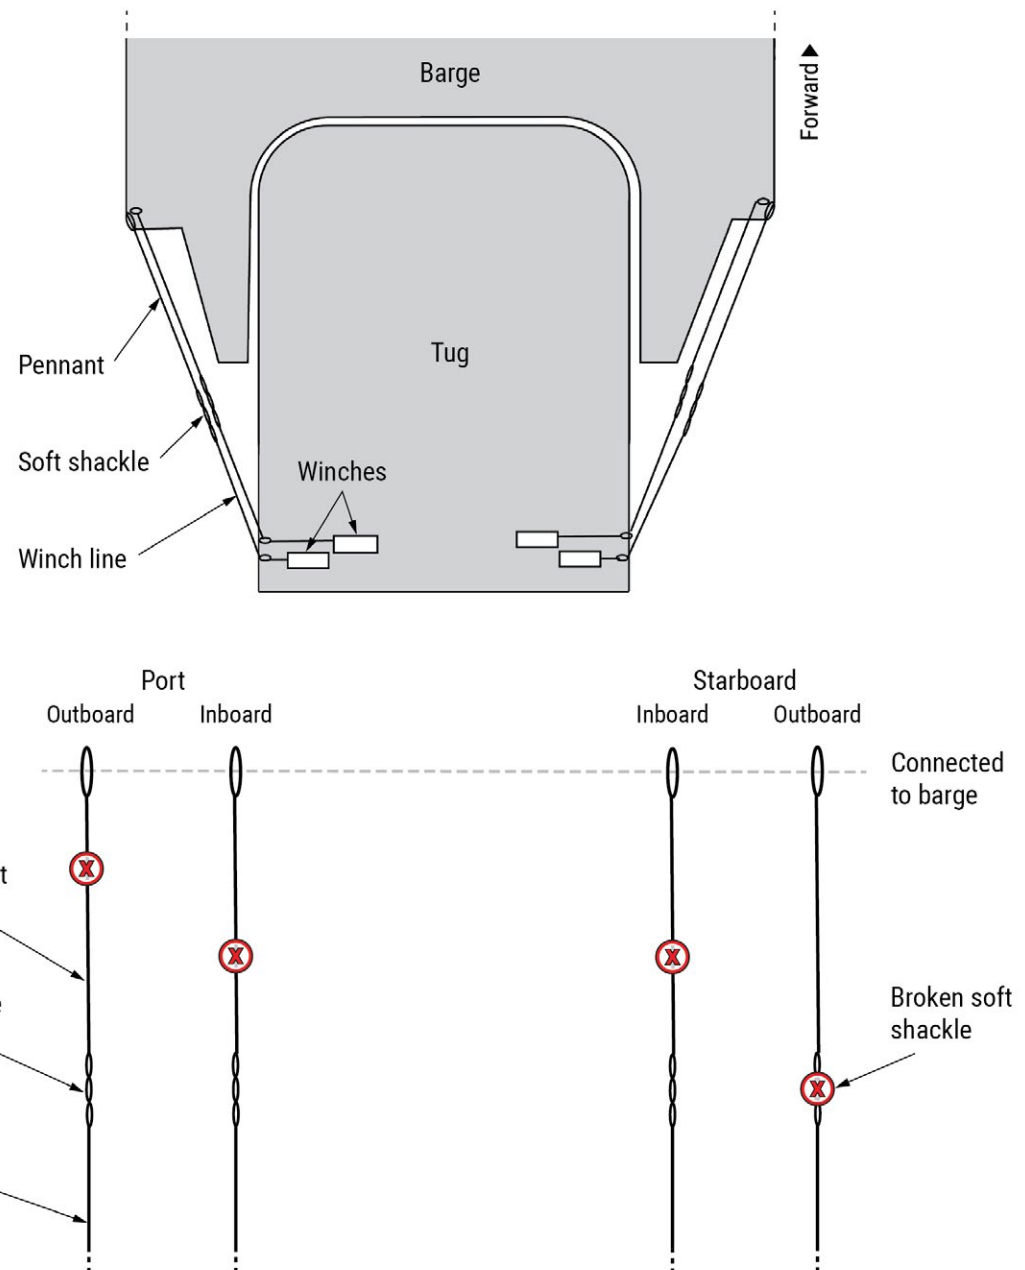
From top: Simplified plan view of the ITB, showing the makeup, arrangement, and location of the push lines connecting the tug to the barge (scale approximate); and diagram showing, with a red X, where each of the push lines parted. BACKGROUND SOURCE: BERING MARINE CORP (TOP), CORDOVA PROVIDER LLC (BOTTOM).
