NATIONAL TRANSPORTATION SAFETY BOARD

# SAFER SEAS

# Digest

Lessons Learned from  
Marine Investigations

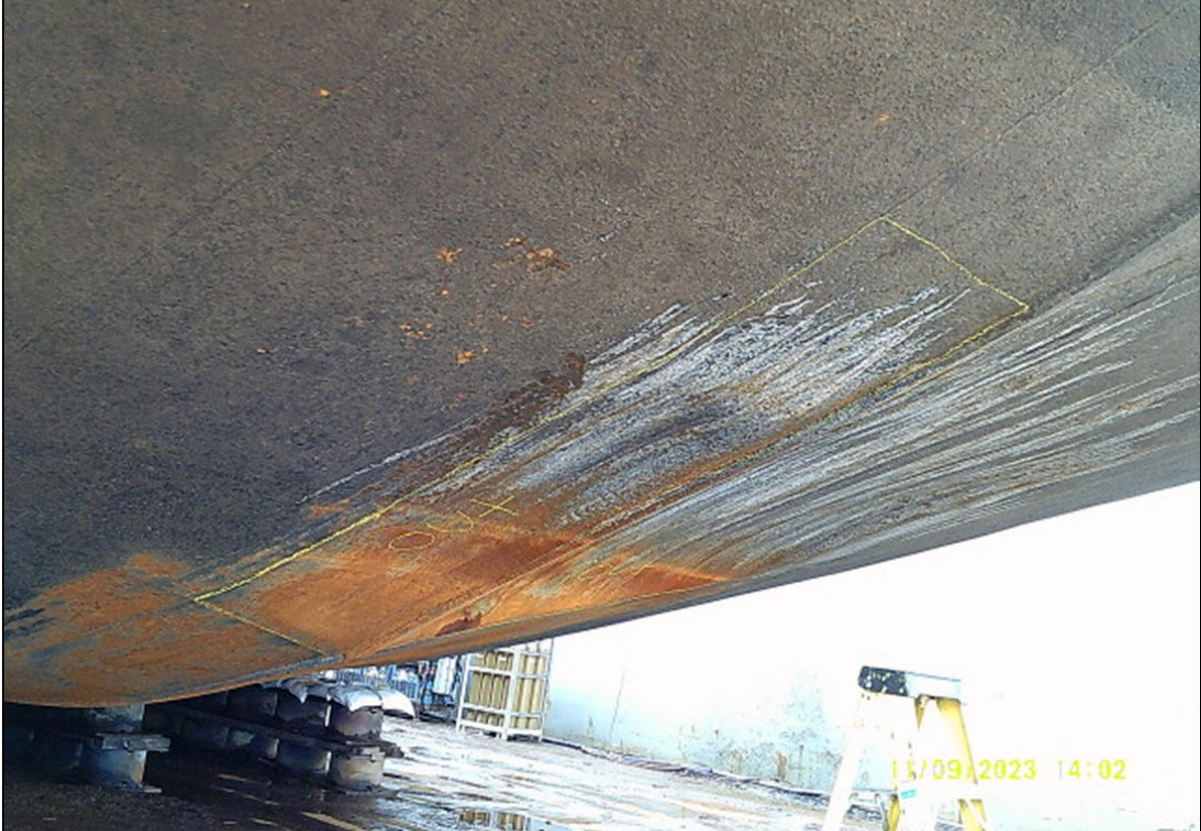
Bottom plating near the bow of the *John M Donnelly* that was inset when the vessel grounded.

On October 30, 2023, at 1610 local time, the towing vessel *John M Donnelly* was pushing 25 empty dry cargo barges upbound at mile 246.5 on the Lower Mississippi River, near Baton Rouge, Louisiana, when it grounded on a submerged obstruction. One crewmember sustained a minor injury. No pollution was reported. The cost of damage to the vessel was \$505,834.

**THE PROBABLE CAUSE** of the grounding of the towing vessel *John M Donnelly* on a submerged obstruction in the Mississippi River was the pilot not identifying the hazard posed by the charted obstruction during low water conditions while maneuvering his tow to avoid other tows.

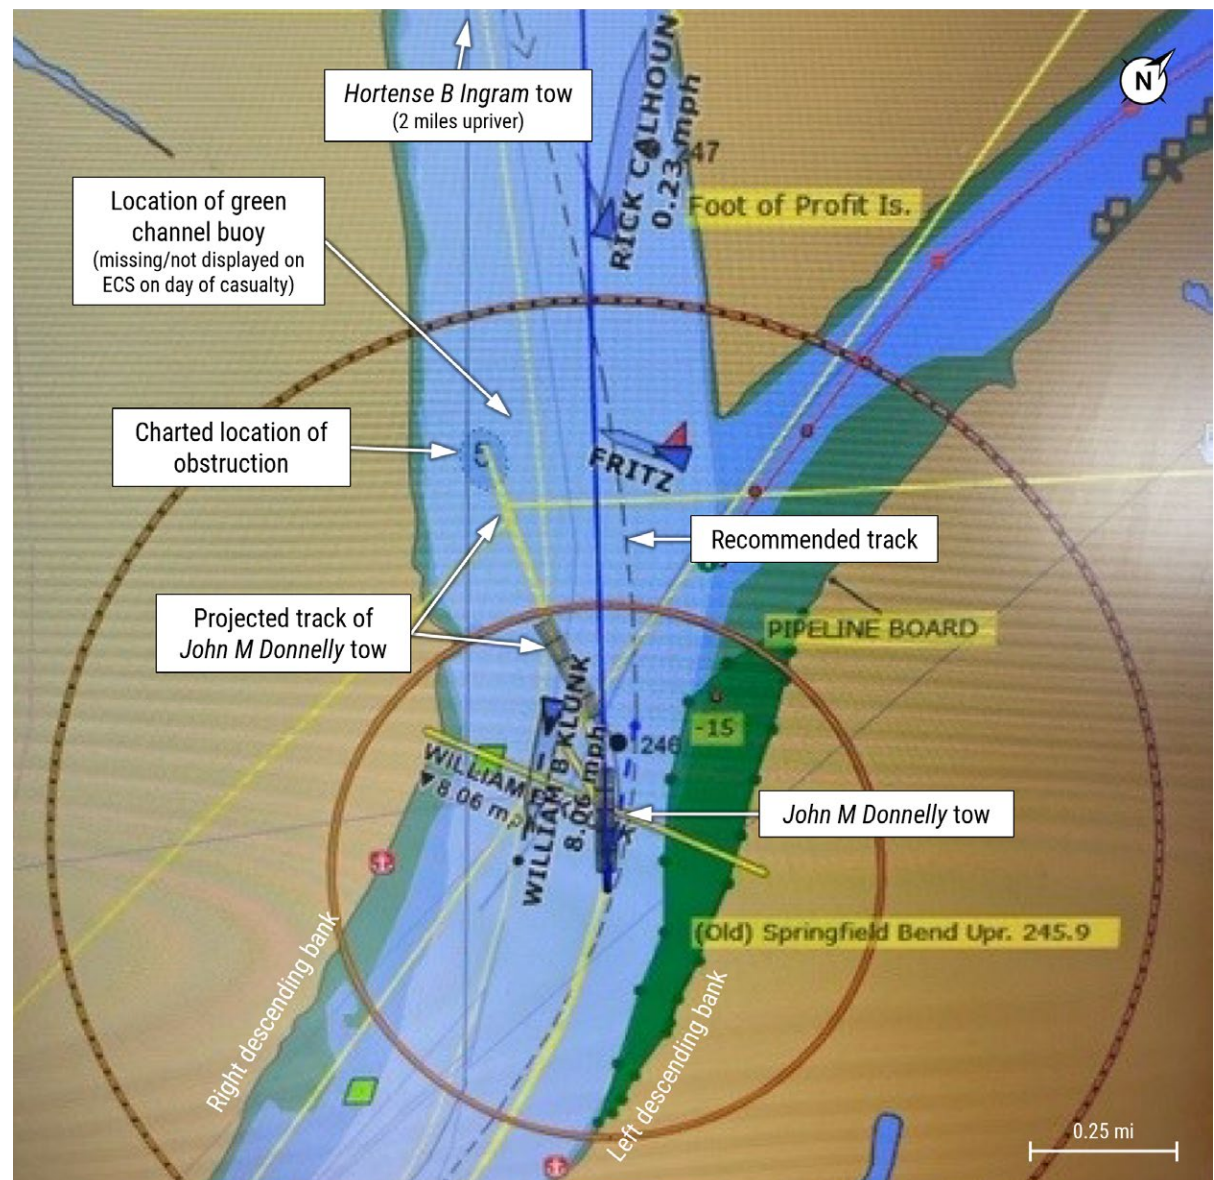
The green buoy marking the edge of the channel near the obstruction was missing at the time of the grounding. Additionally, the buoy was not shown on the *John M Donnelly*'s ECS display when investigators replayed the casualty event on the system. However, the location of the obstruction was visible as an area of shallow water on the *John M Donnelly*'s ECS. The pilot did not identify the hazard ahead as he maneuvered the tow toward the bank to make room for the stopped and downbound tows, resulting in the grounding.

Screen capture from replay of *John M Donnelly* Rose Point ECS at 1604:25 on October 30, 2023, 3.5 minutes before the towing vessel grounded. BACKGROUND SOURCE: COAST GUARD.

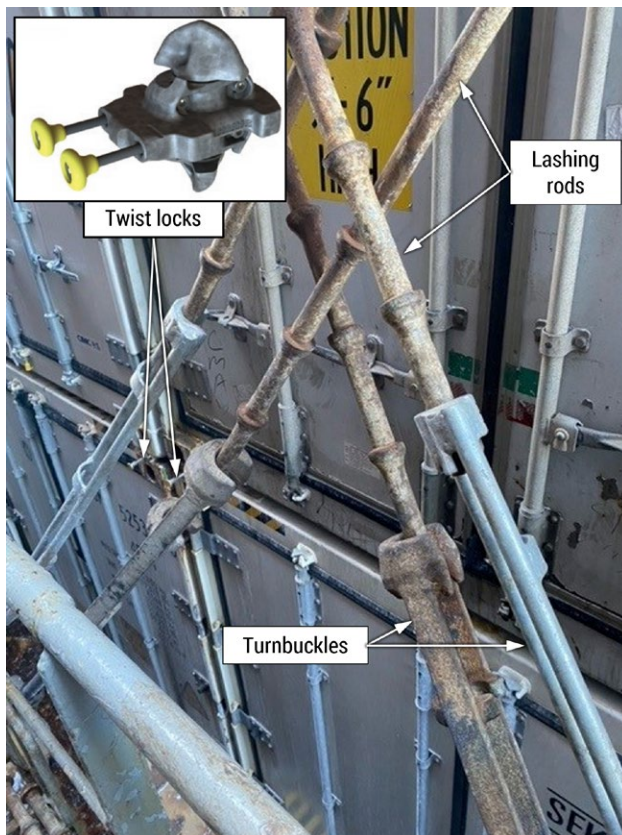
**Intact lashings (lashing rods and turnbuckles) and twist locks on *President Eisenhower* after the casualty. Inset shows an exemplar twist lock.**

After the casualty, the vessel operator found that the overweight and reverse-stratified container stacks exceeded the calculated "lashing forces," which caused the cargo-securing equipment to fail. Throughout the day leading up to the crew's discovery of the lost containers, the vessel had drifted while awaiting entrance to the Port of Oakland, and increased wind and seas caused the vessel to roll

at 18°. The 18° rolls were significantly higher than what the vessel had previously encountered on the transit (reported at a maximum 5°). A postcasualty examination by the classification society found lashing plate and socket damage, indicating that the lashings became overloaded and pulled free. The increased rolling magnitude from seas would have increased the compression forces acting on the containers within the stacks and the racking forces acting on the cargo-securing equipment until the equipment failed, resulting in the container damage and loss.

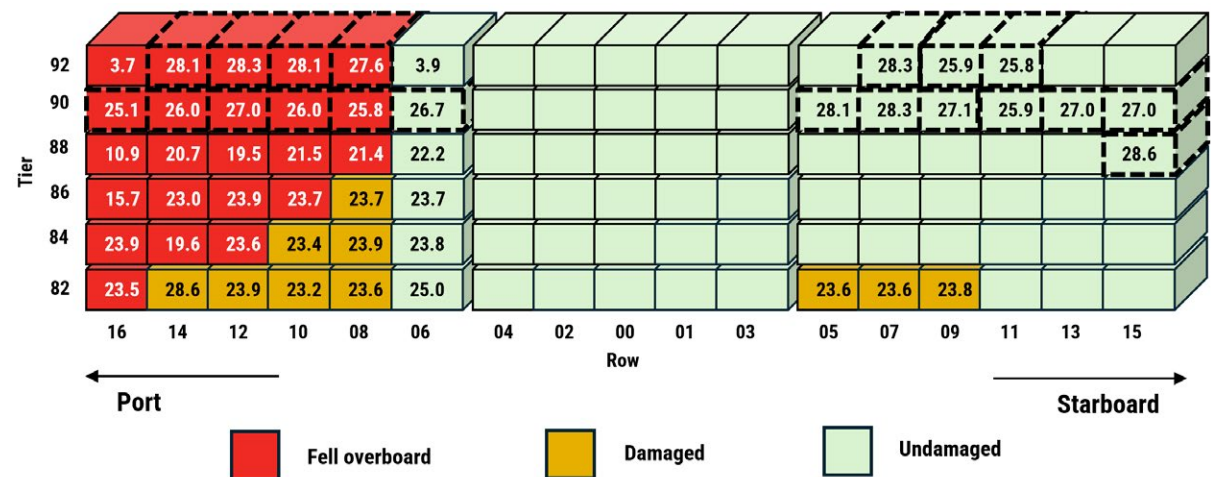
The stack weights in bay 42 exceeded the company cargo securing manual’s allowance, and the forces acting on both the containers and the cargo-securing equipment were greater than what was expected. Additionally, because the container VGMs were incorrect on the cargo loading plan, the container stacks on the port side of bay 42 were inadvertently arranged with heavier containers in the upper tiers and progressively lighter containers toward the bottom tiers—an arrangement called reverse stratification. This arrangement resulted in the stacks having a

higher center of gravity. The cargo-securing equipment (twist locks and lashings) on a reverse-stratified container stack would be subjected to increased forces from vessel motion while underway at sea. Therefore, the loading of containers in overweight and reverse-stratified stacks in bay 42 increased the likelihood of a cargo-securing equipment failure.

**THE PROBABLE CAUSE** of the container loss aboard the container ship *President Eisenhower* was the input of incorrect cargo weight for 39 containers when the cargo loading plan was developed by shoreside planners, resulting in the containers being loaded in overweight and reverse-stratified stacks, causing cargo-securing equipment to fail while the vessel was drifting.

**Bay 42 container stacks showing the location of the lost and damaged containers as well as the actual, shipper-provided VGM for each container in metric tons. The containers with the incorrect VGMs on the cargo loading plan are outlined with a dashed line.**

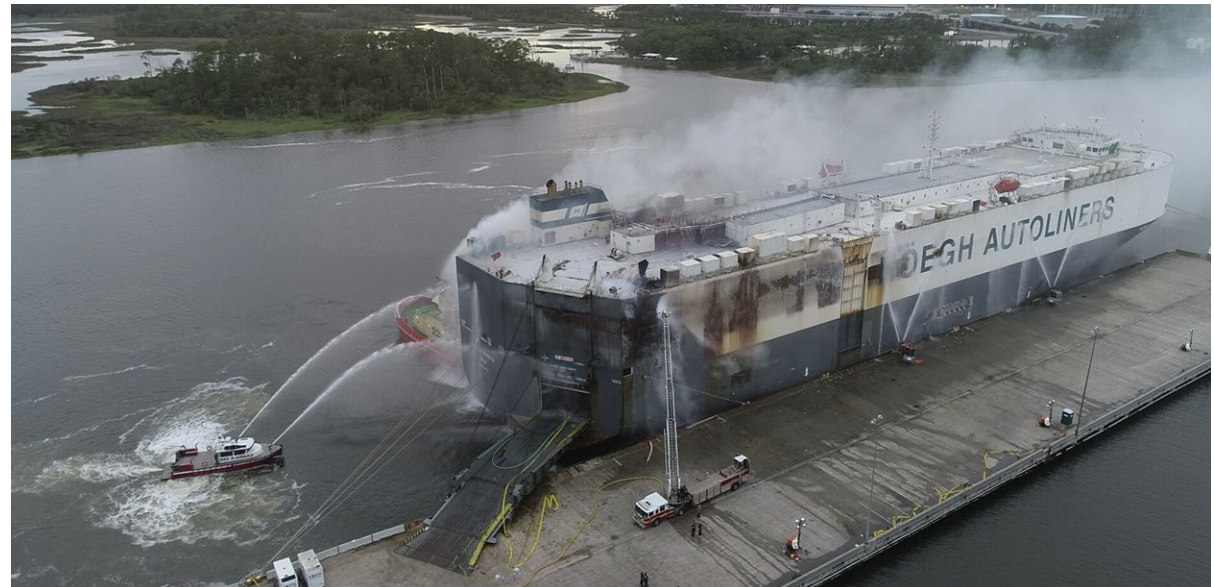
**Firefighters conduct exterior boundary cooling on the *Höegh Xiamen* on June 5, 2021, the day after the fire was discovered. Boundary cooling involves using water deluge to keep bulkheads and decks cool to prevent the spread of fire through conduction and to prevent structural collapse, all while taking care to not flood the ship with firefighting water, which would risk sinking or capsizing the vessel.**

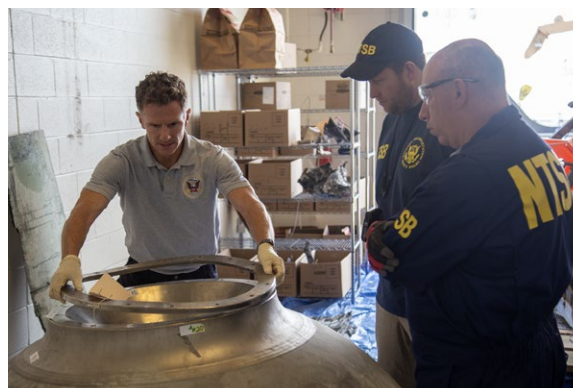
**NTSB investigators examine the recovered wreckage from the Titan.**

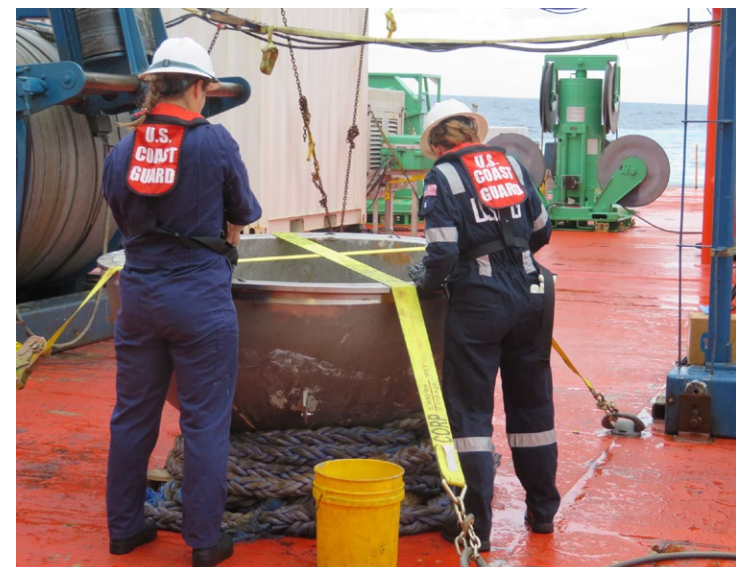
Coast Guard marine safety engineers examine the aft titanium dome from the *Titan* on October 1, 2023, in the North Atlantic Ocean. The dome was recovered from the seafloor and transferred to a US port for analysis.
