Railroad Investigation Report: RIR-25-09

CSX Transportation Conductor Trainee Fatality

Baltimore, Maryland

June 26, 2023

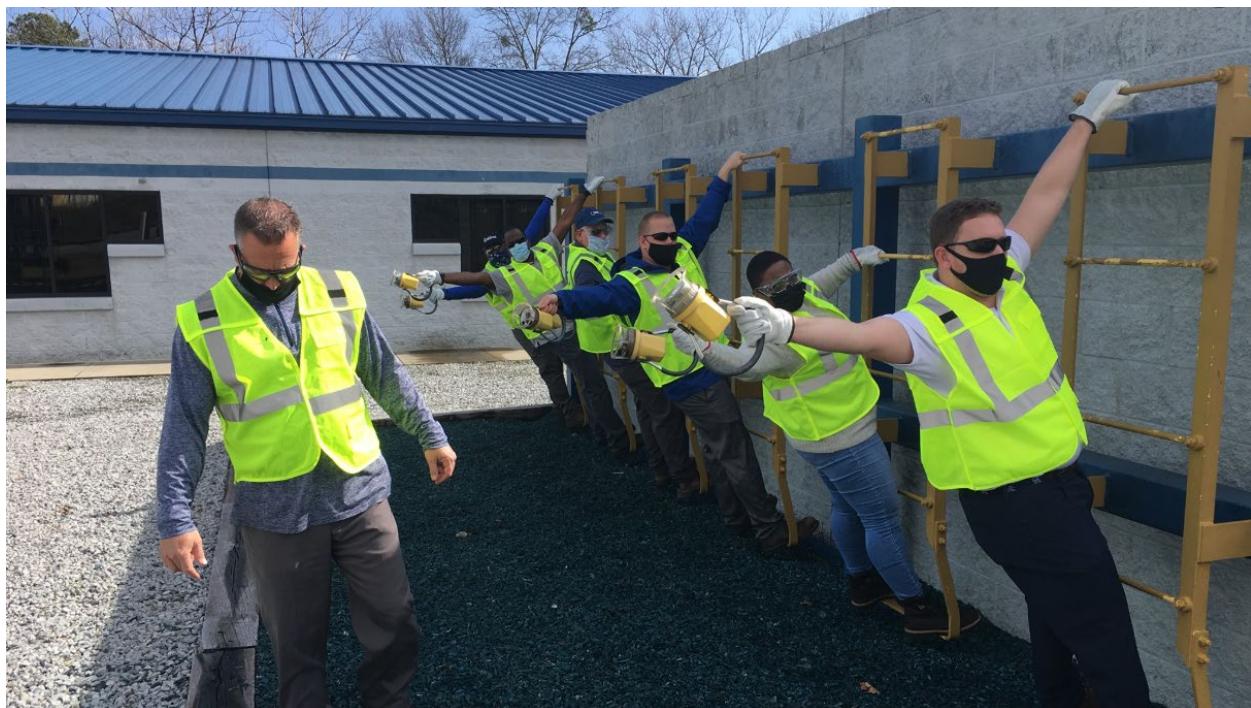
attended CSX phase I conductor training, instructors taught and evaluated conductor trainees on two stances for riding railcars. The first riding stance, the “ladder hang stance,” was a standard position for use on most railcars, including intermodal railcars, and required the rider to place both feet on the step and hands (one or both, depending on whether the rider was also operating a radio or other approved device) on handholds while positioning the body to face the equipment and looking in the direction of travel. (See figure 4.) As discussed in section 1.1, the accident conductor trainer was riding with his feet on the horizontal handhold (which he used as a step) and his hands on the vertical handholds while his body faced the equipment, and he looked in the direction of travel.

Figure 4. Photograph of trainees at the CSX training facility performing the ladder hang stance. (Courtesy of CSX.)

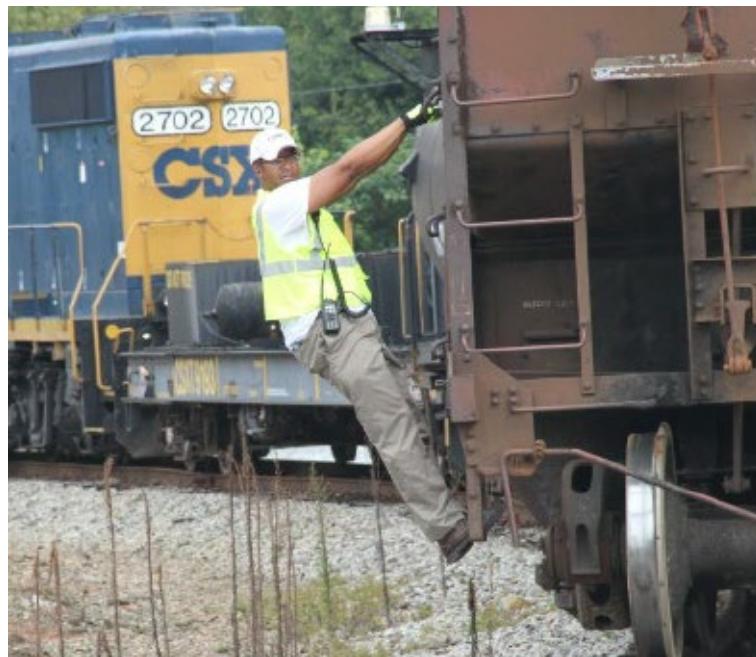
In response to the accident, on June 27, 2023, CSX issued a safety alert to its employees that reminded them of operating rules 104.5, 2102.1, 2102.2, and 2102.3, which apply to employee trainer responsibilities and riding equipment. The alert provided photographs of employees riding several kinds of railcars (although not an intermodal railcar) in compliance with CSX operating rules and a photograph of a noncompliant method for riding an intermodal railcar. (See figure 10 and figure 11.)

Figure 10. Photograph from the CSX safety alert of an employee modeling a compliant method for riding a railcar. (Courtesy of CSX.)
