Ground Fire Aboard Cargo Airplane  
ABX Air Flight 1611  
Boeing 767-200, N799AX  
San Francisco, California  
June 28, 2008

**Aircraft Accident Summary Report**

NTSB/AAR-09/04/SUM  
PB2009-910404

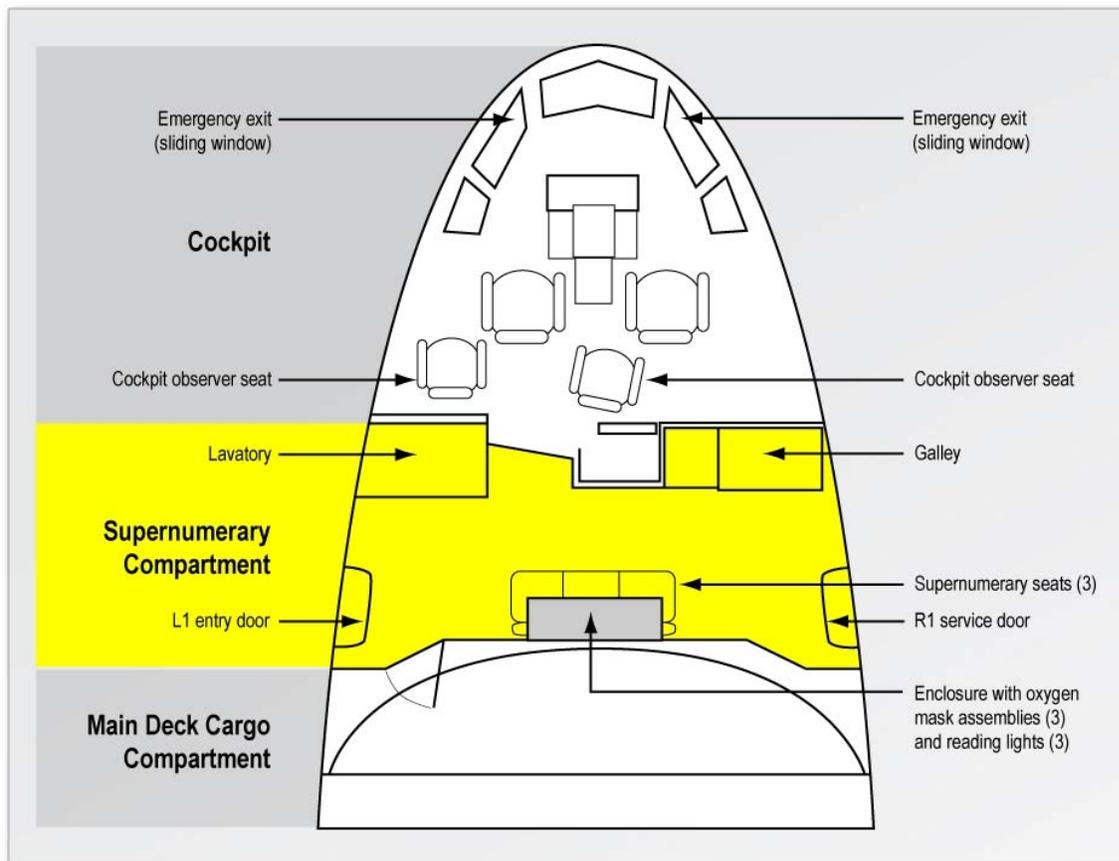
**Figure 1.** Cockpit and Forward Cabin of Airplane

The fire was located in the supernumerary compartment of the airplane. This compartment, which is present on some cargo airplanes, is located directly aft of the cockpit and forward of the main deck cargo compartment, as shown in figure 1.<sup>3</sup> This area is where the lavatory, galley, and three non-flight crew seats (in a bench configuration) are located.<sup>4</sup>
