Loss of Control and Crash  
Marlin Air  
Cessna Citation 550, N550BP  
Milwaukee, Wisconsin  
June 4, 2007

NTSB/AAR-09/06  
PB2009-910406

# Aircraft Accident Report

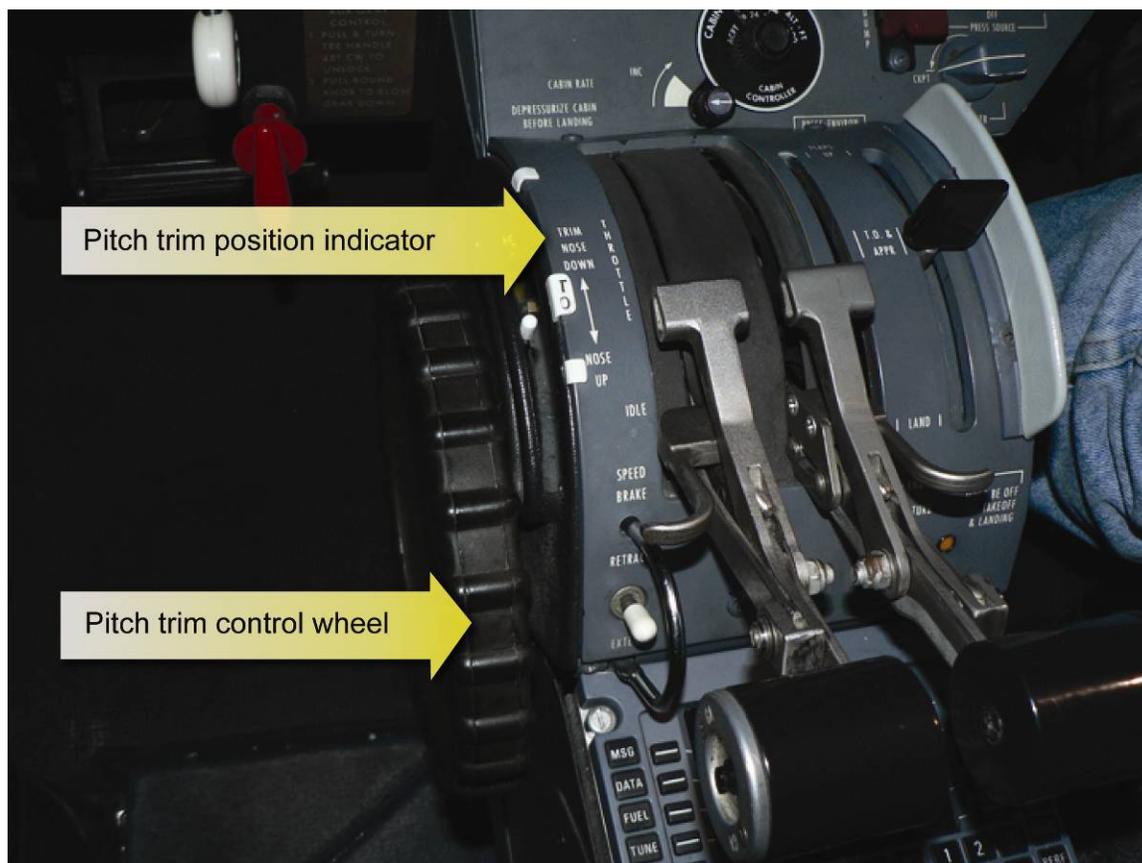
**Figure 2.** Photograph showing the pitch trim control wheel and the white pitch trim position indicator on the left side of the throttle console of a representative Citation, as viewed from the captain's seat.

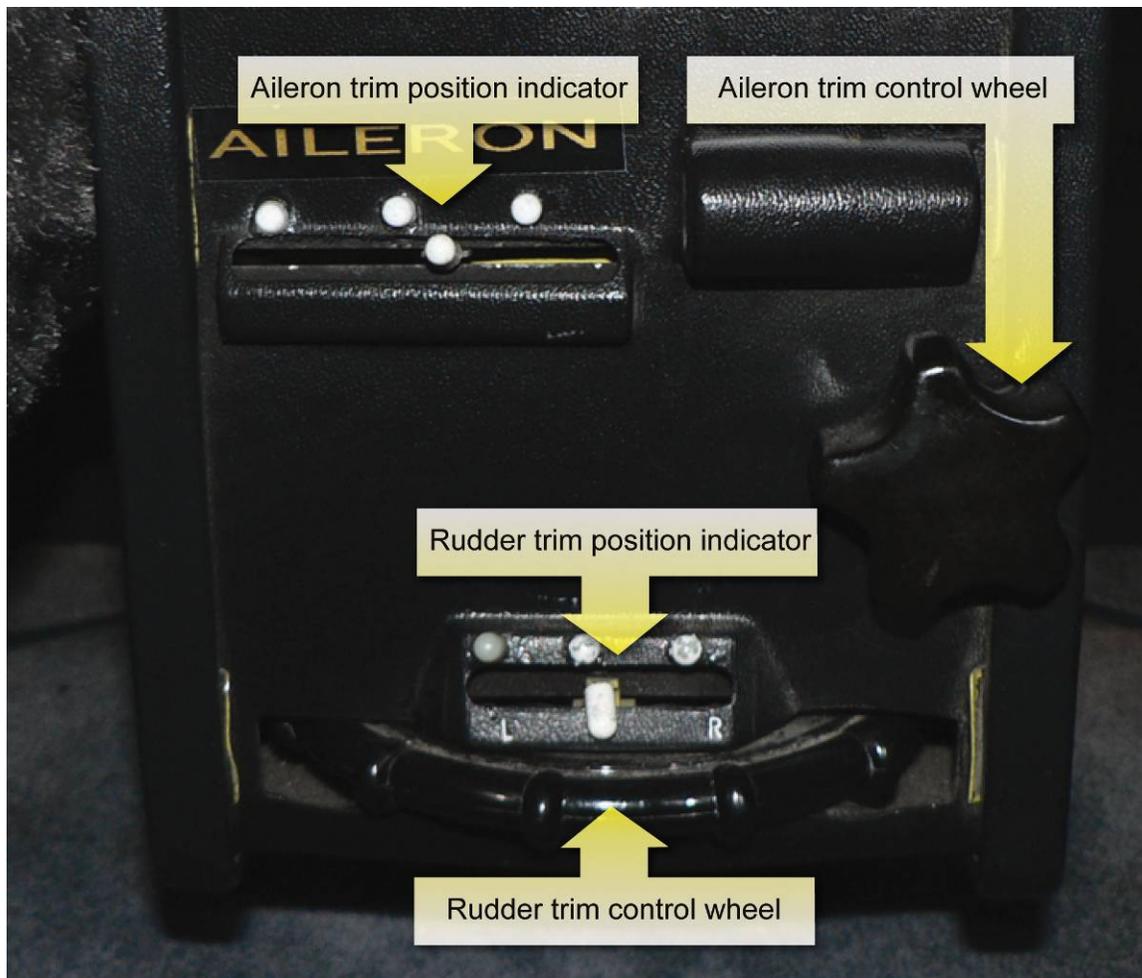
**Figure 3.** Photograph showing the aileron and rudder trim wheels and indicator tabs on the aft face of a representative Cessna 550 throttle console.

Based on postaccident observations in a similar airplane, investigators noted that a centered aileron trim indicator would appear not to be centered when viewed from either pilot's seat, due to parallax.<sup>27</sup> For additional information regarding Cessna Citation aileron trim, see section 1.18.4.

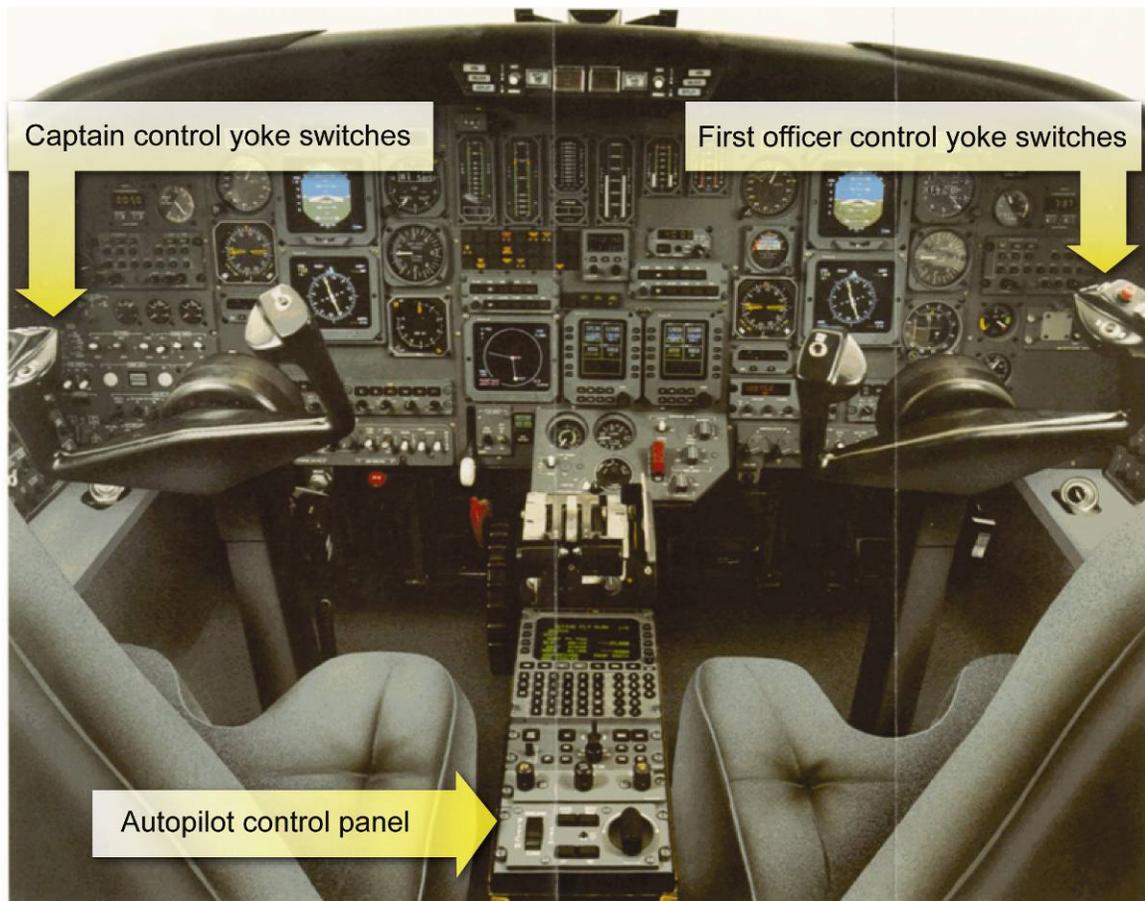
**Figure 4.** Photograph of a representative Citation 550 cockpit, with the autopilot control panel and the pilots' control-yoke-mounted autopilot disconnect buttons indicated.
