Runway Overrun During Rejected Takeoff  
Global Exec Aviation  
Bombardier Learjet 60, N999LJ  
Columbia, South Carolina  
September 19, 2008

NTSB/AAR-10/02  
PB2010-910402

# Aircraft Accident Report

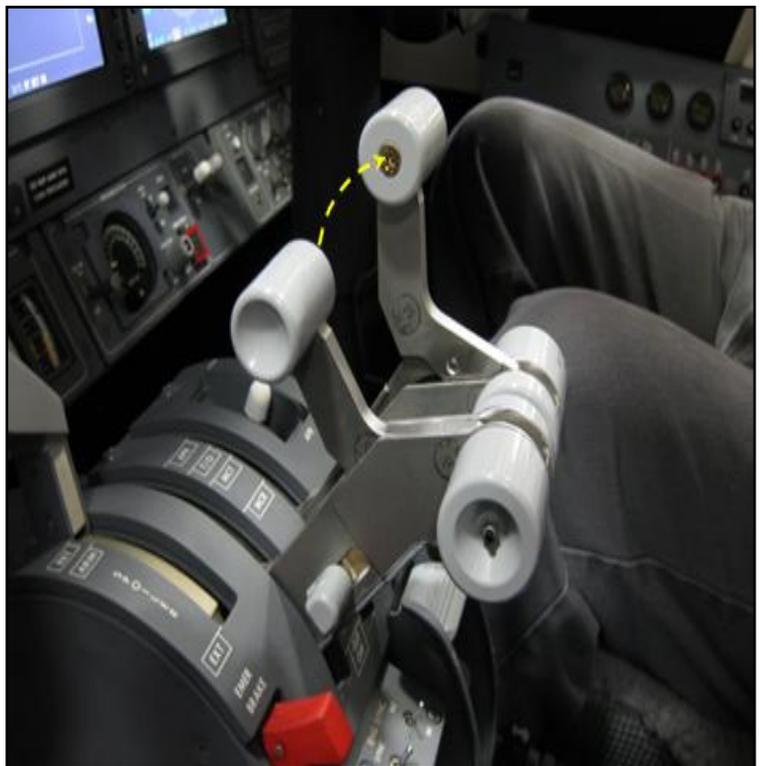
The airplane's thrust reverser system, which is designed to help stop the airplane on the ground, is also electronically controlled. The thrust reverser system responds to the pilot's positioning of the thrust reverser levers (also known as "piggyback" levers because they are located on top of the thrust levers) by using electronic signals to command reverse thrust functions. See figure 2 (at right) for the captain's side view of Learjet 60 thrust levers and thrust reverser levers.

**Figure 2.** Captain's side view of Learjet 60 thrust levers (at idle) and thrust reverser (piggyback) levers. To illustrate lever movement, one thrust reverser lever is in the stowed position, and the other is lifted to command reverse thrust (arrow shows direction lever moves when lifted from the stowed position).

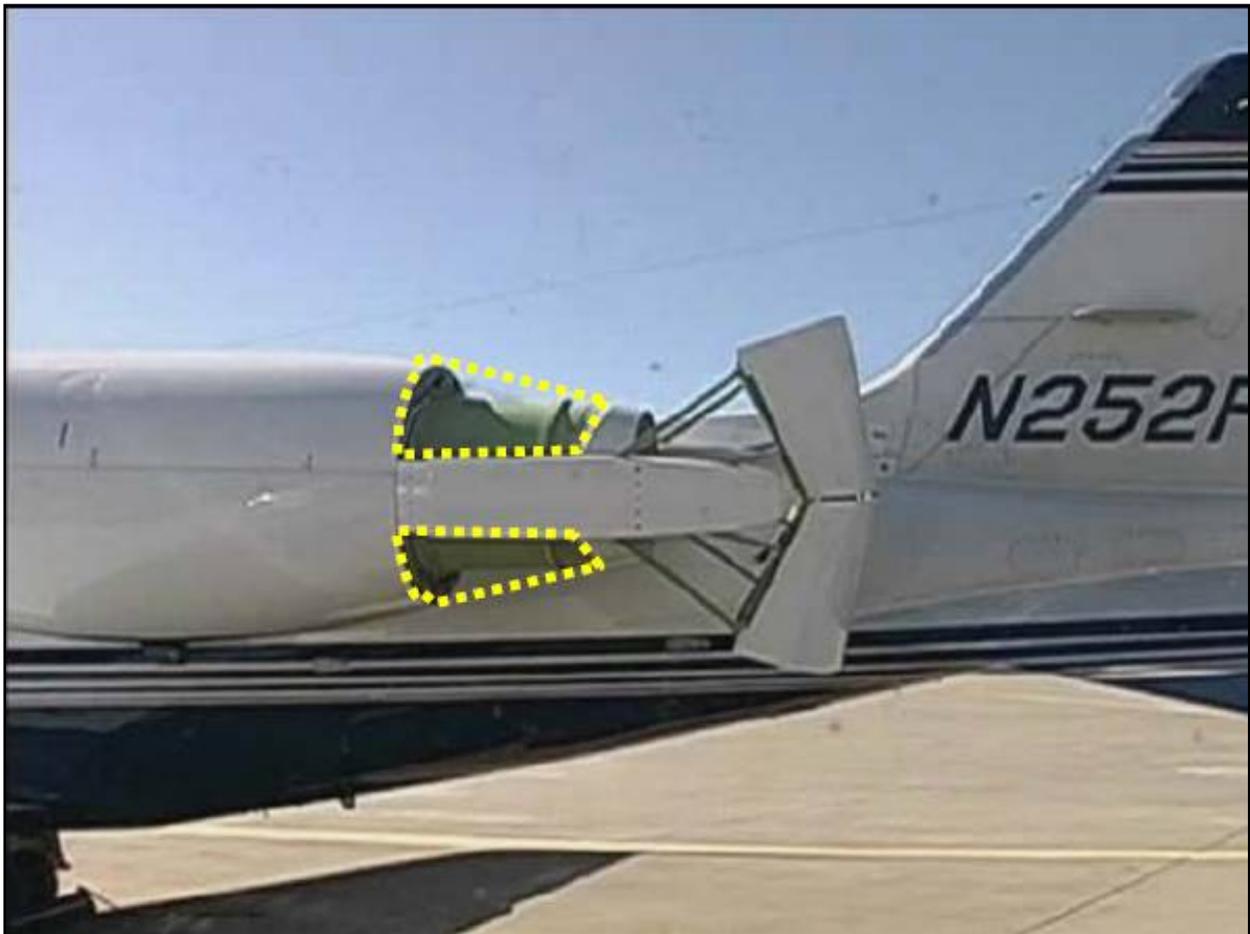
deceleration force to assist with ground braking. (See figure 3 below, which depicts a Learjet 60 with thrust reversers deployed.) Although the use of reverse thrust can reduce the distance needed to stop the airplane, most of the stopping power is provided by the wheel brakes.<sup>21</sup>

**Figure 3.** Learjet 60 with thrust reversers deployed. The dotted yellow lines show the stowed position for the doors.

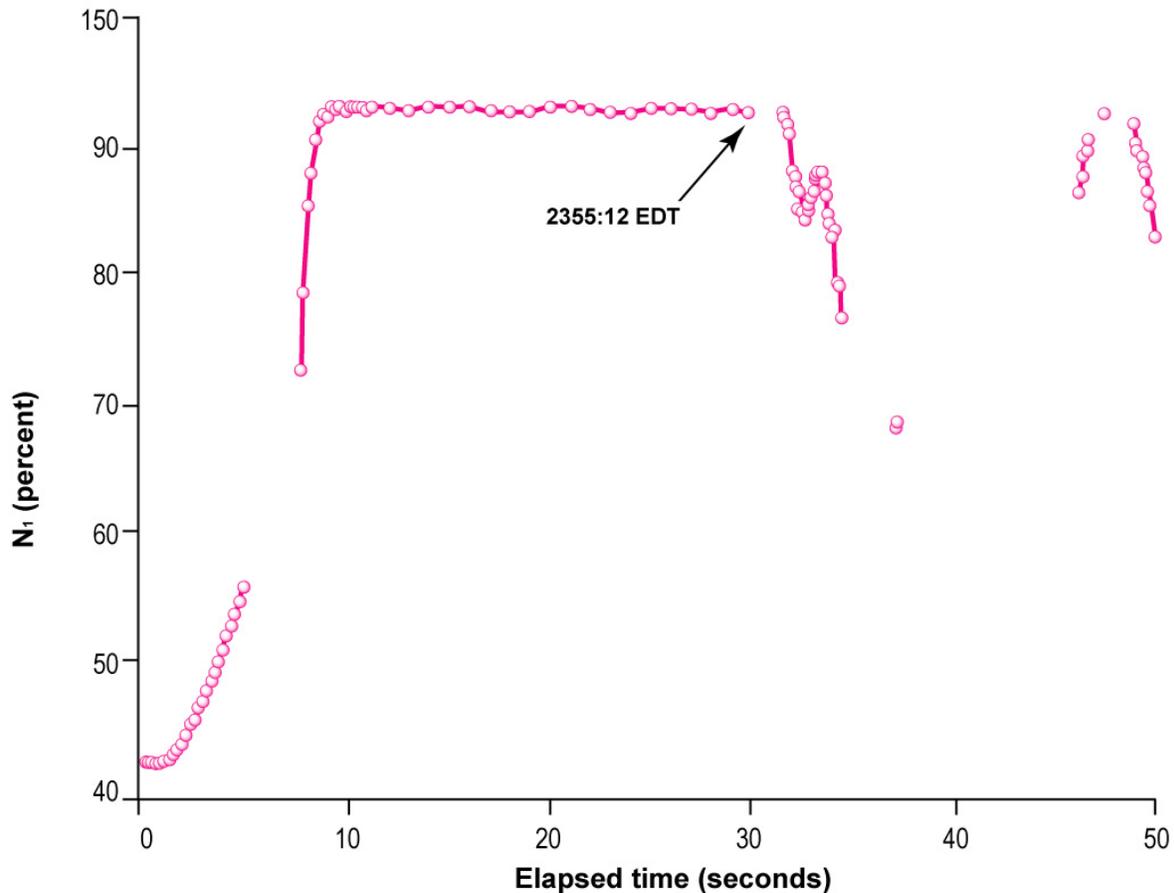
**Figure 4.** Engine N<sub>1</sub> calculated as a function of elapsed time into the takeoff roll (time of the start of the loud rumbling sound is shown).

As shown in figure 4, from 2354:42, the calculated engine N<sub>1</sub> increased to a peak within 10 seconds and then remained constant near that peak level (about 93 percent) for the next 20 seconds until 2355:12, when a distinct noise burst (corresponding with the beginning of a loud rumbling sound) was recorded. After the noise burst, from 2355:14 to 2355:16, there was noticeable wavering of engine N<sub>1</sub>; during this 2-second period, N<sub>1</sub> decreased from about 93 percent to about 84 percent and then increased back up to about 88 percent before finally decreasing below about 76 percent, at which point engine noises became only intermittently discernible. At 2355:19, engine N<sub>1</sub> was about 68 percent. In the final 4 seconds of analyzed audio (beginning at 2355:28), discernible engine noises corresponded with an N<sub>1</sub> rising through about 86 percent to about 93 percent before decreasing again to about 83 percent.

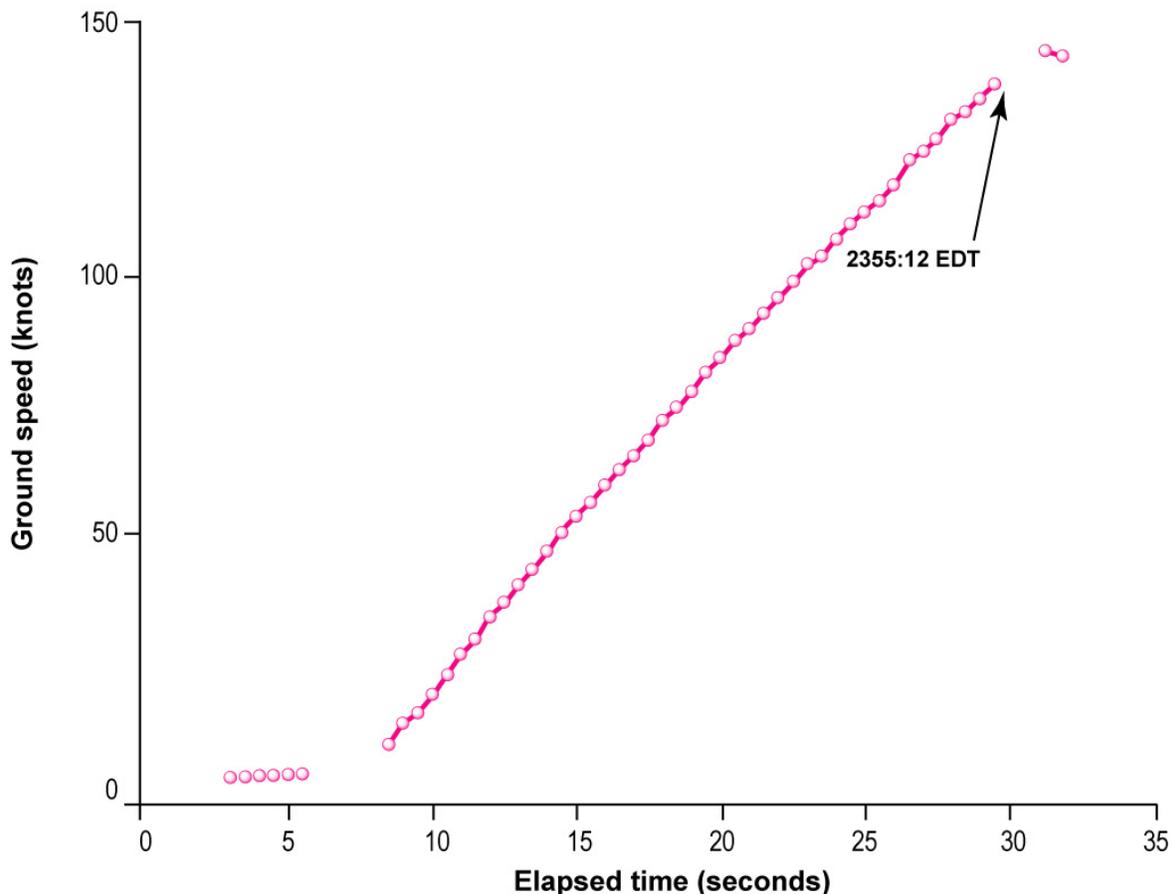
**Figure 5.** Airplane ground speed calculated as a function of elapsed time into the takeoff roll (time of the start of the loud rumbling sound is shown).

As shown in figure 5, the airplane's ground speed increased from about 5 kts about 8 seconds into the recording (at 2454:50) to about 138 kts at the time that the rumbling sound began at 2355:12. The sound spectrum analysis of airplane ground speed ends a few seconds later; tire-rolling sounds beyond that time were not clearly discernible. The analysis indicated a peak ground speed of about 144 kts.
