Aircraft Accident Report
Crash During Takeoff of Carson Helicopters, Inc.
Firefighting Helicopter Under Contract to the
U.S. Forest Service
Sikorsky S-61N, N612AZ
Near Weaverville, California
August 5, 2008

NTSB/AAR-10/06
PB2010-910406

Crash During Takeoff of Carson Helicopters, Inc.,
Firefighting Helicopter Under Contract to
the U.S. Forest Service
Sikorsky S-61N, N612AZ
Near Weaverville, California
August 5, 2008

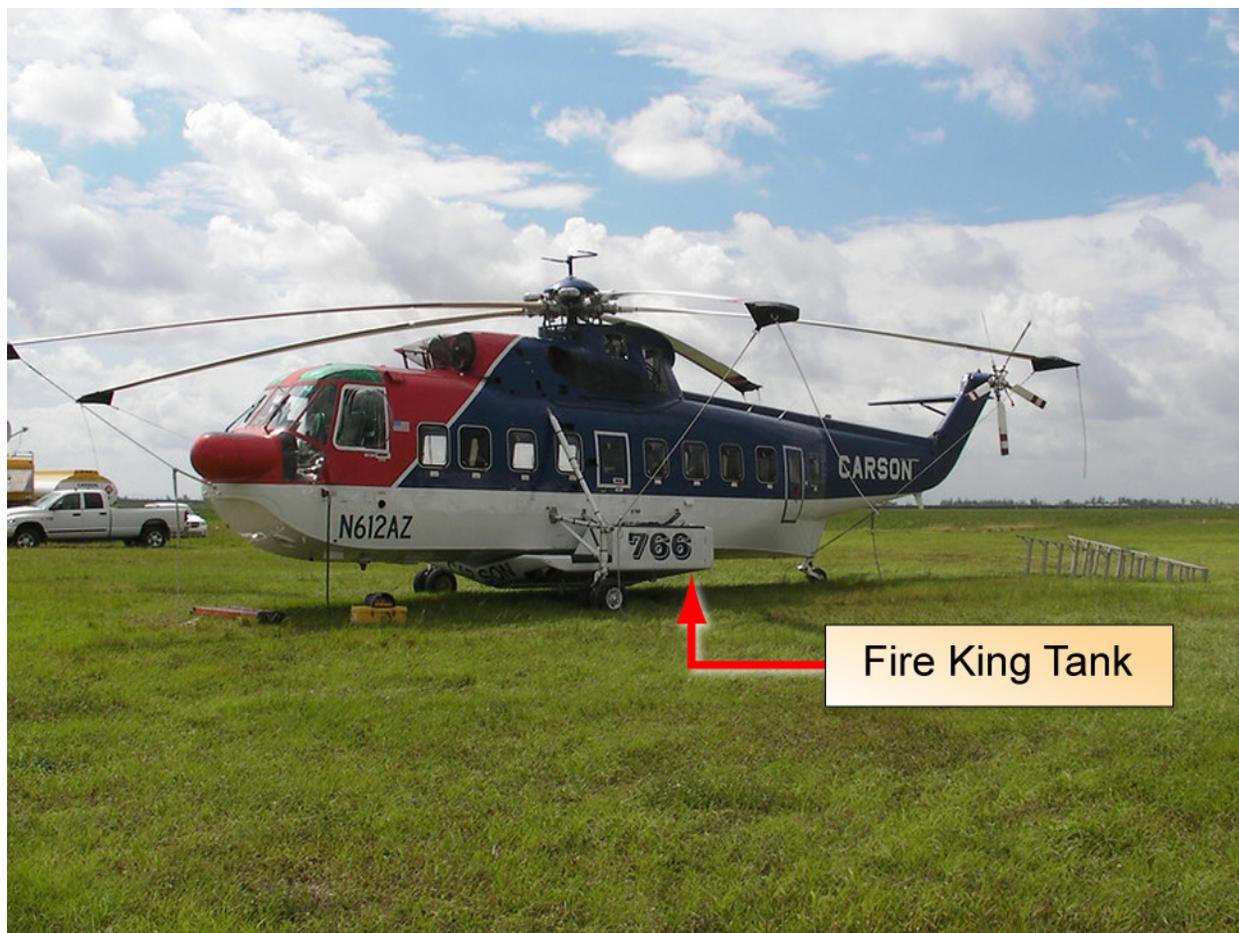
Figure 3. Photograph of accident helicopter.

The Sikorsky S-61N helicopter is a transport-category, dual-engine helicopter that requires two pilots by type certification.²² The accident helicopter was manufactured in 1965 and was originally equipped with metal main rotor blades, which were replaced in 2007 with composite main rotor blades manufactured by CHI. As shown in figure 3, the helicopter was equipped with a Fire King 900-gallon aerial liquid dispensing tank.²³

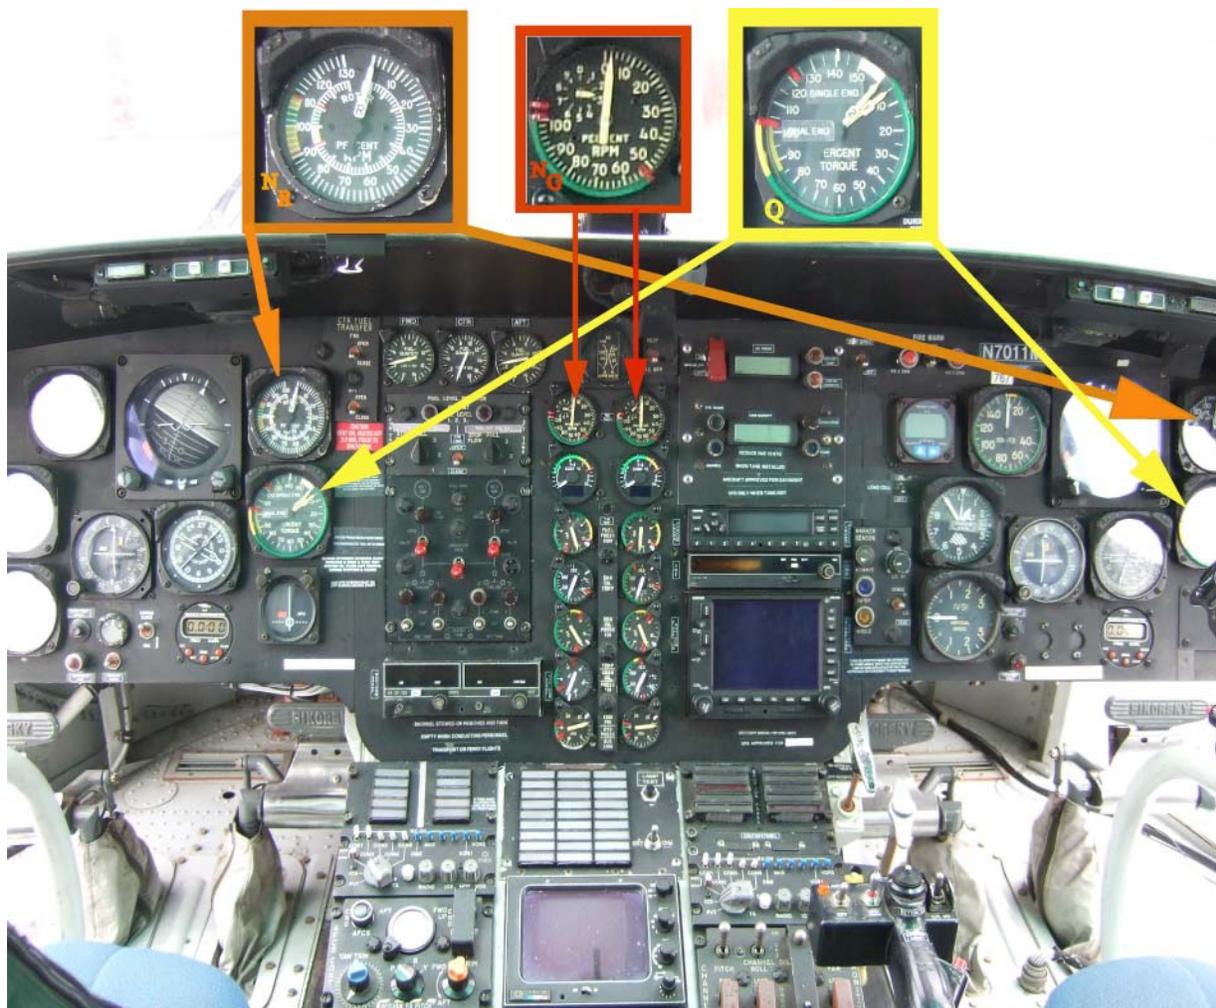
Figure 4. Photograph of exemplar instrument panel, tachometer, N_G gauge, and torque gauge. The tachometer, N_G gauge, and torque gauge are labeled N_R , N_G , and Q , respectively.

Various instruments were installed in the accident helicopter's cockpit to monitor engine performance. Dual-pointer engine torque gauges and triple-needle tachometers were installed in the pilot and copilot sections of the instrument panel. Each torque gauge (Q) had two needles labeled "1" and "2" for the No. 1 and No. 2 engine torque readings, respectively, and the markings on the gauges were incremented at 5-percent intervals. Each tachometer had three needles labeled "1," "2," and "R" for the No. 1 and No. 2 engine power turbine speed readings and the N_R in percent, respectively, and the markings on the gauges were incremented at 2-percent intervals (see figure 4). Additionally, the center section of the instrument panel housed two N_G gauges and two power turbine inlet temperature (T_5) indicators, one each for the No. 1 and No. 2 engines. The N_G gauges were marked with red lines at 100 percent and 102 percent for the 5-minute (takeoff) power limit and the 2.5-minute power limit, respectively.

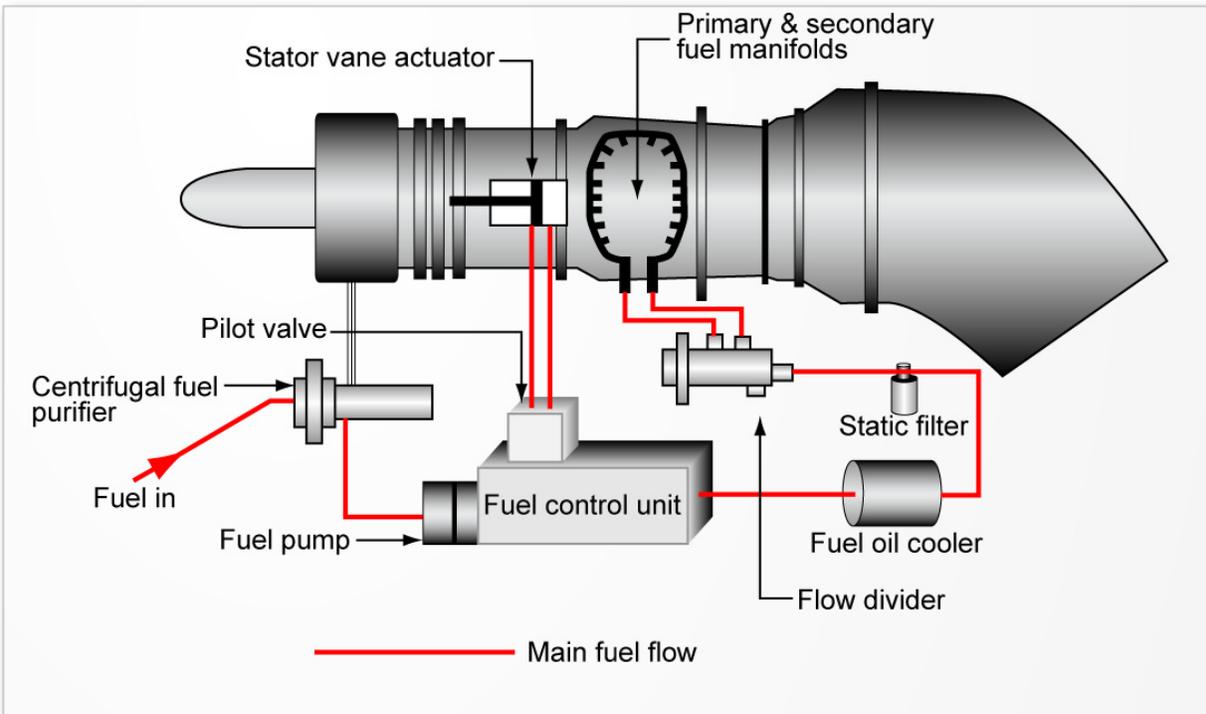
Figure 5. Diagram of the GE CT58-140 engine fuel system.

During engine operation, pressurized fuel from the airframe fuel system is supplied to the engine-driven centrifugal fuel purifier on each engine (see figure 5). This dynamic fuel filter purifies fuel by a centrifugal action rotating filter.³⁰ After leaving the centrifugal fuel purifier, the fuel enters the engine-driven fuel pump inlet. After the pump boosts its pressure, the fuel is supplied to the FCU and to the stator vane actuator (SVA). Fuel entering the FCU is routed through a screen-type filter assembly referred to as the main filter group. Metered fuel exits the FCU and is passed through the oil cooler, static filter,³¹ and flow divider en route to the combustion chamber.

The centrifugal fuel purifiers installed on the helicopter's engines were both installed at an aircraft total time of 35,161.9 hours, or about 238 hours before the accident. According to the CHSI maintenance program, the centrifugal fuel purifiers were inspected and cleaned every 150 flight hours (Phase 2 inspection). The last Phase 2 inspection was accomplished on June 30, 2008, at an aircraft total time of 35,328.7 hours, or about 71 flight hours before the accident.

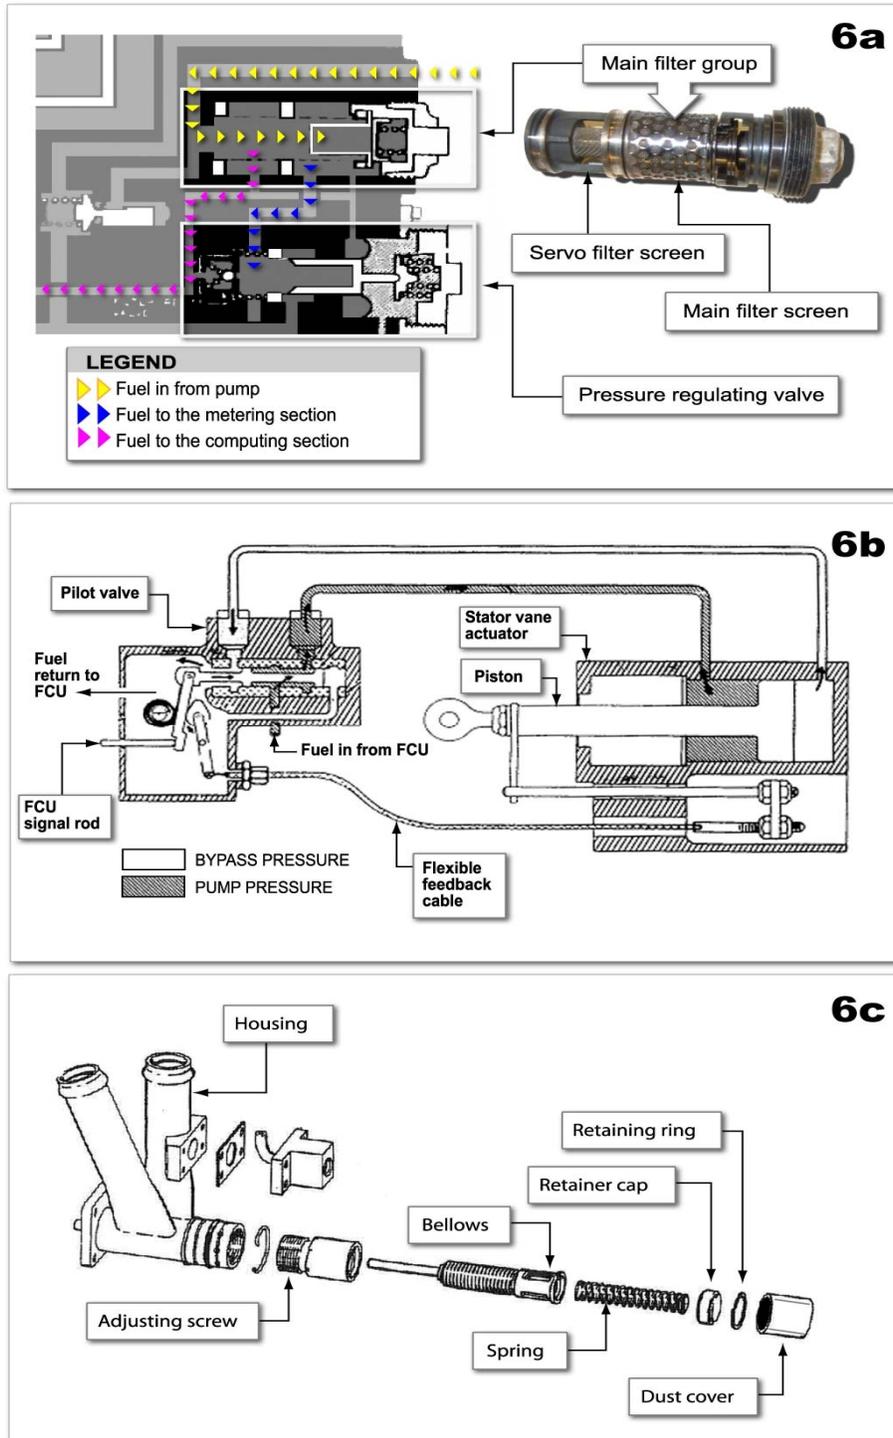
Figure 6. Engine component diagrams: a) FCU main filter group and PRV, b) stator vane actuating system, and c) FCU T₂ bellows group.

The JFC26 FCU is a device designed to meter the fuel flowing to the engine to maintain a constant power turbine speed and, thus, a constant N_R . The FCU has a fuel metering section and a computing section. The metering section controls the rate of fuel flow to the engine's combustion chamber based on information it receives from the computing section. Fuel entering the FCU is routed into the main filter group (see Figure 6a), which is a two-section filter consisting of a cylindrical cast metal housing, a spring-loaded bypass valve, and two 40-micron (about 0.0016-inch) screens (the main screen and the servo screen). Fuel enters the center of the cylindrical housing and flows out along two parallel paths: through the main screen to the metering section and through the servo screen to the computing section. A spring-loaded bypass valve is provided in case the openings in the main screen become blocked with foreign material. If the bypass valve opens, unfiltered fuel is ported to the metering section. The opening of the bypass valve does not result in activation of a cockpit warning light or other indication to the

The stator vane actuating system comprises an SVA, a pilot valve assembly, a feedback cable, a signal actuating mechanism in the FCU, and multiple actuating levers (see figure 6b). The pilot valve receives engine speed commands via movement of the FCU signal actuating mechanism, which results in movement of the pilot valve piston. Depending on the direction of piston motion, the pilot valve ports high-pressure fuel to extend or retract the SVA, which results in corresponding movement of the actuating levers and repositioning of the feedback cable. Movement of the feedback cable results in the pilot valve's piston returning to its null position, shutting off the flow of fuel to the SVA when the desired position is reached.

The T_2 sensing system consists of the T_2 servo and the T_2 bellows group. The T_2 bellows group includes the following major components: bellows, bellows housing, override spring, position adjusting screw,³⁵ spring retainer cap, retaining ring, and dust cover (see figure 6c). The position adjusting screw is manufactured from aluminum tube stock. One end of the screw contains an external thread that attaches to the mating internal threads on the T_2 sensor housing, and the other end contains an internal circumferential groove. The screw is installed in the housing, and the bellows is inserted into the end of the position adjusting screw that contains the groove. The spring and spring retainer cap are then inserted, and the spring is compressed until the retaining ring can be inserted into the groove. In the installed condition, the retaining ring presses against the internal groove in the position adjusting screw and prevents the bellows, spring, and spring retainer cap from sliding out of the housing. The T_2 bellows is protected from the environment by the position adjusting cover, which is a dust cover manufactured from plastic or aluminum.

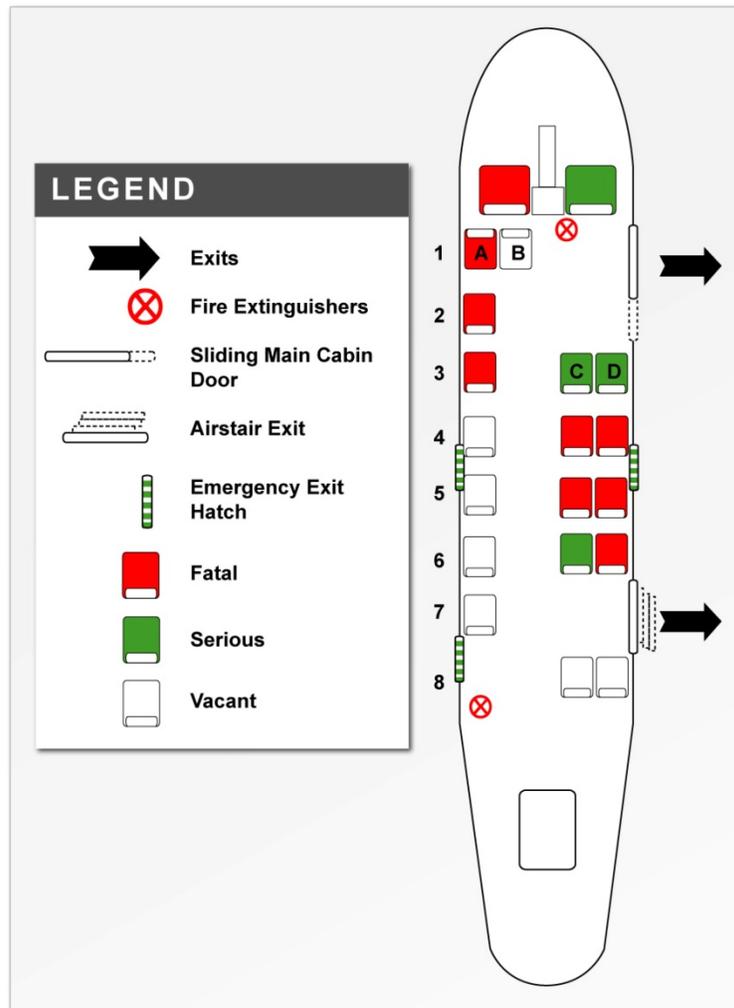
Figure 12. Cabin diagram for N612AZ.

The helicopter was equipped with 2 pilot seats in the cockpit and 18 passenger seats in the cabin. As shown in figure 12, five rows of forward-facing double seats with non-locking folding seatbacks were on the right side of the cabin, and six rows of forward-facing single seats with non-locking folding seatbacks were on the left side of the cabin. A double seat faced aft on the forward left side of the cabin. The aft-facing double seat and the first forward-facing single seat on the left side of the cabin were designated for helicopter crewmembers. An aisle separated the passenger seats on either side of the cabin. For reference, NTSB investigators numbered the cabin seats from front to back by row (1 to 8) and from left to right by letter (A to D).
