Collision with Terrain  
Promech Air, Inc.  
de Havilland DHC-3, N270PA  
Ketchikan, Alaska  
June 25, 2015

NTSB/AAR-17/02  
PB2017-102178

# Aircraft Accident Report

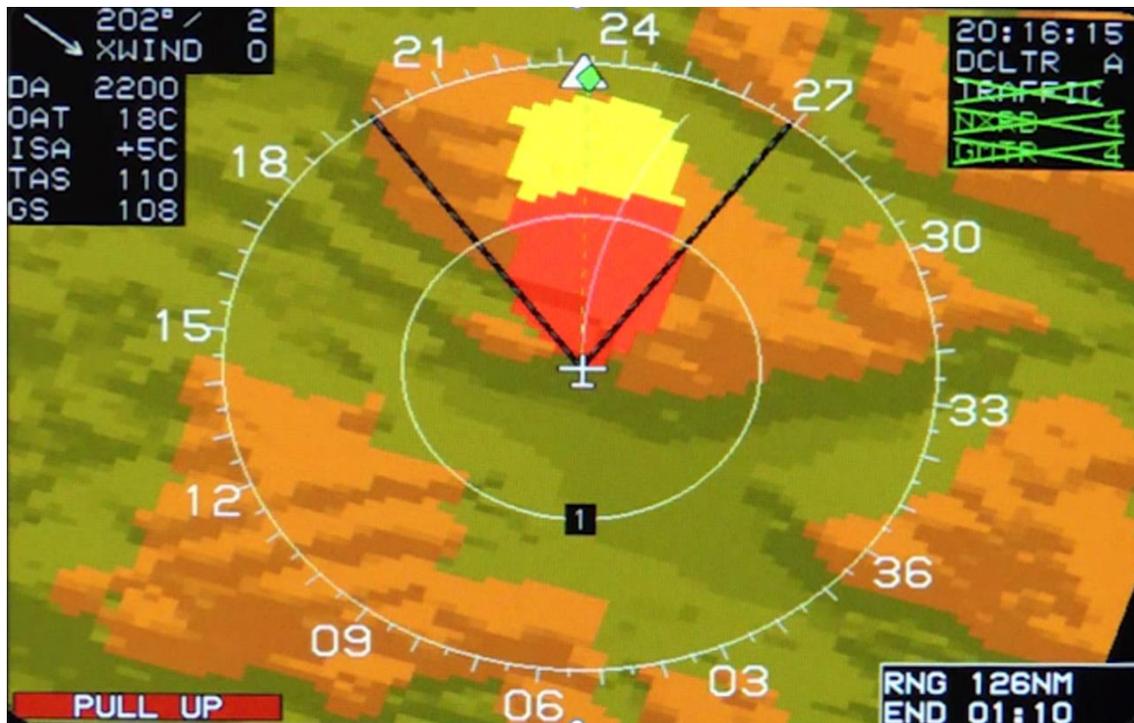
The Chelton EFIS in the accident airplane included a terrain awareness and warning system (TAWS), software version 6.0B, that provided color-coded cautions and warnings of terrain on the moving map on the MFD and a forward-looking "virtual" model of the outside world (a replica of a day VFR view out the front window in proper scale and perspective according to the aircraft's position, altitude, and heading) on the PFD. The system's integrated caution/warning/advisory system (CWA) also provided auditory and flag alerting functions. The CWA alerts for the TAWS features included an auditory annunciation (such as "pull up") accompanied by a red flag and text (such as "PULL UP") on the display. (See figure 6.)

**Figure 6.** An example of how the Chelton EFIS software version 6.0B depicts TAWS cautions (yellow) and warnings (red) on the MFD.

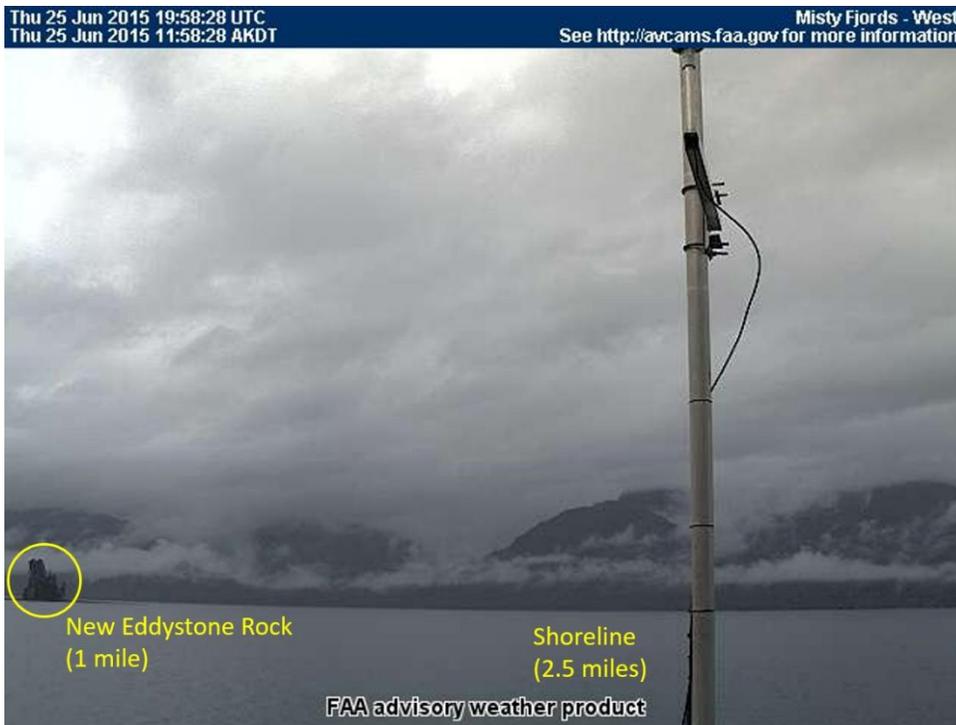
The following three figures show annotated images from the west-facing Misty Fjords camera. Figure 9 is an exemplar image from a clear day with measured distances to identifiable landmarks labeled for reference. The other two images were captured on the day of the accident; figure 10 was captured at 1158 (a few minutes before the airplane departed), and figure 11 was captured about 3 minutes before the accident. The images show that the higher ridge elevations were obscured by clouds with a layer of stratiform clouds below the peaks. Visibility also decreased during the period with rain.

**Figure 10.** Image from west-facing (259°) Misty Fjords camera at 1158, a few minutes before the airplane’s departure from Rudyerd Bay.

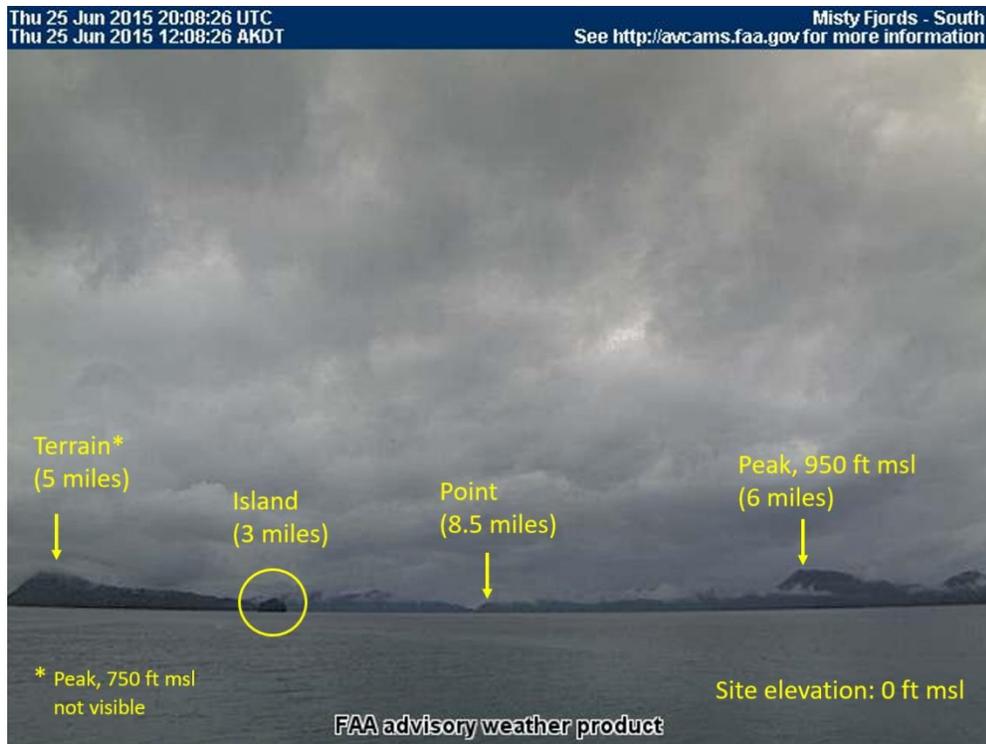
An FAA weather camera in Ketchikan facing toward the accident location also depicted the higher terrain obscured by clouds with visibility restricted less than 1 mile during the period. Figure 12 is an image captured by the south-facing Misty Fjords camera at 1208. This camera view showed that conditions in Behm Canal, which is part of the long route over the water, included good visibility.

**Figure 12.** Image from south-facing (196°) Misty Fjords camera at 1208, showing conditions on the long route over the water.

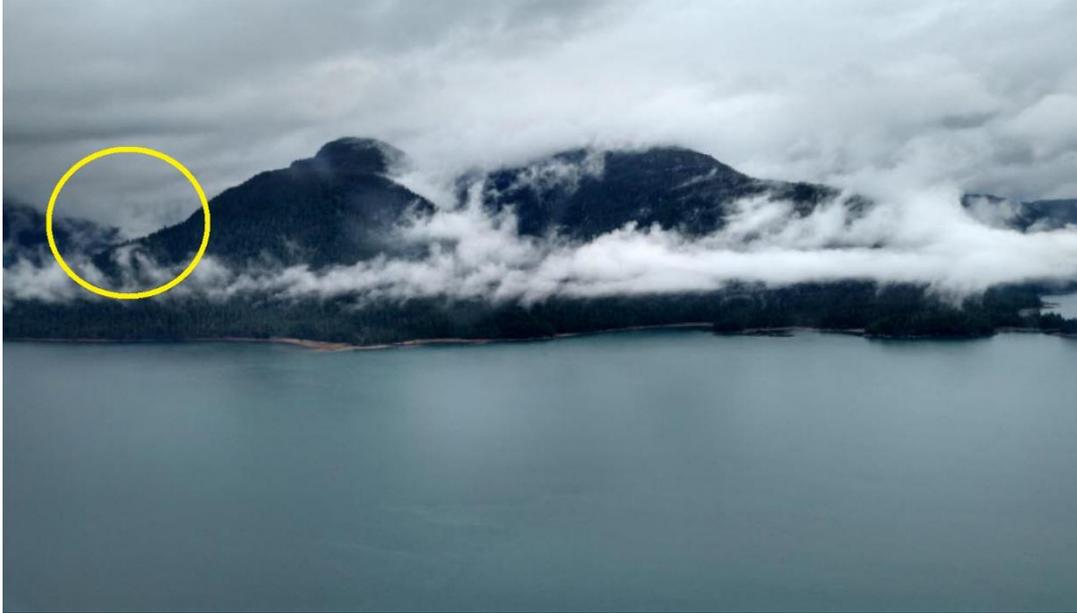
**Figure 13.** Photograph of entrance to Ella Narrows (circled) taken by a passenger on board the first Promech flight in the accident tour group to depart Rudyerd Bay.

The pilot of this first Promech flight stated that, when his flight reached Ella Lake, a cloud ceiling was above the lake about 1,600 to 1,700 ft msl, with a slightly lower ceiling (about 1,400 to 1,600 ft msl) over the south end of the lake. He reported that there were no “jagged edges” or “hanger” clouds below the ceiling. He recalled encountering misty rain and flying near the clouds but said his visibility was never obscured and recalled that he could see Thorne Arm (located about 5 nm from the south end of Ella Lake) while the flight was over the lake.

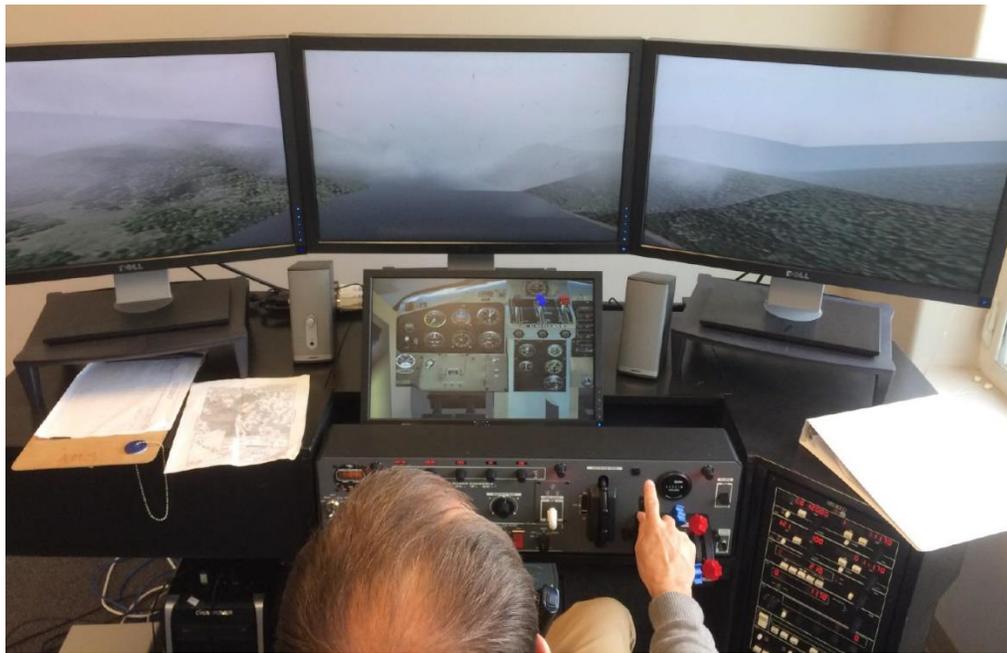
The cue-based training module that the accident pilot completed in the BATD included a scenario that required him to escape an inadvertent encounter with IMC by reversing course. NTSB investigators observed a demonstration of the training module, which involved an overwater flight with progressively decreasing cloud ceiling and visibility. Investigators noted that both the ceiling height and forward visibility were uniform and transitioned abruptly when adjusted by the instructor. Also, the terrain features and ground texture were not photorealistic.

**Figure 15.** Medallion Foundation BATD and CFIT-avoidance training scenario.
