Midair Collision over George Inlet
de Havilland DHC-2, N952DB,
and de Havilland DHC-3, N959PA
Ketchikan, Alaska
May 13, 2019

NTSB/AAR-21/04
PB2021-100915

Aircraft Accident Report

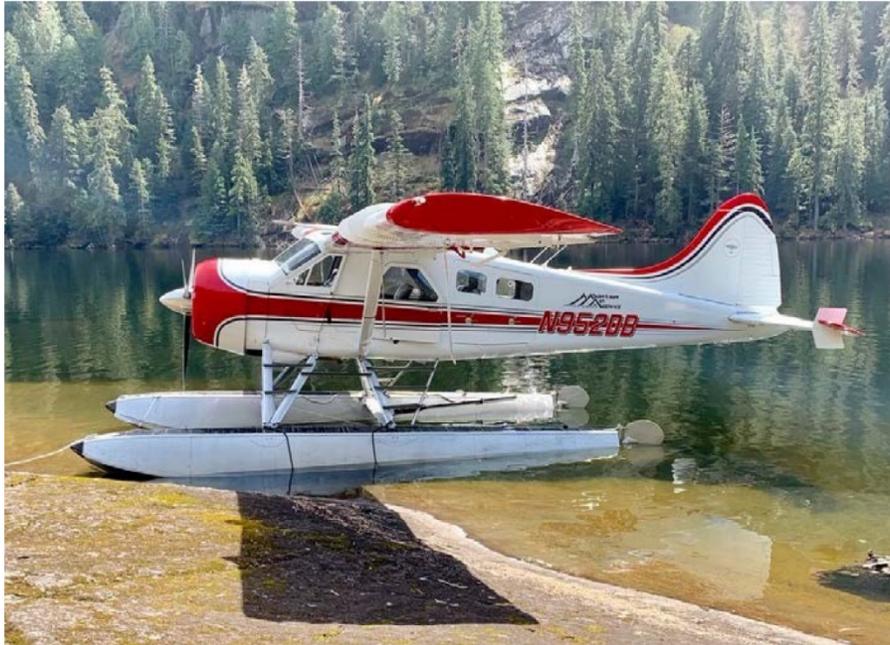
Figure 3. Photo of accident DHC-2 airplane (N952DB).

The DHC-2 is a single-engine, propeller-driven, high-wing, short takeoff and landing (STOL) airplane (see figure 3). The accident airplane (N952DB) was powered by a single reciprocating, radial Pratt & Whitney R-985 engine and was configured with Edo 58-4580 floats. It was equipped with position lights, landing lights, wingtip strobe lights, and an anti-collision beacon, as well as one pilot seat and six passenger seats.

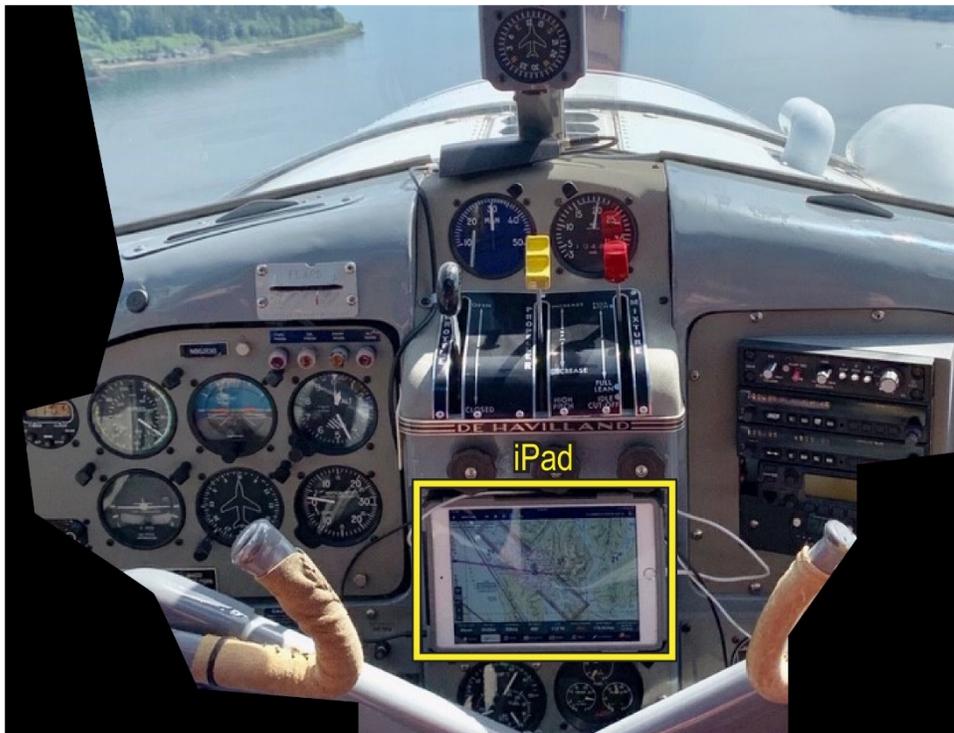
Figure 4. Photo of DHC-2 cockpit

Avionics installed on the DHC-2 included ADS-B Out and In.¹⁵ The ADS-B system was comprised of FreeFlight Systems components: an FDL-978-XVR transceiver (commonly referred to as a RANGR 978 transceiver), a TC-978 controller, and a Wi-Fi controller. The RANGR 978 transceiver was used to send and receive ADS-B position reports.¹⁶ The TC-978 controller provided the interface between the pilot and the RANGR 978 transceiver and controlled the output (and input) of ADS-B messages. The Wi-Fi controller provided a Wi-Fi hotspot that enabled compatible portable devices to connect to and receive the traffic information (ADS-B In data) from the RANGR 978 transceiver. An iPad, which was connected to the Wi-Fi controller (through a Bluetooth connection) and mounted in the center of the instrument panel, had a ForeFlight mobile application that could display the traffic information (see figure 4).

At the time of the accident, the ForeFlight application generated a visual and aural traffic alert if the “Traffic Alerts” setting is enabled when a target approaches within 1.8 nm horizontally and $\pm 1,200$ ft vertically of the “ownship.”¹⁷ The ForeFlight application depicted all traffic targets that do not have a traffic alert as filled cyan (blue) arrowheads, and those that are in “alert status” are depicted as filled yellow arrowheads. The ForeFlight visual traffic alert includes a traffic pop-up that contains the target’s clock position, distance, and relative altitude from the ownship (see figure 5). The aural alert contains the same information and can be transmitted to the pilot’s headset via Bluetooth if the headset is so equipped, or through the tablet speaker.¹⁸ If the ForeFlight “Hide Distant Traffic” setting is enabled, traffic more than 15 nm from or more than 3,500 ft above or below the ownship will not be displayed.

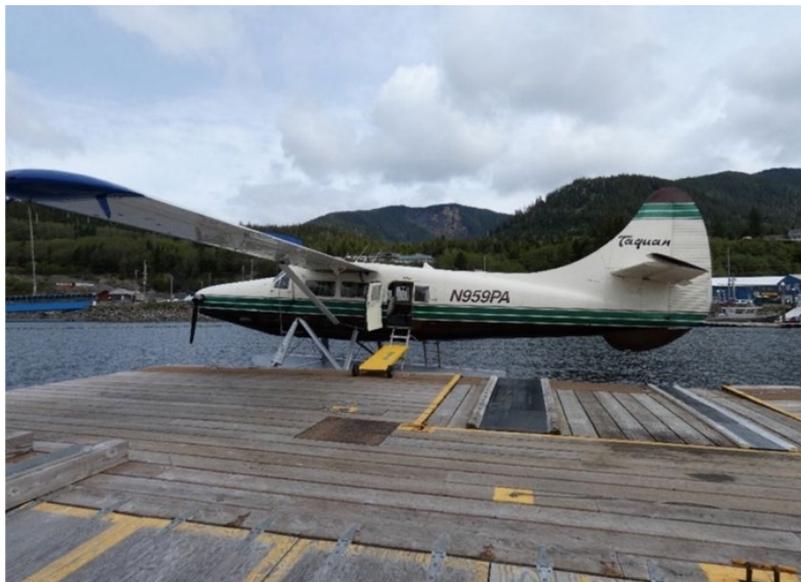
Figure 6. Photo of accident DHC-3 airplane (N959PA).

The DHC-3 is a single-engine, propeller-driven, high-wing, STOL airplane with a cruciform tail (see figure 6). The accident airplane (N959PA) was powered by a single turboprop Pratt & Whitney PT6A engine and was configured with Edo 7490 floats. It was equipped with position lights, landing lights, and an anti-collision beacon, as well as 1 pilot seat and 10 passenger seats.

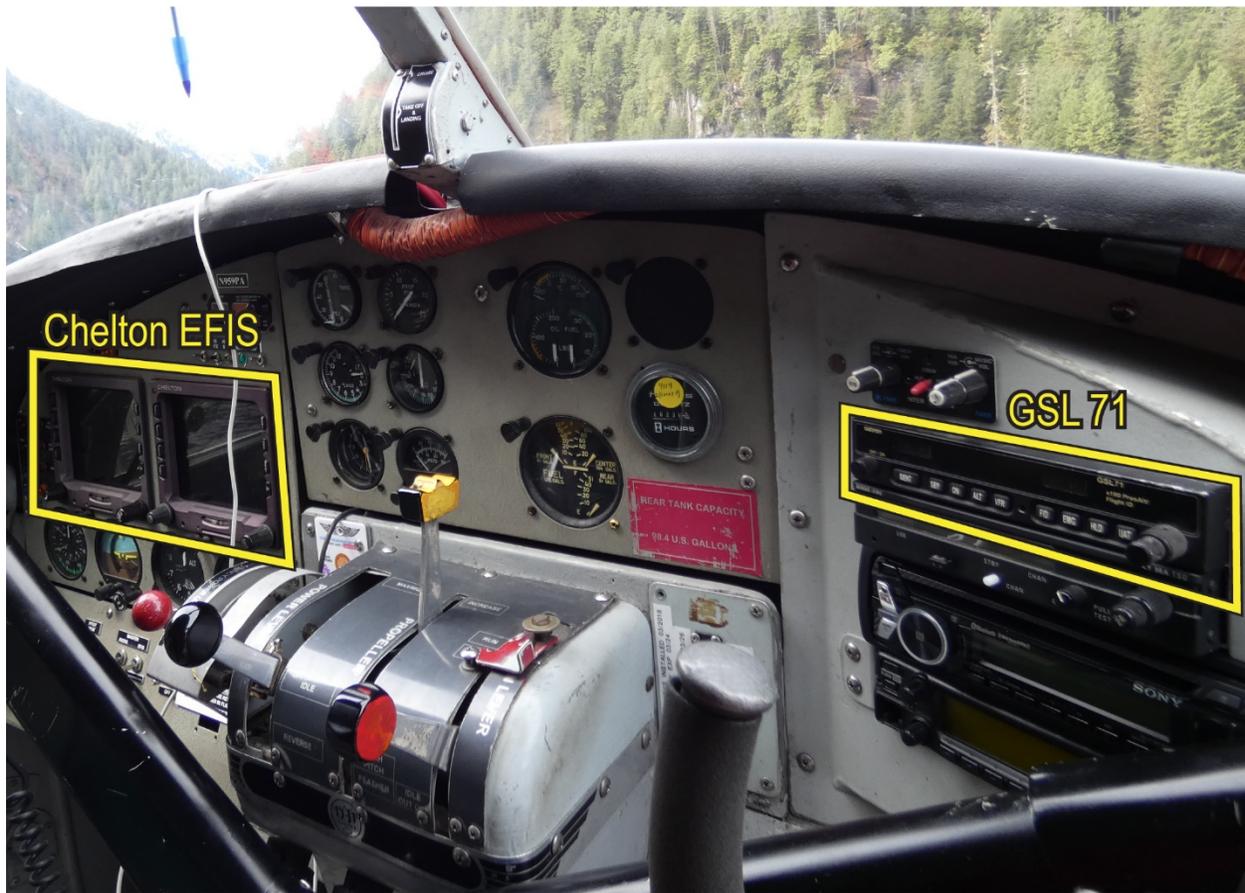
Figure 8. Photo of the DHC-3 cockpit.

- **An inadequate checklist used in Taquan Air's operation.** The DHC-3 was not transmitting pressure altitude data on the day of the accident because its Garmin GSL 71 control head selector knob was in the OFF position; this information was necessary for the DHC-2 pilot's traffic alerting system to produce visual and aural alerts. The checklist found in the DHC-3 (which listed the name of a different operator) did not contain a checklist item to ensure the GSL 71 control head selector knob was in the ON position and in the ALT mode before takeoff. Leaving the GSL 71 in the OFF position constituted an unacceptable hazard that could have been mitigated through a procedural safeguard, such as a checklist item.

The airplane had two Chelton FlightLogic electronic flight instrument system (EFIS) integrated display units that were configured to operate as a primary flight display (PFD) or a multi-function display (MFD).²¹ The PFD showed aircraft parameter data, including altitude, airspeed, attitude, vertical speed, and heading. The MFD showed navigational information using a moving map. Additionally, the DHC-3 Chelton EFIS units could display traffic information received by the RANGR 978 transceiver. Figure 8 shows the location of the Chelton EFIS units and the GSL 71 in the cockpit.

The Chelton EFIS display could generate aural and visual alerts for particular traffic targets if the traffic messages associated with those targets were received from a device that formats and provides traffic messages in an “alert status.” The RANGR 978 transceiver was not designed to send “alert status” messages; therefore, the DHC-3 did not have the capability to generate aural or visual traffic alerts.²²

- A procedural safeguard, such as a checklist item that addresses the position of the Garmin GSL 71 control head selector knob, can mitigate the hazard of the selector knob being inadvertently and indefinitely placed in the OFF position.
