AAR-21-05

Runway Overrun During Landing

Peninsula Aviation Services Inc. d.b.a. PenAir flight 3296

Saab 2000, N686PA

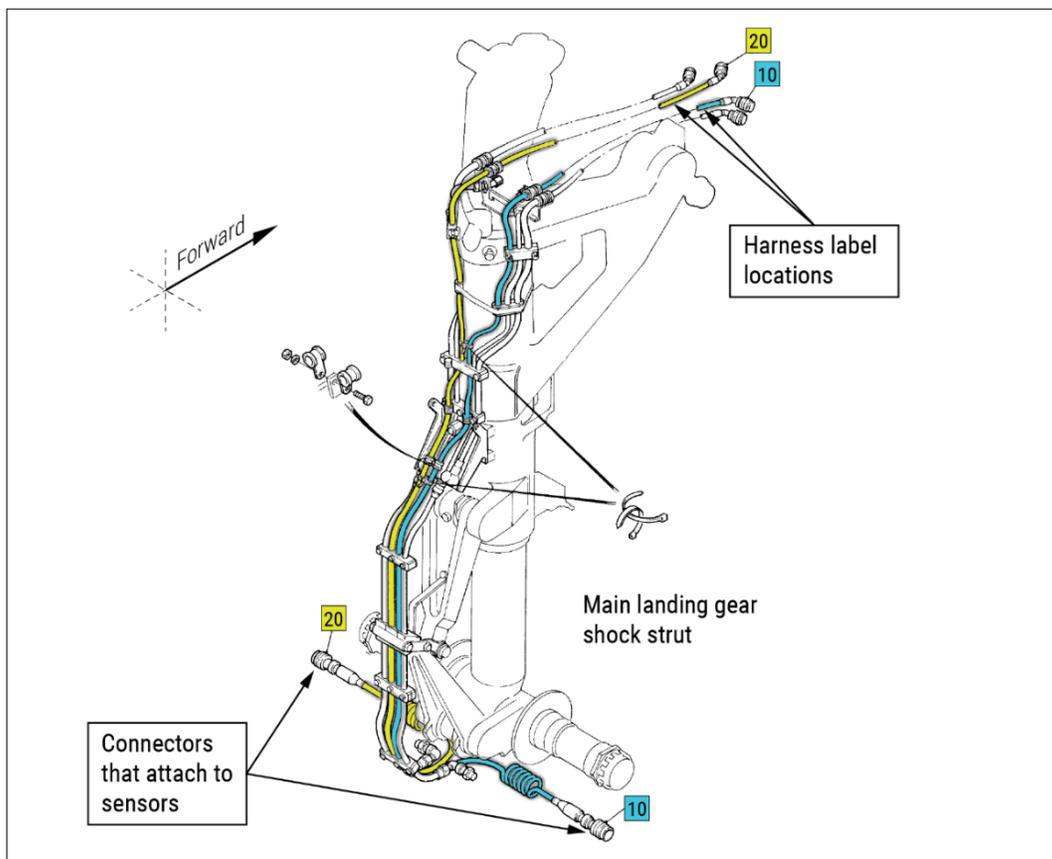
Figure 7. Routing for wheel speed transducer wire harnesses (Source: APPH).

Note: The wheel speed transducer wire harness with illustrated parts list item No. 10 indicates right wheel routing (the left MLG inboard wheel and the right MLG outboard wheel), and item No. 20 indicates left wheel routing (the left MLG outboard wheel and the right MLG inboard wheel). Wheel speed transducer wire harness item No. 10 has two labels near the upper connector (not shown); one indicates 5/6 GA-P4 (the component identifier), and the other indicates AIR134484 (the manufacturer part number). Wheel speed transducer wire harness item No. 20 also has two labels near the upper connector (not shown); one indicates 5/6 GA-P5 (the component identifier),

It is possible for the wheel speed transducer wire harnesses to be incorrectly routed at the lower portion of the MLG shock strut, but photographs of the left MLG taken on scene showed that the harness for the outboard wheel was routed on the left side of the strut and that the harness for the inboard wheel was routed on the right side of the strut, consistent with the installation instructions. The incorrect routing occurred at the top of the strut, with the wire harnesses with item Nos. 10 and 20 in figure 7 in the opposite positions.

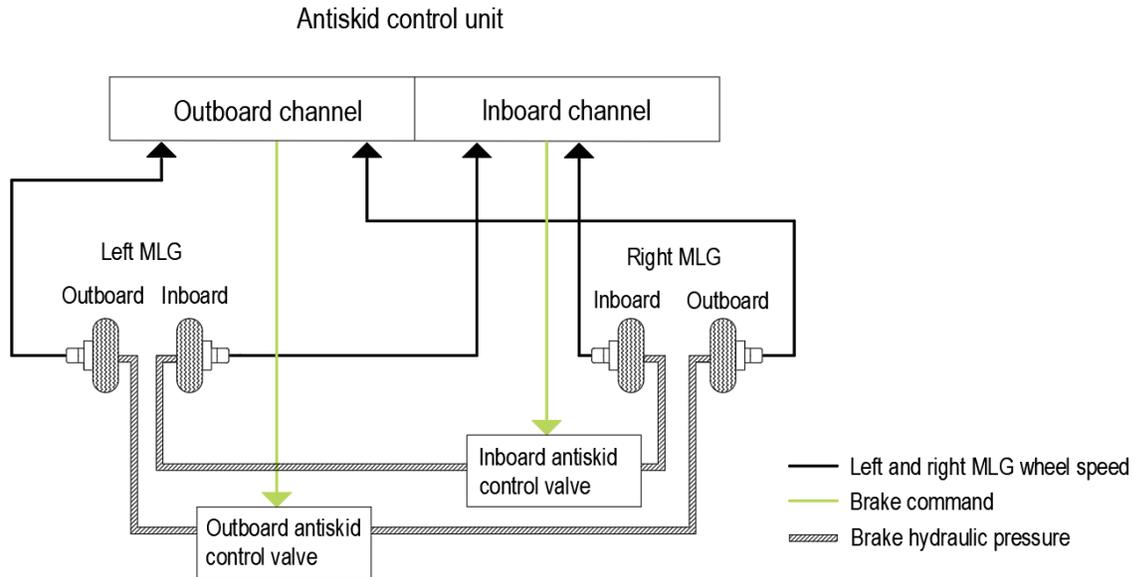
Figure 8. Wheel speed transducer wiring as designed.

Figure 8 shows the correct wiring for the left MLG wheel speed transducer. The crossed wiring of the left MLG wheel speed transducers, as described in the previous section, is shown in figure 9; the crossed wiring is shown in red.

Postaccident examination of the wire harnesses for the wheel speed transducers showed that the left MLG outboard and inboard harnesses were incorrectly routed (see figure 9) at the top of the MLG shock strut. This incorrect routing caused the left outboard wheel speed transducer to be connected to the inboard channel of the antiskid control unit and the left inboard wheel speed transducer to be connected to the unit's outboard channel. As a result, the antiskid system was incapable of relieving a skid that was sensed by either of the left MLG wheels. This cross-wiring condition was not discovered until after the accident in part because the airplane was not in revenue service between the left MLG overhaul in January 2017 and PenAir's first revenue flight in June 2019.

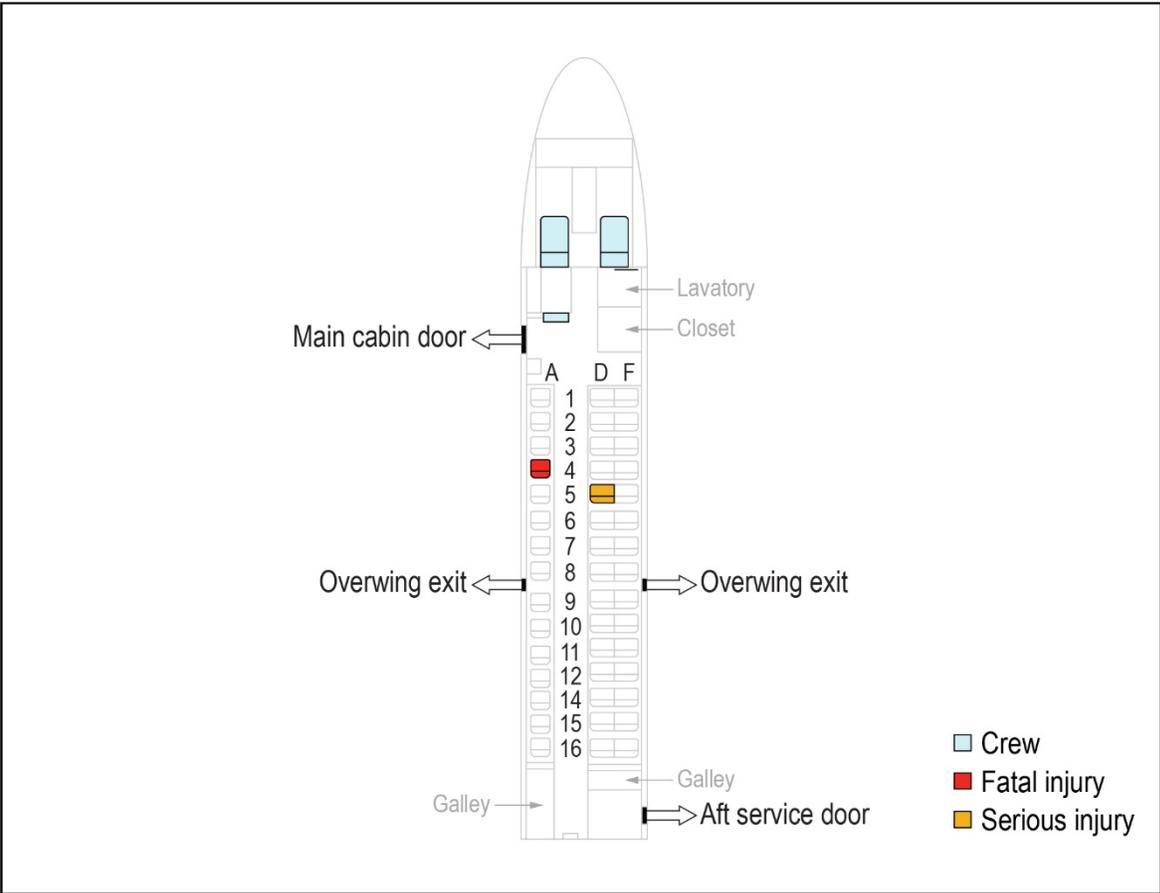
Figure 10. Airplane interior configuration and location of fatal and serious injuries.

Note: This figure does not show the seating positions of the eight passengers who received minor injuries because most of those injuries occurred during the evacuation, as discussed in section 1.9.2.

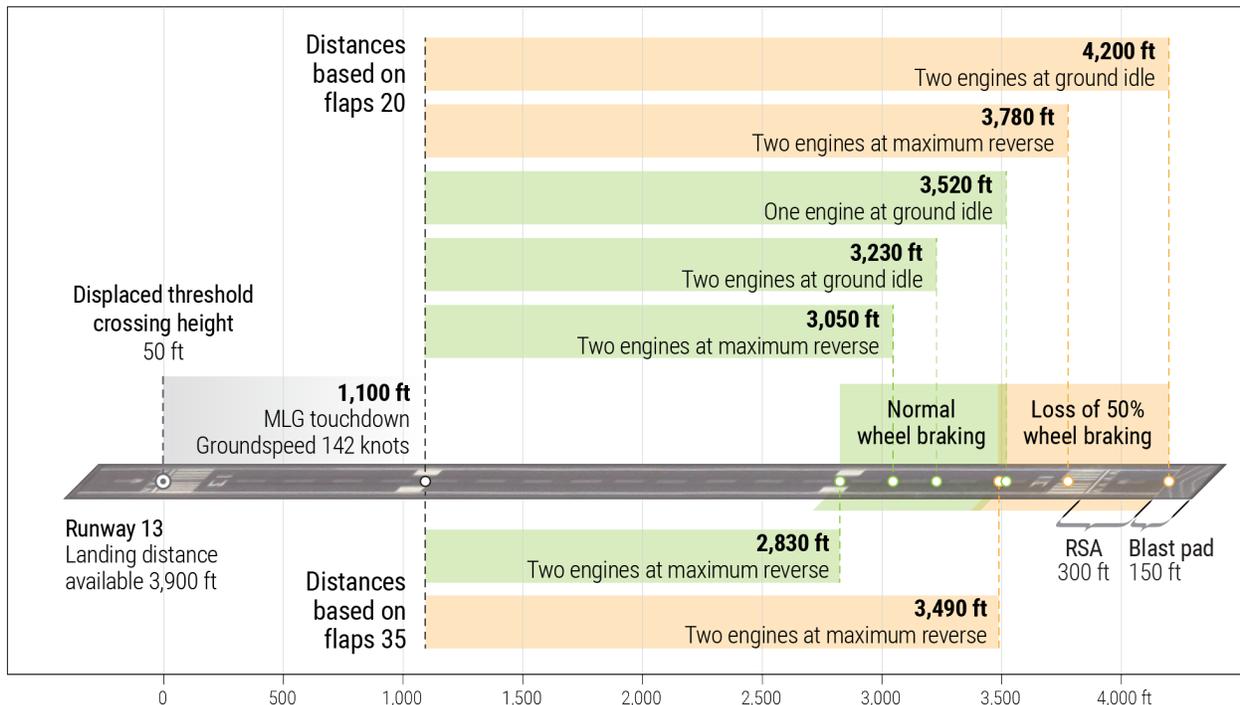
Figure 13. Aircraft performance study calculations for various landing configurations.

For the flaps 20 configuration, the calculations indicated that the accident airplane should have had adequate performance capability to stop within the landing distance available on runway 13 for all cases in which both antiskid circuits were operating and for the case in which one antiskid circuit was inoperative (no braking for two of the four wheels) and both engines were operating at maximum reverse power. Also, the airplane should have been able to stop on the paved surface near the RSA/blast pad transition point with one antiskid circuit inoperative and both engines operating at ground idle power. The landing distance required for the accident airplane to stop (based on the average deceleration it demonstrated from MLG touchdown to RSA departure) with a flap setting of 20° was 4,490 ft, which exceeded the landing distance available.
