AIRCRAFT ACCIDENT REPORT

**CHICAGO & SOUTHERN AIRLINES, INC.
Beech E18S (ATECO WESTWIND II) N51CS**

**Peoria, Illinois
October 21, 1971**

**NATIONAL TRANSPORTATION SAFETY BOARD
Washington, D. C. 20591
REPORT NUMBER: NTSB-AAR-72-15**

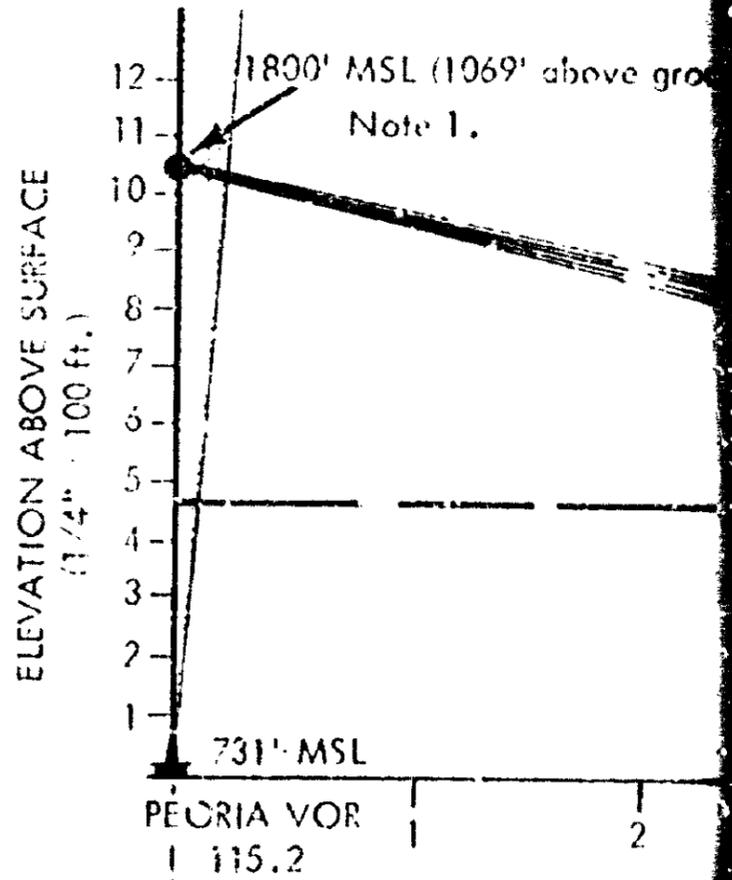
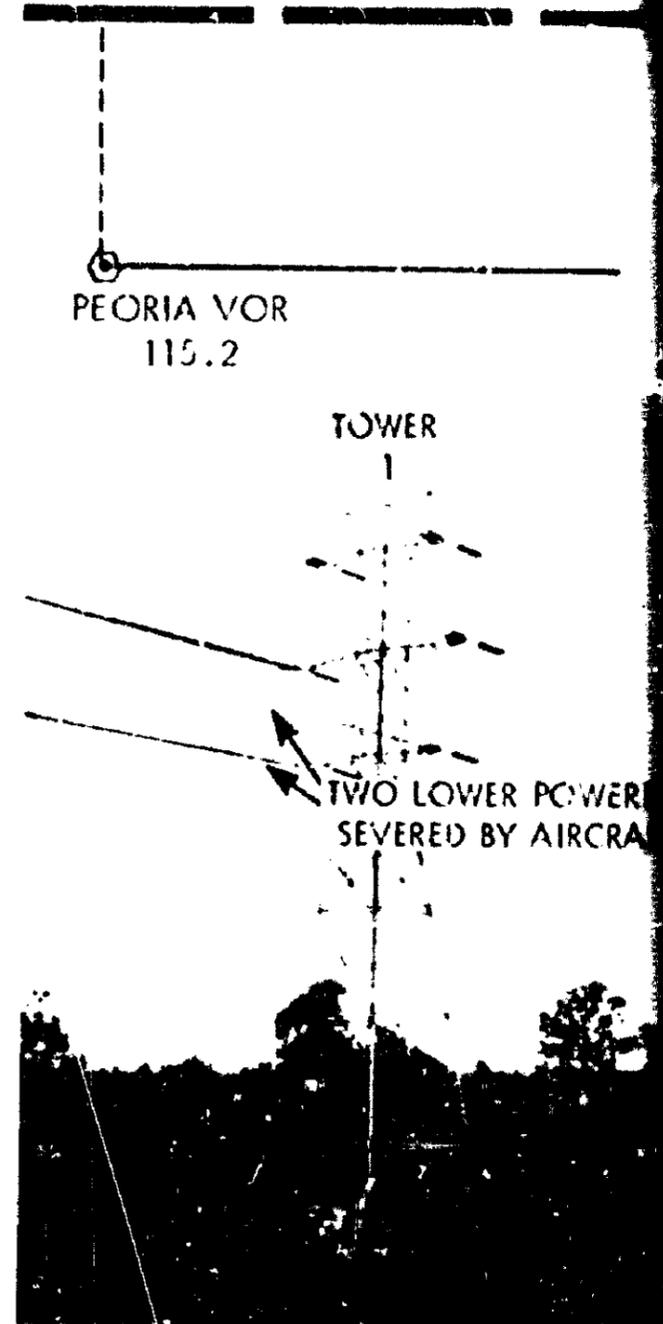
1. Descent profiles based on VOR departure at 1800' MSL, and a constant descent rate of approximately 1000 feet per minute. Variables of wind, speed fluctuations, or crew actions not considered.
 - A - at 140 mph. ground speed
 - B - at 135 mph. ground speed
 - C - at 130 mph. ground speed
 - D - at 125 mph. ground speed
 - E - at 120 mph. ground speed
2. Towers and photographs not to scale.
3. Power lines struck by aircraft accentuated for clarity.
