1. Report No. NTSB-AAR-75-8	2. Government Accession No.	3. Recipient's Catalog No.	
4. Title and Subtitle Aircraft Accident Report -- International Business Machines, Inc., Grumman G-1159, N720Q, Kline, South Carolina, June 24, 1974		5. Report Date May 14, 1975

INTERNATIONAL BUSINESS MACHINES, INC.,
GRUMMAN G-1159, N720Q,
KLINE, SOUTH CAROLINA
JUNE 24, 1974

NATIONAL TRANSPORTATION SAFETY BOARD
Washington, D. C. 20594
REPORT NUMBER: NTSB-AAR-75-8

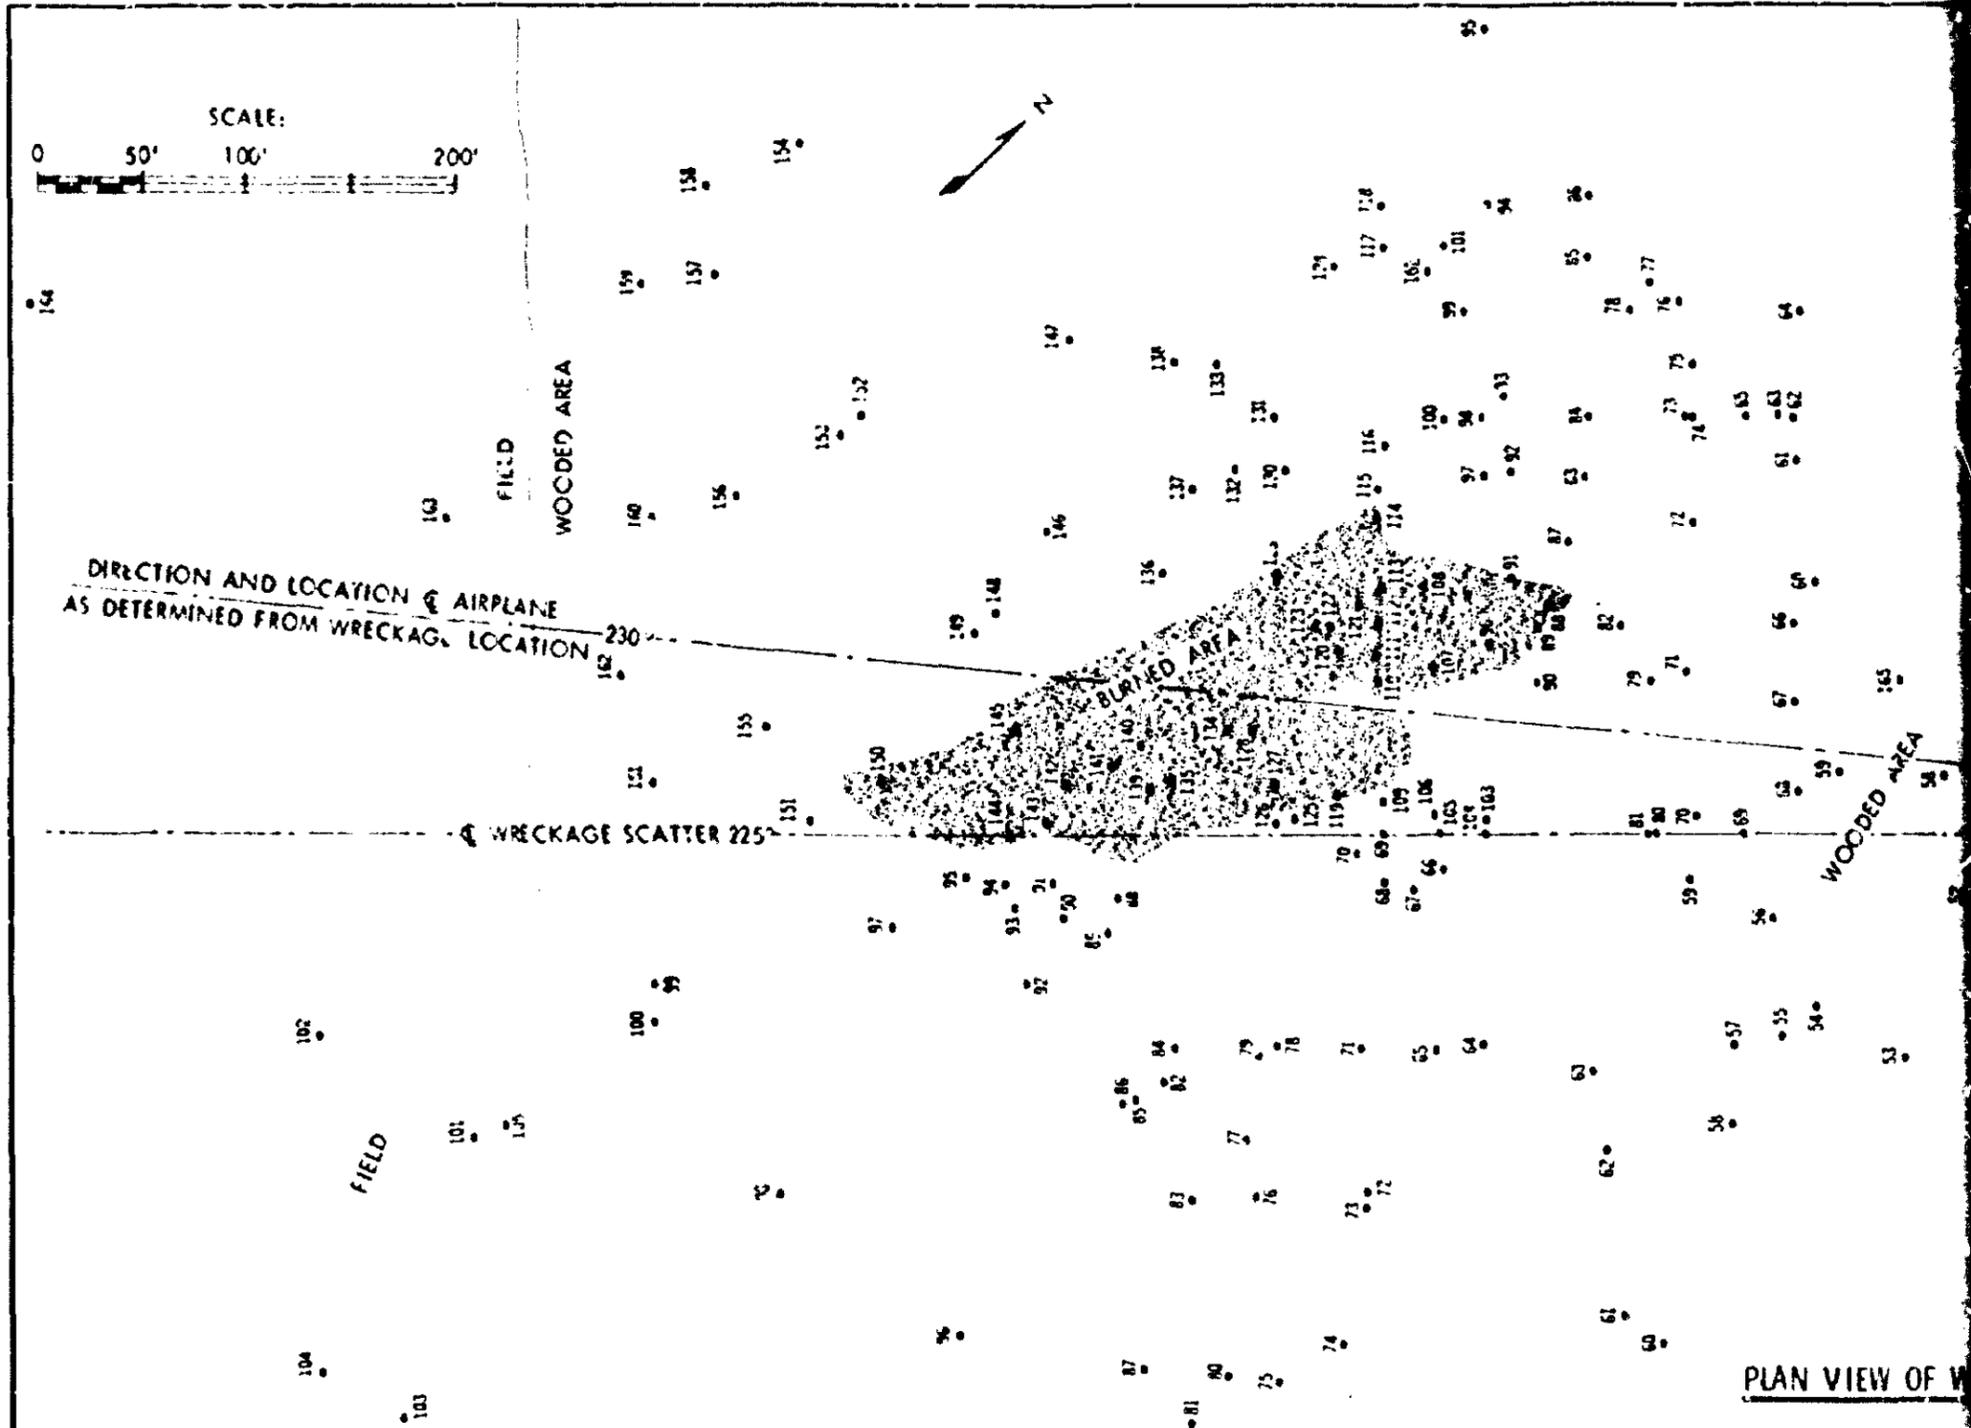
PLAN VIEW OF W

RIGHT WING
TIPS
WATER
DROPPED FROM IMPACT
CRATER
MATERIAL FROM
CRAFT CENTERLINE
INNER WING LOWER
SURFACE MATERIAL
BURNED TREES
(DETAIL A)
MATERIAL FROM LEFT WING
