Aerotransportes Entre Rios S. R. L.
Canadair CL-44-6, LV-JSY, Miami, FL,
International Airport, Sep 27, 1975

1. Report No. NTSB-AAR-76-9		2. Government Accession No.		3. Recipient's Catalog No.	
4. Title and Subtitle Aircraft Accident Report - Aerotransportes Entre Rios S.R.L. Canadair CL-44-6, LV-JSY, Miami International Airport, Miami, Florida, September 27, 1975				5. Report Date March 10, 1976

AIRCRAFT ACCIDENT REPORT

AEROTRANSPORTES ENTRE RIOS S.R.L.
CANADAIR CL-44-6, LV-JSY
MIAMI INTERNATIONAL AIRPORT
MIAMI, FLORIDA
SEPTEMBER 27, 1975

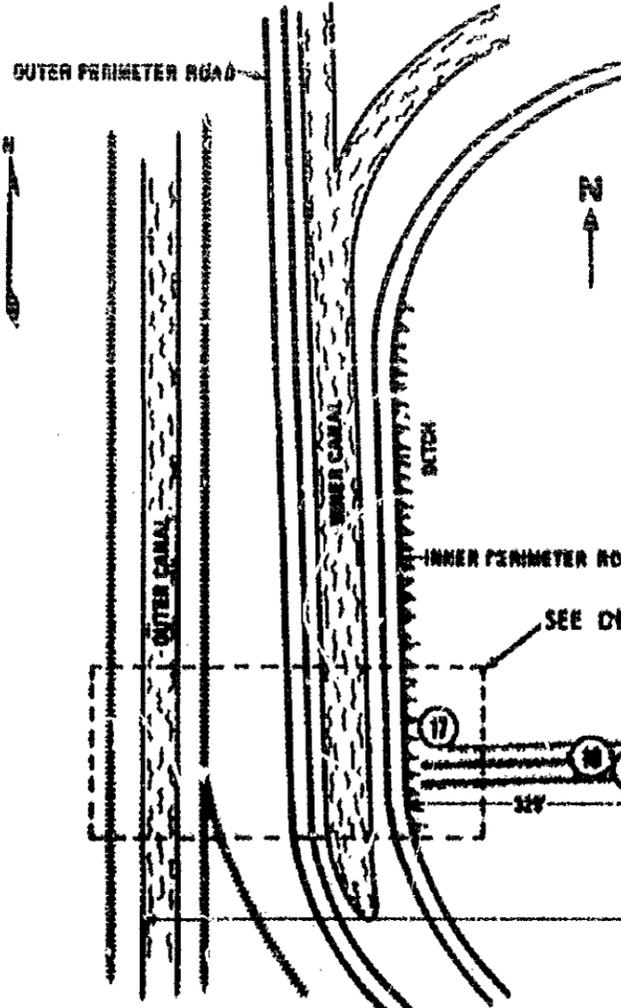
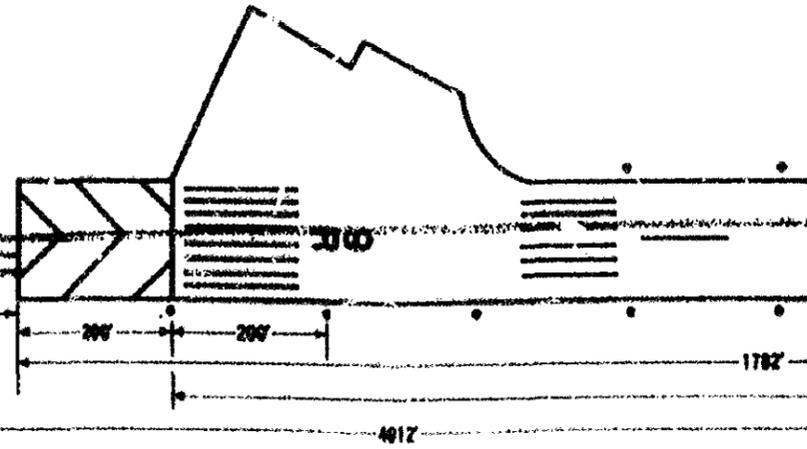
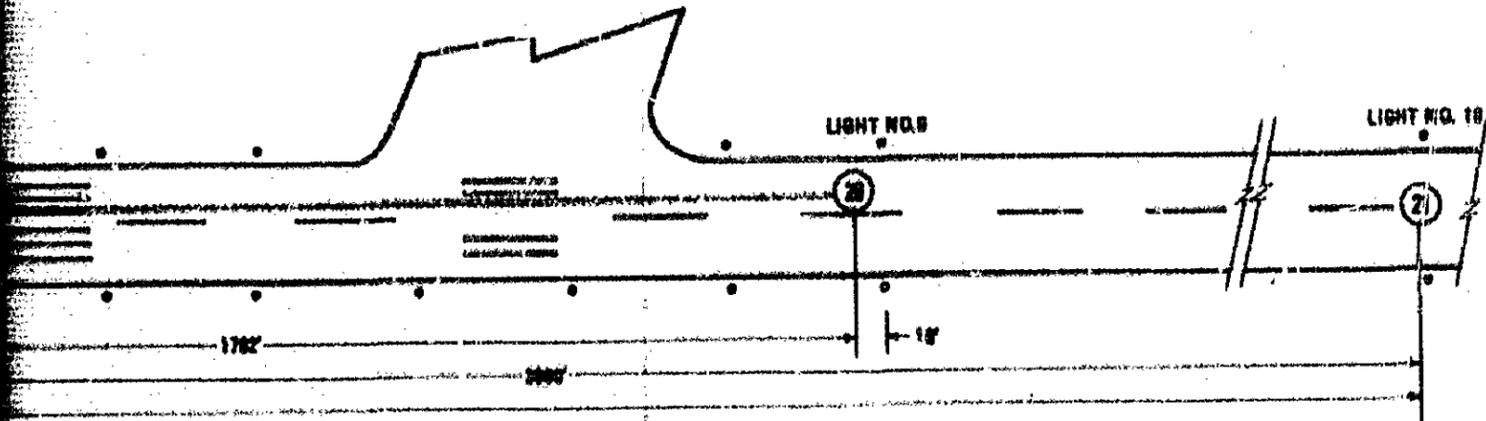
WRECKAGE DISTRIBUTION CHART
AEROTRANSPORTES ENTRE RIOS
CANADAIR CL-44-6, LV-1SY, S/N106925
MIAMI INTERNATIONAL AIRPORT
MIAMI, FLORIDA
SEPTEMBER 27, 1975
DCA 76-AZ-005

| | 20. TWIN RIGHT GEAR TIRE MARKS, NO. 9 LIGHT EAST OF GR THRESHOLD |
| | 21. PIECES OF NOSE GEAR TIRE TREAD, No. 18 LIGHT EAST OF GR THRESHOLD |
