**Aircraft Accident Report - Columbia  
Pacific Airlines, Beech 99, N199EA,  
Richland, Washington, February 10, 1978**

**(U.S.) National Transportation Safety Board, Washington, DC**

**21 Dec 78**

COLUMBIA PACIFIC AIRLINES  
BEECH 99, N199EA  
RICHLAND, WASHINGTON  
FEBRUARY 10, 1978

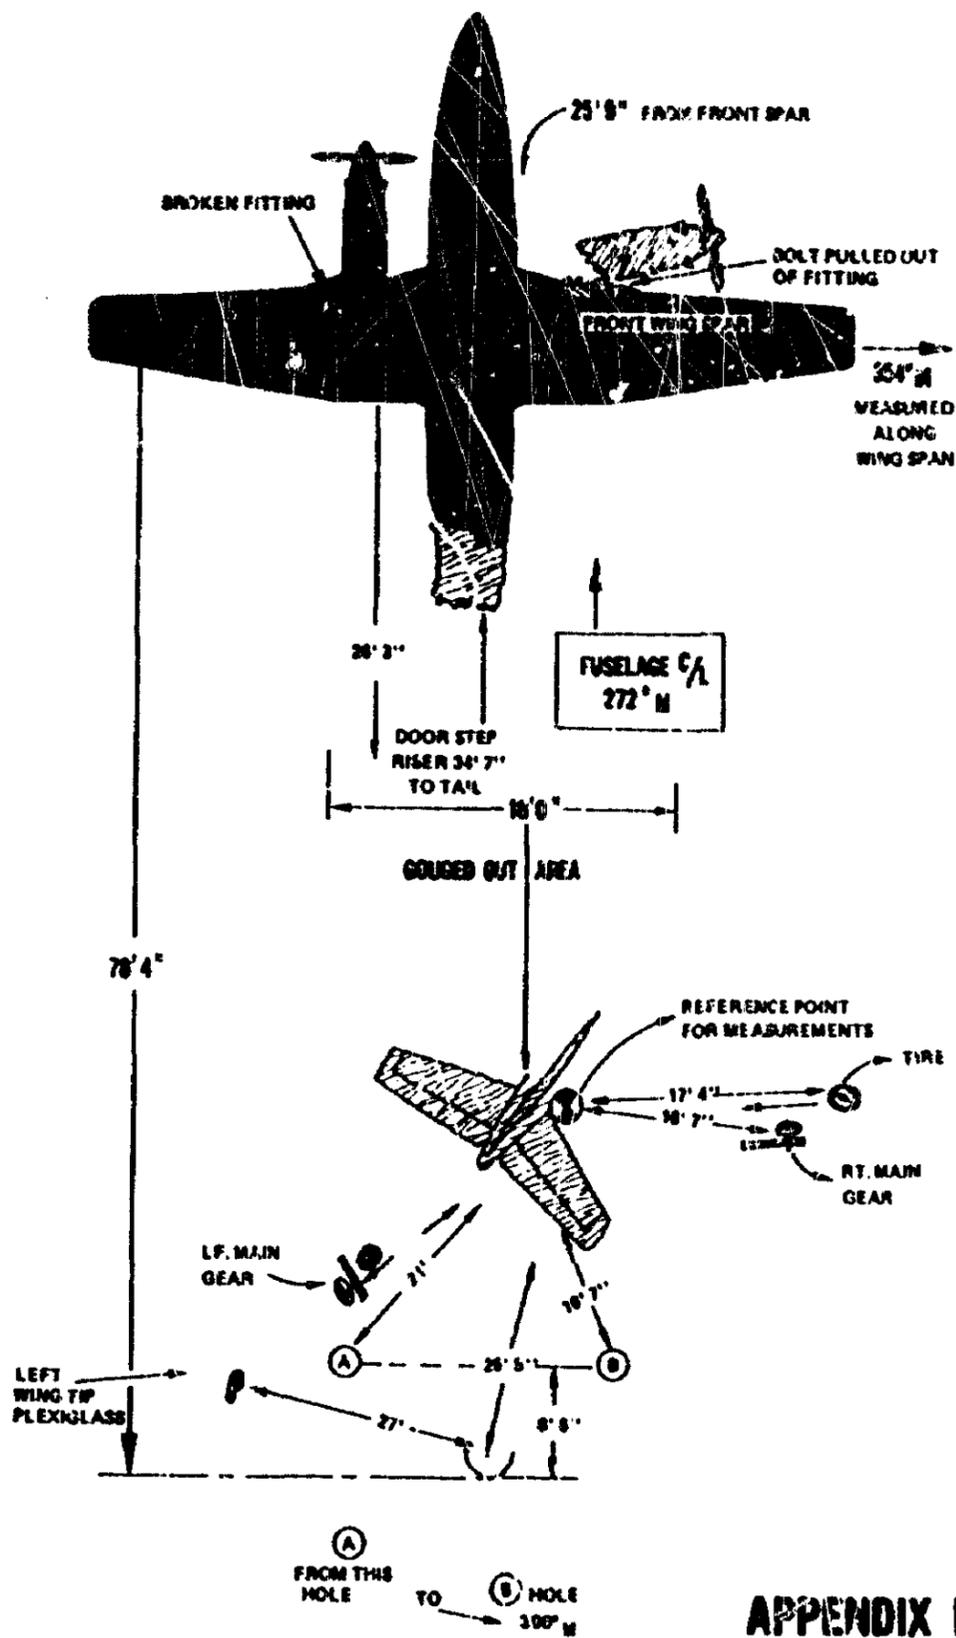
### APPENDIX E

NATIONAL TRANSPORTATION SAFETY BOARD  
Washington, D.C. 20594  
WRECKAGE DISTRIBUTION CHART  
COLUMBIA PACIFIC AIRLINES  
BEECH MODEL 19, N 188 EA  
Richland Washington Airport  
Richland, Washington  
February 11, 1978
