NATIONAL TRANSPORTATION SAFETY BOARD

AIRCRAFT ACCIDENT REPORT

**LAS VEGAS AIRLINES
PIPER PA-31-350, N44LV**

**LAS VEGAS, NEVADA
AUGUST 30, 1978**

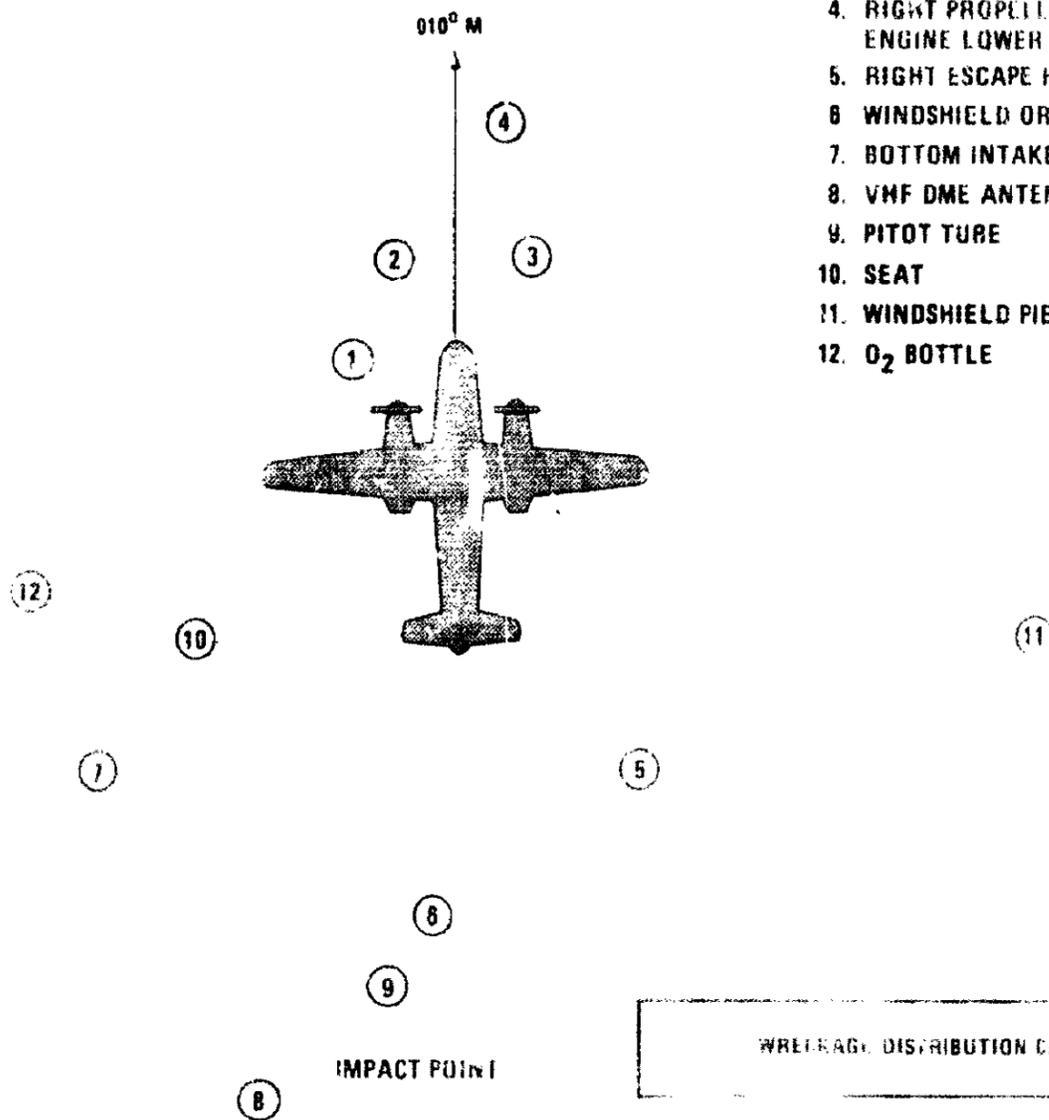
NOTE:
CIRCLES PHYSICALLY REPRESENT
LOCATION OF PARTS IMMEDIATELY
AFTER IMPACT
