**Aircraft Accident Report - Near Collision of Delta Air
Lines, Inc., Boeing 727-200, N467DA, and Flying Tiger,
Inc., Boeing 747-F, N804FT, O'Hare International Airport
Chicago, Illinois, February 15, 1979**

1. Report No. NTSB-AAR-79-11	2. Government Accession No.	3. Recipient's Catalog No.	
4. Title and Subtitle Aircraft Accident Report, Delta Air Lines, Inc., Boeing 727-200, N467DA and Flying Tiger, Inc., Boeing 747-F, N804FT, O'Hare International Airport, Chicago, Illinois, February 15, 1979		5. Report Date August 2, 1979

DELTA AIR LINES, INC., BOEING 727-200, N467DA
AND
FLYING TIGER, INC., BOEING 747-F, N804FT
O'HARE INTERNATIONAL AIRPORT, CHICAGO, ILLINOIS
FEBRUARY 15, 1979

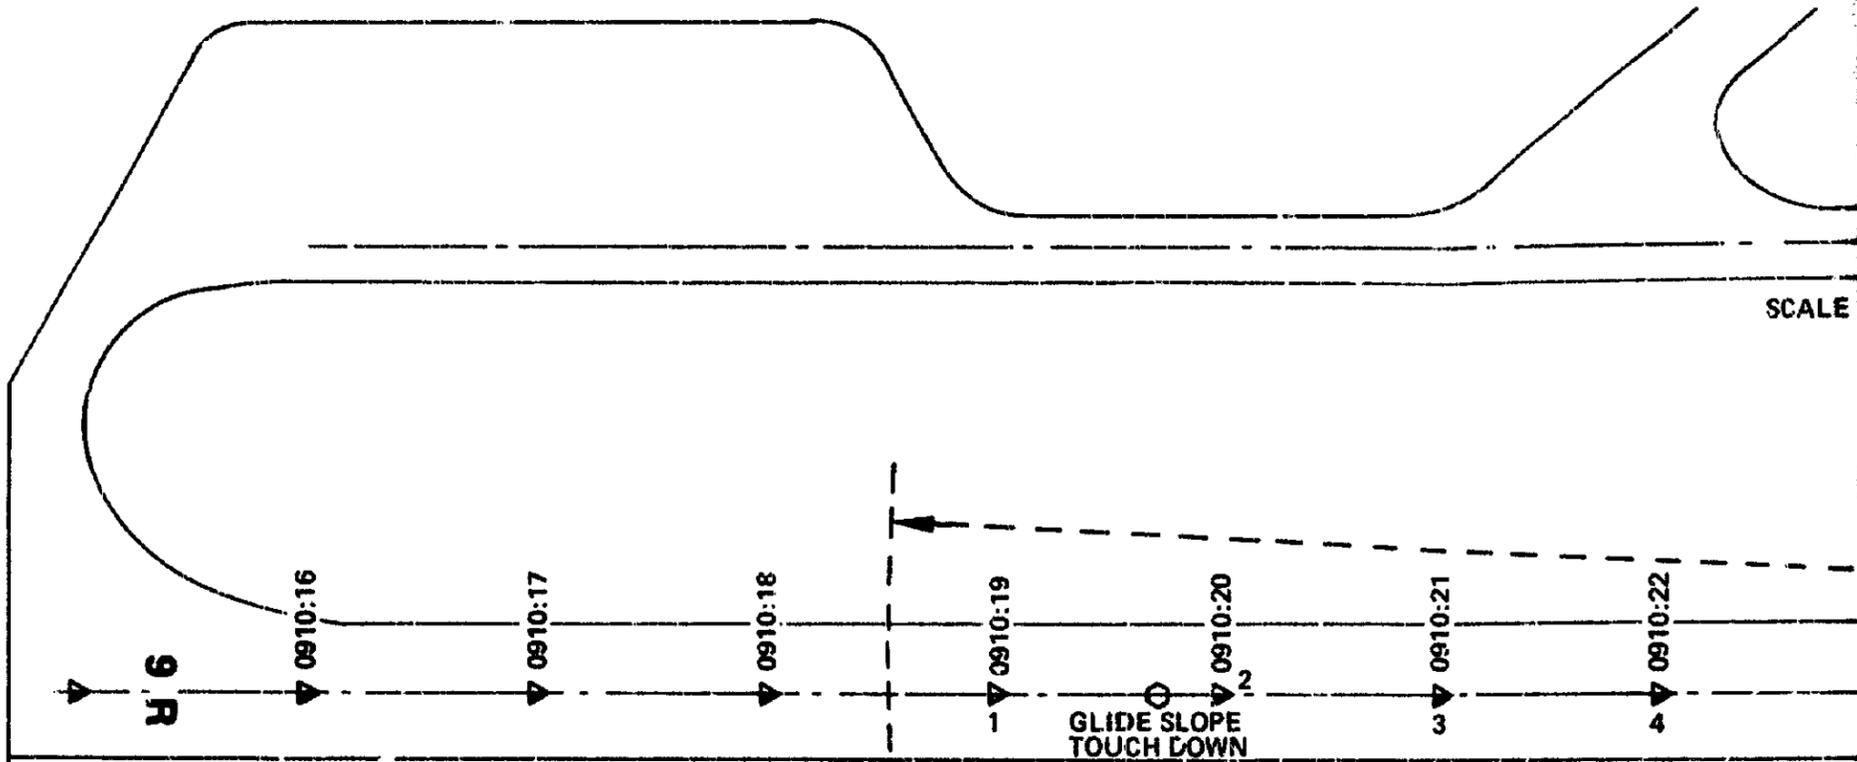
VISUAL RANGE OF B-727 (3000')

NEAR COLLISION
FLYING TIGER BOEING 747, N467DA
DELTA AIR LINES BOEING 727, N480DA
 O'HARE INTERNATIONAL AIRPORT, CHICAGO, ILL.
 FEBRUARY 15, 1979 DCA 79-A-A003

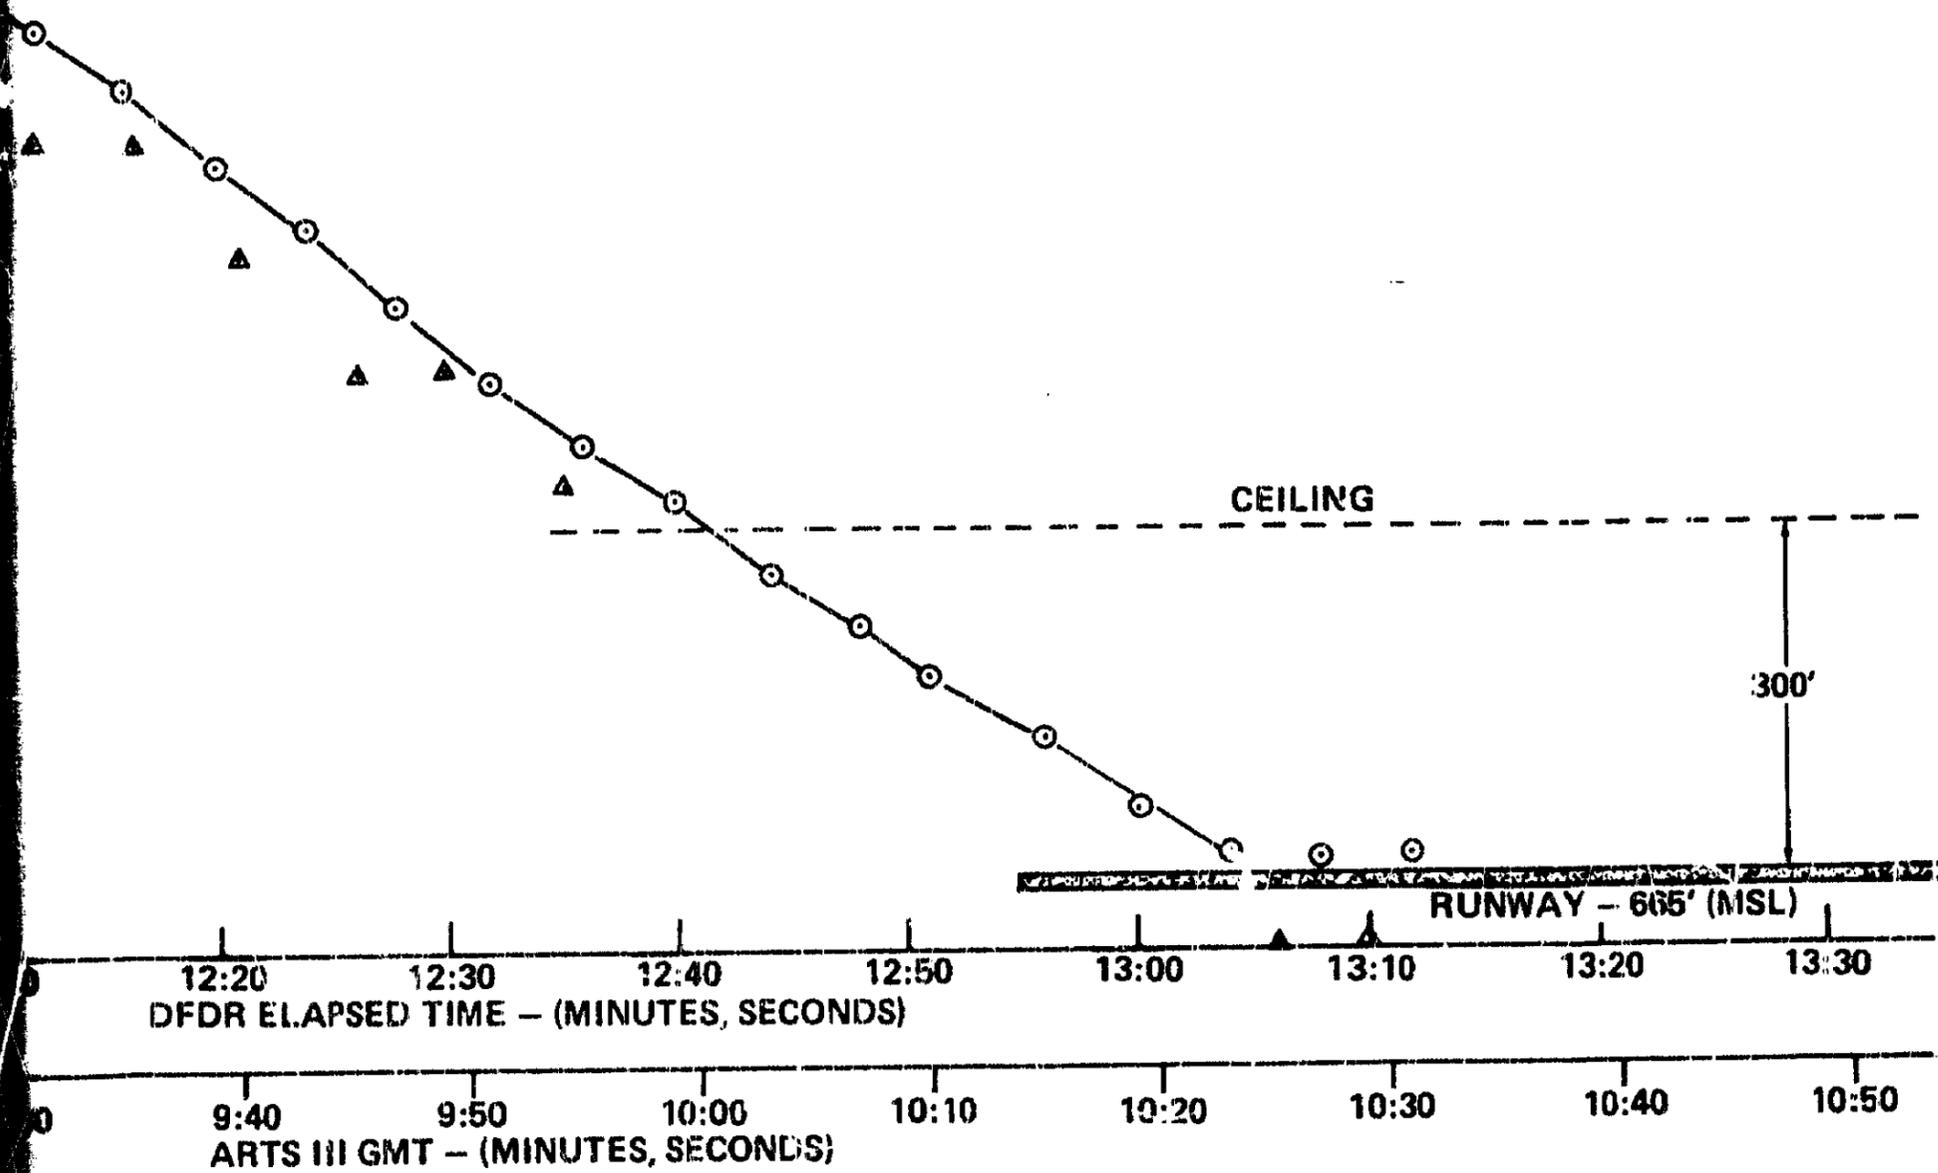
APPENDIX E

ING TIGER LINE BOEING 747
DFDR ALTITUDE DATA AND
ARTS III ALTITUDE DATA
Vs.
TIME

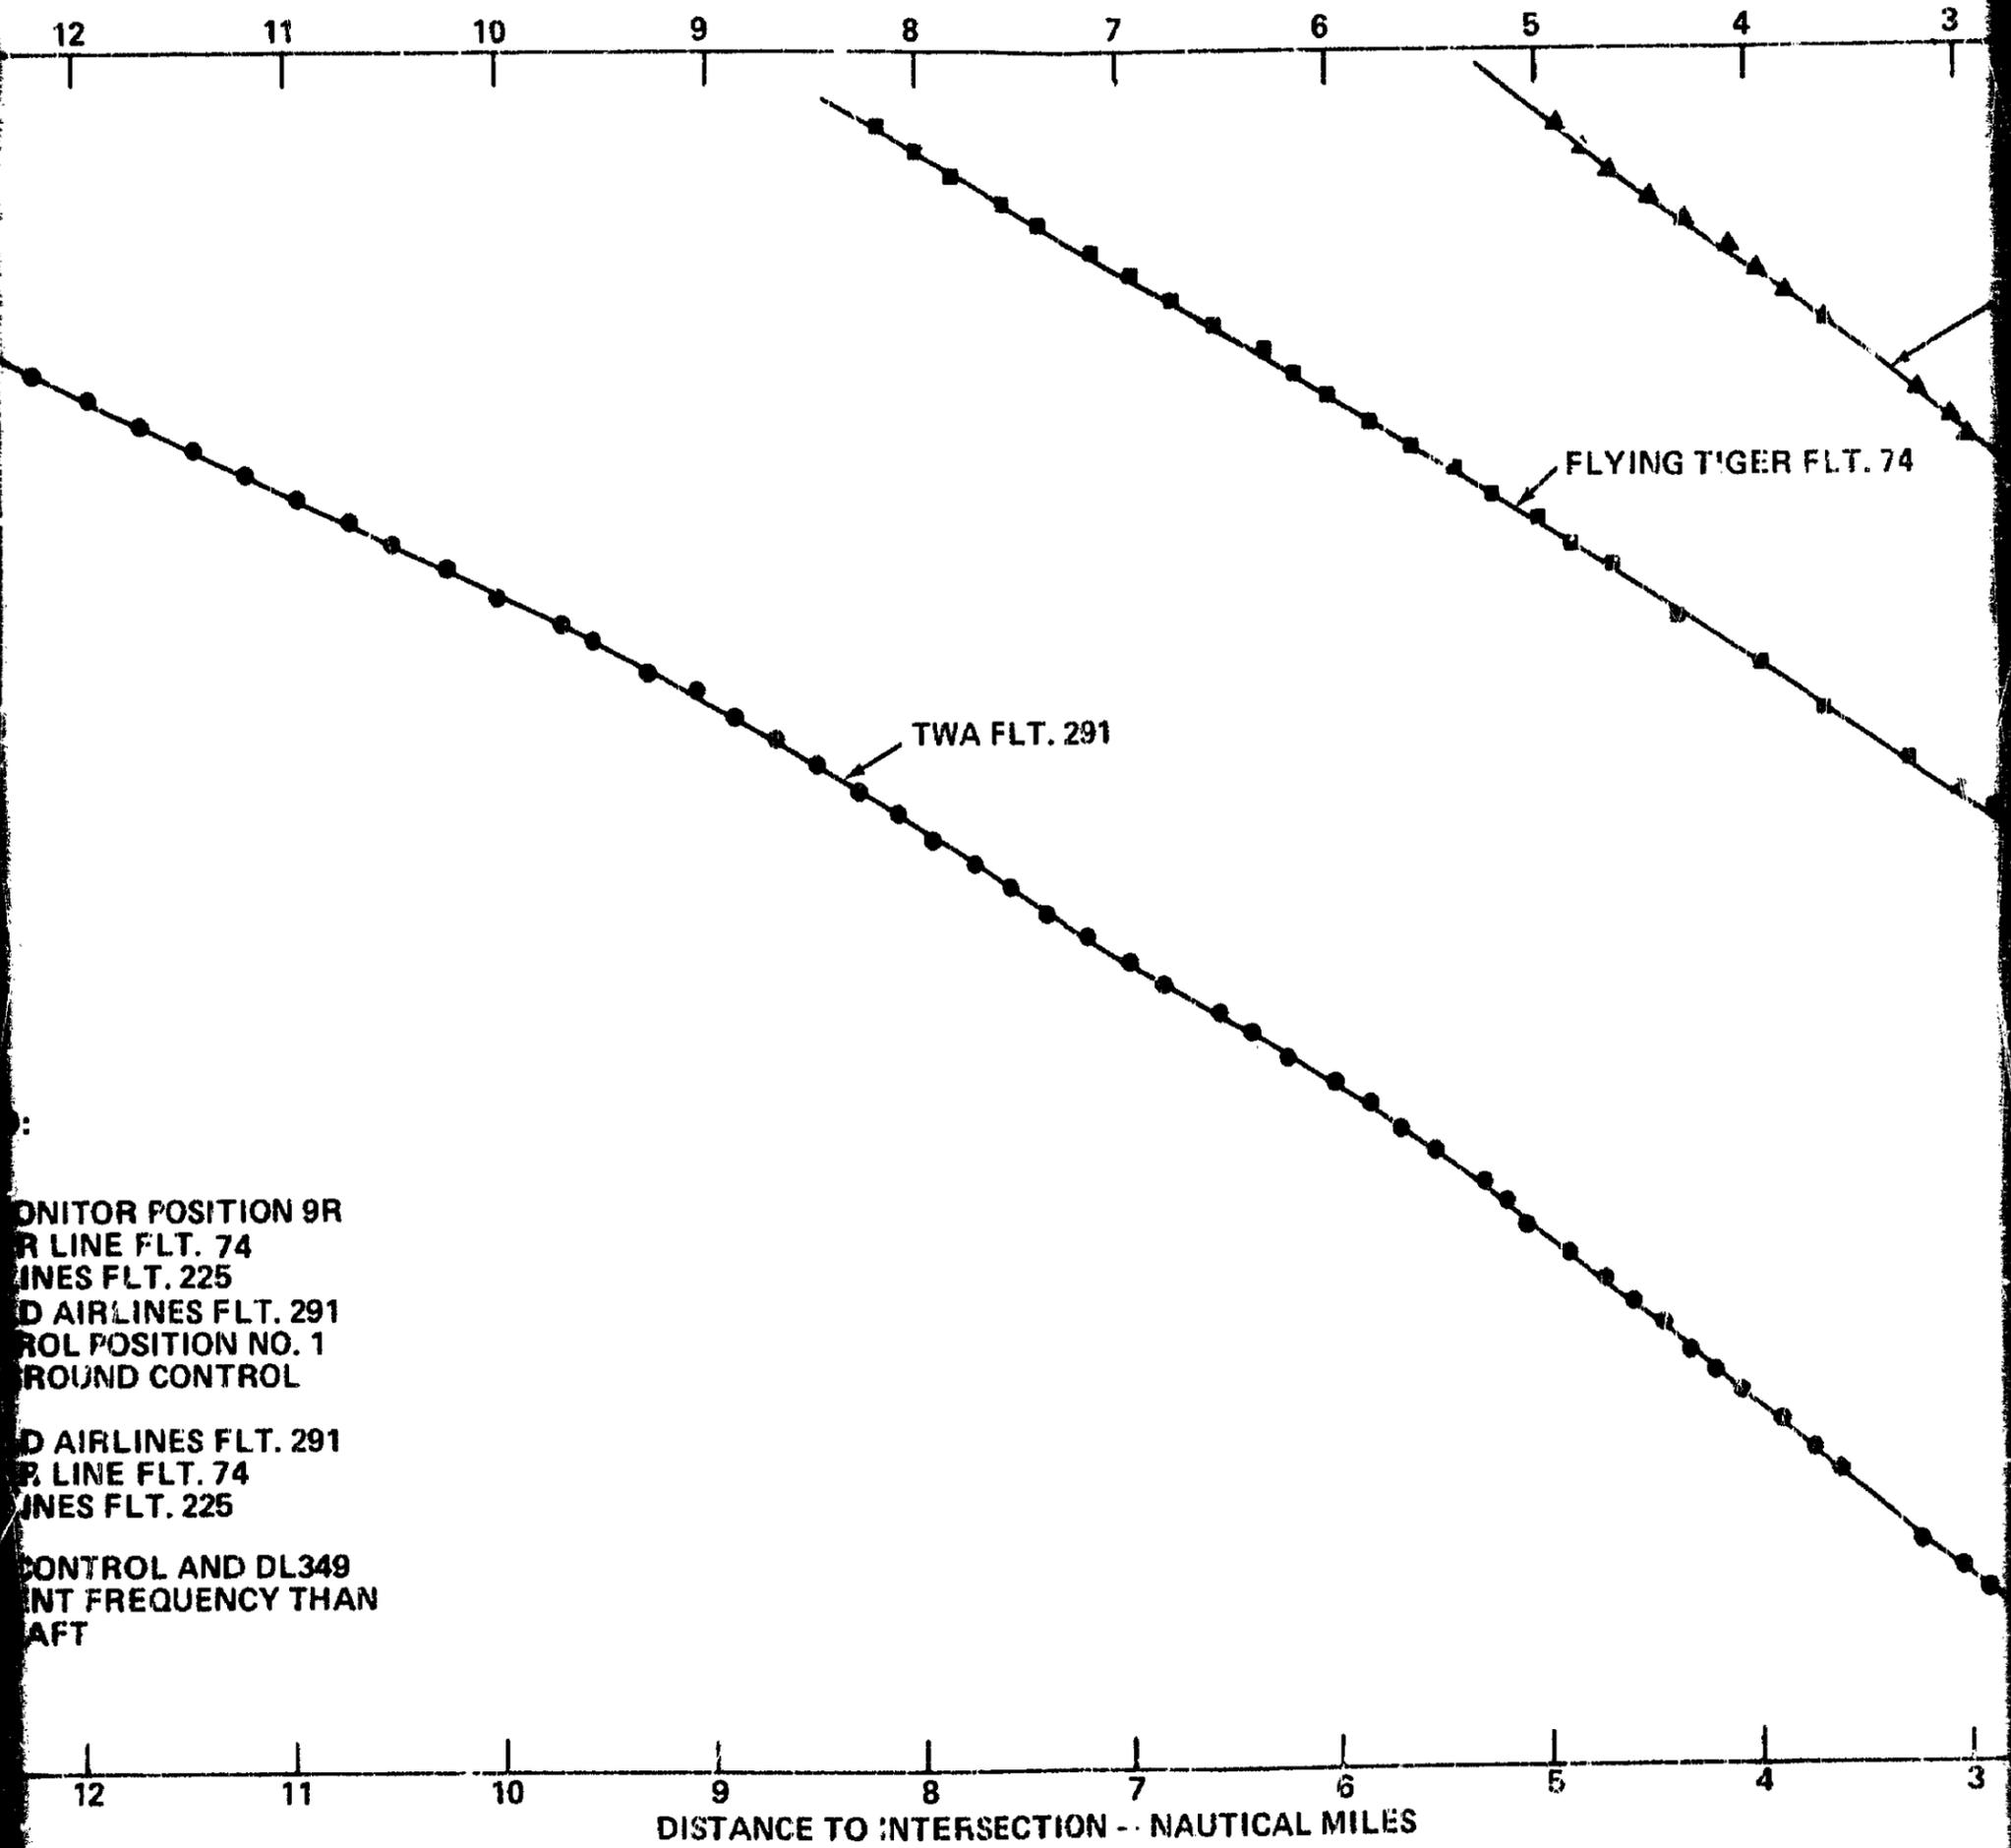
PLOT OF LANDING SEPARATION DISTANCE Vs. TIME (GMT)

MONITOR POSITION 9R
 AIRLINE FLT. 74
 AIRLINES FLT. 225
 DELTA AIRLINES FLT. 291
 CONTROL POSITION NO. 1
 GROUND CONTROL
