NATIONAL TRANSPORTATION SAFETY BOARD

AIRCRAFT INCIDENT REPORT

AEROMEXICO
DC-10-30, XA-DUH
OVER LUXEMBOURG, EUROPE
NOVEMBER 11, 1979

NTSB-88R-80-10

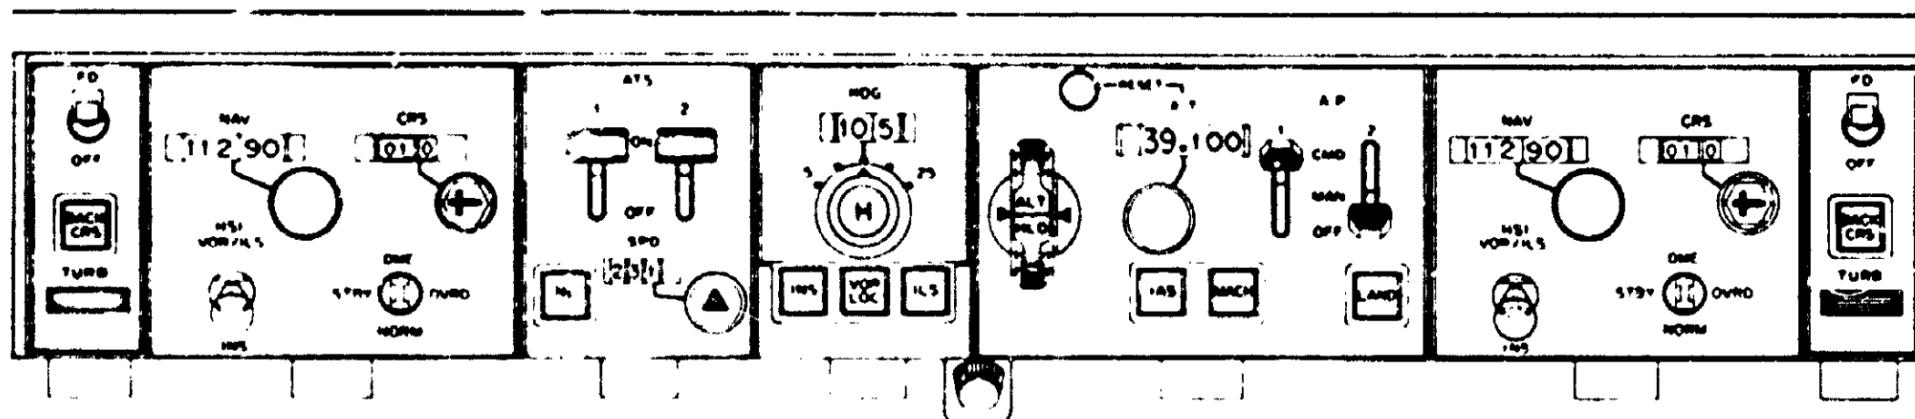
Figure 3.--Flight guidance and control system panel.

The manufacturer recommends that the autopilot "Indicated Airspeed Hold" (IAS Hold) and "Mach Hold" (MACH) modes be used primarily to climb or to descend. The IAS and MACH pushbutton switches are seen on the flight guidance and control panel below the autopilot levers in figure 3. With the autopilot in "CMD," pressing one of these switches commands the autopilot to adjust the pitch of the aircraft to maintain the airspeed or Mach existing when the switch was pressed. The pitch mode window annunciates IAS Hold or Mach Hold depending on which switch is depressed.

The vertical speed selector on the left side of the autopilot levers on the Flight Guidance and Control Panel, figure 3, is synchronized to the aircraft's vertical speed at all times except when the "Vertical Speed" (VERT SPD) or the "Altitude Hold" (ALT HOLD) mode is engaged. When the vertical speed selector is manually rotated to the altitude hold detent, the flight director pitch command bars will move correspondingly and the pitch annunciator will display "ALT HOLD." The vertical speed selector wheel functions as an indicator or as a control. If the altitude hold mode has been engaged, the vertical speed selector wheel will remain in the altitude hold detent and will command "ALT HOLD." If the vertical speed mode has been engaged (either a climb or a descent), the vertical speed selector wheel will remain in the selected position and will command a climb or a descent at the selected rate. When the "IAS Hold" or "Mach Hold" is engaged, the vertical speed selector wheel will automatically synchronize to the velocity of the aircraft.

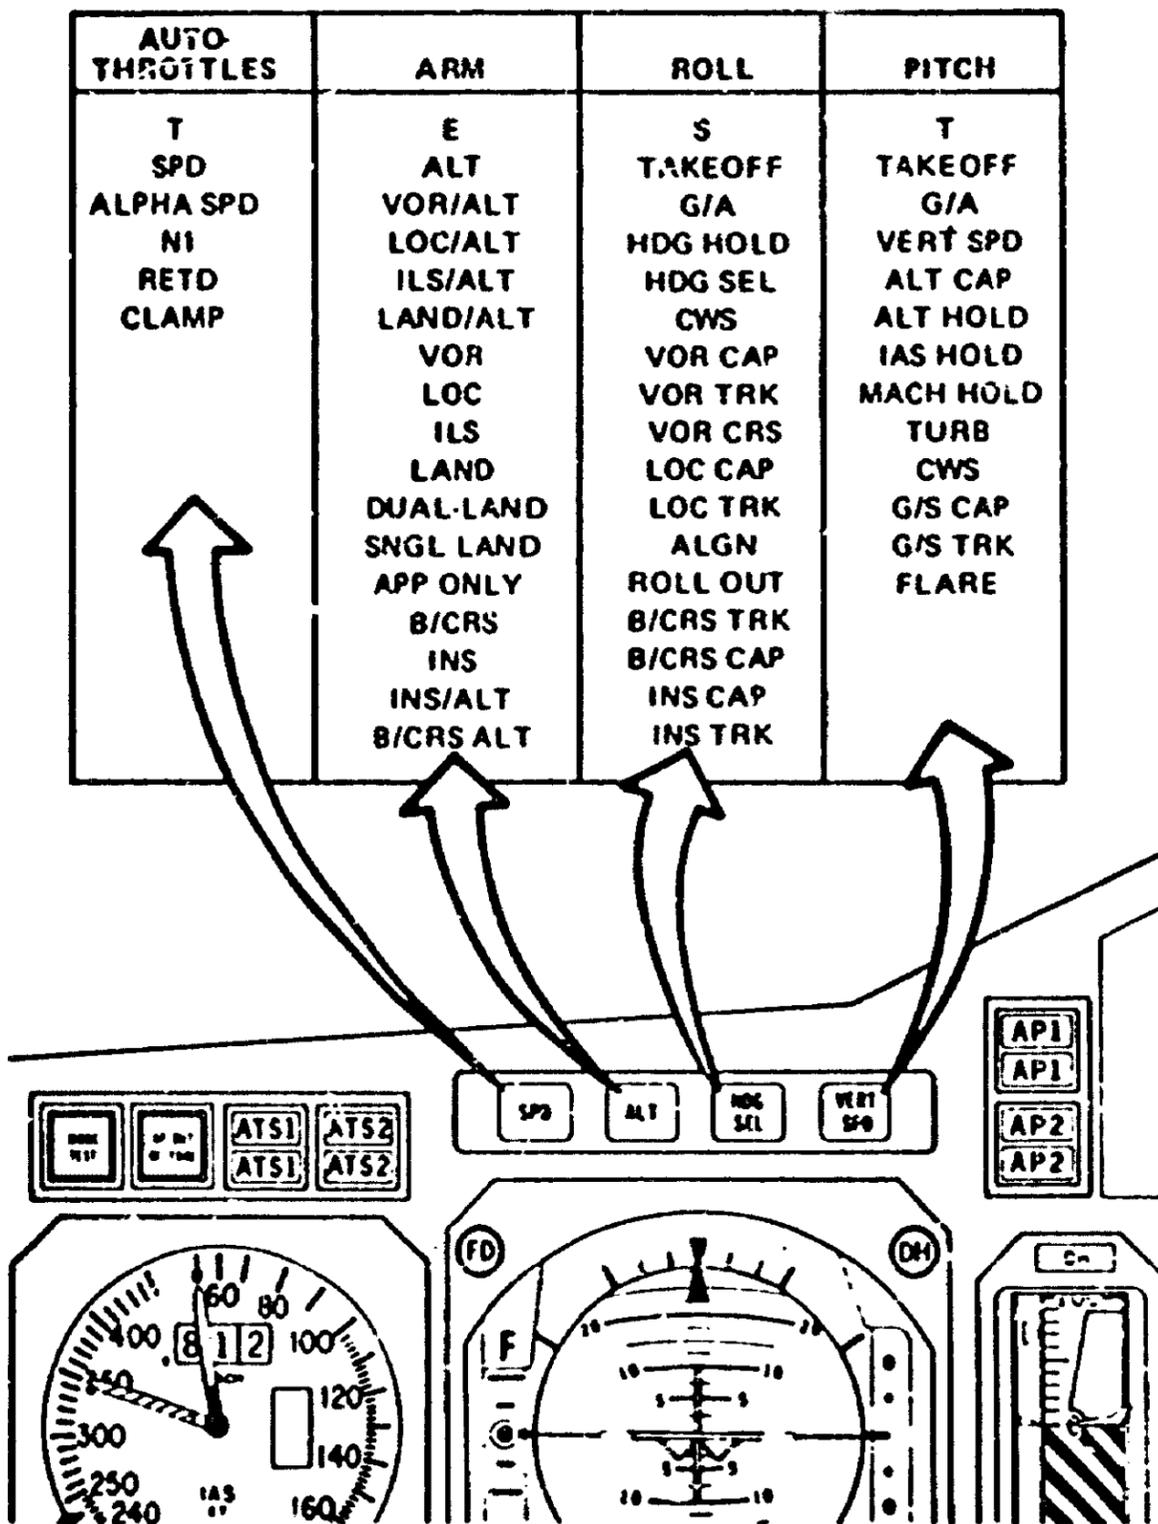
Figure 4.—Mode annunciator panel.

Some airline procedures allow an alternate use of vertical speed mode for the climb. Airspeed must be closely monitored for the vertical speed climb procedure as this FD/AP mode will try to maintain the climb rate programmed by the vertical speed wheel, regardless of airspeed or Mach. The autopilot will automatically command the trim and elevator to maintain this rate of climb at the sacrifice of airspeed at the higher altitudes. The flight recorder data for this incident showed a constant rate of climb with continually decreasing airspeed before buffet onset and sustained aircraft stall. A speed selection in the ATS speed readout, if it is in the N_1 mode, would not result in any speed control of the aircraft until the ATS speed mode was engaged. If the ATS speed mode was engaged in the climb, a mode conflict between the FD/AP IAS Hold mode would cause the autopilot to revert to the VERT SPD mode. However, both airspeed and the VERT SPD mode of the FD/AP would be conspicuously annunciated. (See figure 4.)
