NATIONAL TRANSPORTATION SAFETY BOARD

AIRCRAFT ACCIDENT REPORT

**AIR WISCONSIN, INC.,
SWEARINGEN SA-226 METRO, N650S
VALLEY, NEBRASKA
JUNE 12, 1980**

NTSB-AAR-80-15

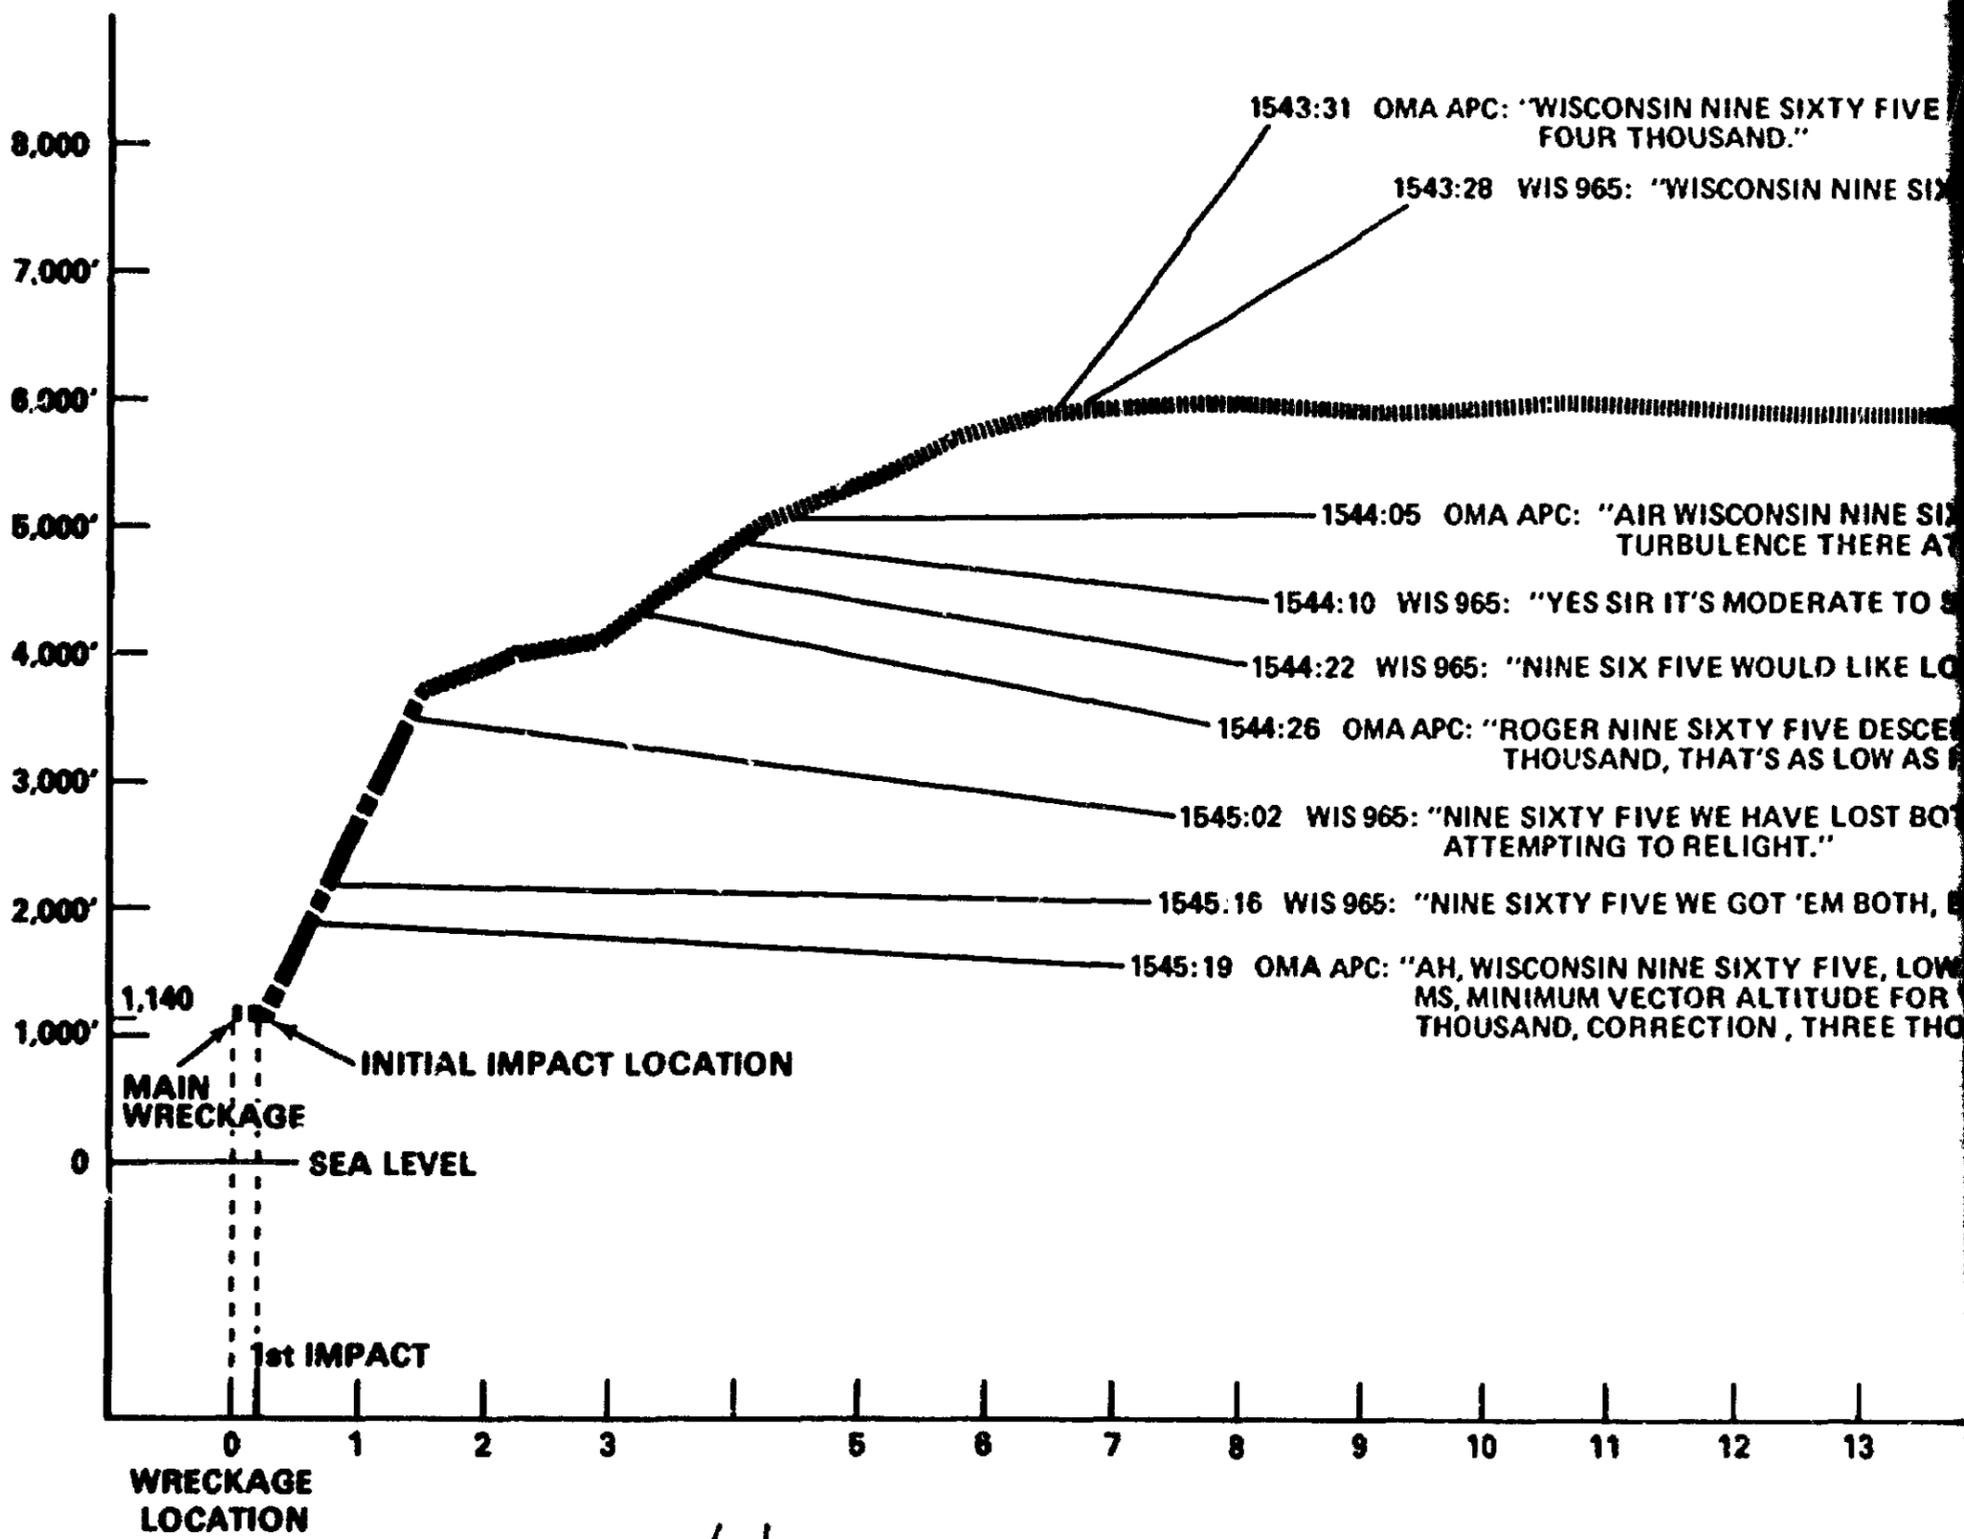
██████████ MODE - C DERIVED DESCENT PROFILE
 ■ ■ ■ ■ ■ ■ PRESUMED DESCENT PROFILE
 WIS 965 - AIR WISCONSIN FLIGHT 965
 OMA APC - OMAHA APPROACH CONTROLLER

NAS STAGE A REPORTED ALTITUDES AS
 DERIVED FROM MINNEAPOLIS ARTCC RDP:
 ALTITUDE POSITIONS FROM RDP ARE PLOTTED
 AT 11 to 13 SECOND INTERVALS AFTER 1543:34
