AIRCRAFT ACCIDENT REPORT

CONTINENTAL AIRLINES /
AIR MICRONESIA, INC.
BOEING 727-92C, N18479
YAP AIRPORT
YAP, WESTERN CAROLINE ISLANDS
NOVEMBER 21, 1980

NTSB-AAR-81-7

**CONTINENTAL AIRLINES/AIR MICRONESIA INC.
BOEING 727-92C, N18479
YAP AIRPORT
YAP, WESTERN CAROLINE ISLANDS
NOVEMBER 21, 1980**

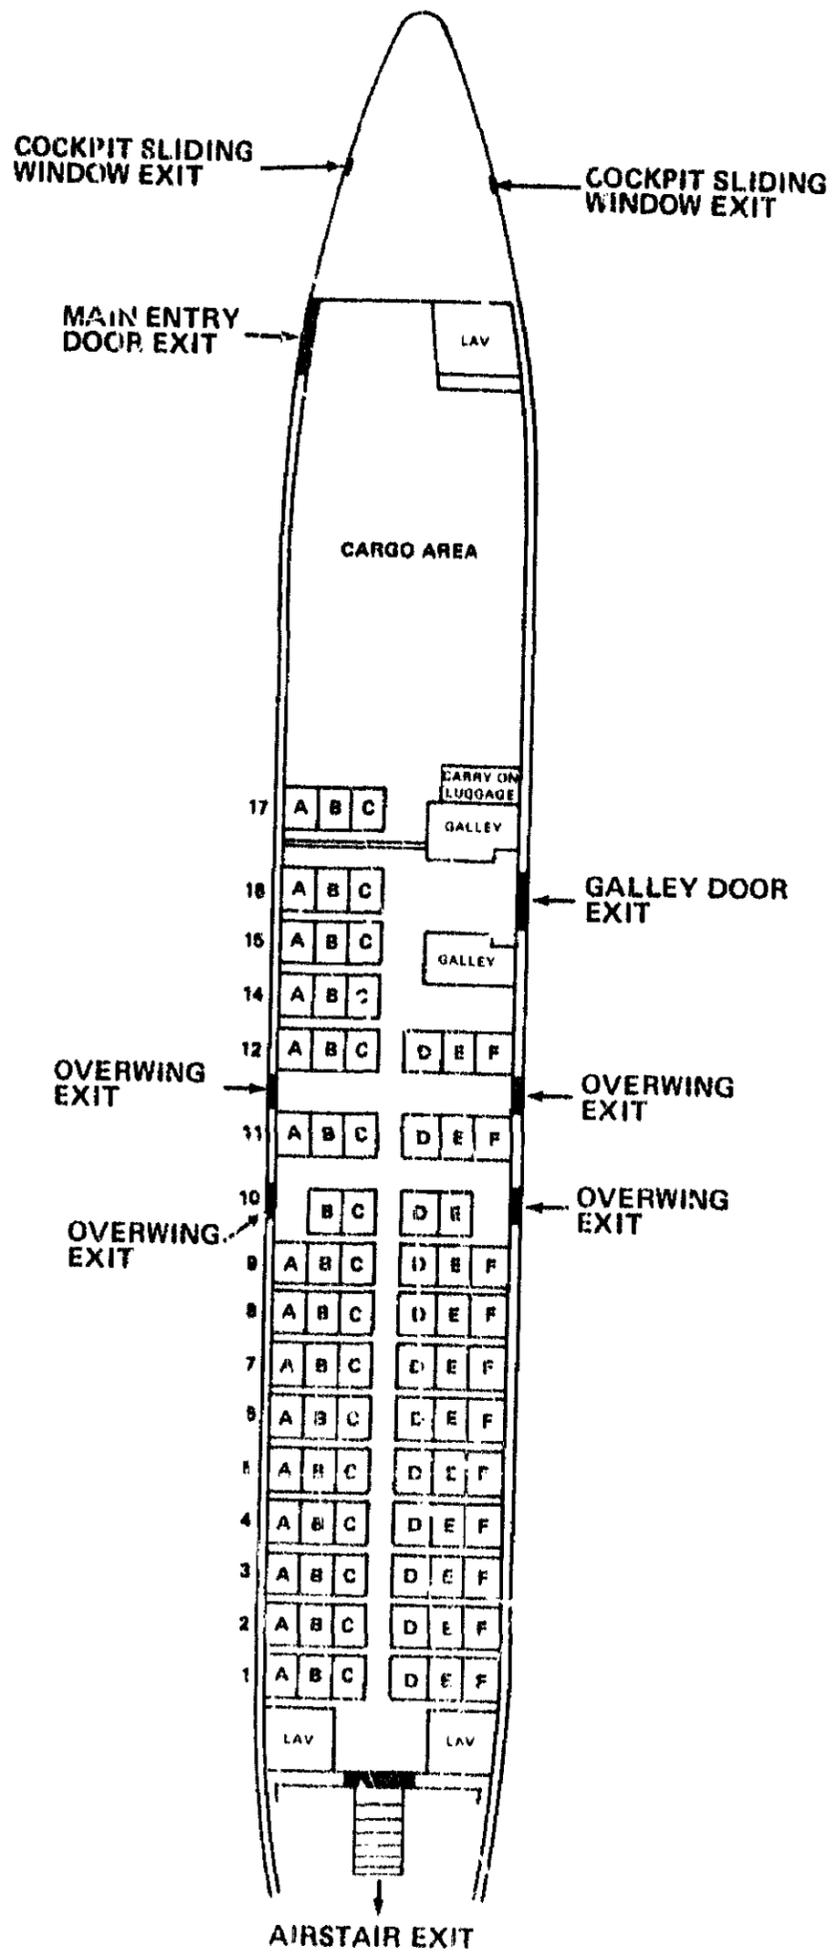
Figure 1.--Aircraft seating and exit locations.

The aircraft was manufactured as a convertible cargo-passenger type. At the time of the accident it was configured for two pallets of cargo forward and 78 passenger seats in the aft cabin. (See figure 1.) As part of the certification for operation in the mixed configuration, the aft airstair door exit was a required emergency exit. A pneumatically actuated emergency "blow-down" system was required to be operational to provide positive opening of that exit with the aircraft in the most adverse exit opening condition that would result from the collapse of one or more of the landing gear. The system was reportedly operational for the flight.

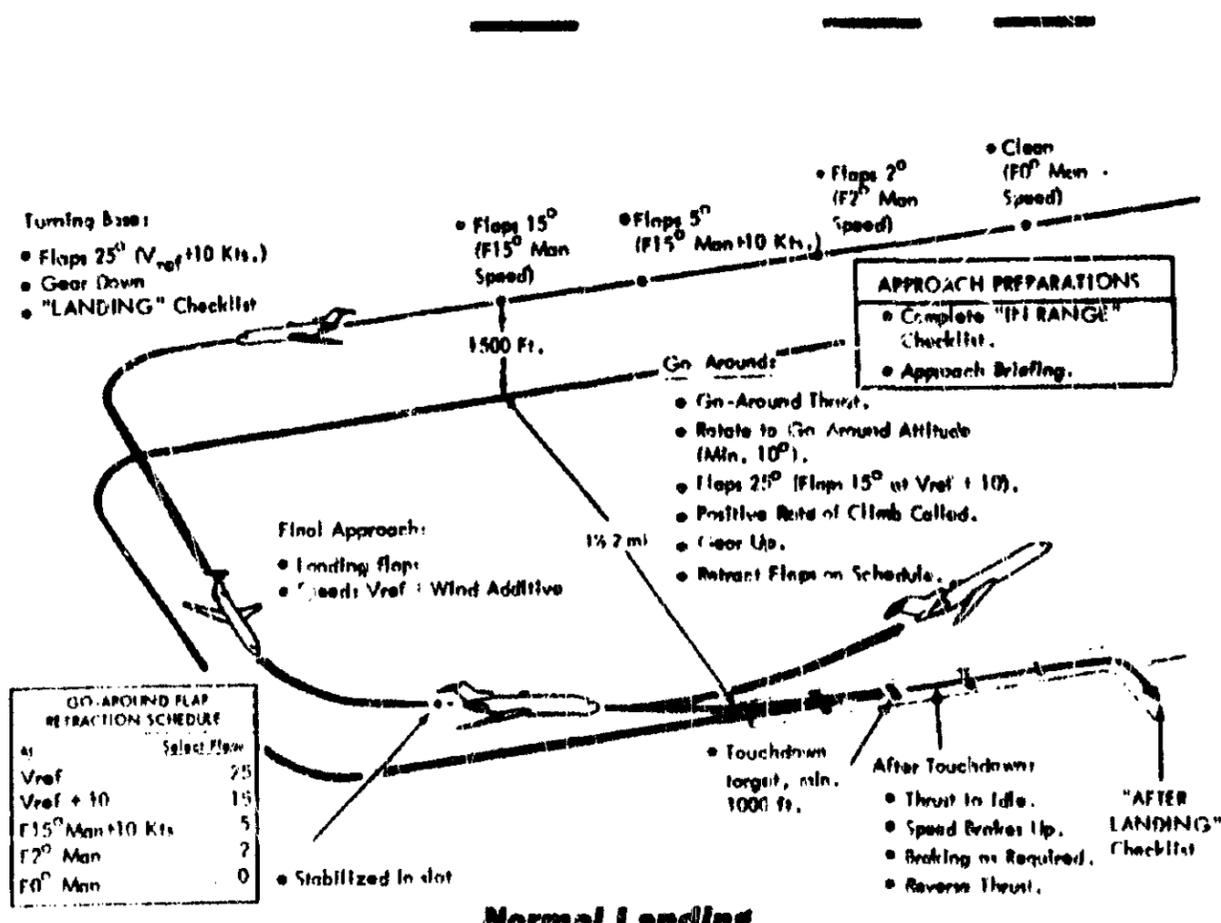
Figure 3.-- Depiction of normal landing from flight manual.

The Continental Airlines flight manual for the Boeing 727-100/100C graphically depicts the normal approach situation. (See figures 3 and 4.) Flap and landing gear extension points were selected to minimize crew workload and thrust changes during the approach. The flight manual states, in part, "The airplane must be stabilized on final approach at least 500 ft above field elevation." Following are excerpts from the flight manual regarding other landing procedures:

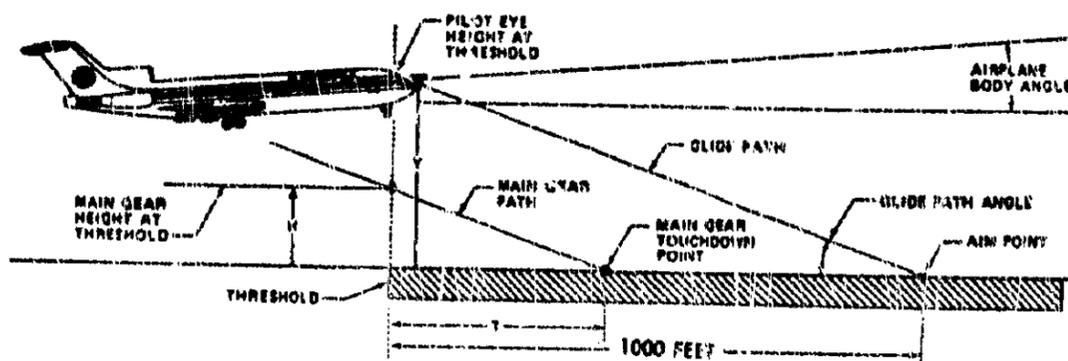
ESTIMATED TOUCHDOWN POINT (NO FLARE) ASSUMING A 1000 FT. AIM POINT
(SPEED - ON BUG, FLAPS - 30)

NOTE: MAIN GEAR 60 FT. BEHIND AND 14 FT. 10 IN. BELOW PILOT IN LEVEL FLIGHT.

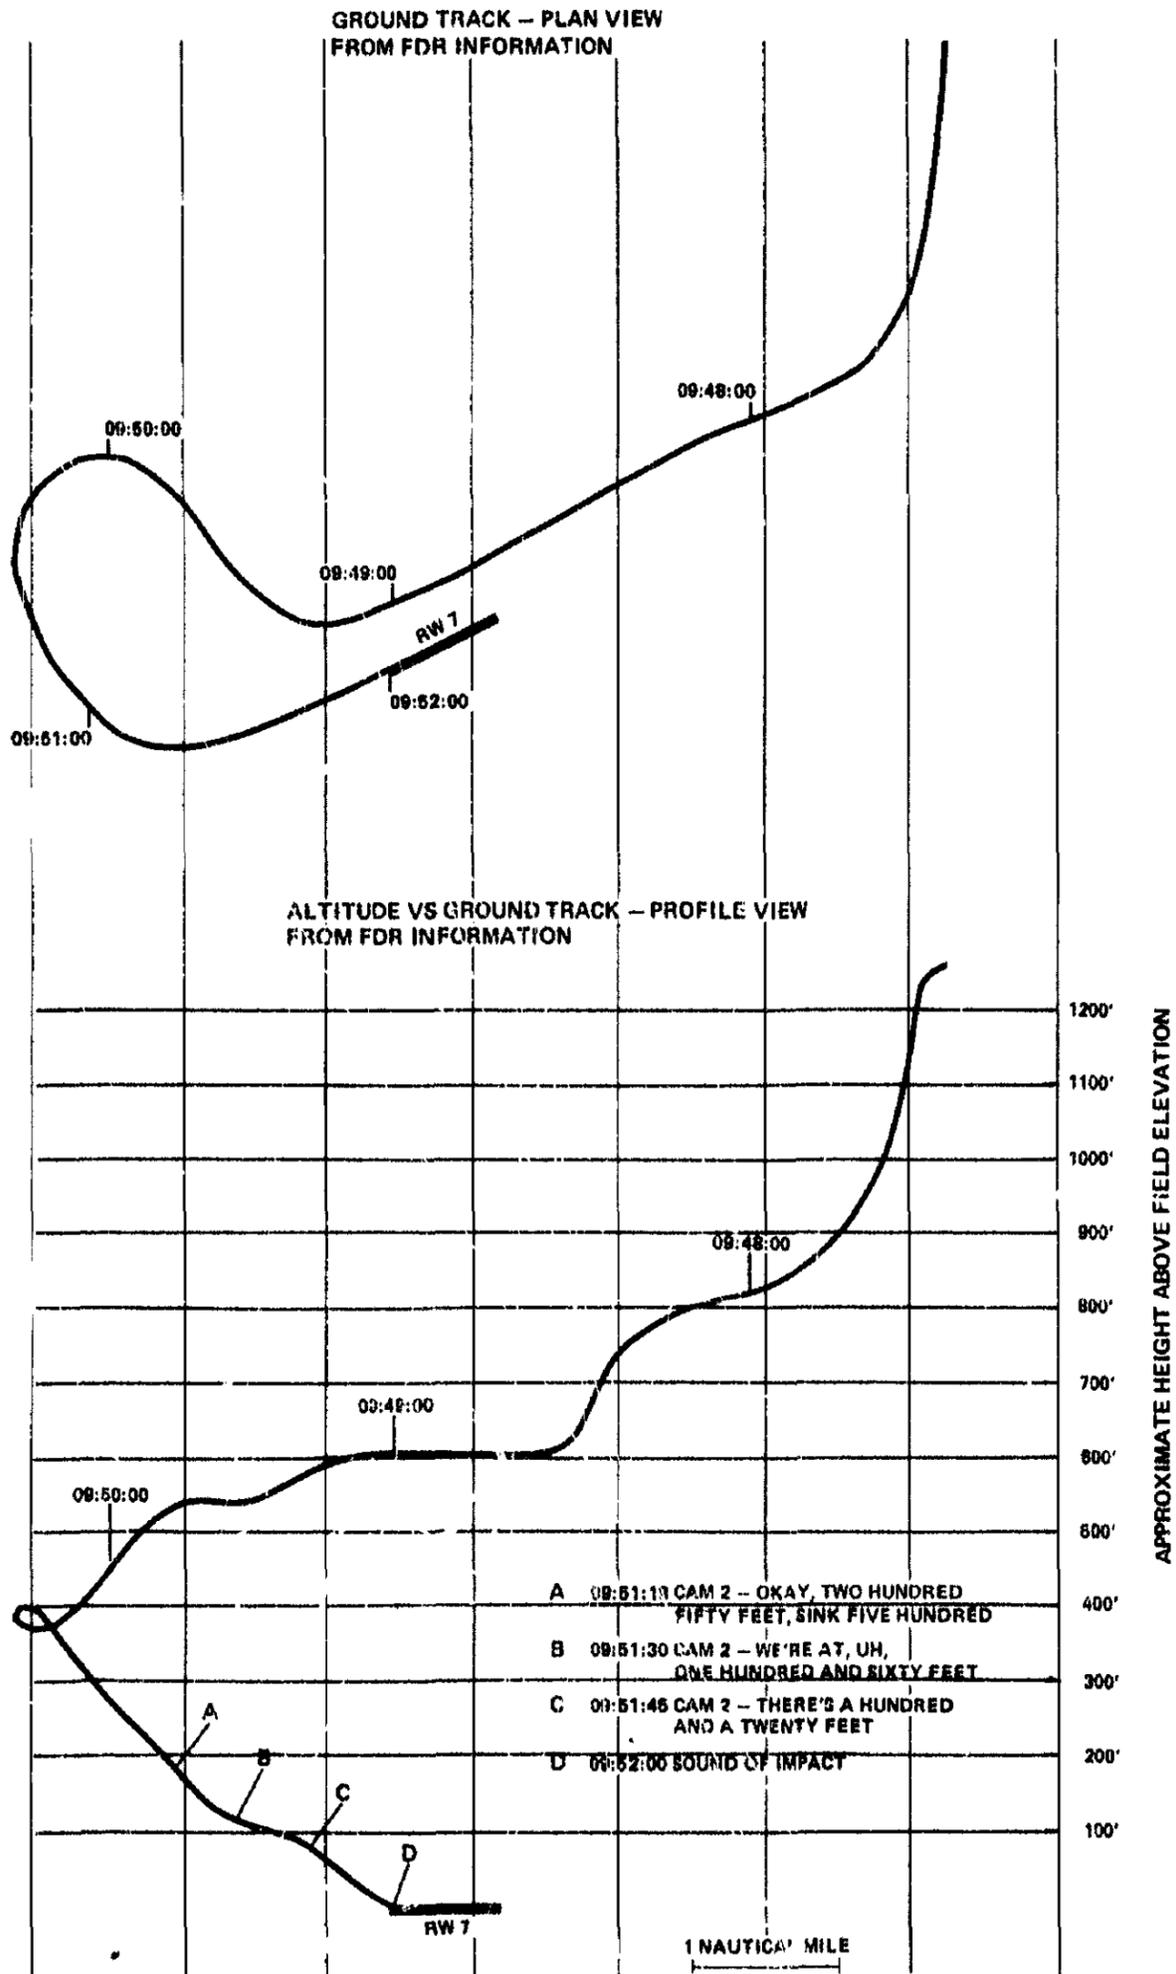
FLIGHT DATA RECORDER TRACES

A Fairchild model 5424 flight data recorder (FDR), serial No. 6061, was installed in N18479. The recorder was recovered from the wreckage and sent to the Safety Board's laboratory in Washington, D.C., for examination. The recorder sustained no impact or fire damage. The metal foil recording medium was examined, and all traces were found to have recorded in a clear and active manner with no evidence of malfunction.
