# **NATIONAL TRANSPORTATION SAFETY BOARD**

## **AIRCRAFT ACCIDENT REPORT**

**WORLD AIRWAYS INC., FLIGHT 32,  
MCDONNELL DOUGLAS DC-10-30CF, N112WA,  
OVER NORTH ATLANTIC OCEAN  
SEPTEMBER 20, 1981**

**NTSB-AAR-82-1**

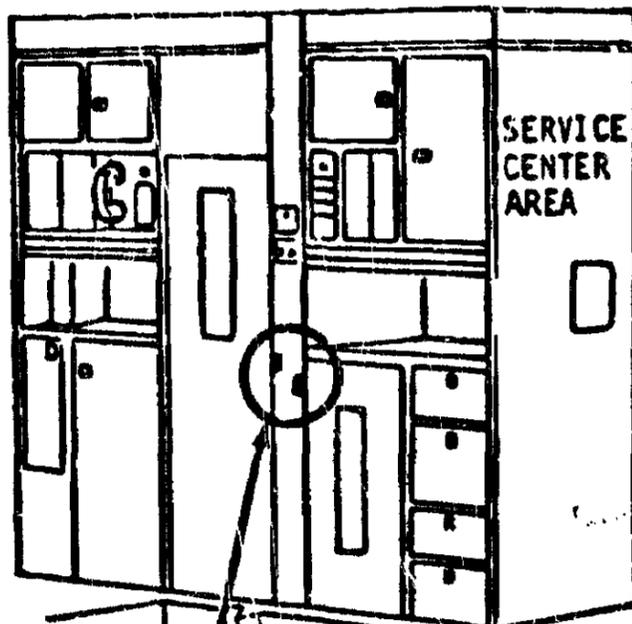
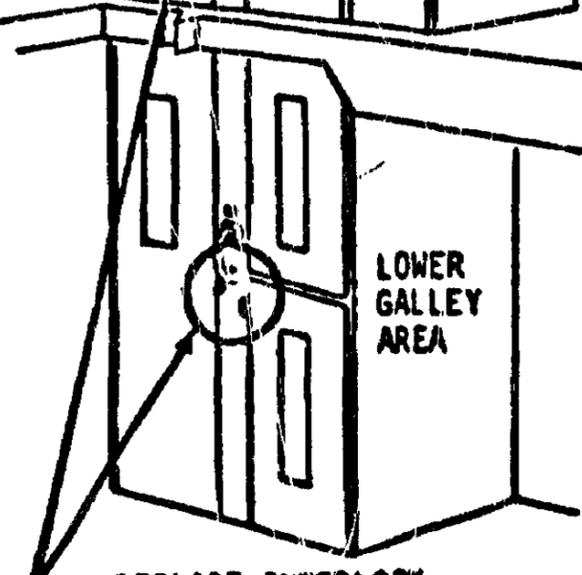
**ANALYSIS:** Two operators reported two  
instances where the galley lift system  
was operated with the door open.  
Investigation revealed that in both  
instances the galley lift system door  
interlock switches failed and allowed  
the lift to be operated with the door  
open. Switch failures are attributed  
to contamination by various types of  
foreign liquid substances. This  
condition could result in injury to  
flight personnel when operating the  
cart lift with the lift door open.

**CORRECTIVE ACTION:** Replace eight  
galley lift system door interlock  
switches. Replacing the galley lift  
system interlock switches with new  
hermetically sealed switches will  
minimize the possibility of switch  
failure.
