NATIONAL TRANSPORTATION SAFETY BOARD

AIRCRAFT ACCIDENT REPORT

EASTERN AIRLINES FLIGHT 935
LOCKHEED L-1011-384, N309EA,
NEAR COLTS NECK, NEW JERSEY,
SEPTEMBER 22, 1981

NTSB-AAR-82-5

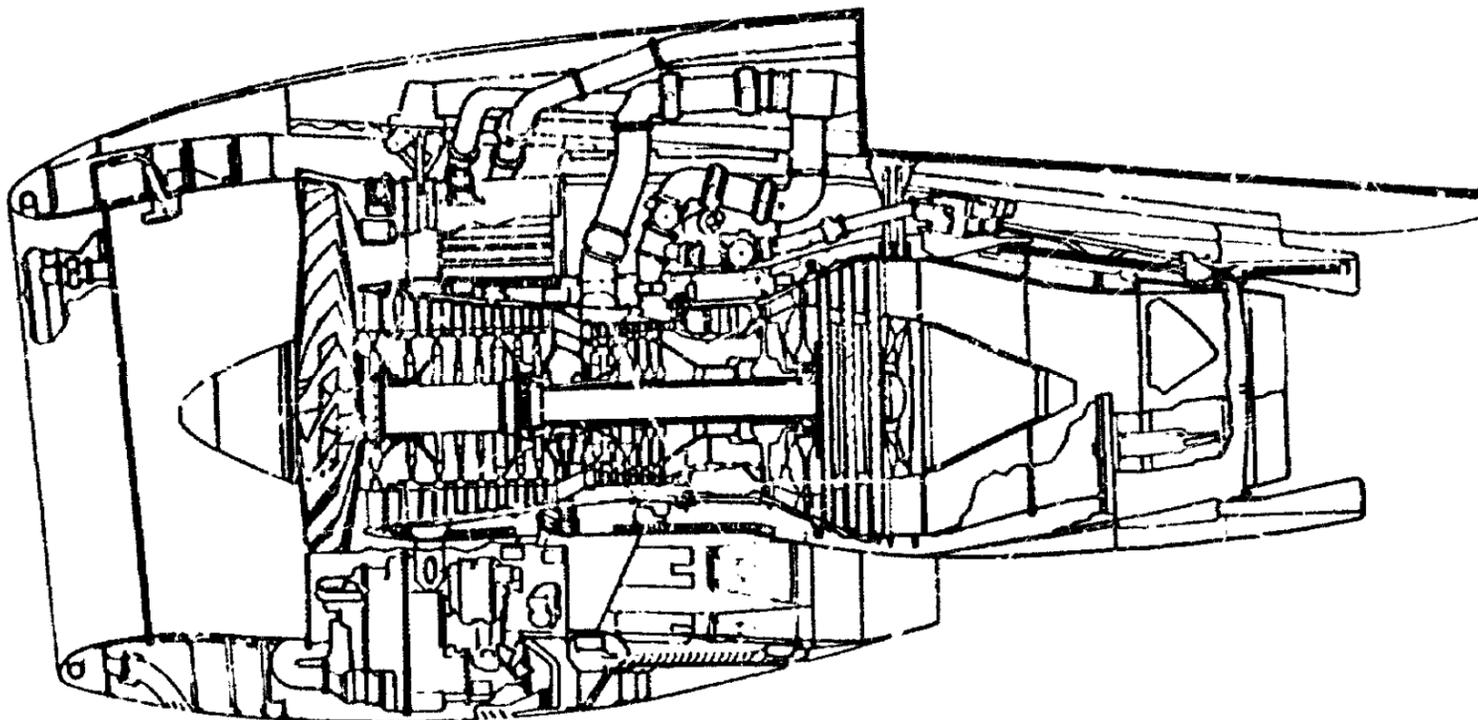
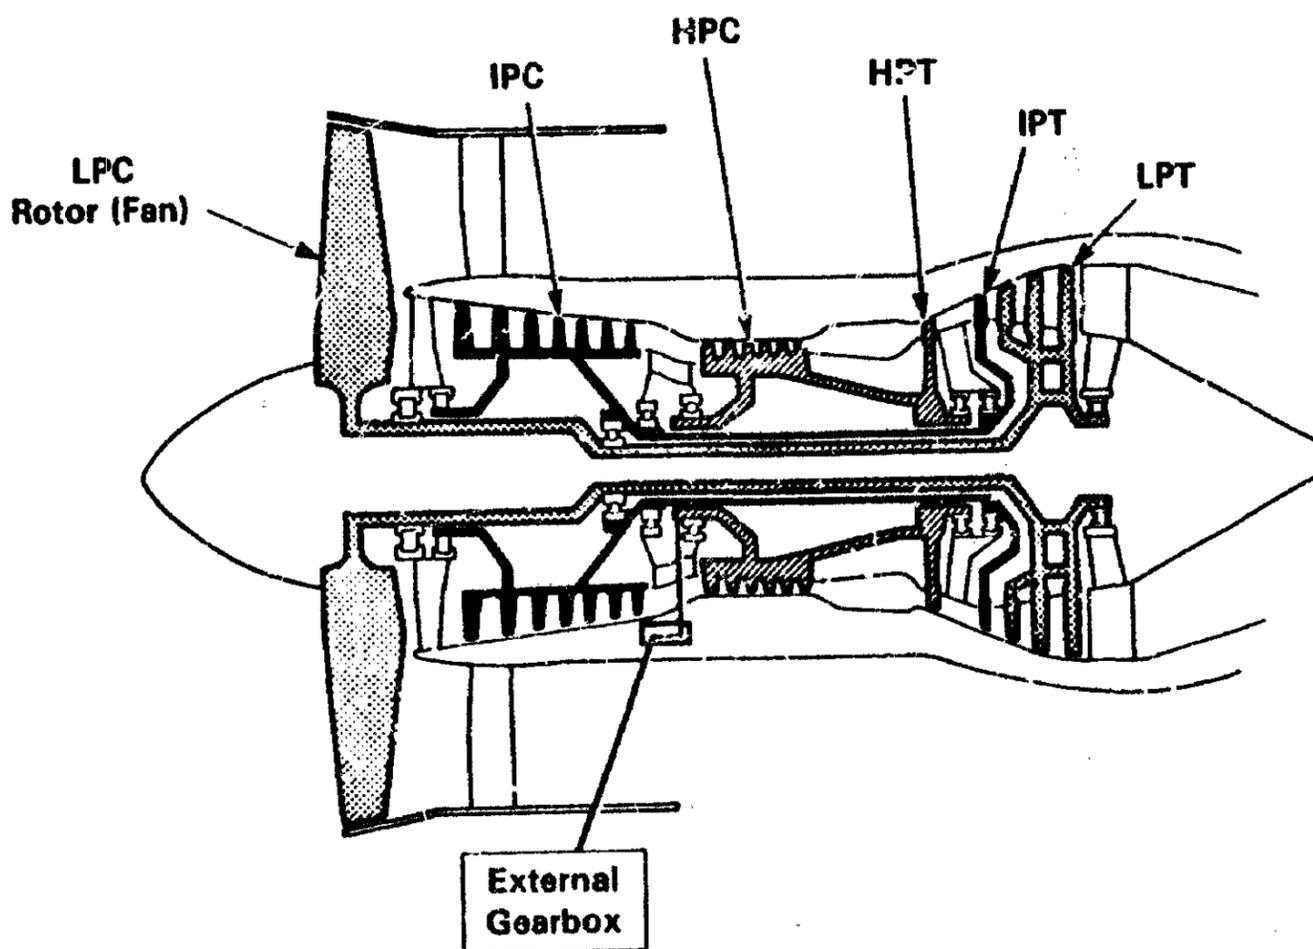
Figure 2. --- Propulsion System General Arrangement and Main Rotating Assemblies.

The engine has six rotating assemblies: the low-pressure compressor (LPC) rotor or fan, the intermediate-pressure compressor (IPC), the high-pressure compressor (HPC), the high-pressure turbine (HPT), the intermediate-pressure turbine (IPT), and the low-pressure turbine (LPT). (See figure 2.)

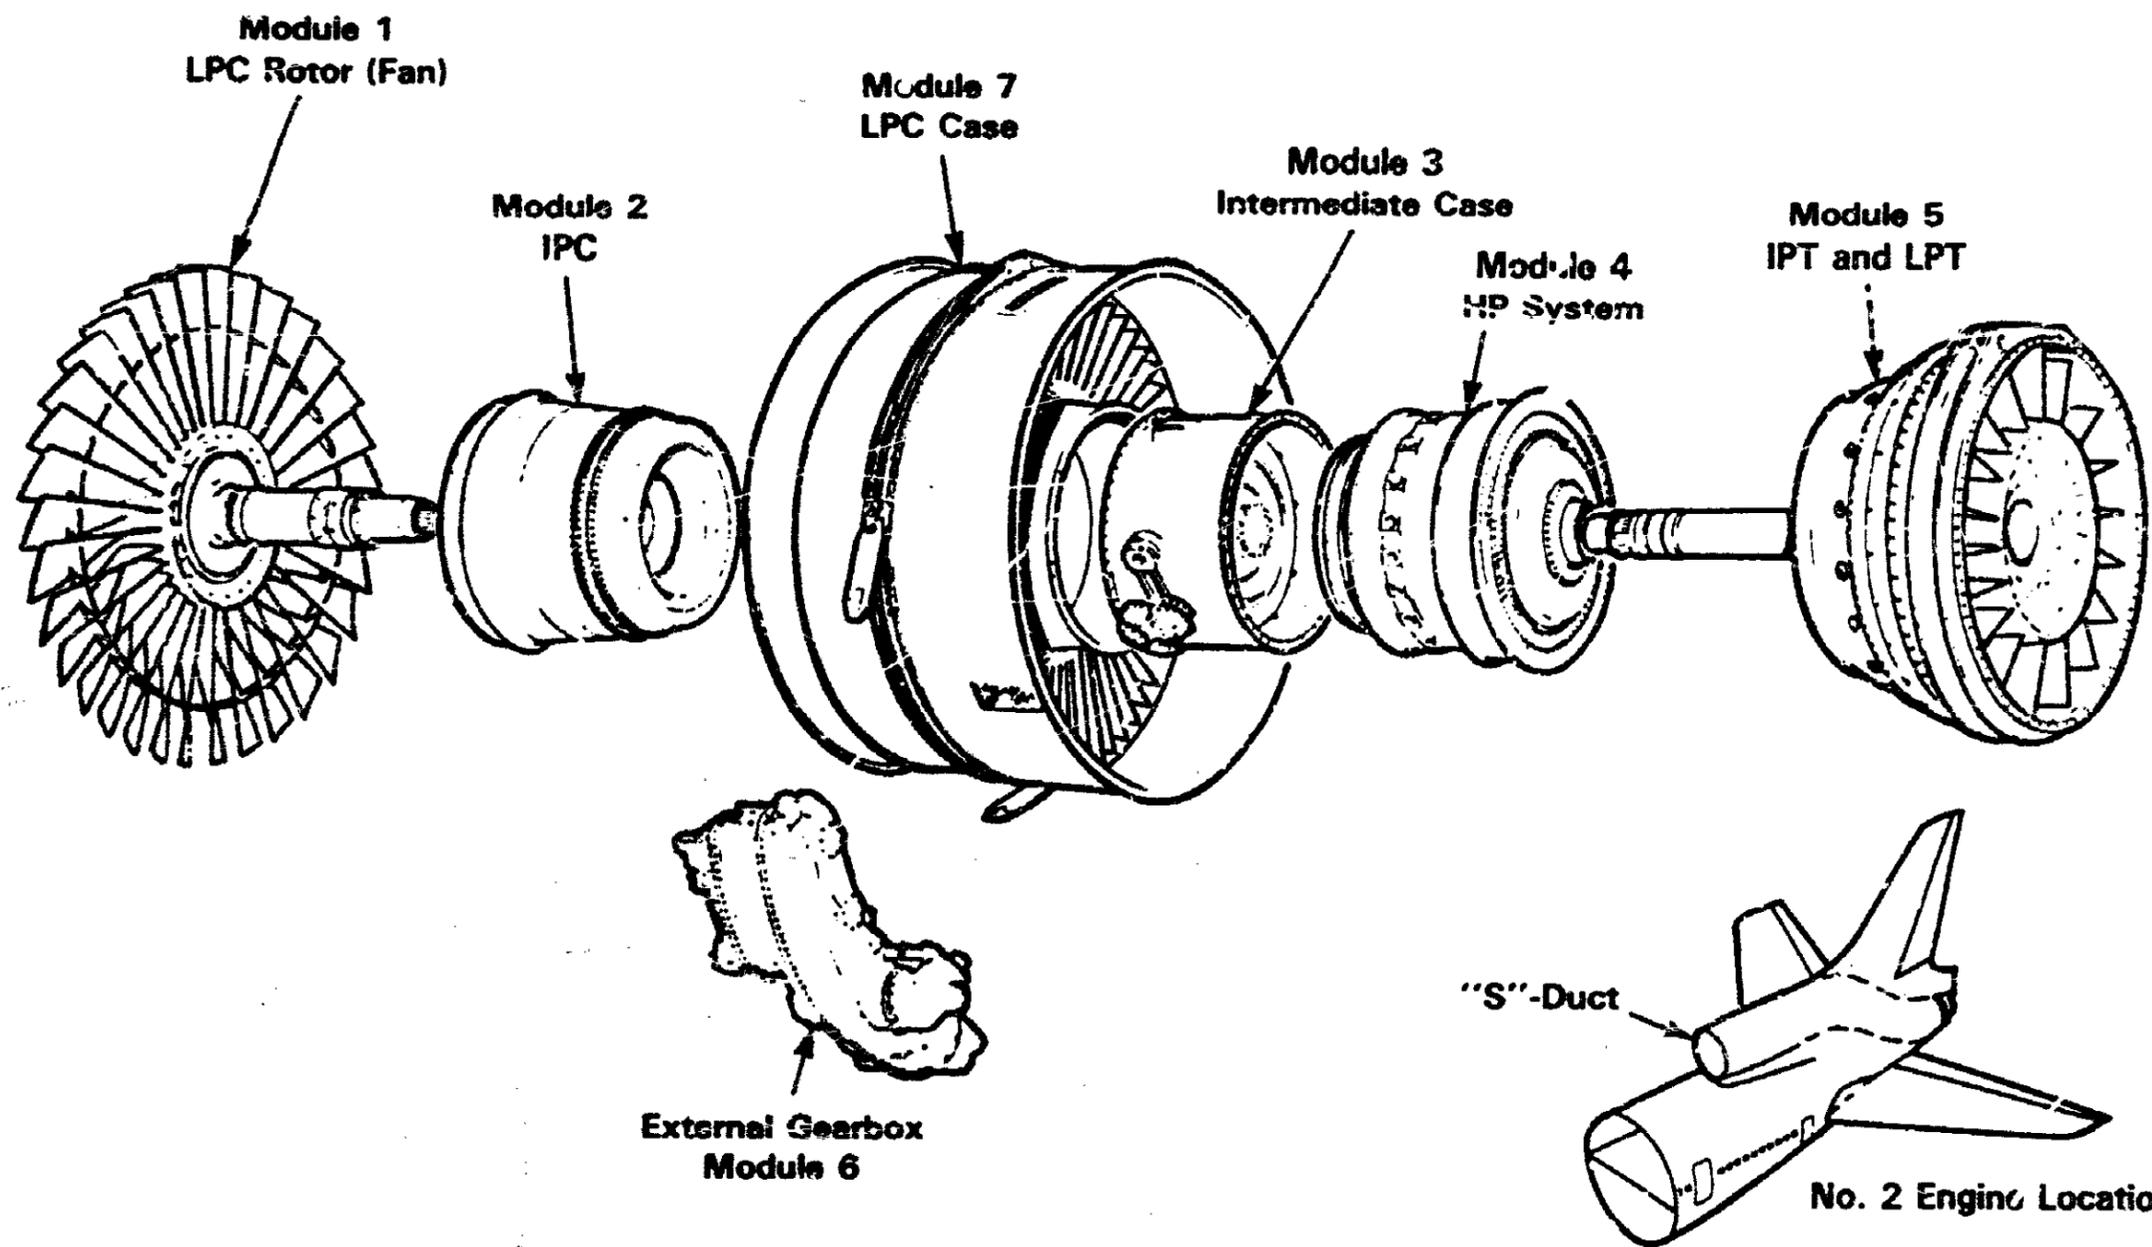
Figure 3. -- Module Breakdown of Engine.

Engine Modules--The engine has been designed to break down into seven major modules. These are: (See figure 3.)

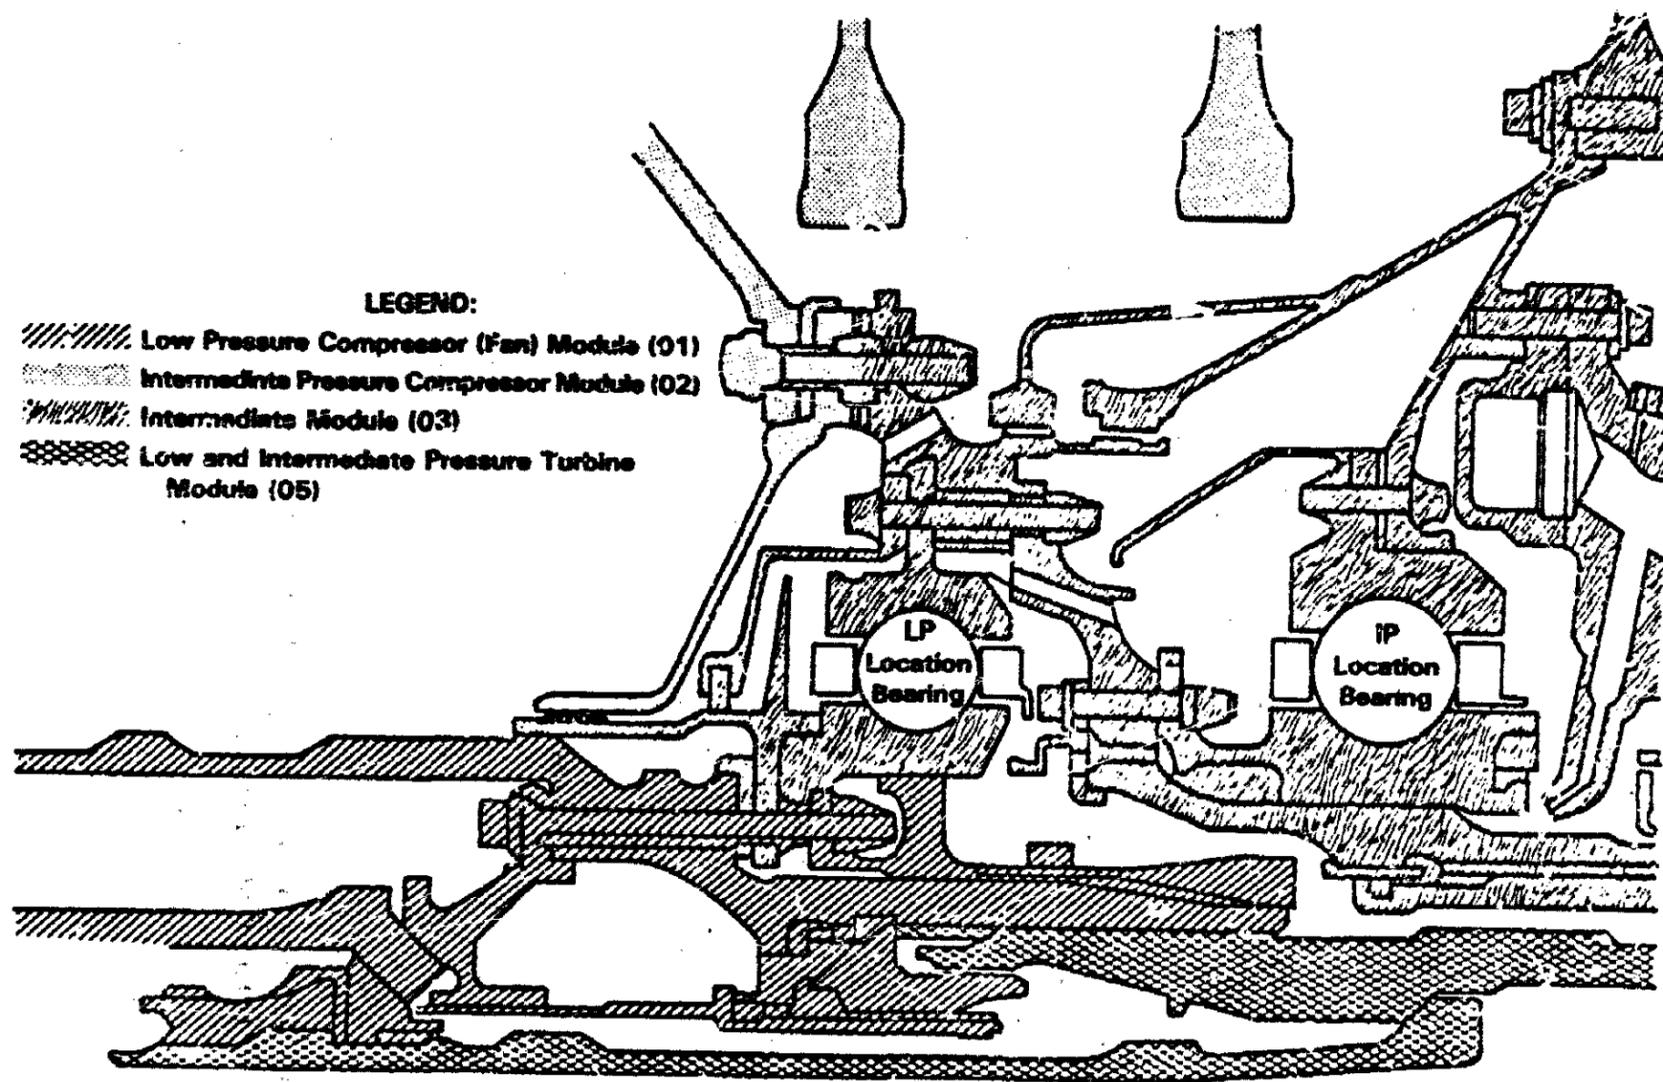
Figure 4. -- RB-211-22B Module Arrangement.

The compressor rotor shaft has five titanium discs in the forward section and two steel discs forming the rear section. Titanium rotor blades are used throughout. The rear stub shaft is splined and locked to the IPT shaft. (See figure 4.)

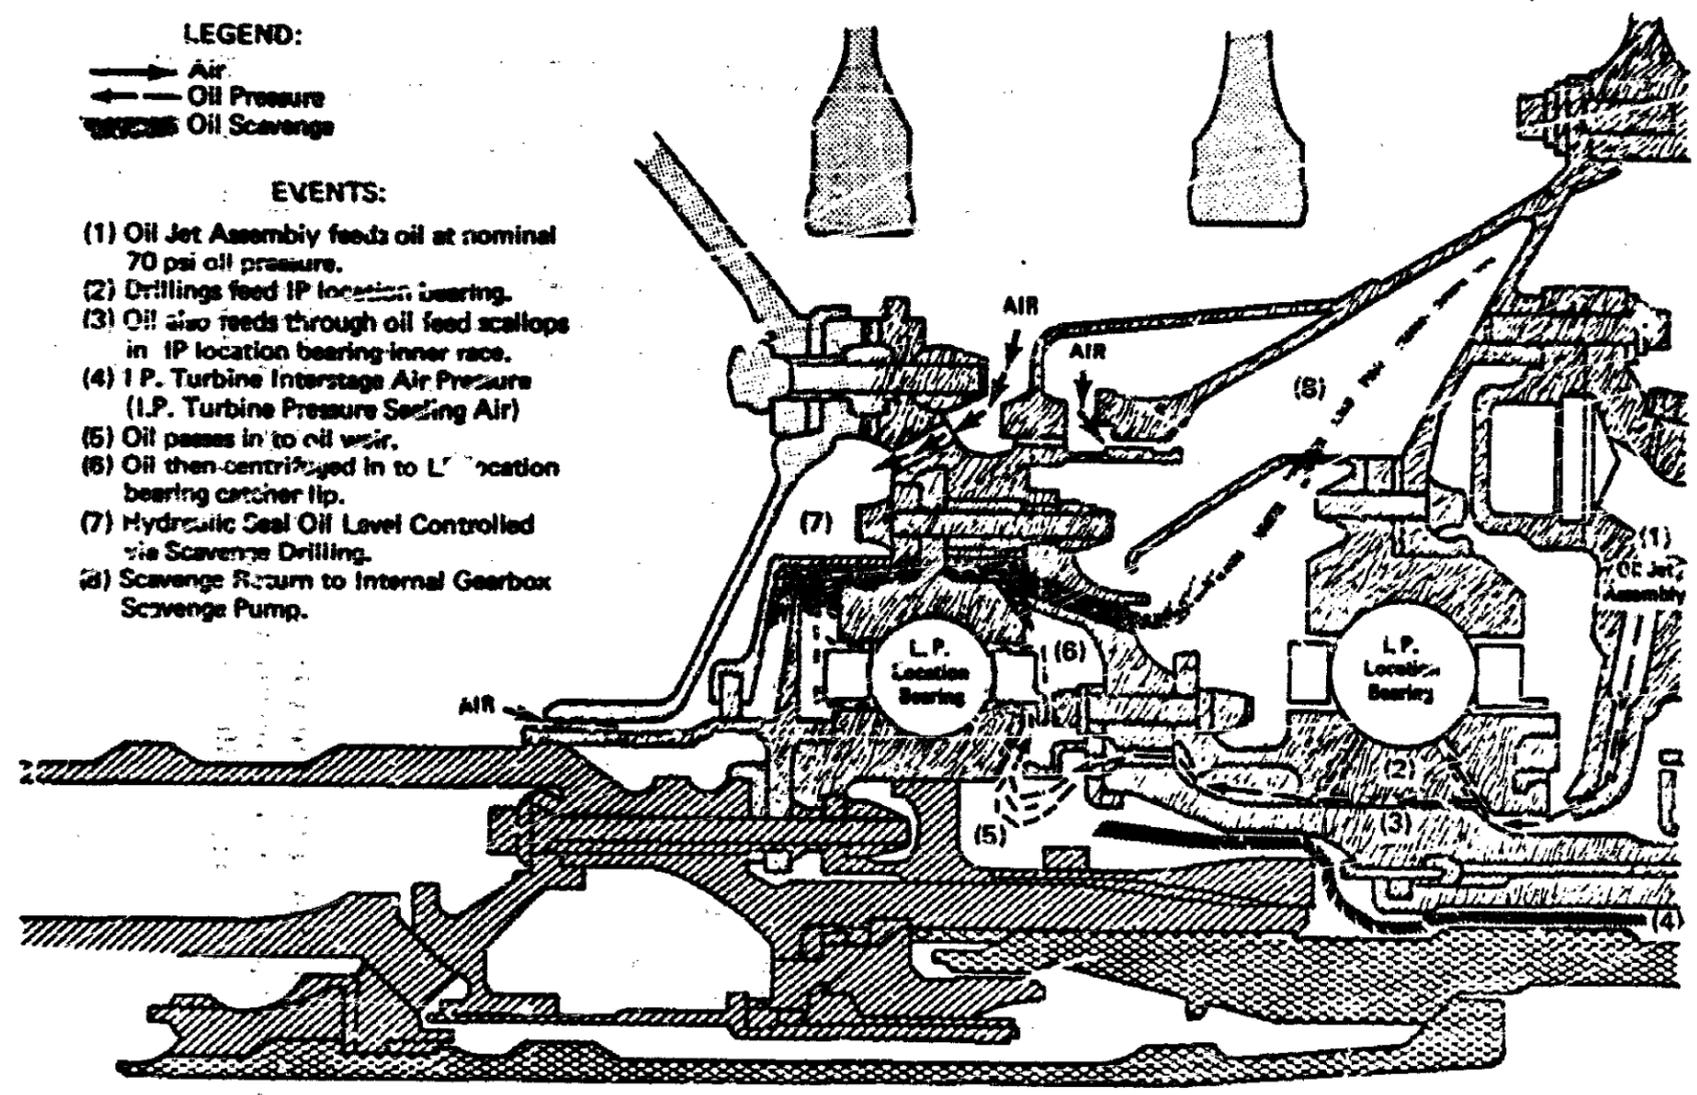
Figure 6. -- LPLB Normal Oil Supply and Scavenge.

- EVENTS:**
- (1) Oil Jet Assembly feeds oil at nominal 70 psi oil pressure.
 - (2) Drillings feed IP location bearing.
 - (3) Oil also feeds through oil feed scallops in IP location bearing inner race.
 - (4) I.P. Turbine Interstage Air Pressure (I.P. Turbine Pressure Sealing Air)
 - (5) Oil passes in to oil weir.
 - (6) Oil then centrifuged in to L.P. location bearing catcher lip.
 - (7) Hydraulic Seal Oil Level Controlled via Scavenge Drilling.
 - (8) Scavenge Return to Internal Gearbox Scavenge Pump.
