AIRCRAFT ACCIDENT REPORT

RONSON AVIATION
BELL 206B, N27670 AND
SEMINOLE AIR CHARTER
PIPER PA-34-200T, N8110R
MIDAIR COLLISION
EAST RUTHERFORD, NEW JERSEY
SEPTEMBER 23, 1981

NTSB-AAR-82-6

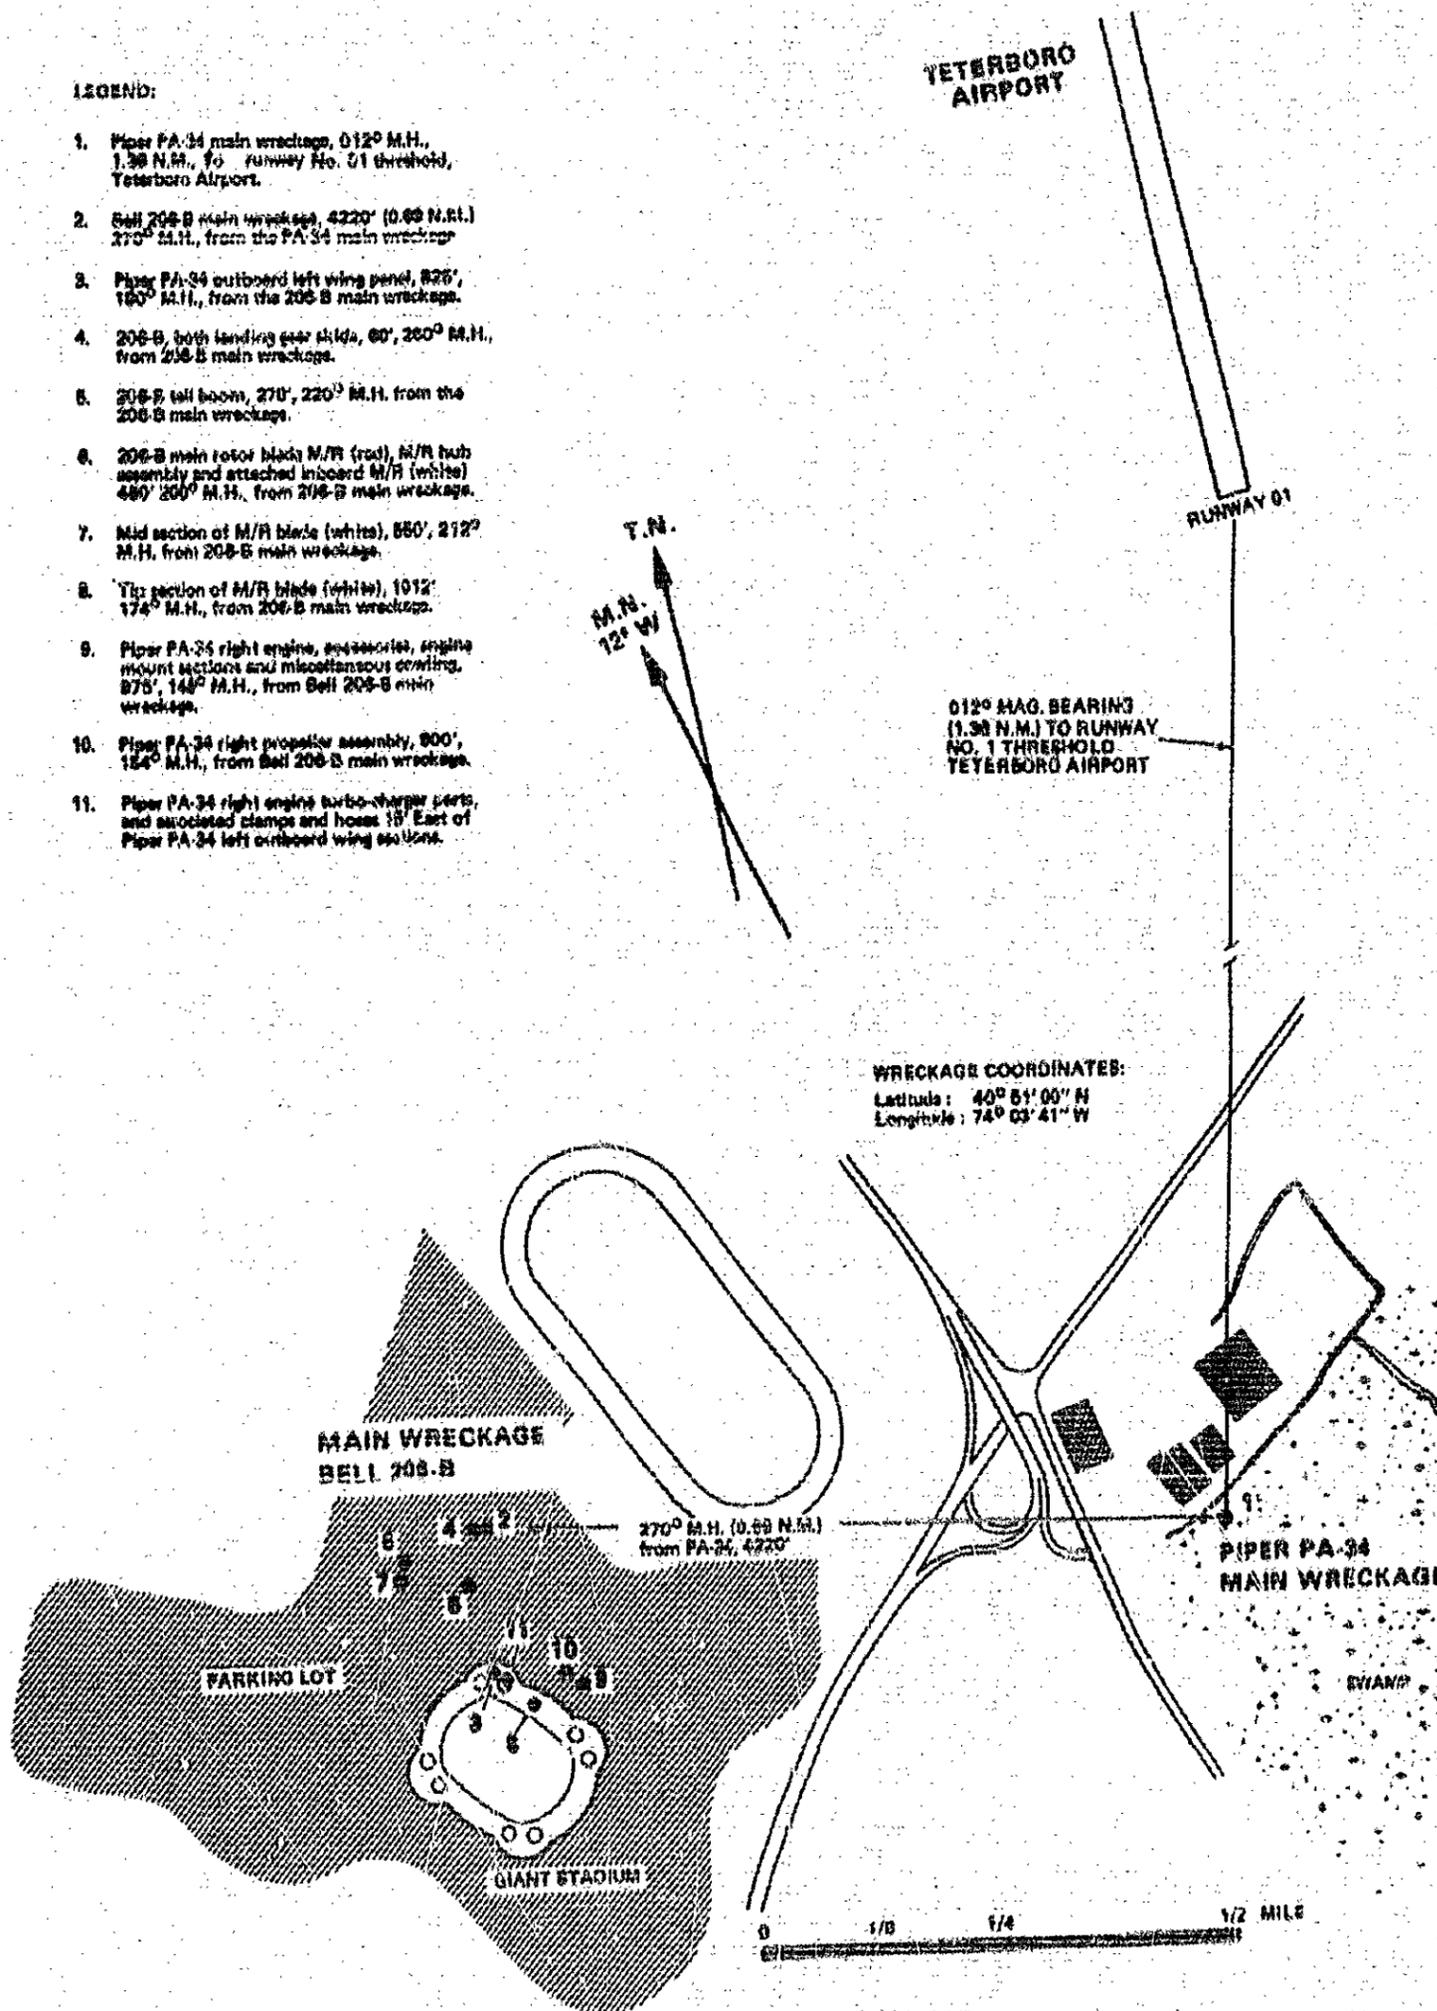
9. Piper PA-34 right engine, accessories, engine mount sections and miscellaneous wiring, 878', 148° M.H., from Bell 206-B main wreckage.
10. Piper PA-34 right propeller assembly, 800', 154° M.H., from Bell 206-B main wreckage.

11. Piper PA-34 right engine turbo-charger parts, and associated clamps and hoses 15' East of Piper PA-34 left outboard wing sections.
