AIRCRAFT ACCIDENT REPORT

**EMPIRE AIRLINES
FLIGHT 141, PIPER PA-31, N546BA
ITHACA, NEW YORK
JANUARY 5, 1982**

NTSB-AAR-82-11

Adopted September 22, 1982

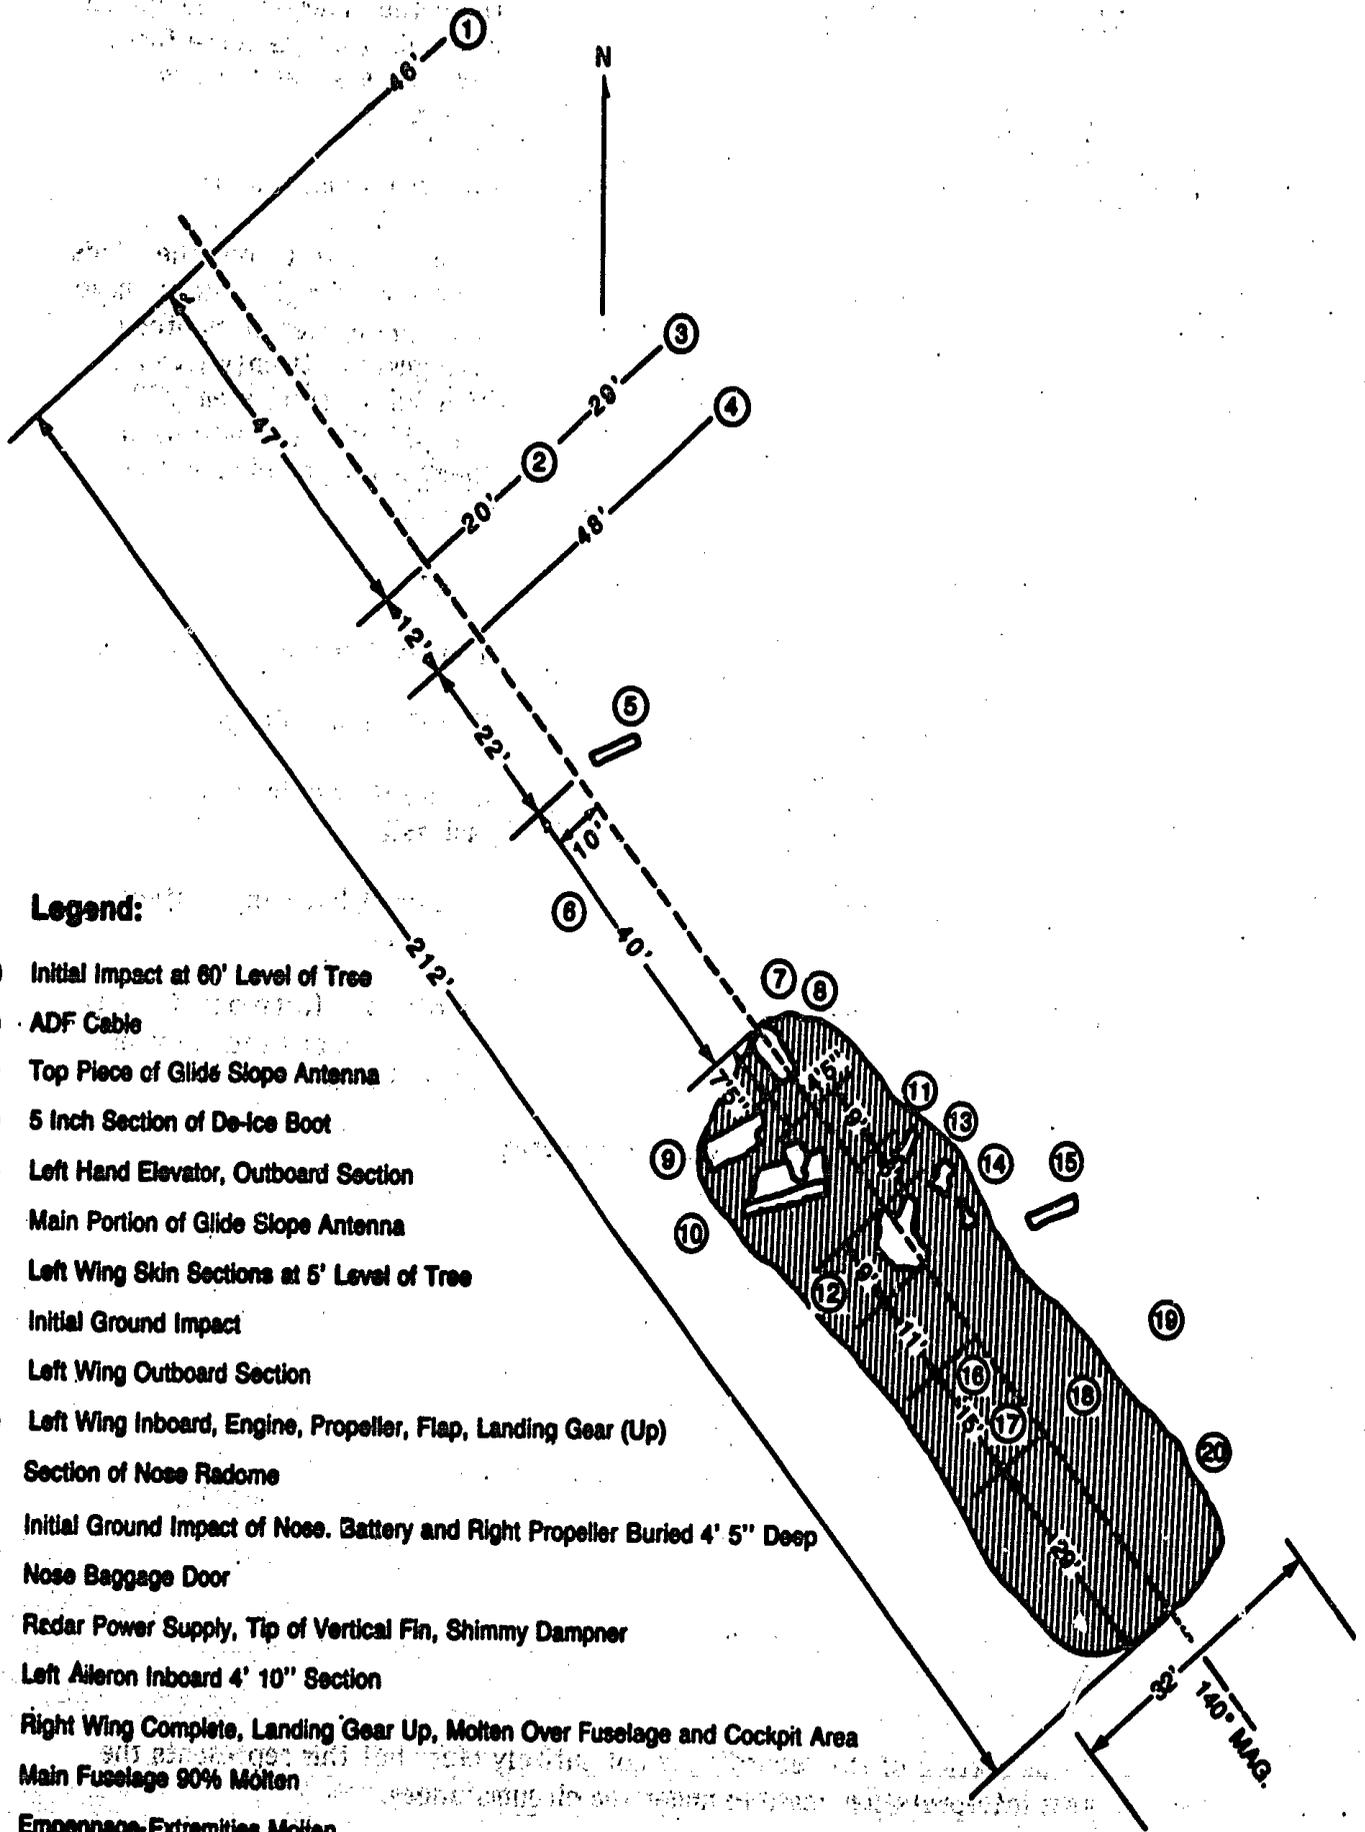
WRUCKAGE DISTRIBUTION CHART

The airplane first hit the trees about 60 feet above ground level. The airplane first hit the ground about 120 feet horizontally from initial tree impact. The pattern of damage to the trees indicated that the airplane passed through the trees with an 80° to 90° left wing-down bank angle and a 24° nosedown pitch angle.

The disintegration of the airplane was extensive. Parts of all major sections of the structure and of the flight control surfaces were identified at the wreckage site. The intense ground fire consumed about 85 percent of the fuselage, wings, and empennage; the landing gear was found retracted.
