NATIONAL TRANSPORTATION SAFETY BOARD

AIRCRAFT ACCIDENT REPORT

NORTH AMERICAN ROCKWELL AERO COMMANDER
MODEL 560E, N3827C
AND CESSNA 182Q, N96402
MIDAIR COLLISION
LIVINGSTON, NEW JERSEY
NOVEMBER 20, 1982

NTSB/AAR-83/03

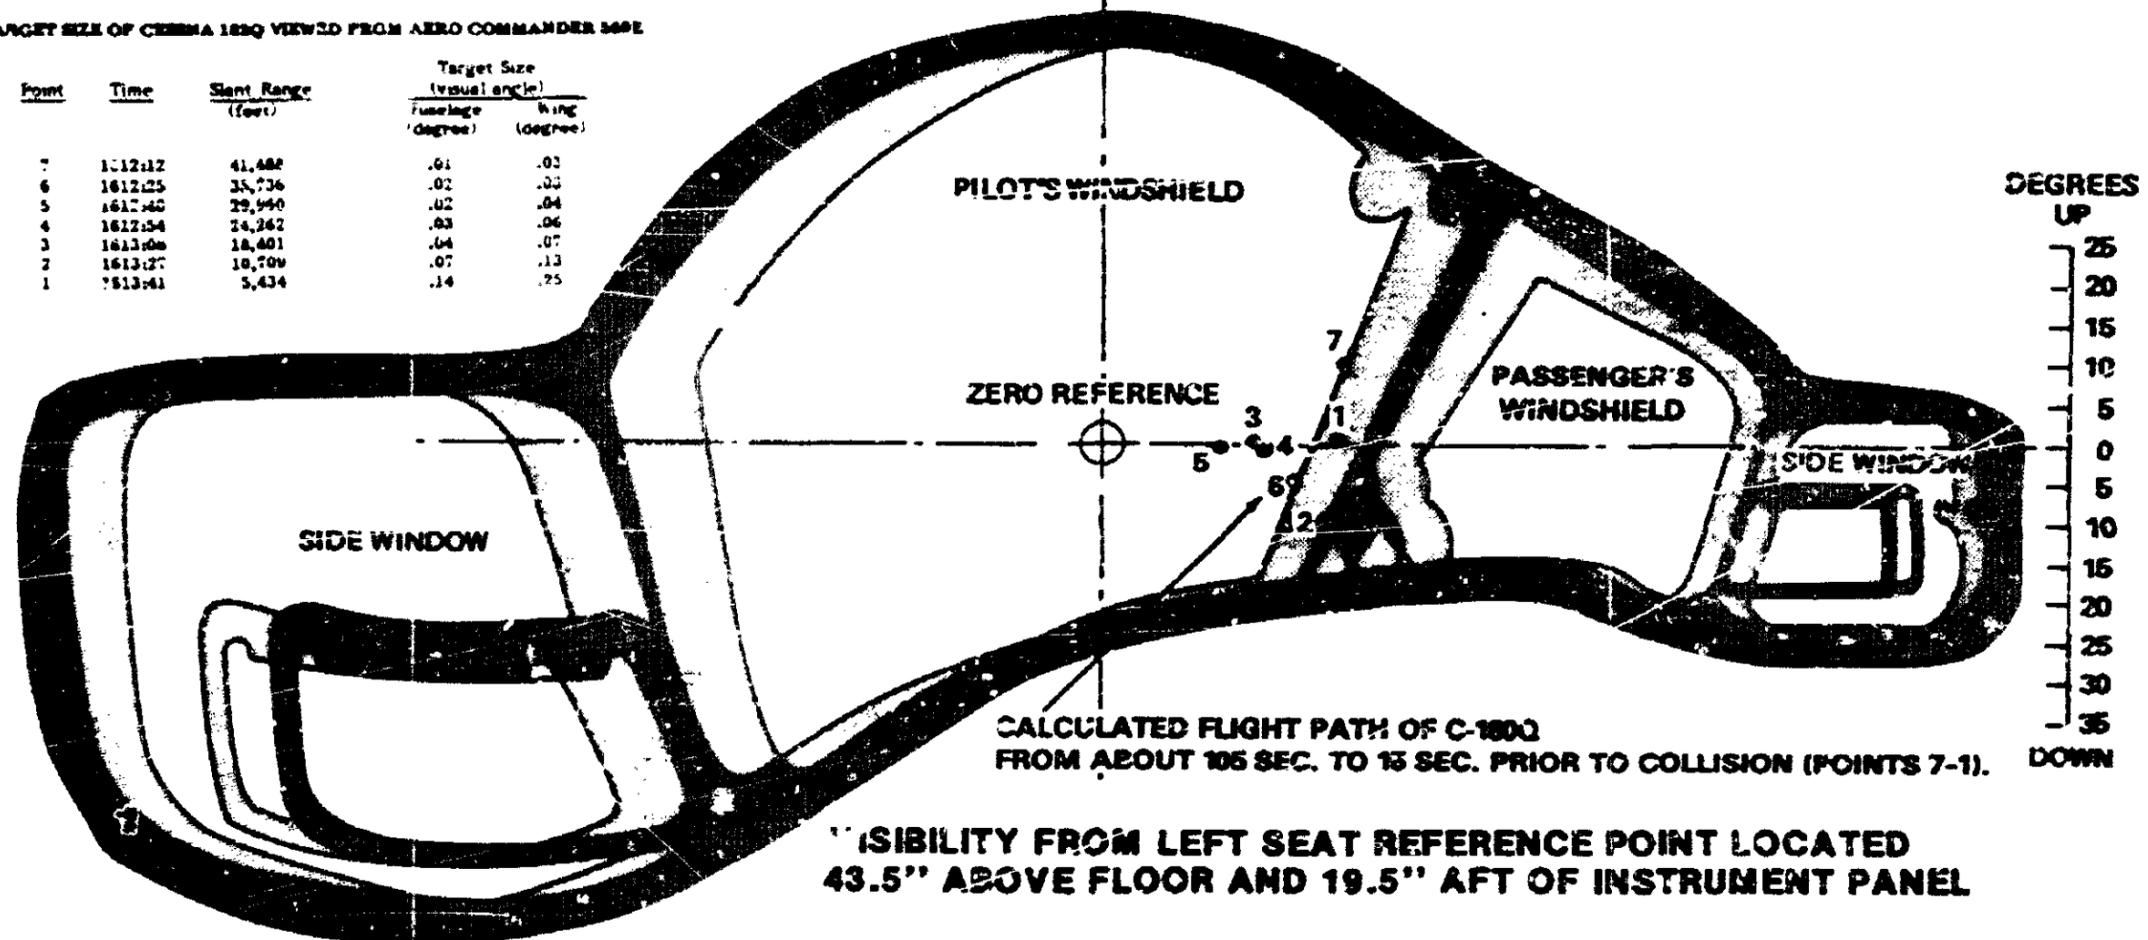
TARGET SIZE OF CESSNA 180Q VIEWED FROM AERO COMMANDER 560E

Point	Time	Slant Range (feet)	Target Size (visual angle)	
			Fuselage (degree)	Wing (degree)
7	1612:12	41,482	.01	.02
6	1612:25	35,736	.02	.03
5	1612:40	29,990	.02	.04
4	1612:54	24,262	.03	.06
3	1613:08	18,401	.04	.07
2	1613:27	10,709	.07	.13
1	1613:41	5,434	.14	.25

NOTE: BLACK AREAS REPRESENT OBSTRUCTED VISION.
 SHADED AREAS REPRESENT MONOCULAR VISION.
 CLEAR AREAS REPRESENT BINOCULAR VISION

THE ACCURACY OF THESE ILLUSTRATIONS IS LIMITED BY
 THE PROCESS BY WHICH THE ILLUSTRATIONS WERE PRODUCED.
 THAT IS, THE ILLUSTRATIONS WERE PRODUCED FROM TRACINGS
 OF THE ORIGINAL BINOCULAR PHOTOGRAPHS.
