# **NATIONAL TRANSPORTATION SAFETY BOARD**

## **AIRCRAFT ACCIDENT REPORT**

**MIDAIR COLLISION OF  
U.S. ARMY U-21A, ARMY 18061,  
AND SACHS ELECTRIC COMPANY  
PIPER PA-31-350, N60SE  
INDEPENDENCE, MISSOURI  
JANUARY 20, 1987**

NTSB/AAR-88/01

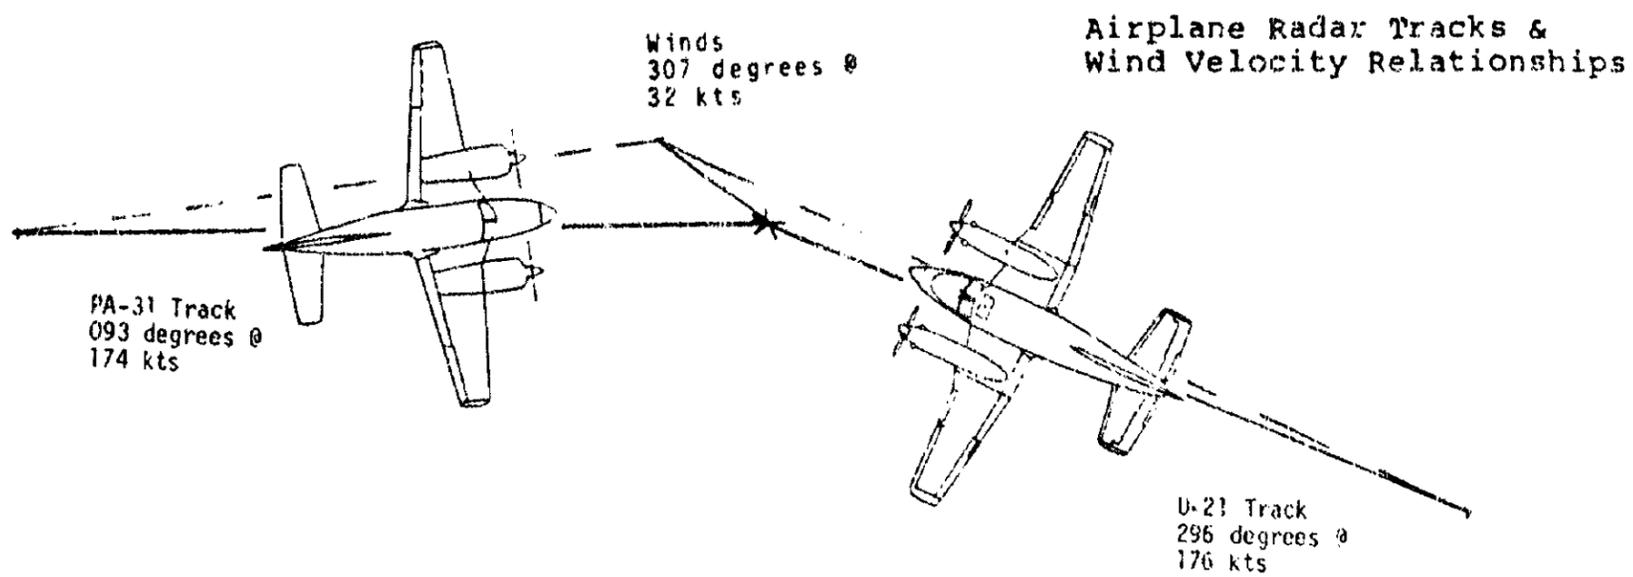
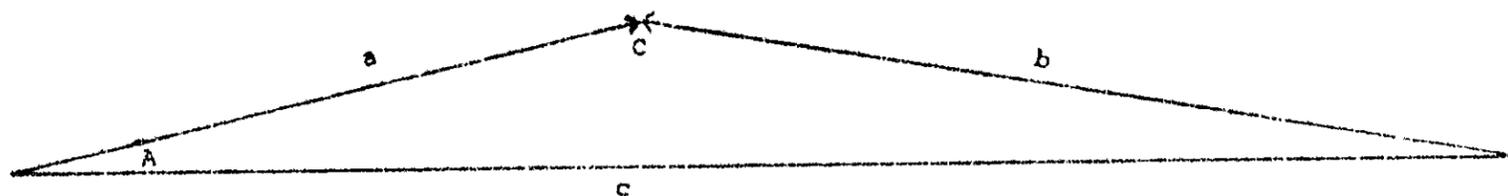
Figure 3.--Horizontal and vertical relationship of the airplanes at impact.

In addition to the cabin roof, the entire aft fuselage and empennage of the U-21 was separated from the forward cabin area in the collision. This was evidenced by the disintegration of the empennage and the scatter of the aft fuselage and empennage debris. Contact between the PA-31 cabin or right wing, as the PA-31 rode over the top of the U-21, would have caused such damage. The recovery of a piece of the vertical stabilizer from the U-21 in the PA-31 cabin showed that the vertical stabilizer had contacted or passed through the PA-31 cabin. (See figure 3.)

Angle A = Scratch Angle - Drift Angle =  $(20-7) = 13$  degrees
