# **NATIONAL TRANSPORTATION SAFETY BOARD**

## **AIRCRAFT ACCIDENT REPORT**

**TRANS-COLORADO AIRLINES, INC., FLIGHT 2286  
FAIRCHILD METRO III, SA227 AC, N68TC  
BAYFIELD, COLORADO  
JANUARY 19, 1988**

NTSB/AAR-89/01

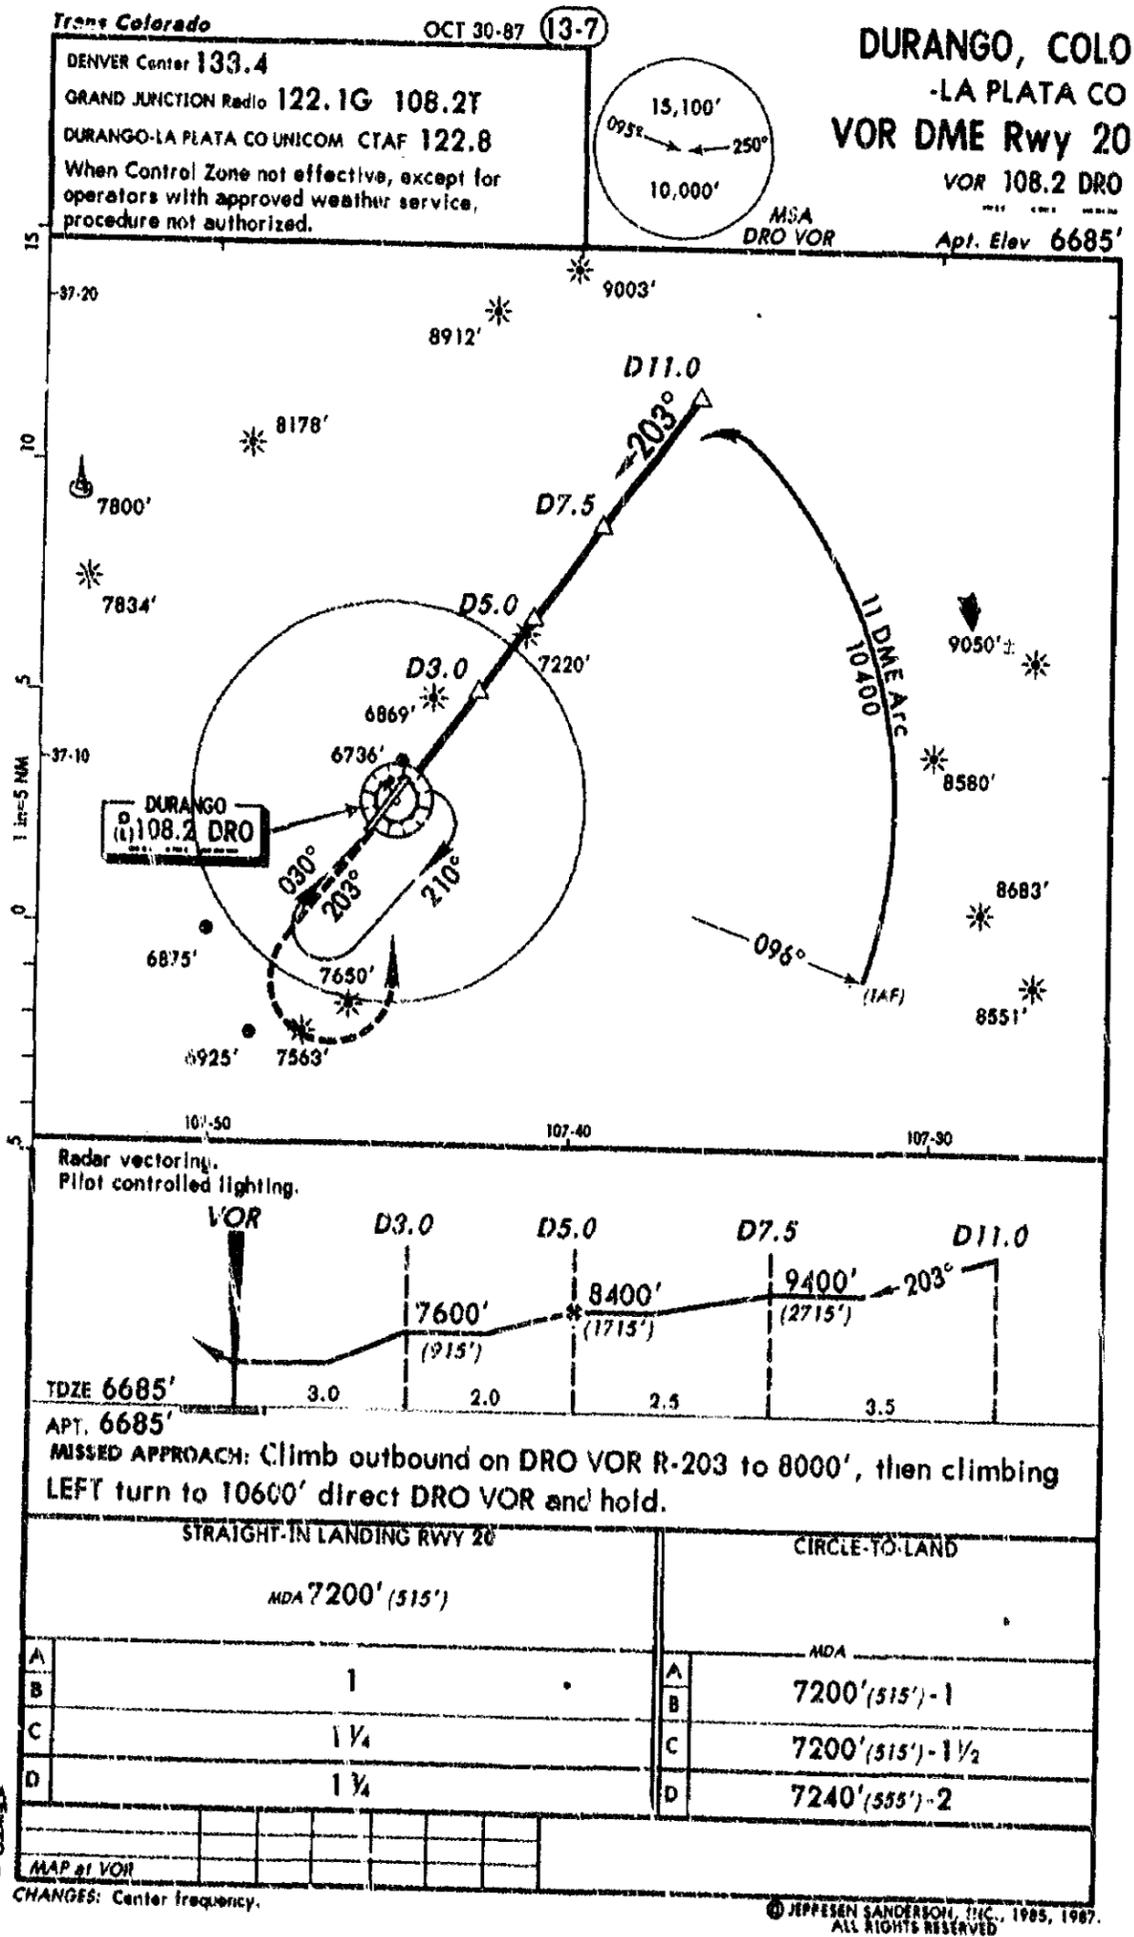
Figure 1.--VOR DME approach to runway 20 of DRO.  
 Copyright Jeppesen-Sanderson Company.  
 Reprinted with permission.

flight, "...if you want to proceed direct to the [DRO] zero two three radial eleven mile fix that's approved." The captain acknowledged. (See figure 1.)
