AIRCRAFT ACCIDENT REPORT

MARKAIR, INC.
BOEING 737-2X6C, N670MA
CONTROLLED FLIGHT INTO TERRAIN
UNALAKLEET, ALASKA
JUNE 2, 1990

On June 2, 1990, at 0937 Alaskan Daylight Time, MarkAir, Inc., flight 3087, a Boeing 737-2X6C, registered in the US as N670MA, crashed about 7.5 miles short of runway 14, Unalakleet, Alaska, while executing a localizer approach to that runway. The flight originated at 0828 at Anchorage International Airport, Anchorage, Alaska. Instrument meteorological conditions existed at the time, and the flight was on an IFR flight plan. The captain, the first officer, and a flight attendant sustained minor injuries. Another flight attendant sustained serious injuries. There were no passengers on board, and the airplane was destroyed. The flight was operated under FAR Part 121.

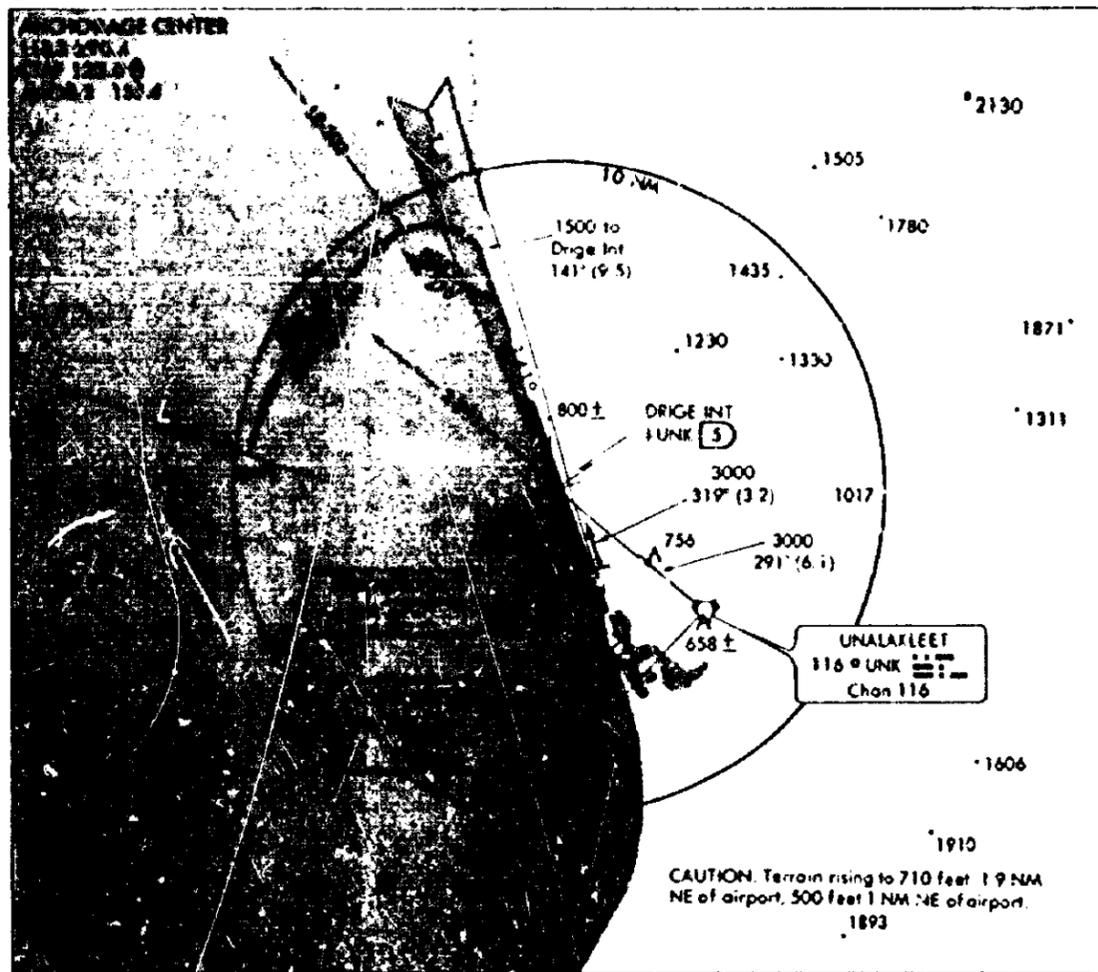
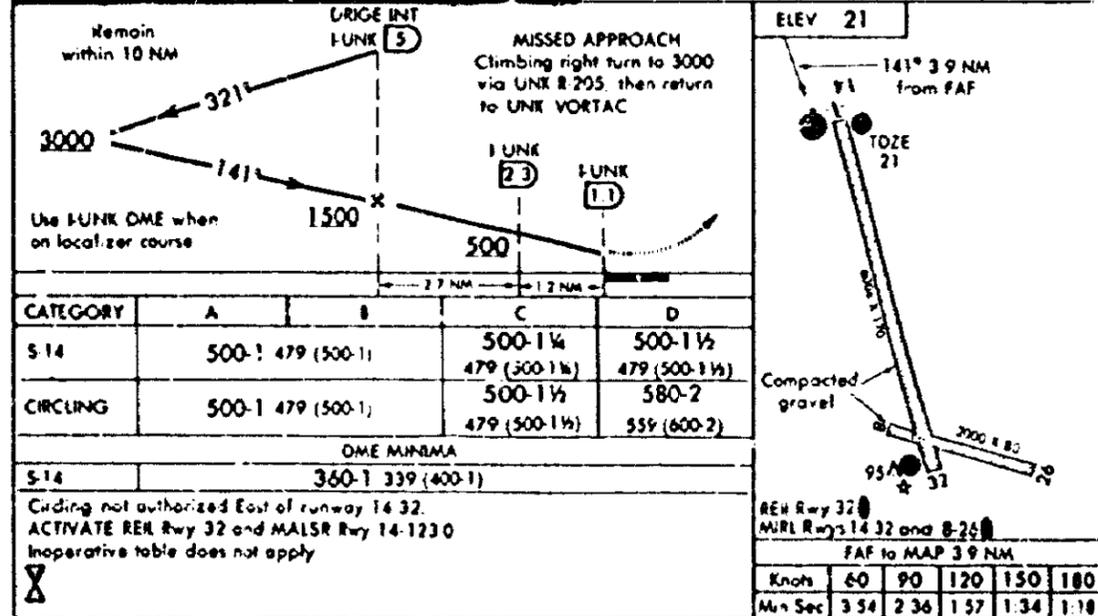
LOC RWY 14

These conditions were above minimums for the localizer runway 14 (LOC Rwy 14) instrument approach to be flown by the captain. (See figure 1).
