PB91-910408
NTSB/AAR-91/07

AIRCRAFT ACCIDENT REPORT

**FUEL FARM FIRE AT
STAPLETON INTERNATIONAL AIRPORT
DENVER, COLORADO
NOVEMBER 25, 1990**

**ADOPTED: October 1, 1991
NOTATION 5576**

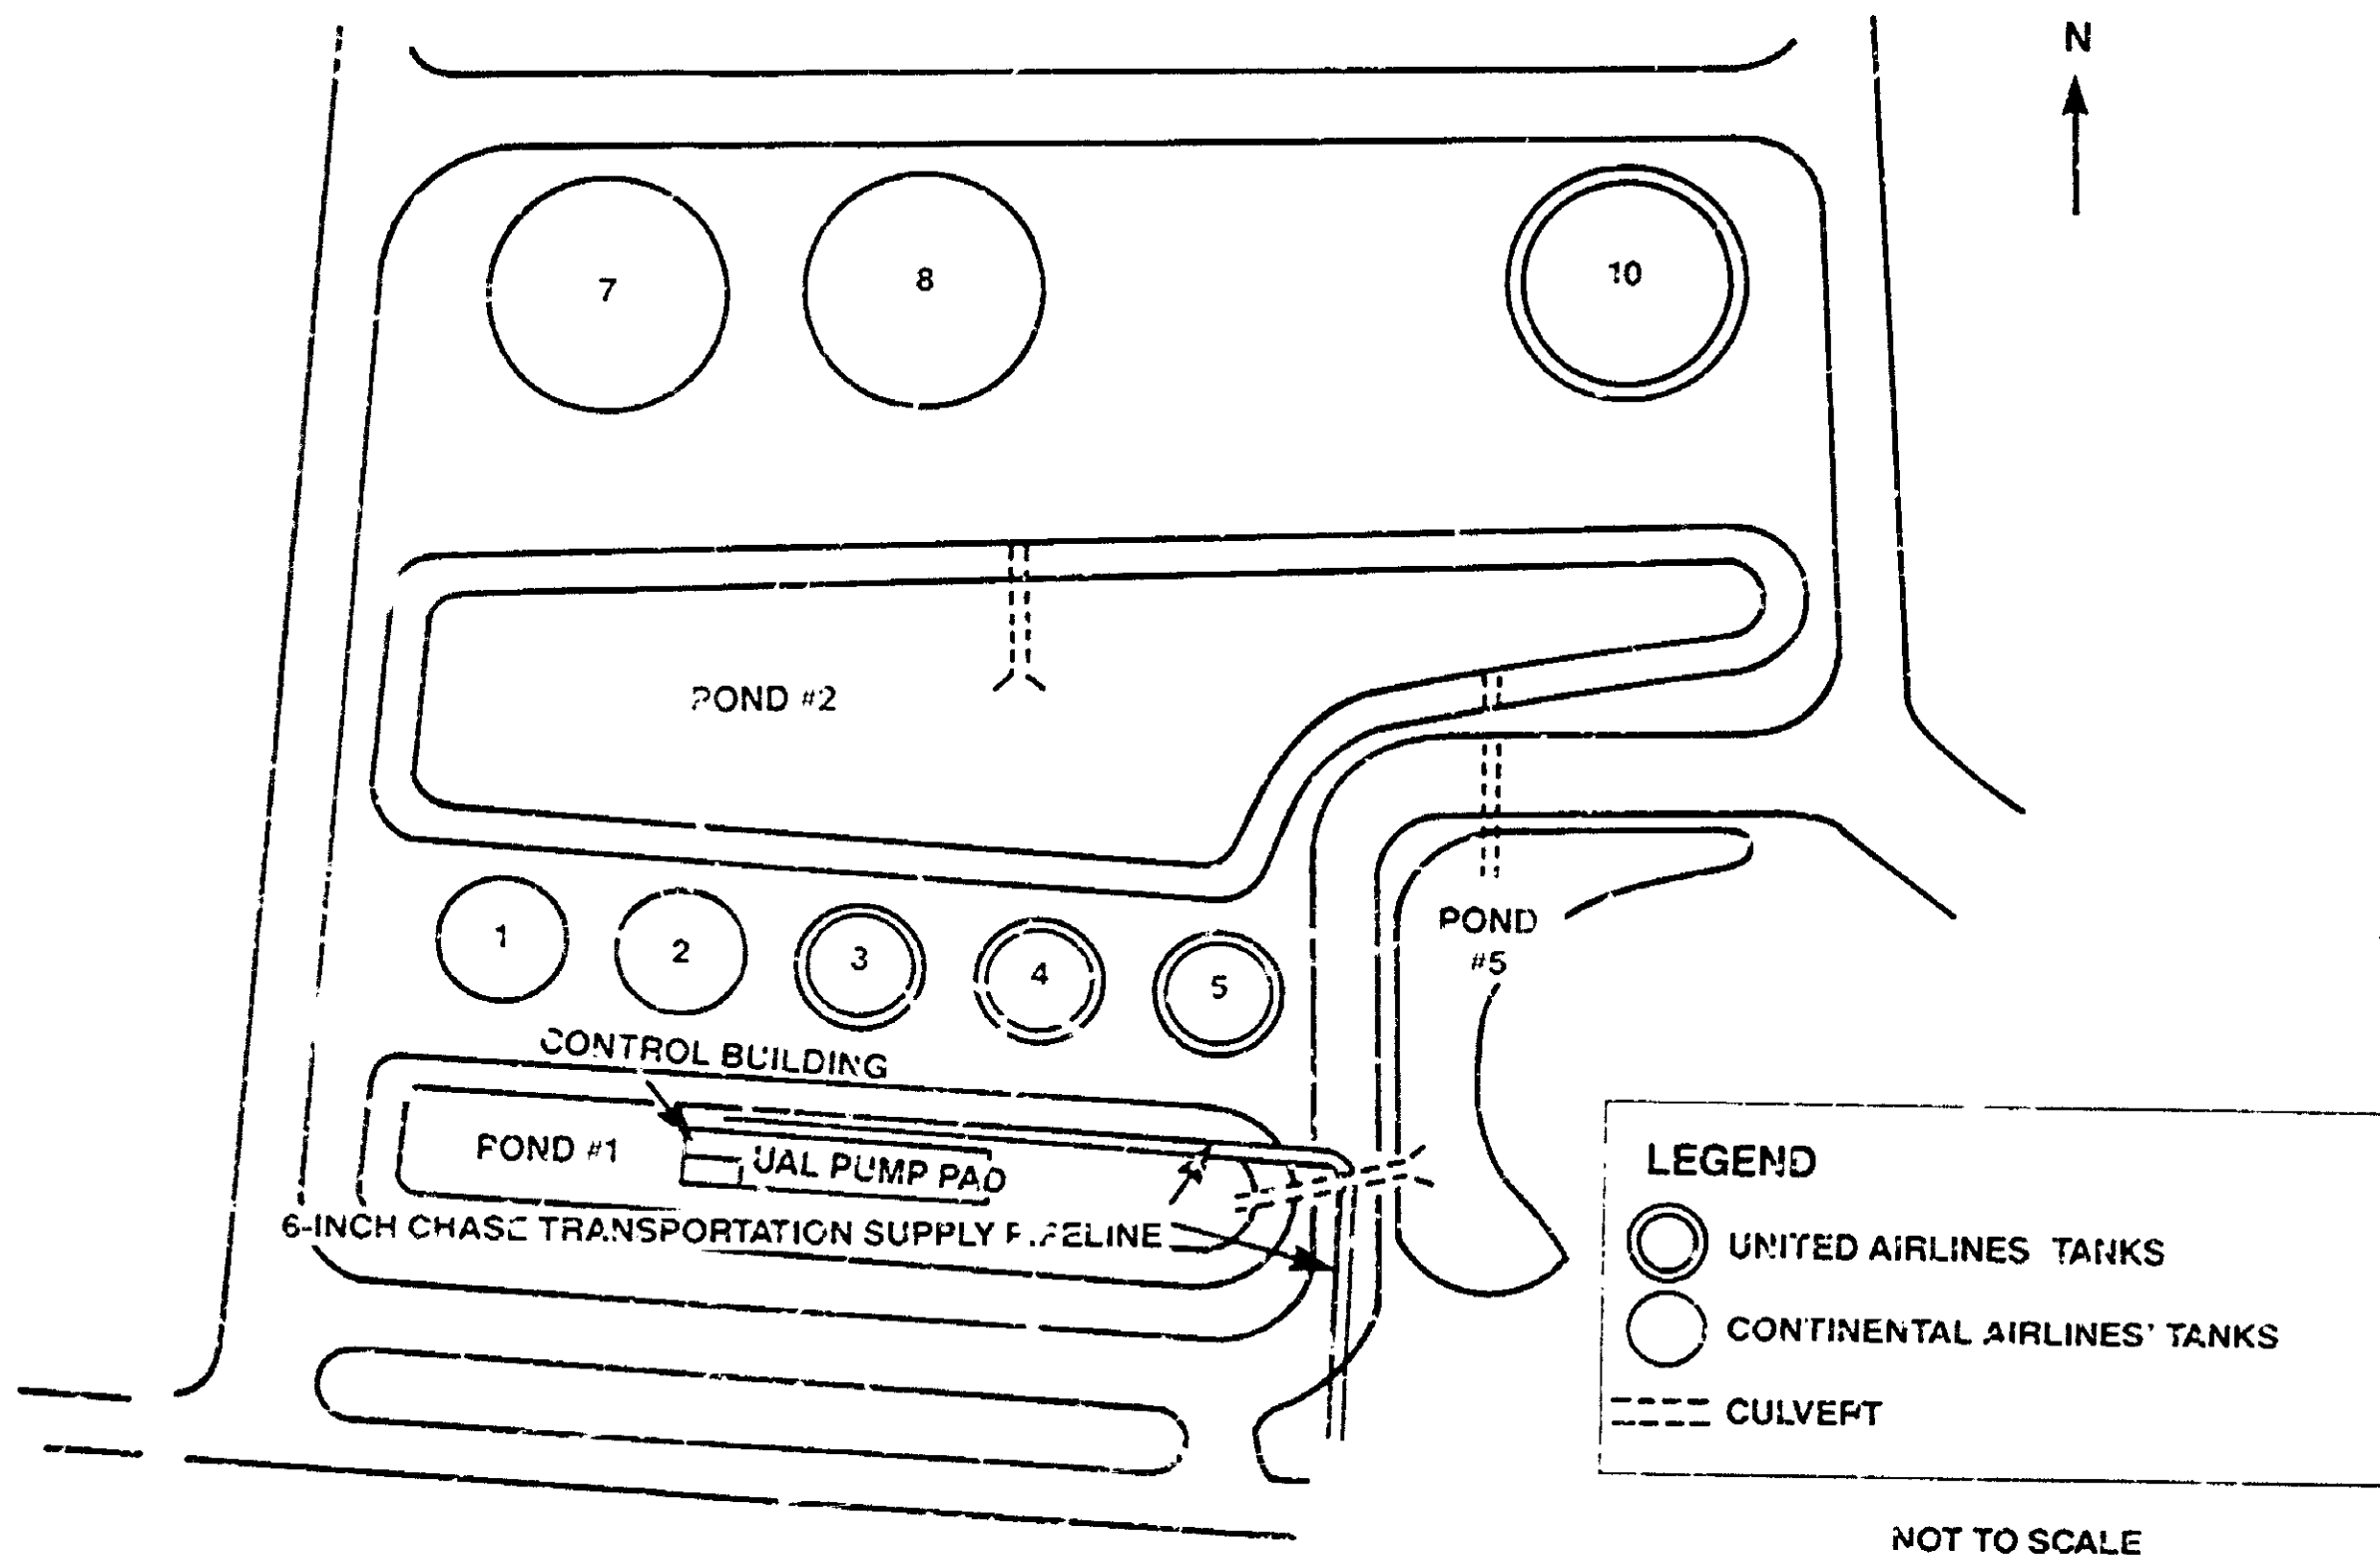
Figure 2.--Portion of the fuel farm involved in the fire.

Arriving firefighting crews observed a large fire, near United's fuel tanks 3 and 4, in a containment area (pond 1)⁵ that contained pipes, pumps, valves, and a control building (see figure 2). Also, burning fuel was spraying from equipment in front of tanks 3 and 4 in "tentacles" 8 to 10 feet long.

About 2130, a large amount of fuel began to flow into the containment area (pond 1). Firefighters stated that they believed that this increase in fuel was caused from the release of a discharge pipe attached to tank 4. Fuel and water began overflowing pond 1 and flowed into pond 2 via pond 5 (see figure 2). Burning fuel was then impinging on tanks 1 and 10, in addition to tanks 2, 3, 4, and 5. As flames from the burning fuel continued to impinge on tanks 1 and 2, firefighters applied hose streams directly on those tanks to keep them cool and to preclude their rupture.

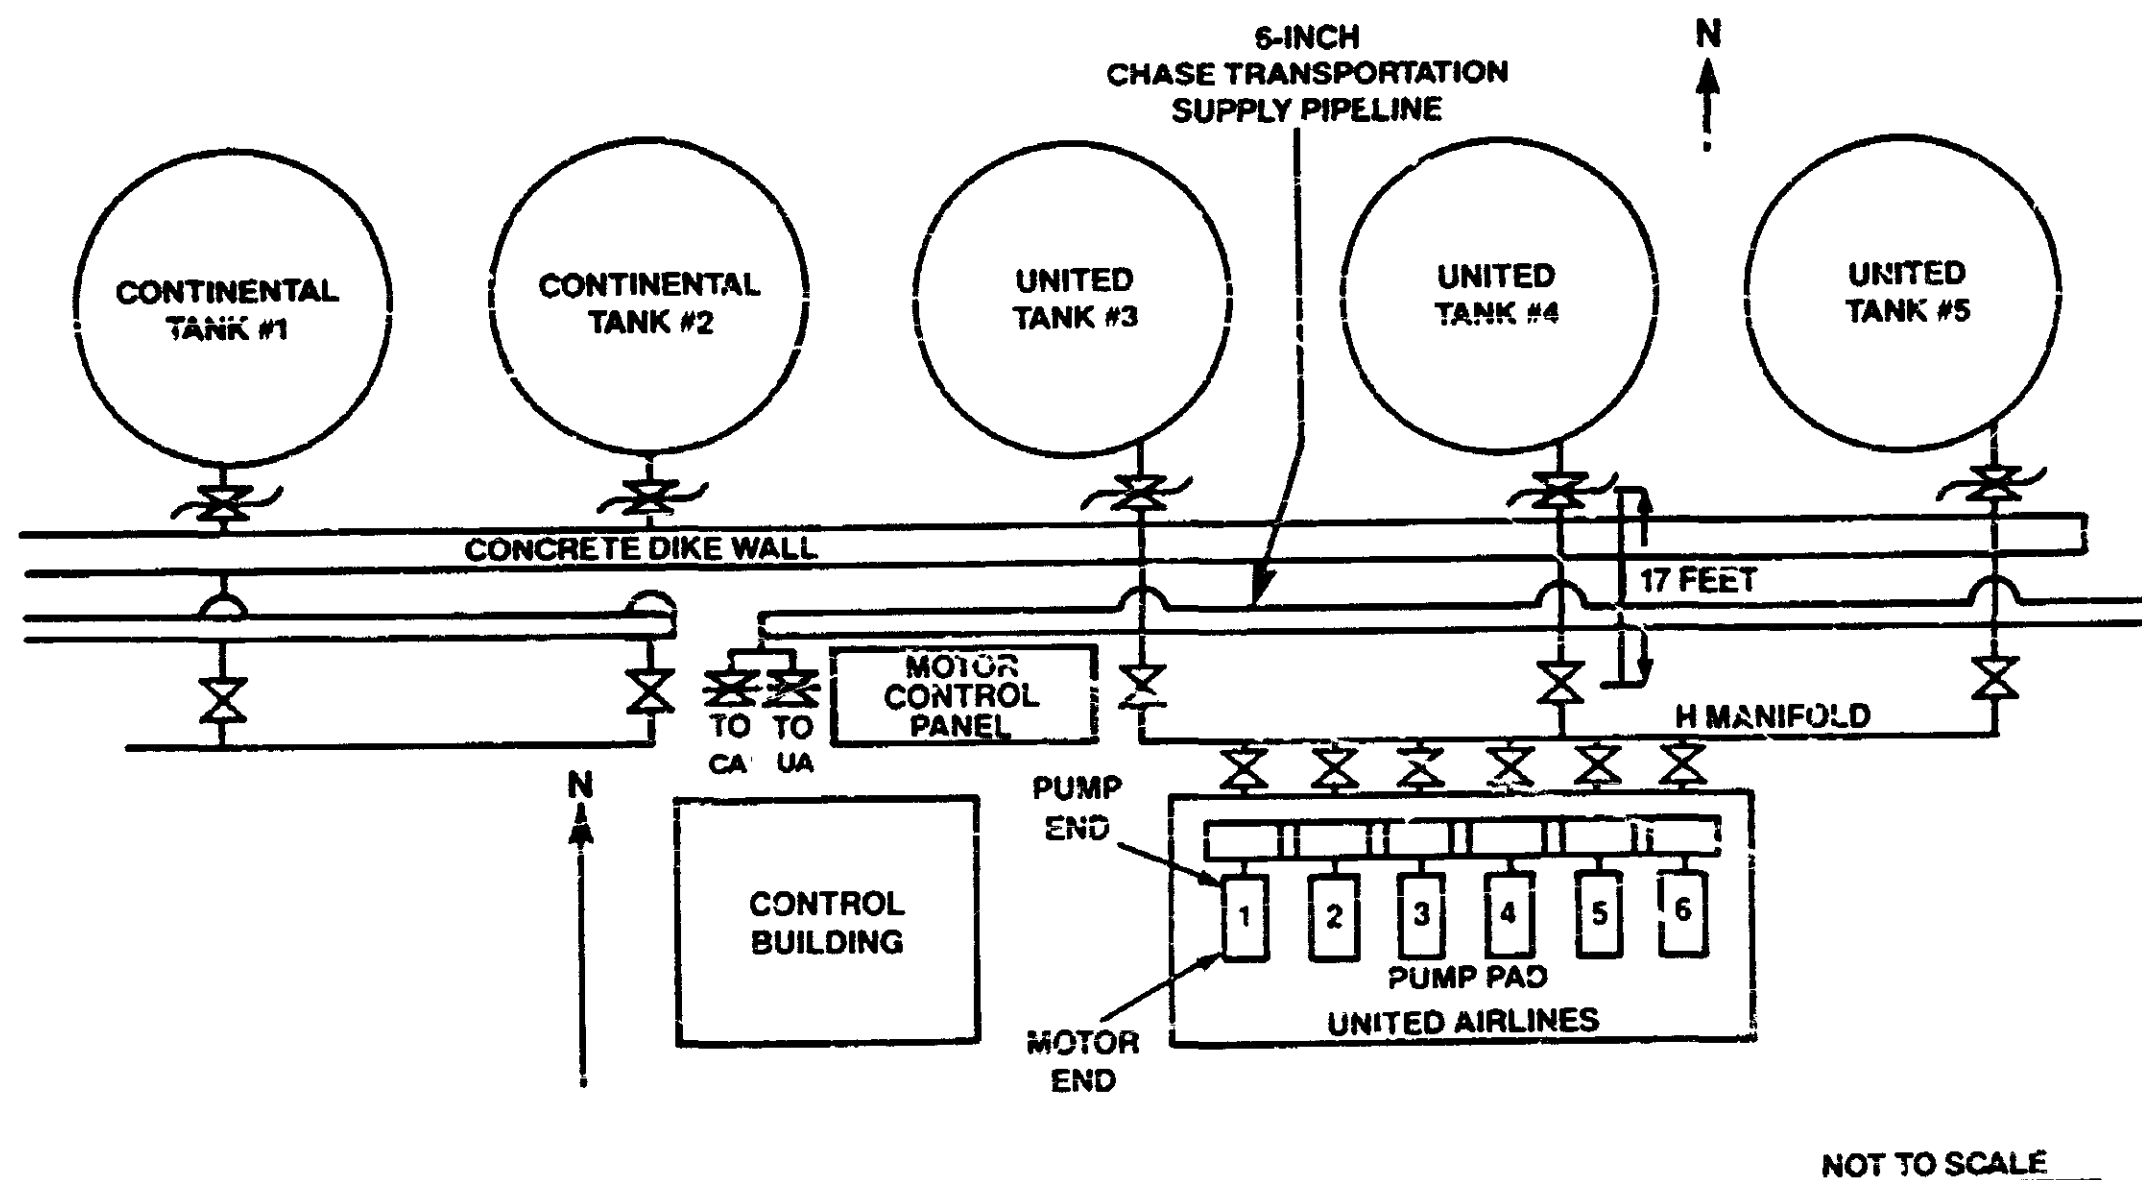
Figure 5. — Location of various valves in relation to tanks and motor/pump units.

The inlet/outlet piping on tanks 1, 2, 3, 4, 5, 7, 8, and 10 had manually operated "butterfly" valves at the base of each tank.¹¹ (See figure 5.) These fire-rated¹² steel valves were bolted externally onto the tank outlets. According to United, these valves were primarily closed for maintenance purposes, but were otherwise normally left open.

Tanks 1 through 5 had pneumatically operated control valves on both the inlet and outlet piping located about 17 feet from the manually operated "butterfly" valves. (See figure 5.) These valves on the piping for tanks 1, 3, and 4 were designed to automatically close if electrical power was lost and air pressure remained on the valve's operating control system. In the event air pressure was also lost, the valves would have to be closed manually. The pneumatically operated control valves on tanks 2 and 5 were fail-safe in the sense that they were designed to automatically close (spring loaded) if either electrical or air pressure was lost. The compressors providing the air supply for operating these valves were located in the control building, which was located in the containment area (pond 1).

United Airlines piped fuel from tanks 3, 4, and 5 to six motor/pump units (see figure 5) that discharged fuel into a manifold that was connected to underground pipelines that ran to the airport terminal for fueling aircraft.¹⁴ The number of pumps in operation at any particular time depended on fuel demand, measured by line pressure and fuel flow. Each month a different motor/pump unit was designated as the lead pump; other pumps would automatically be switched on as determined by fuel demand. For the month of November, pump 4 was the lead pump. As demand dictated, pump 3 would be activated after pump 4, followed by pumps 2, 1, 6, and 5. A 24-hour, 2-channel circular paper chart recorder recorded line pressure and fuel flow to the terminal. The chart recorder, the pumping controls, and associated electrical equipment switches for the United fueling system were housed in the control building located in the containment area (pond 1) forward of tanks 2 and 3 (see figure 2).
