National Transportation Safety Board Aircraft Accident Report  
Aborted Takeoff Shortly After Liftoff, Trans World Airlines  
Flight 843, Lockheed L-1011, N11002, John F. Kennedy  
International Airport, Jamaica, New York, July 30, 1992

PB93-910404  
NTSB/AAR-93/04

ABORTED TAKEOFF SHORTLY AFTER LIFTOFF  
TRANS WORLD AIRLINES FLIGHT 843  
LOCKHEED L-1011, N11002  
JOHN F. KENNEDY INTERNATIONAL AIRPORT  
JAMAICA, NEW YORK  
JULY 30, 1992

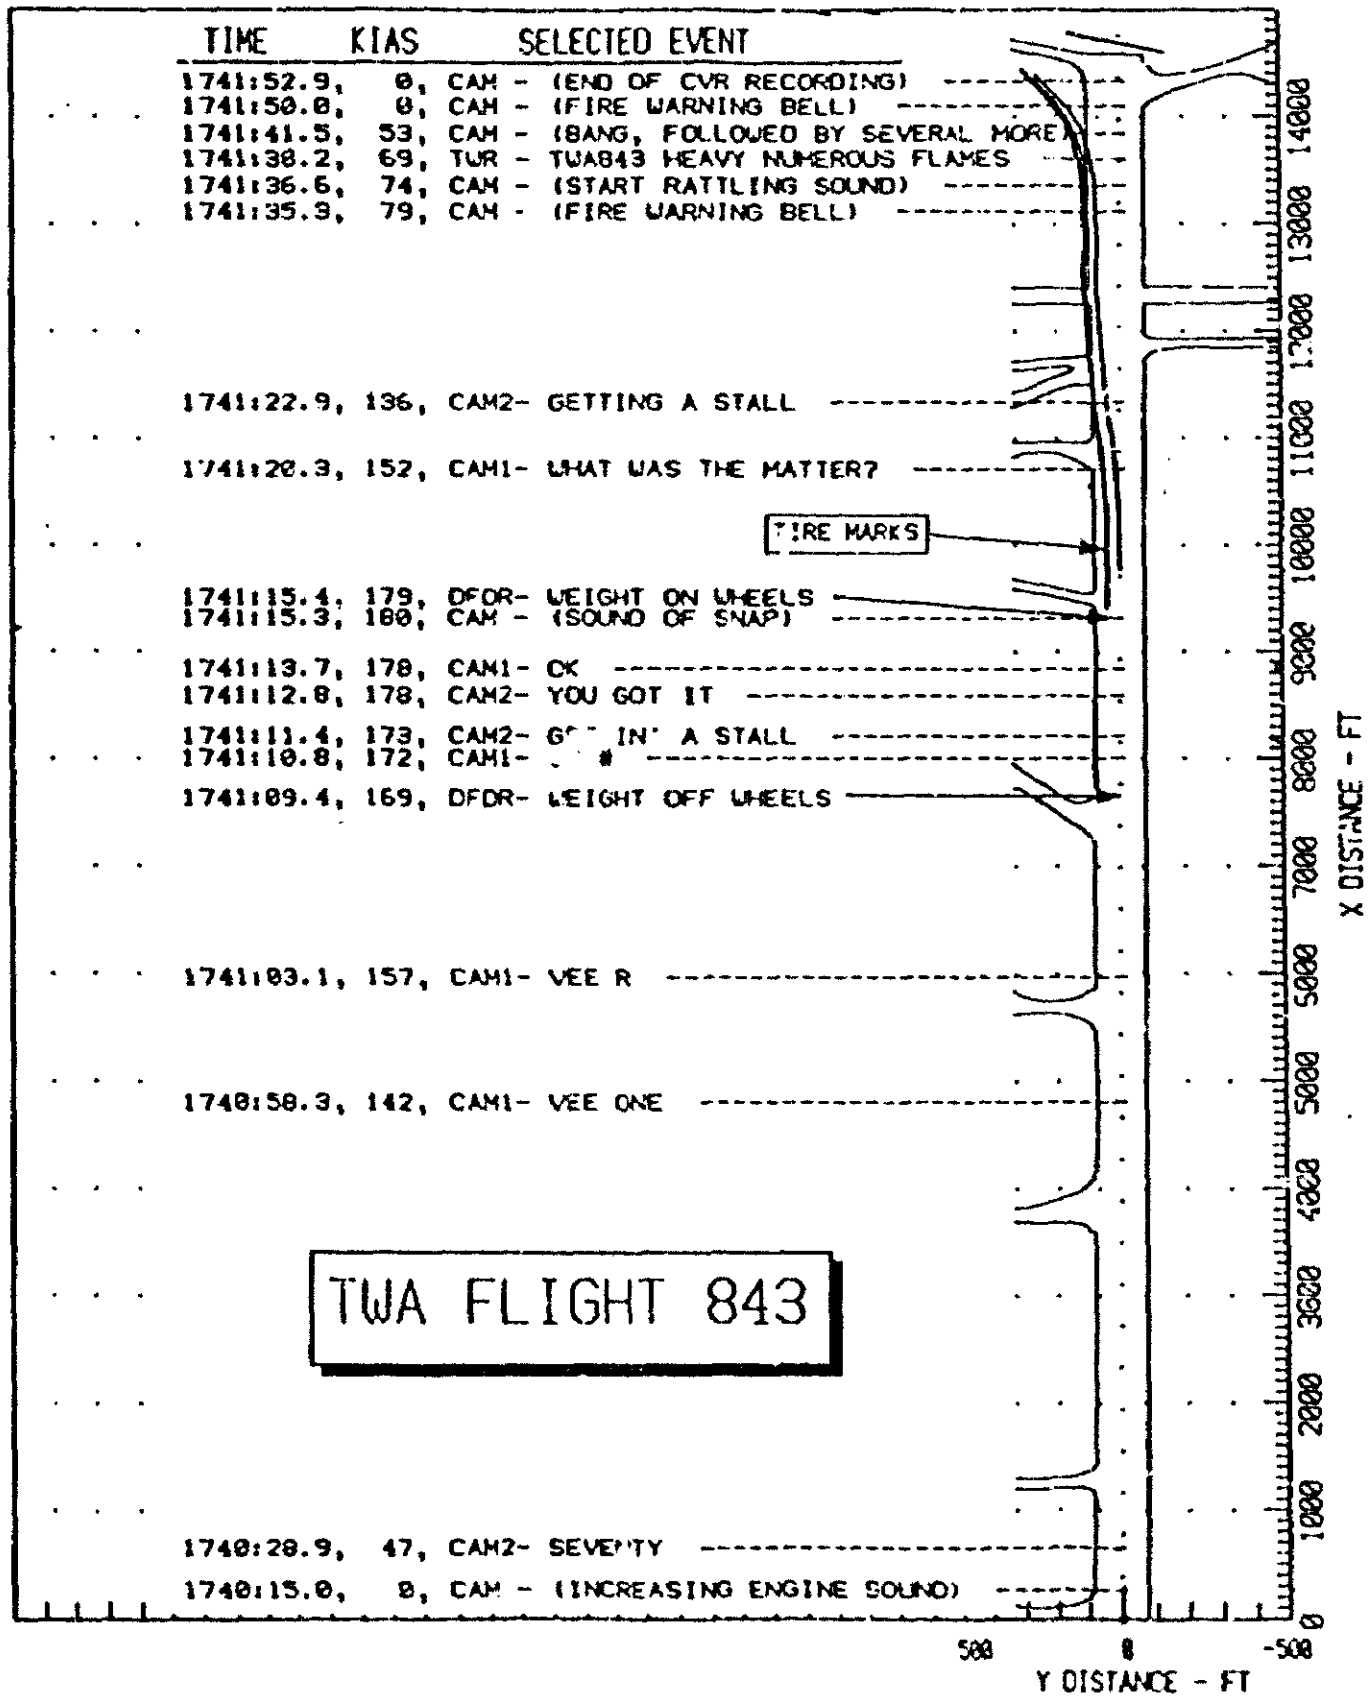
Figure 2.--Selected CVR and FDR data.

As recorded on the cockpit voice recorder (CVR), at 1740:58, the captain called out " $V_1$ ." (See appendix D). At 1741:03, he called " $V_R$ ." At 1741:11, the first officer said, "Gettin' a stall," and 1.4 seconds later he said, "You got it." The captain said, "O.K." at 1741:13. At 1741:15, there was a sound of a snap, followed by the captain saying, "Oh Jes--." The first officer then said, "Abort, get it on." The flight engineer said, "Get it off." The first officer again said, "Get it on." The flight engineer again said, "Get it off." At 1741:20, the captain said, "What was the matter?" The first officer said, "Getting a stall." At 1741:32, the first officer said, "Stay with it." Then he said, "Stay on the brakes, stay on the brakes." At 1741:38, the JFK tower broadcast, "TWA eight forty three heavy, numerous flames." As recorded on the flight data recorder (FDR), the airplane was airborne for about 6 seconds. Figure 2 depicts selected CVR and FDR derived times and events during the takeoff and landing back on the runway.

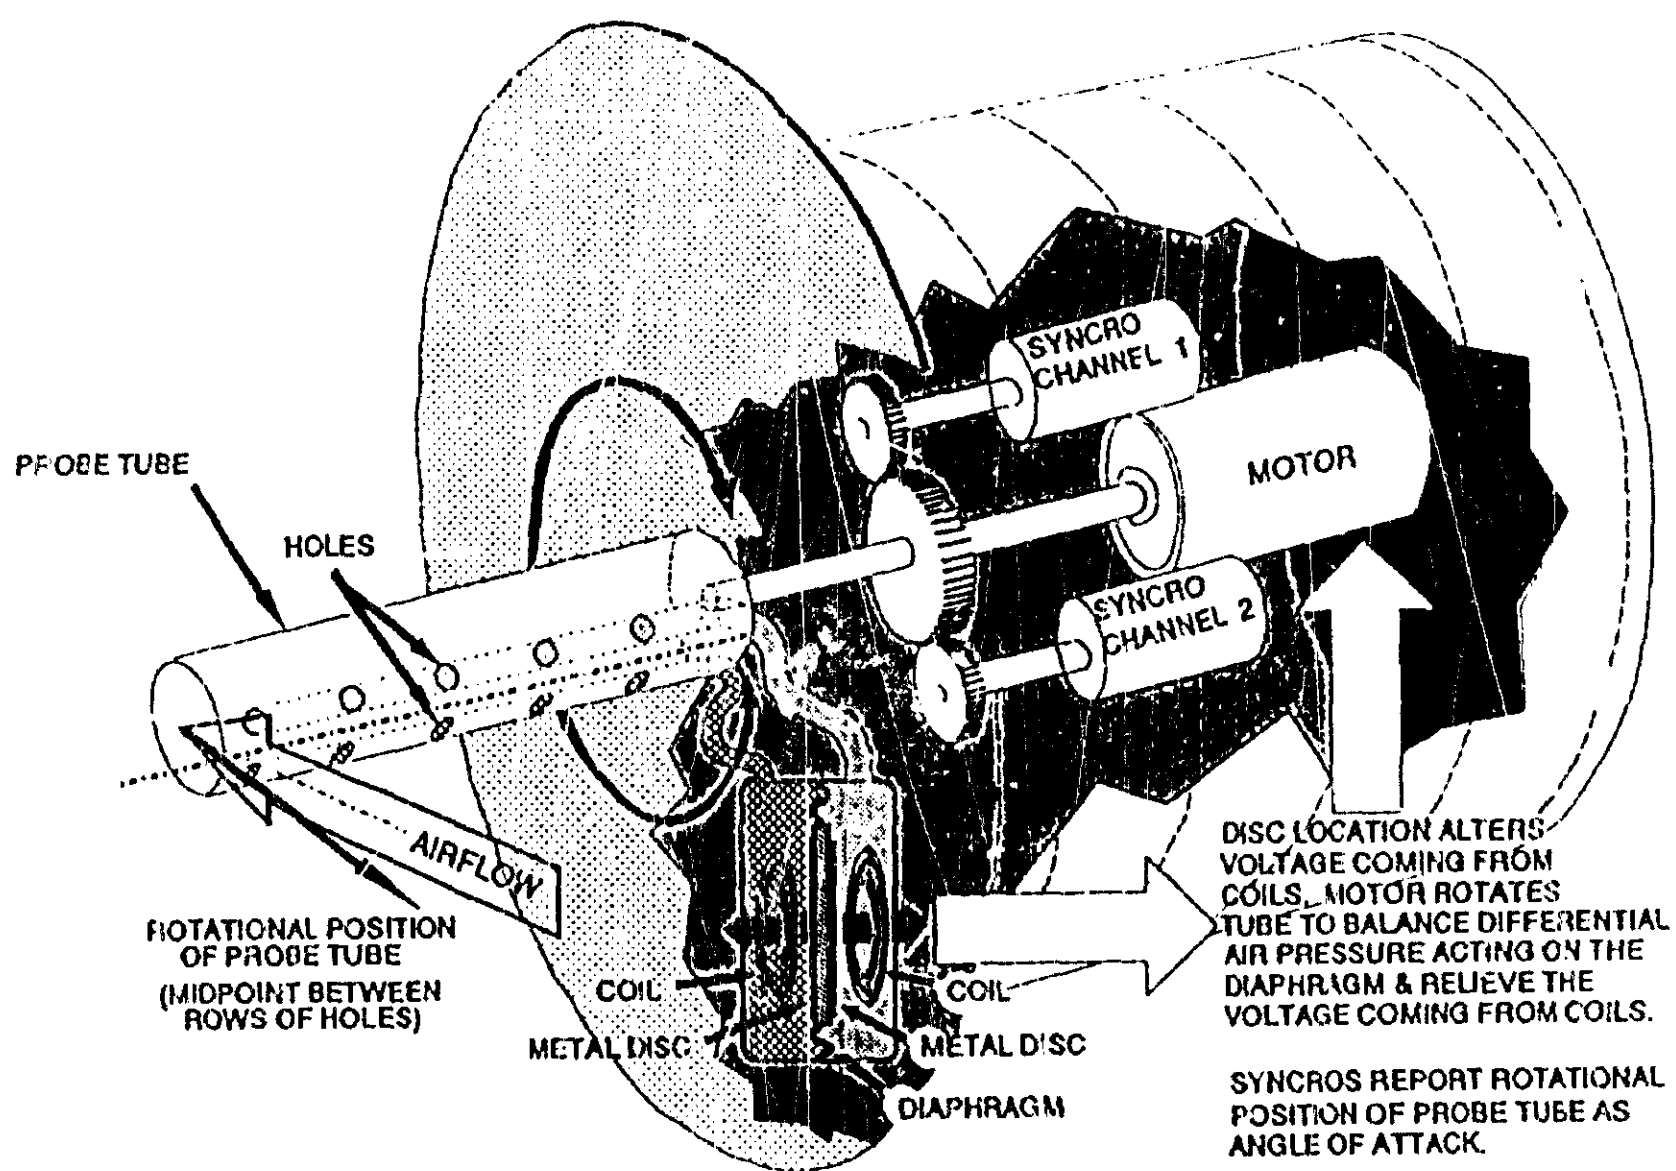
Figure 7.--Angle of attack probe basic components.

One element of the AOA sensor is a tubular probe that protrudes into the airstream. One is located on each side of the fuselage below the cockpit side windows. There are two rows of holes through the wall of the tube that are separated by an angle of about 90 degrees. The dynamic pressure measured by each row is applied to opposite sides of a diaphragm so that the differential pressure acting on the diaphragm is a function of the angular position of the tubular probe relative to the direction of the airstream. (See figures 7 and 8).

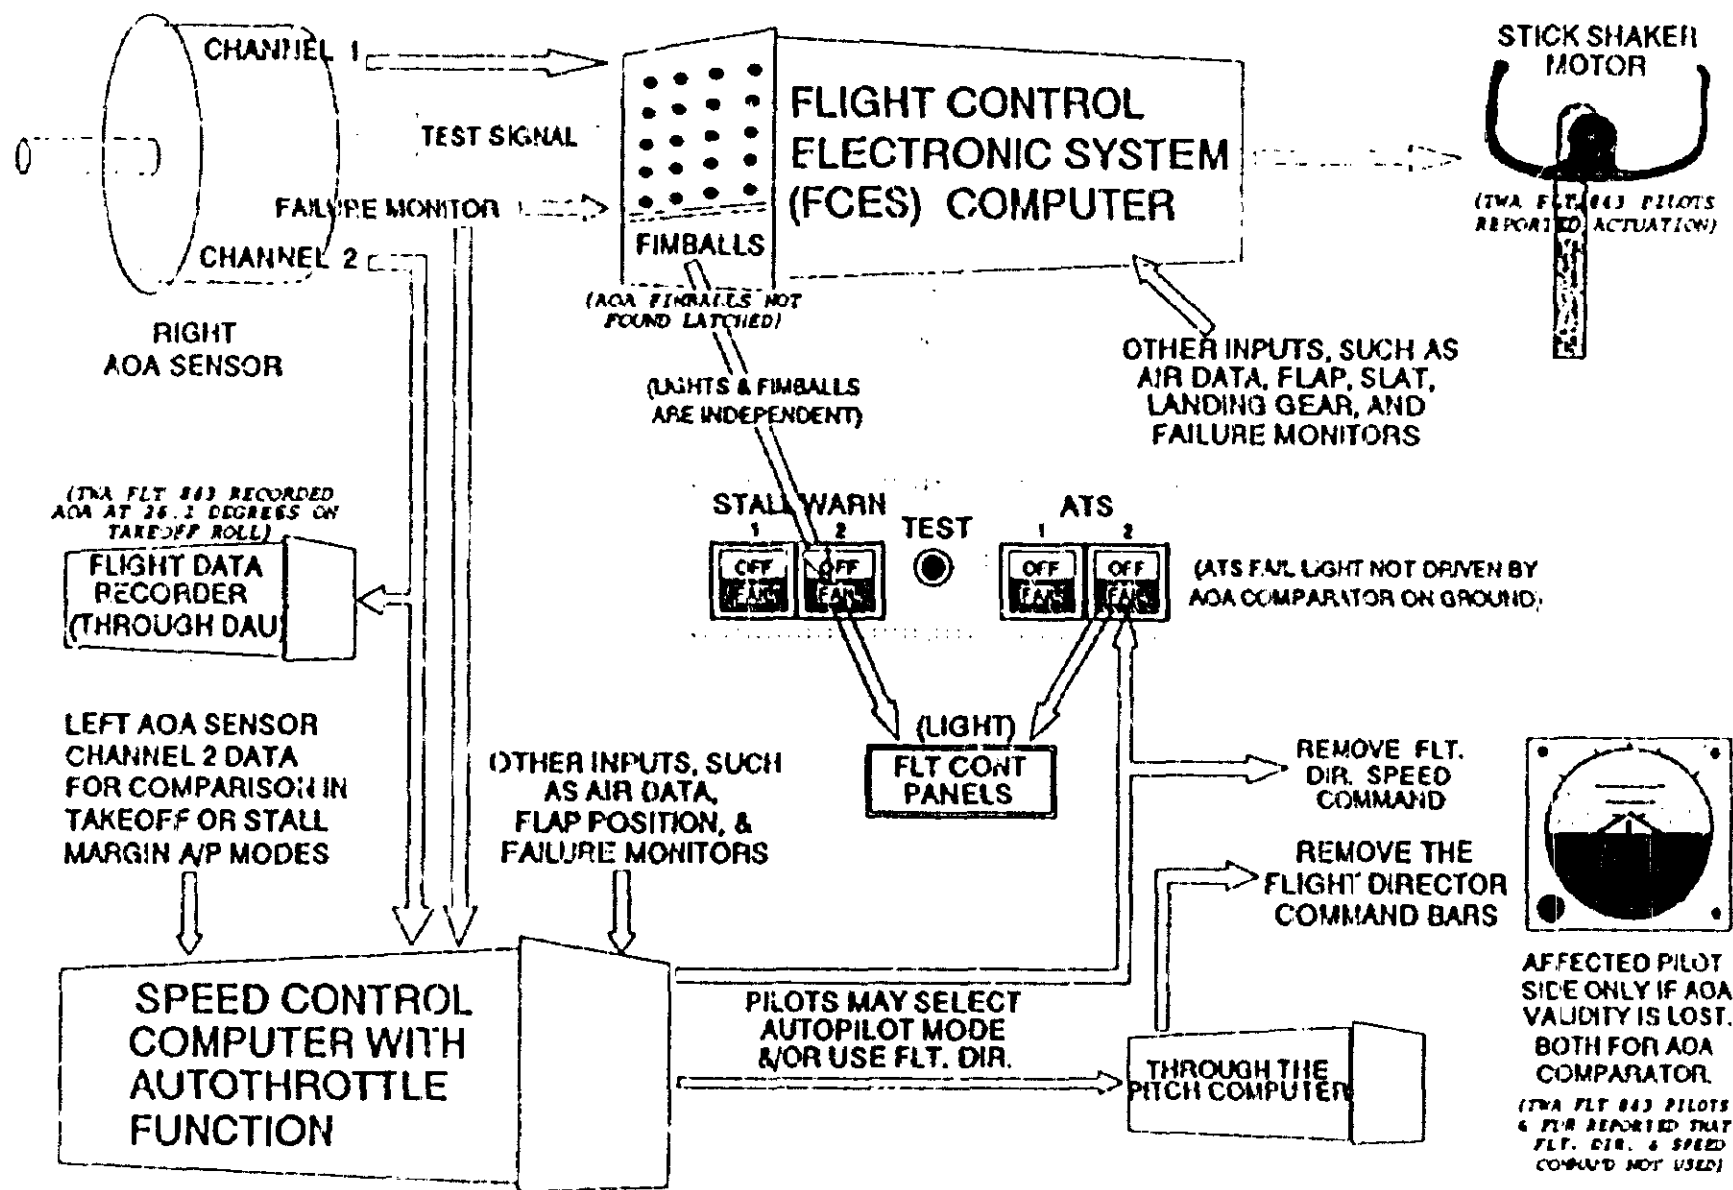
Figure 8.--Stall warning and ATS fail block diagram.

Two switches, (called switchlights, since they illuminate to display system status) located on the cockpit overhead panel, control power to stall warning systems No. 1 and No. 2, respectively. With electrical power on the airplane, the switchlights will illuminate an "OFF" legend that will extinguish when the switches are depressed and power is applied to the stall warning system. The systems have a self-monitoring feature that will cause the "FAIL" legend to illuminate in the switchlight under certain conditions. One of these conditions is a failure of the servomotor in the AOA sensor to rotate the tubular probe to null the electrical signal from the pressure diaphragm. The circuitry includes a time delay to prevent nuisance fail indications so that an error signal output from the pressure diaphragm

that persists for more than 10 seconds will cause a system fail indication. The illumination of the fail light would also cause an amber light, with the legend FLT CONT PANELS, to illuminate on the lower part of the pilot's center instrument panel. The purpose of this light is to direct the pilot's attention to the overhead panel to ascertain the source of the problem.<sup>3</sup>

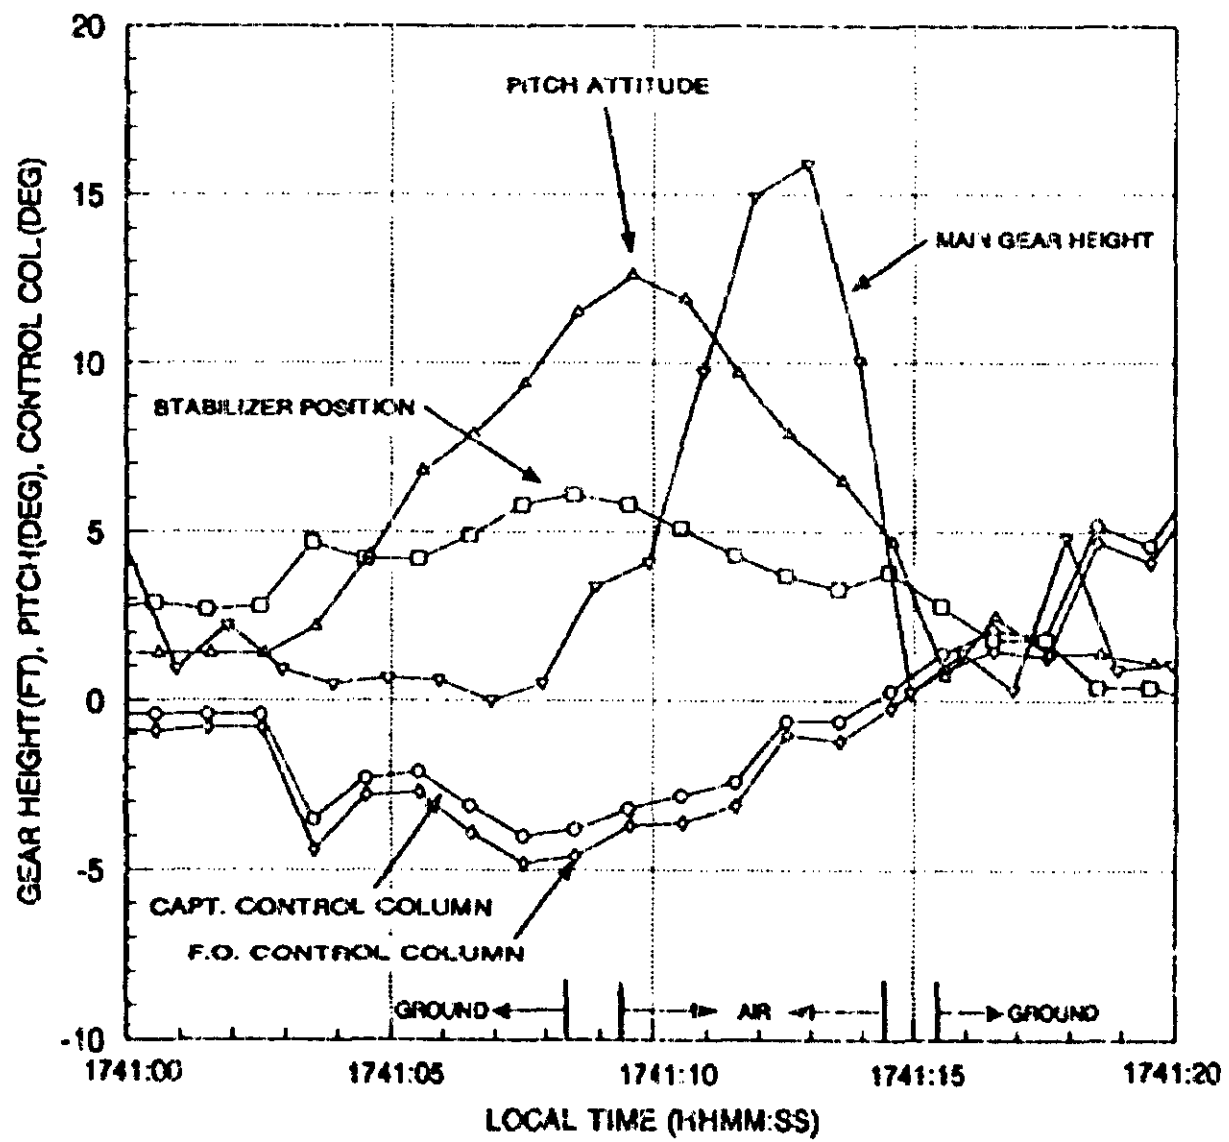
Figure 9.--Flight control inputs and airplane response.

Figure 9 depicts the flight control inputs and response of N11002 during the accident takeoff. The control column positions recorded for the captain and first officer agree within approximately 1 degree. The two control column curves track each other and appear normal. The stabilizer movement is consistent with changes in control column position, and the pitch attitude curve responds to changes in stabilizer position. The actual altitude of the main landing gear (derived from FDR radar altitude) indicates that the airplane climbed to a peak altitude of approximately 16 feet. Altitude values then begin to decrease, consistent with the decreasing pitch attitude of the airplane shortly after liftoff.

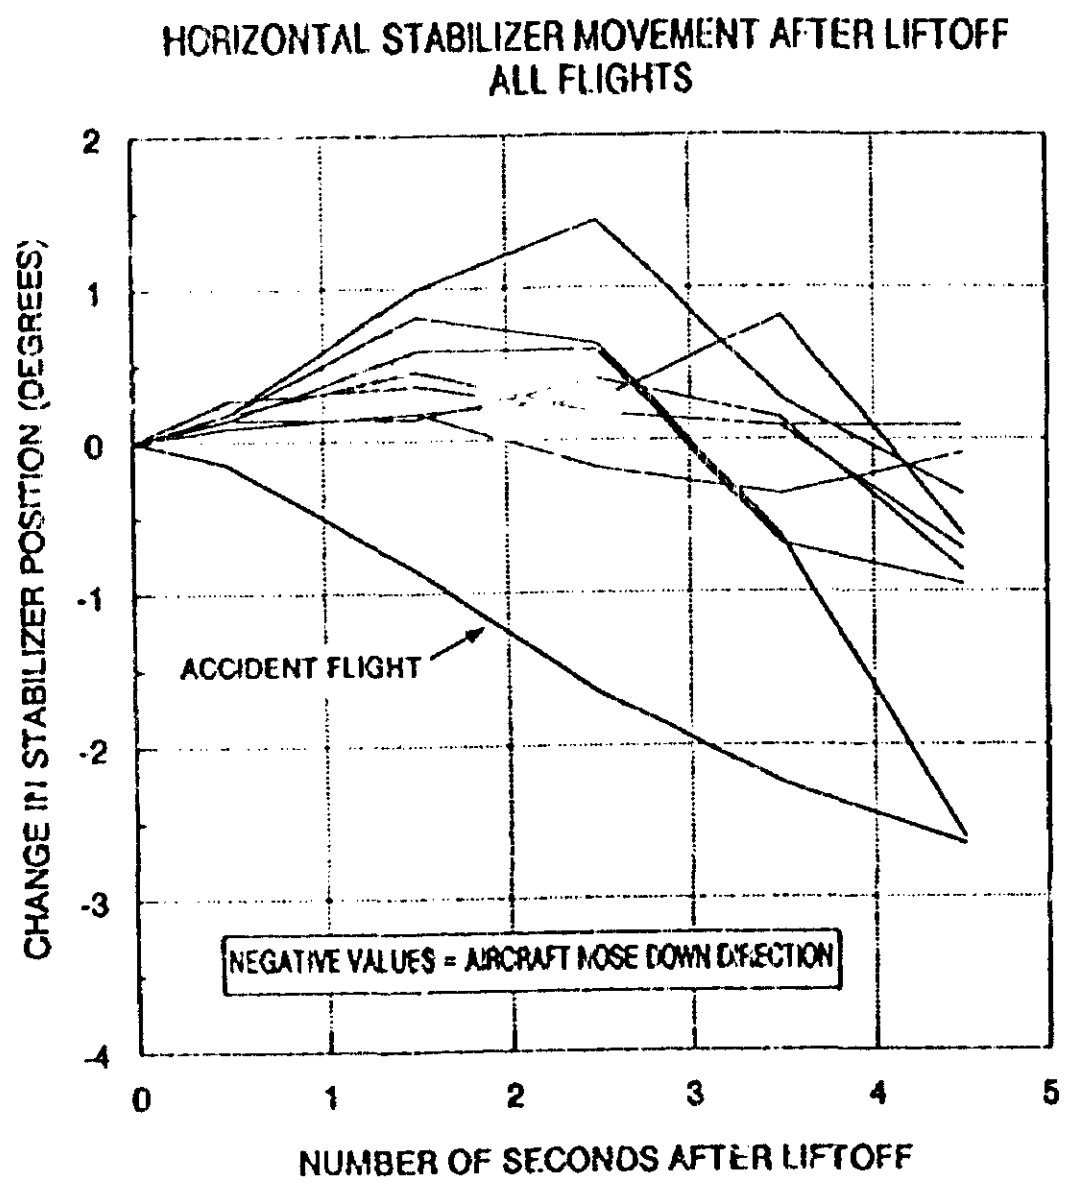
Figure 10.--Horizontal stabilizer movement after liftoff.

Figure 10 shows the horizontal stabilizer movement after liftoff for the accident and eight previous takeoffs. This figure shows the change in horizontal stabilizer position with respect to its position at liftoff.

During the first 3 seconds after liftoff, the previous takeoffs show a positive trend (airplane nose up, A.N.U.) of horizontal stabilizer movement during the initial climbout. Stabilizer positions for the accident flight reveal a negative (airplane nose down, A.N.D.) rotation of the horizontal stabilizer during the first 3 second time period.

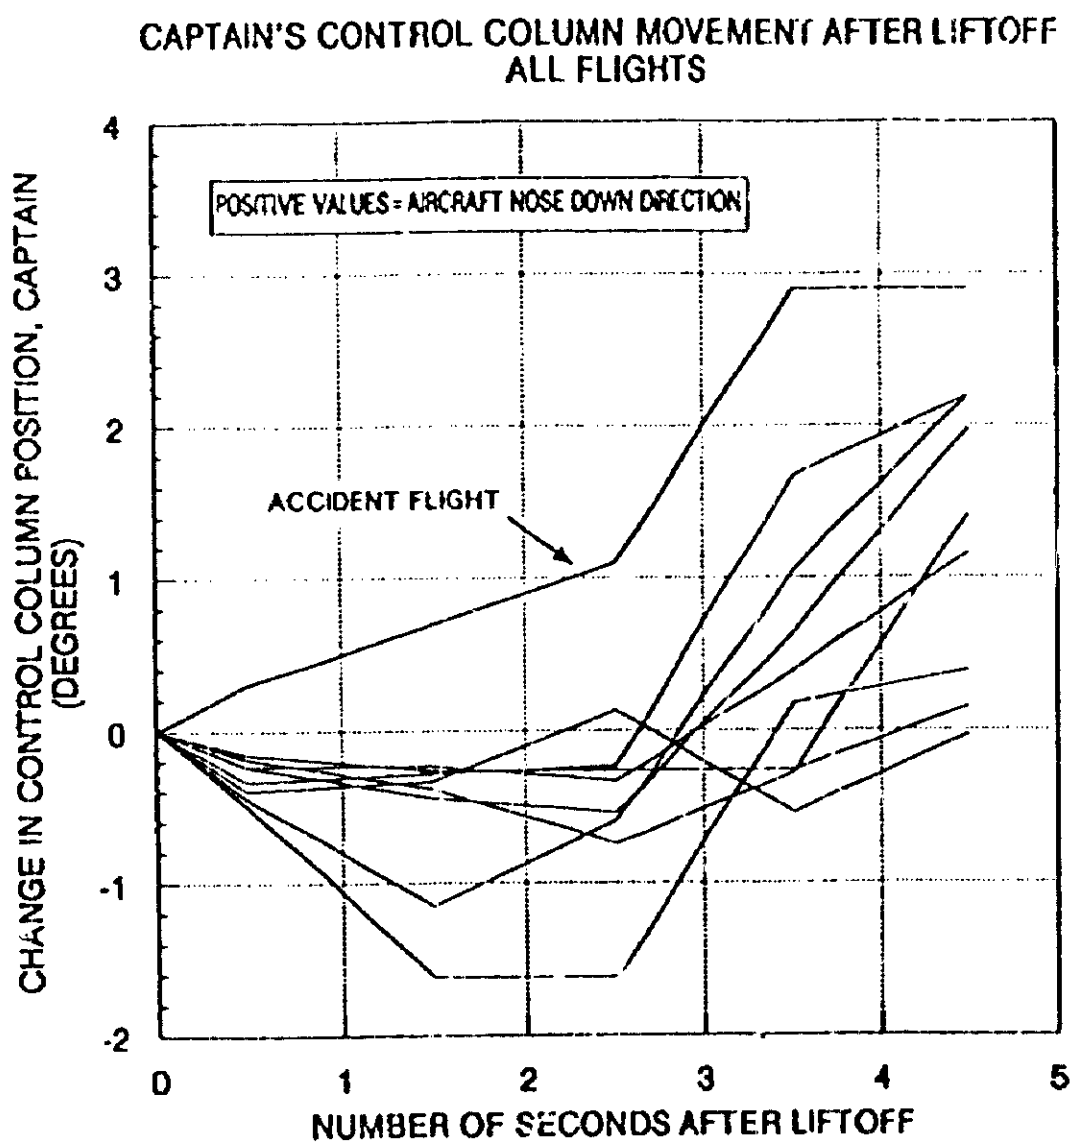
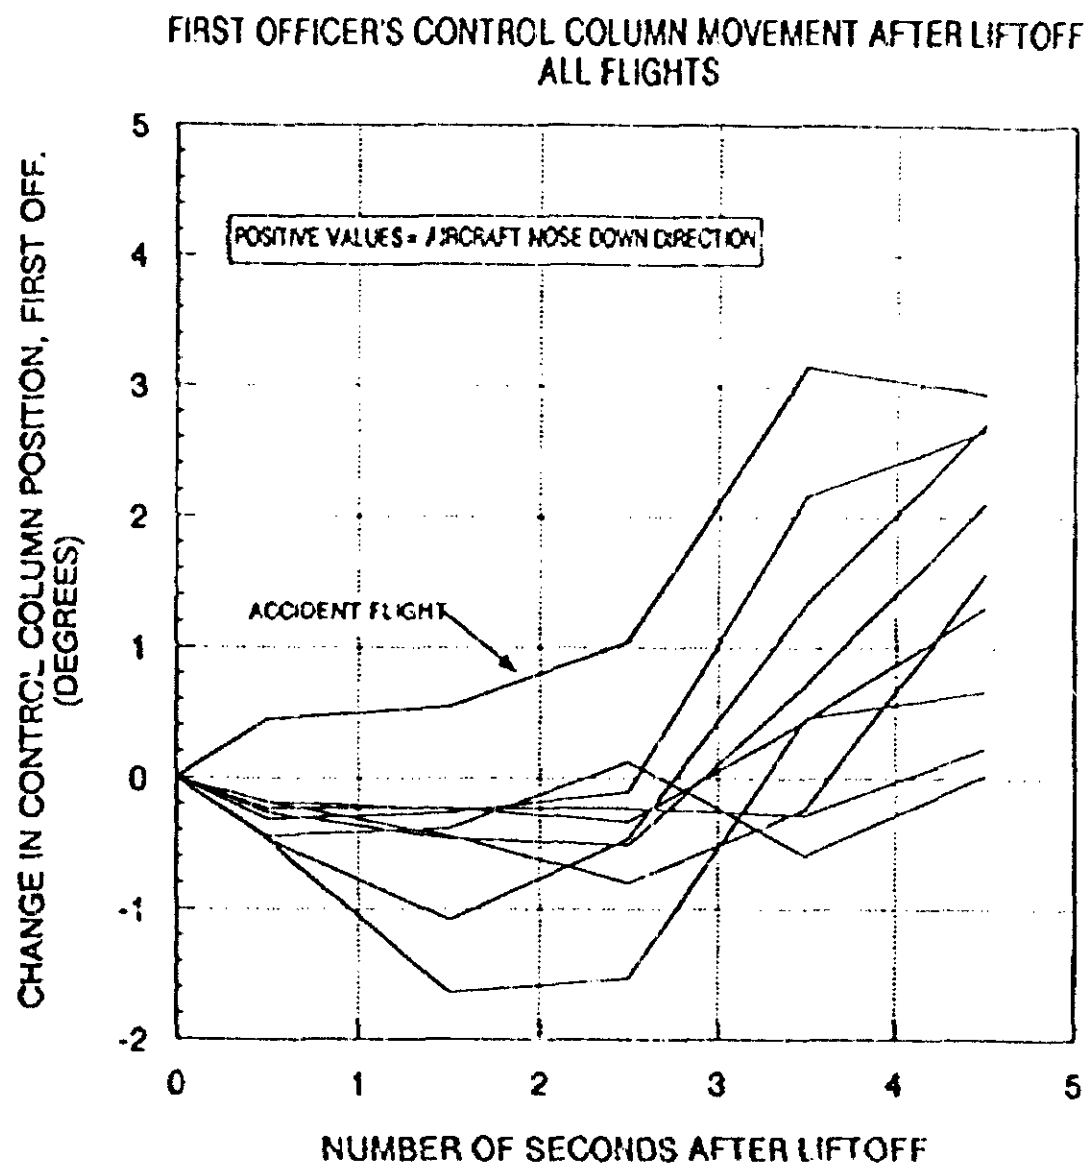
Figures 11 and 12 show the pilots' control column movements after liftoff. These plots show the change in control column position with respect to the control column position at liftoff. During the first 2 to 3 seconds after liftoff, the previous takeoffs show a negative, or aft control column trend (aft A.N.U.) during the initial climbout. The accident flight control column positions reveal a positive, or forward control column movement (forward A.N.D.) during the first 3 seconds.

The movements of the control columns and horizontal stabilizer after liftoff indicate that a forward movement of the control column occurred earlier on the accident flight than on the previous eight takeoffs. The control column on the accident flight moved forward immediately after liftoff, several seconds earlier than any previous takeoff recorded by the FDR. The forward control column movement occurred at an altitude of only 4 feet, which is inconsistent with FDR data from previous takeoffs. The FDR does not record the control forces used by the pilot; it records only column position. Figure 13 shows the overall flight performance data of the airplane.
