PB95-910404
NTSB/AAR-95/04
DCA95MA007

AIRCRAFT ACCIDENT REPORT

CRASH DURING EMERGENCY LANDING
PHOENIX AIR
LEARJET 35A, N521PA
FRESNO, CALIFORNIA
DECEMBER 14, 1994

**Adopted: August 1, 1995
Notation 6588**

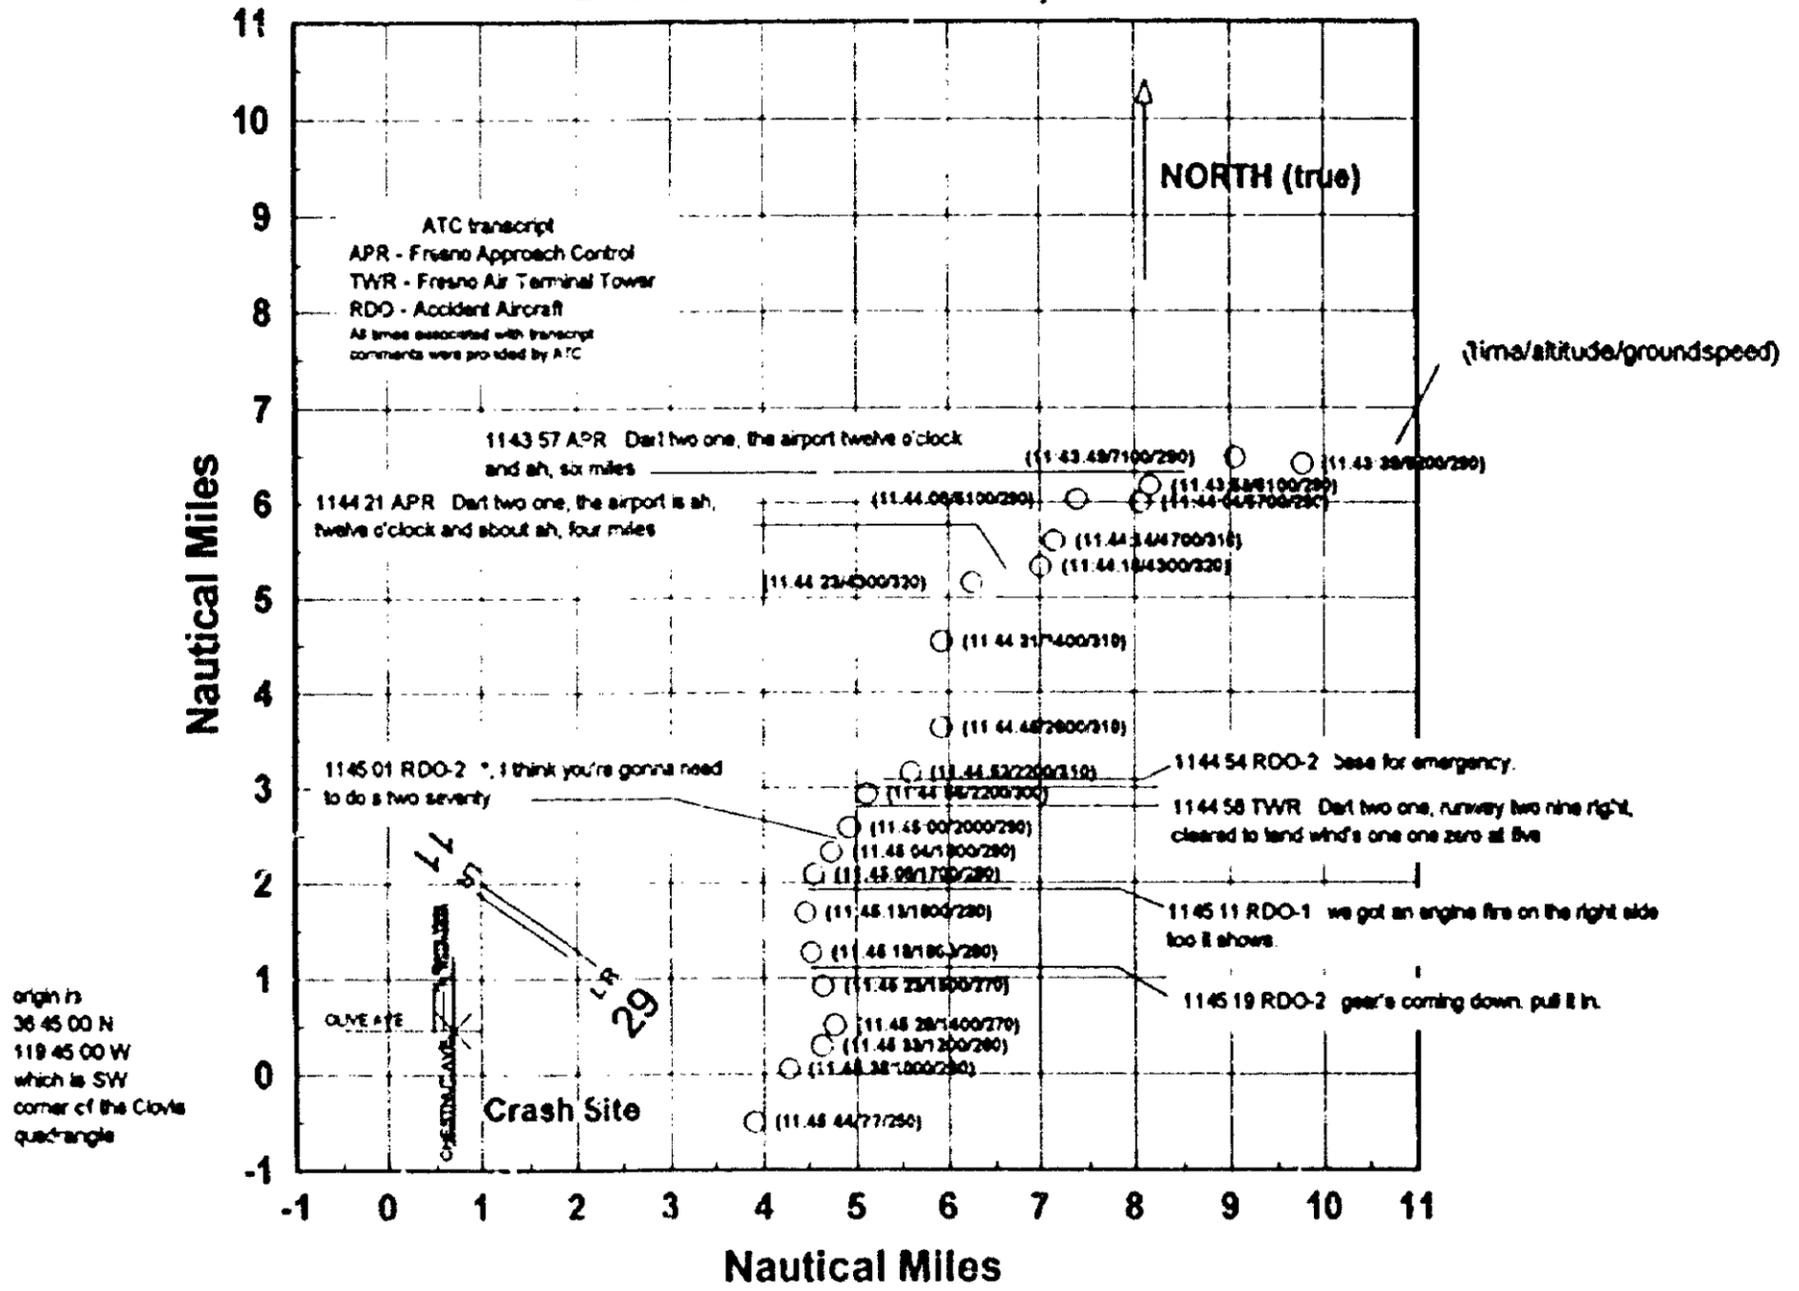
Figure 1a.--Ground track.

After the airplane passed to the southwest of the extended centerline, it appeared to tower controllers to gradually descend very low. The tower supervisor stated that the landing gear appeared to be down about that time. The airplane then climbed back up gradually from what appeared by line of sight to tower controllers to be above the tree tops. It then again gradually descended in an apparent westerly heading. The airplane climbed or "porpoised" up a second time, more severely. It then descended sharply until view was obstructed by trees. A fireball and smoke were then observed.
