NTSB/AIR-22-05

Collision into Terrain

Safari Aviation Inc.

Airbus AS350 B2, N985SA

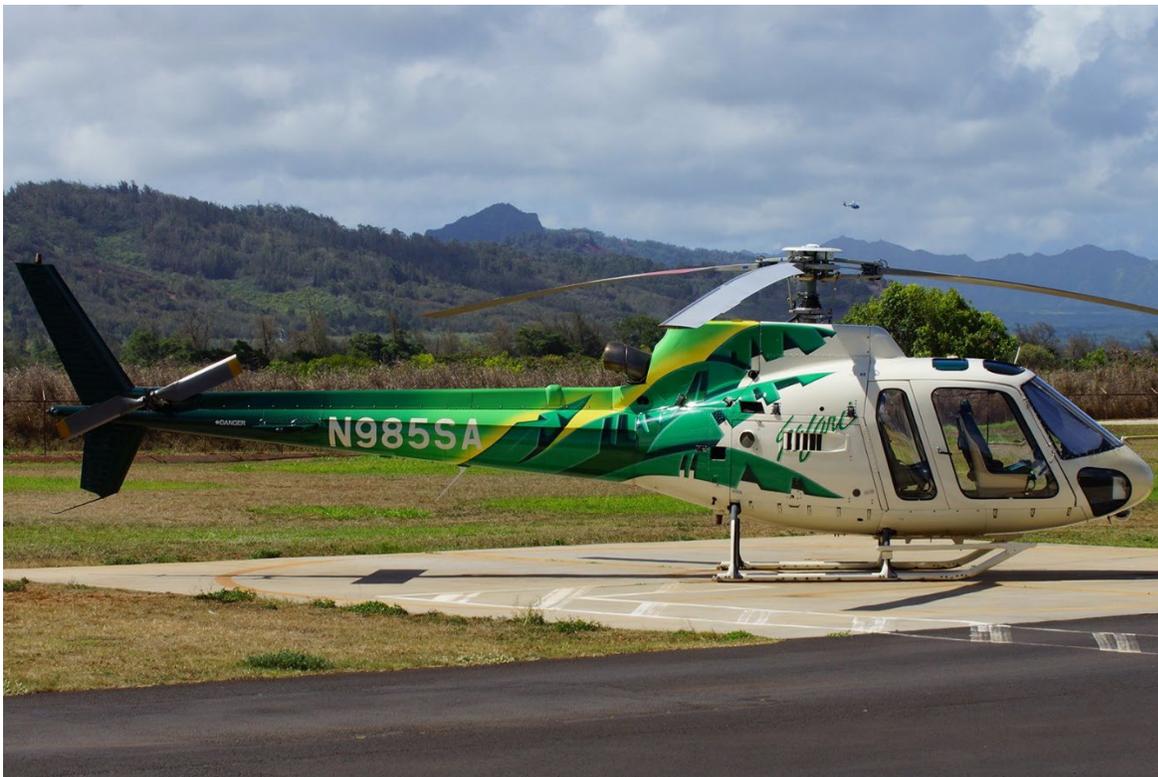
On December 26, 2019, about 1657 Hawaii standard time, an Airbus AS350 B2 helicopter, N985SA, was destroyed when it collided into terrain in a remote, wooded area about 11 miles north of Kekaha, Hawaii, on the island of Kauai.¹ The pilot and the six passengers were fatally injured. Safari Aviation Inc. (Safari), doing business as Safari Helicopters, operated the flight as a Title 14 *Code of Federal Regulations* (CFR) Part 135 on-demand air tour under visual flight rules (VFR).² (See Figure 1.)

Figure 1. Accident helicopter (Source: Tomas Milosch).

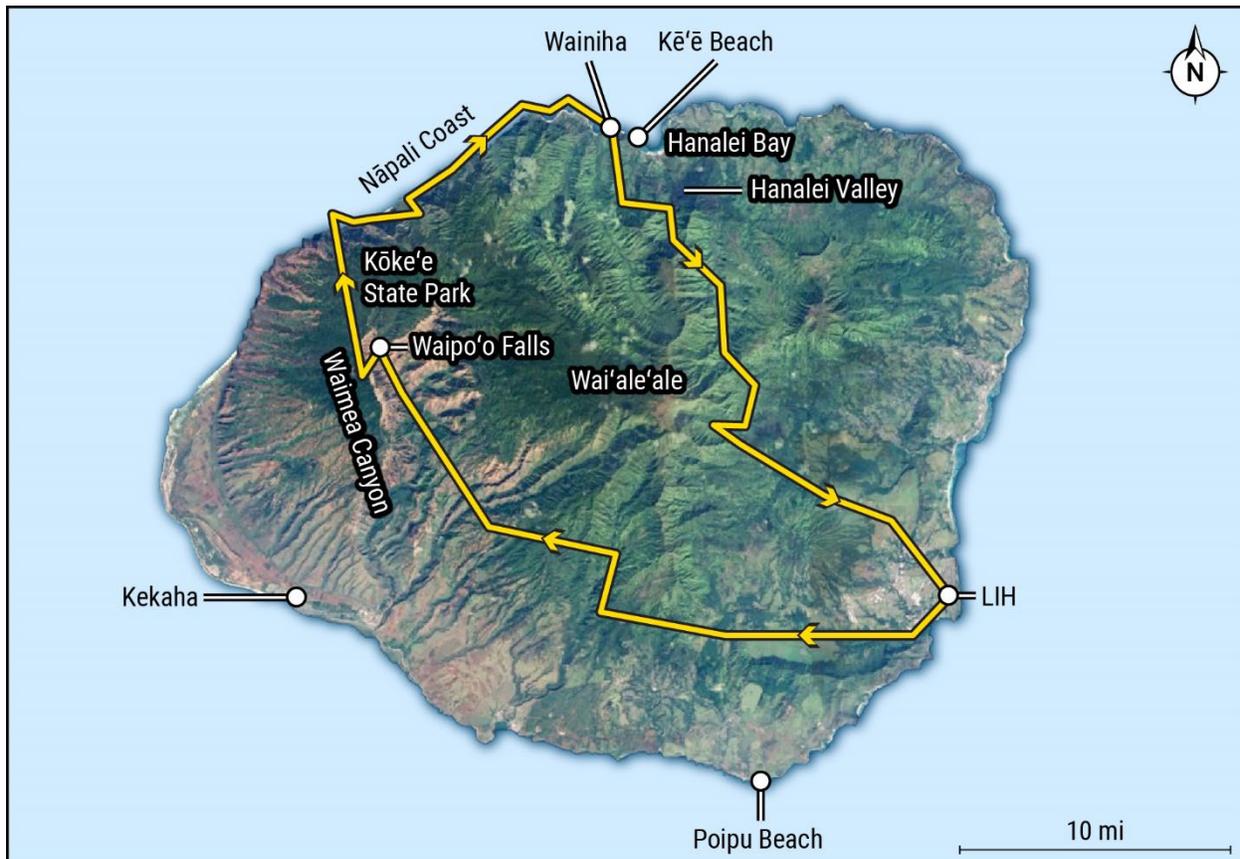
Limited information was available about the accident helicopter's flight track. A series of air traffic control (ATC) radar returns showed that a VFR aircraft departed LIH at the time of the accident flight's departure and proceeded south then west and northwest before the returns ceased about 1639 at the expected limits of the radar coverage for low-flying aircraft in that area.⁴ Presuming the accident pilot followed the standard tour route as expected, the flight would have continued northwest and north to the Nāpali Coast as part of a clockwise loop around the island (see Figure 2).⁵

Figure 2. Safari's standard nonstop tour route.

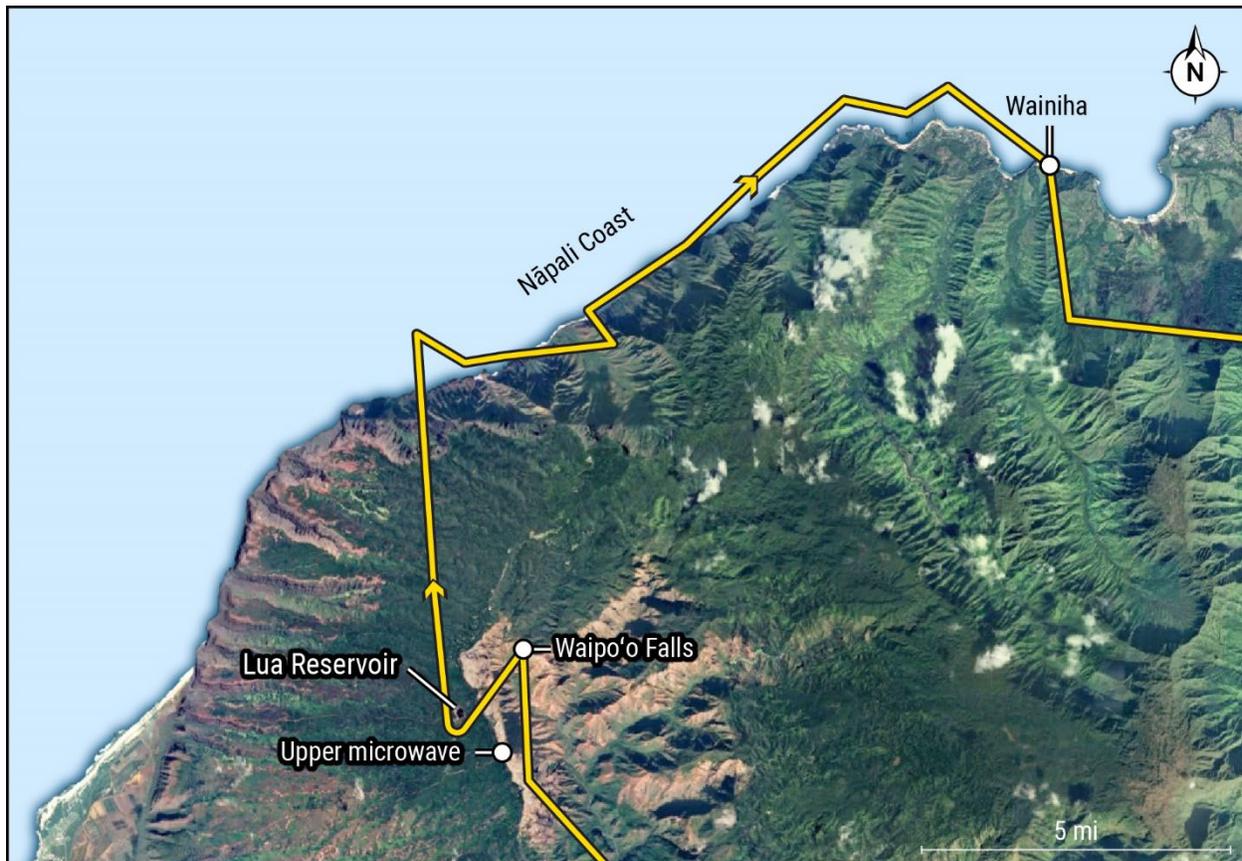
Based on the accident flight's departure time and the typical progression of a tour, the accident flight would be expected to reach the north end of Waimea Canyon (near Waipo'o Falls) about 1648.⁶ Per the standard tour route, the flight would next proceed southwest through the canyon before exiting over the canyon's west rim between the Lua Reservoir and the upper microwave tower site, which pilots referred to as "upper mic" when providing radio position reports (see Figure 3).⁷

Figure 3. Upper microwave tower site.

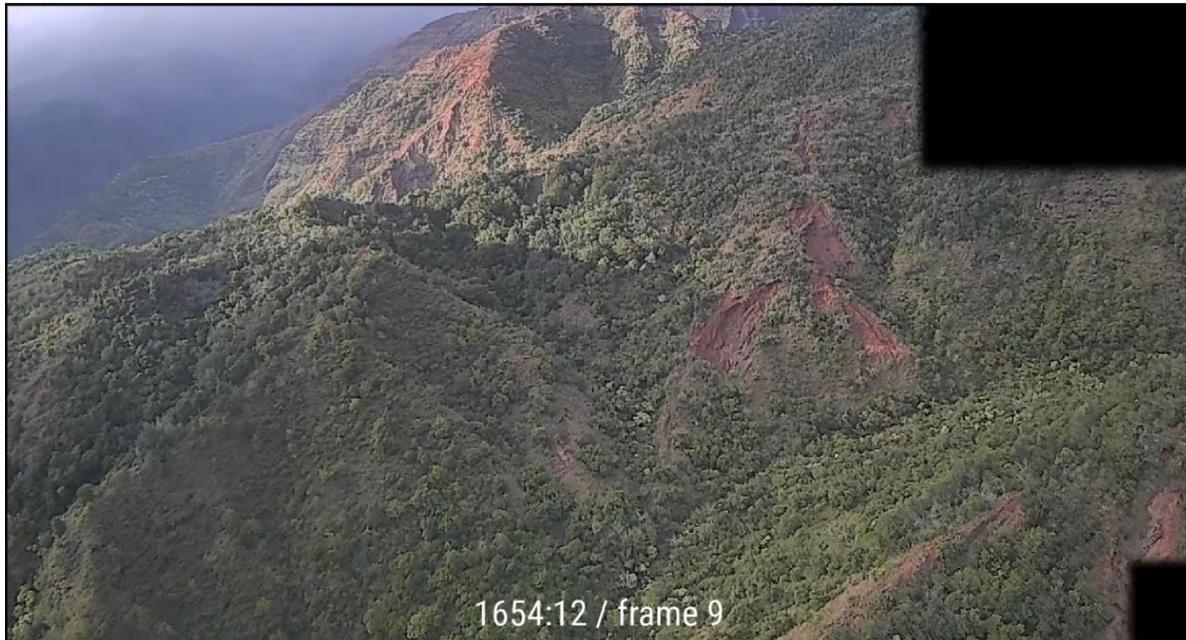
A pilot for another helicopter tour operator (referred to as “Company 2” in this report) estimated that his tour was about 5 minutes behind the accident flight when he heard the accident pilot transmit “upper mic” over the radio. The Company 2 pilot said that, upon hearing the accident pilot’s transmission, he could see adverse weather at the north end of Waimea Canyon but presumed that, because the accident flight had continued, there must have been a way through the weather. The Company 2 pilot decided to continue his tour to see whether he could also go that way. Onboard video from this pilot’s tour showed that, about 1654, his helicopter was flying in good visibility with an area of visible moisture ahead (see Figure 4), and he told his passengers that the next site would be Waimea Canyon.⁸ The video showed

Figure 4. Company 2 pilot's tour en route to Waimea Canyon about 1654.

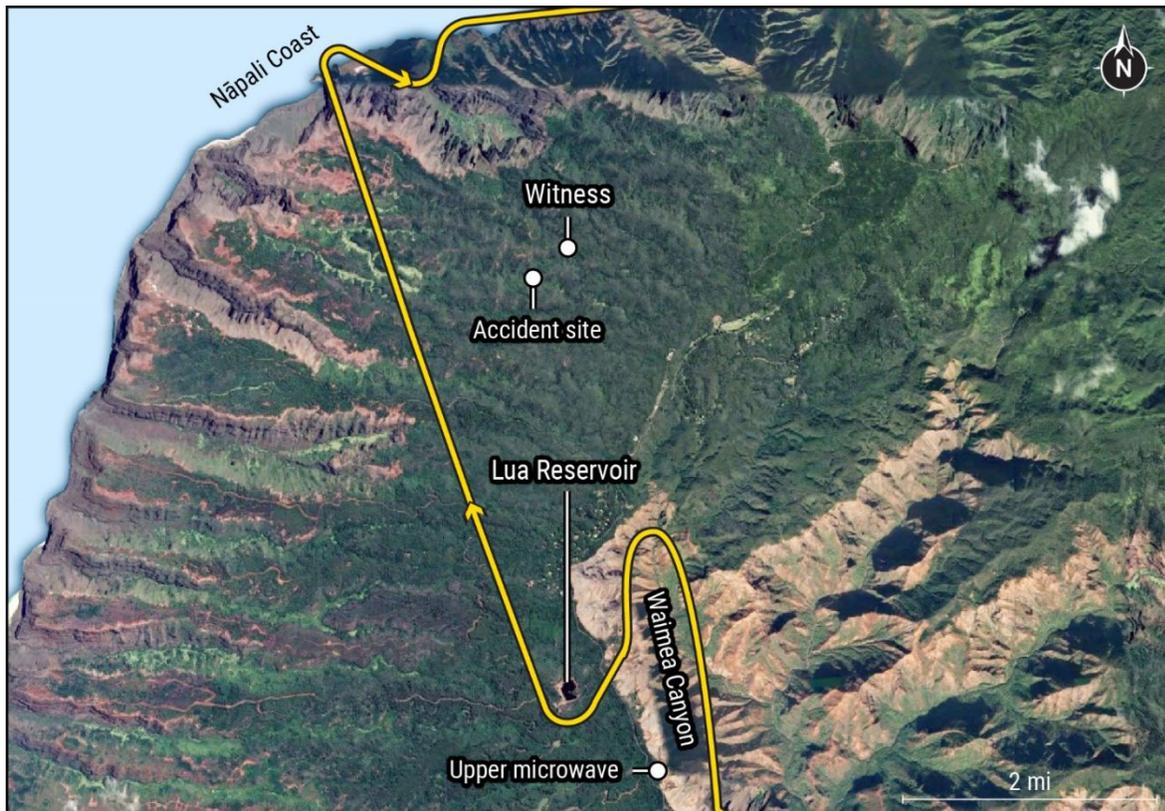
The next morning at 0932, a rescue helicopter team spotted the wreckage in wooded, mountainous terrain in Kōke'e State Park at an elevation of about 3,000 ft msl. (See section 1.6). The accident site was about 0.5 nautical mile (nm) east of the standard tour route and about 0.27 nm southwest of where the witness on the Nu'alolo Trail was standing when he heard the helicopter noise stop (see Figure 6 and Figure 7).

Figure 6. Accident location (map view).

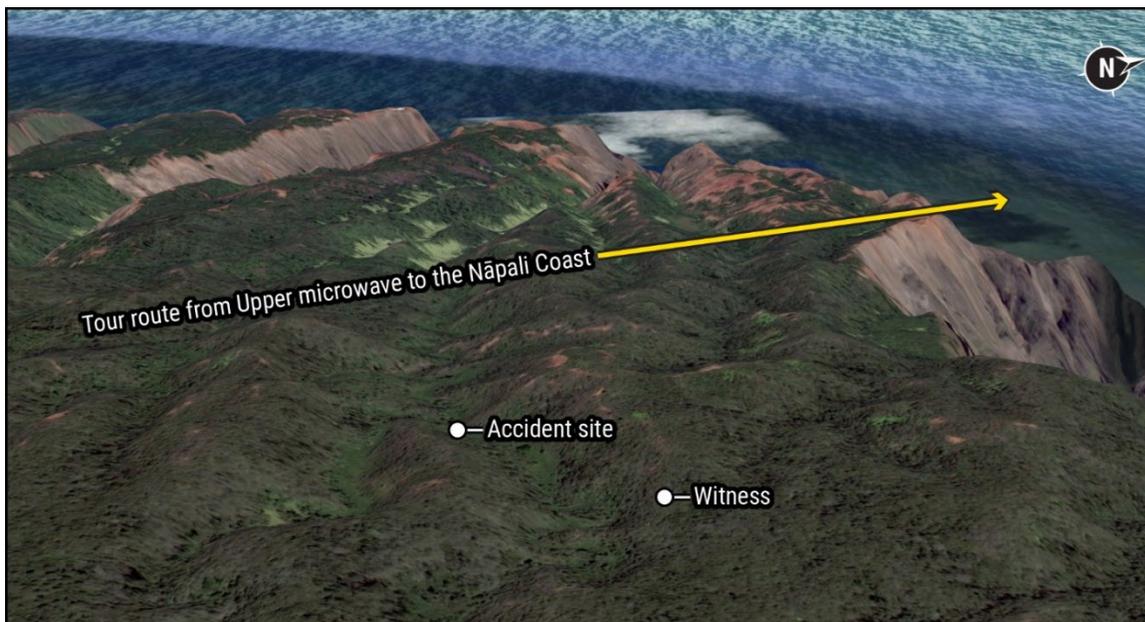
Figure 7. Accident location (terrain view).

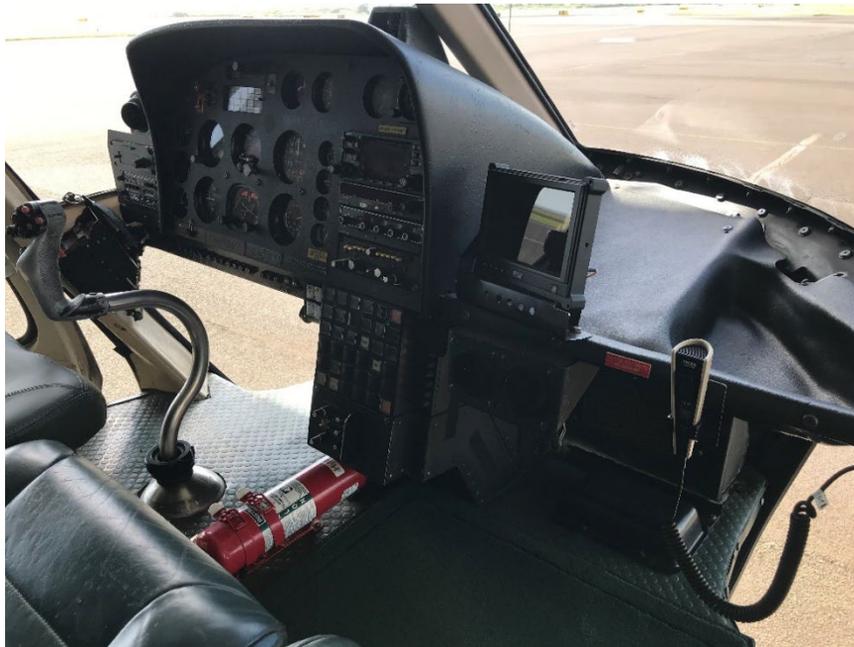
The accident helicopter was an Airbus (formerly Eurocopter) AS350 B2 helicopter equipped with a Safran Helicopter Engines (formerly Turbomeca) Arriel 1D1 turboshaft engine, three-bladed main rotor, two-bladed tail rotor, and skid-type landing gear. It was configured for a single pilot and six passengers (with four passenger seats in the back and two in the front). It was modified under a supplemental type certificate to move the pilot controls from the right to the left front seat (see Figure 8).

Figure 8. Accident helicopter's pilot controls and instrument panel.

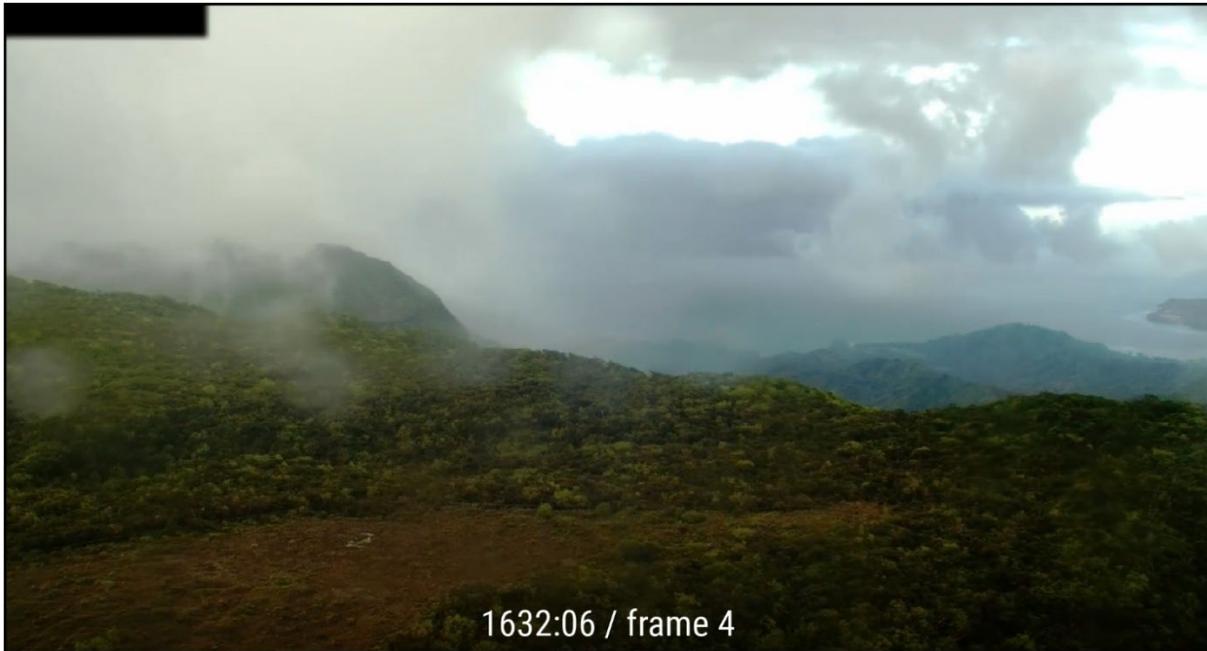
and visible moisture was ahead and to the left (west) of the helicopter (see Figure 11). The helicopter subsequently turned left and flew west along the Nāpali Coast, entering an area of visible moisture (see Figure 12).

Figure 11. Company 1 pilot's tour approaching Hanalei Bay about 1632.

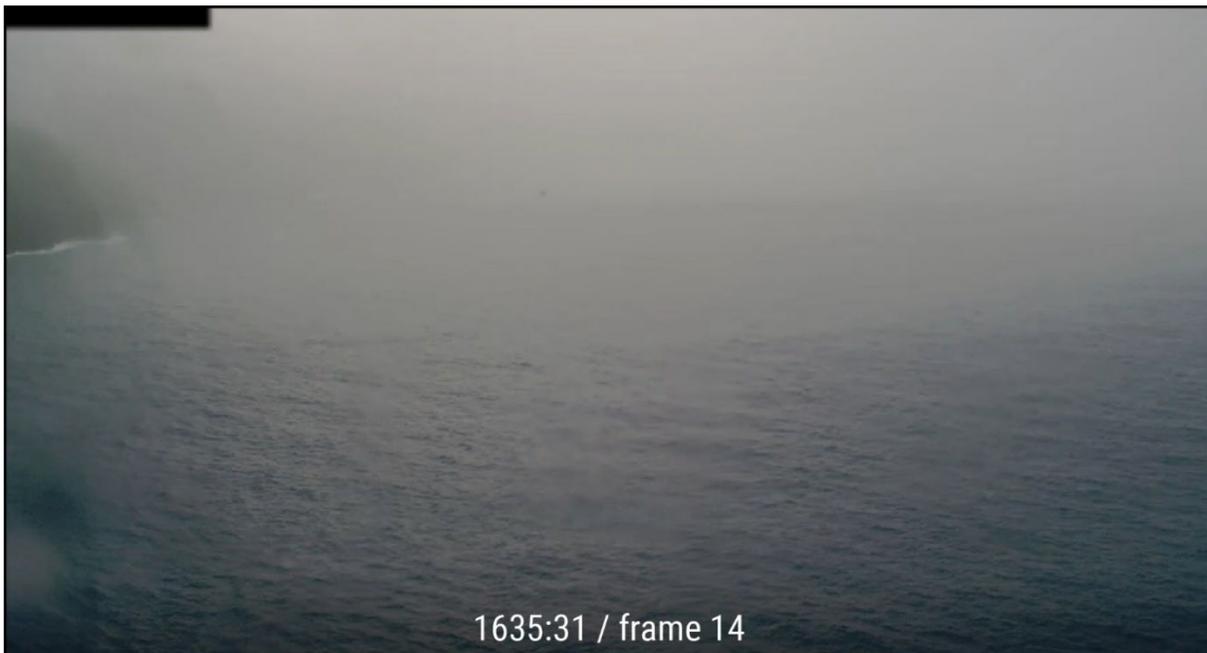
Figure 12. Company 1 pilot's tour flying west along the Nāpali Coast about 1635.

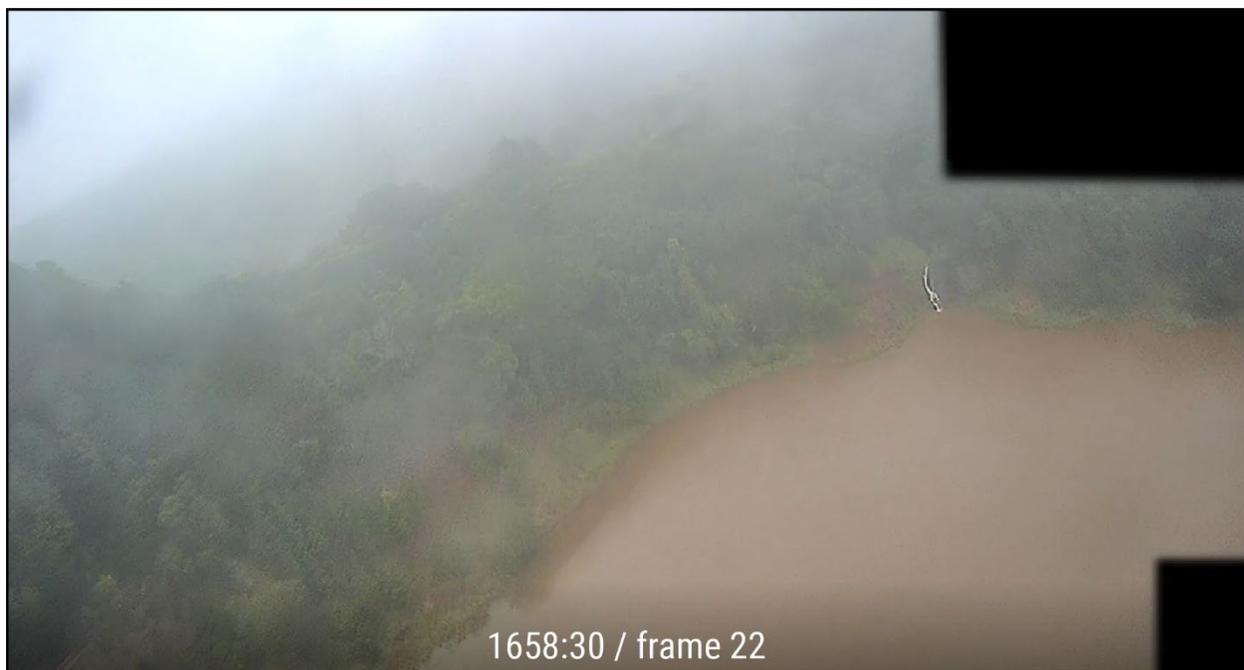
The Company 2 pilot's onboard video recorded that, after his tour exited the canyon, he discussed the clouds and rain with his passengers and told them he did not know if he could continue along the route. He said he could "check it out a little further" but then advised them that he would need to "find a way back to the canyon and take a different route." The video showed that, during this time (from 1658:10 to 1700:14), this pilot overflew Lua Reservoir and continued north briefly before reversing course to divert the tour (see Figure 13 and Figure 14).

Figure 13. Company 2 pilot's tour about 1658 over Lua Reservoir.

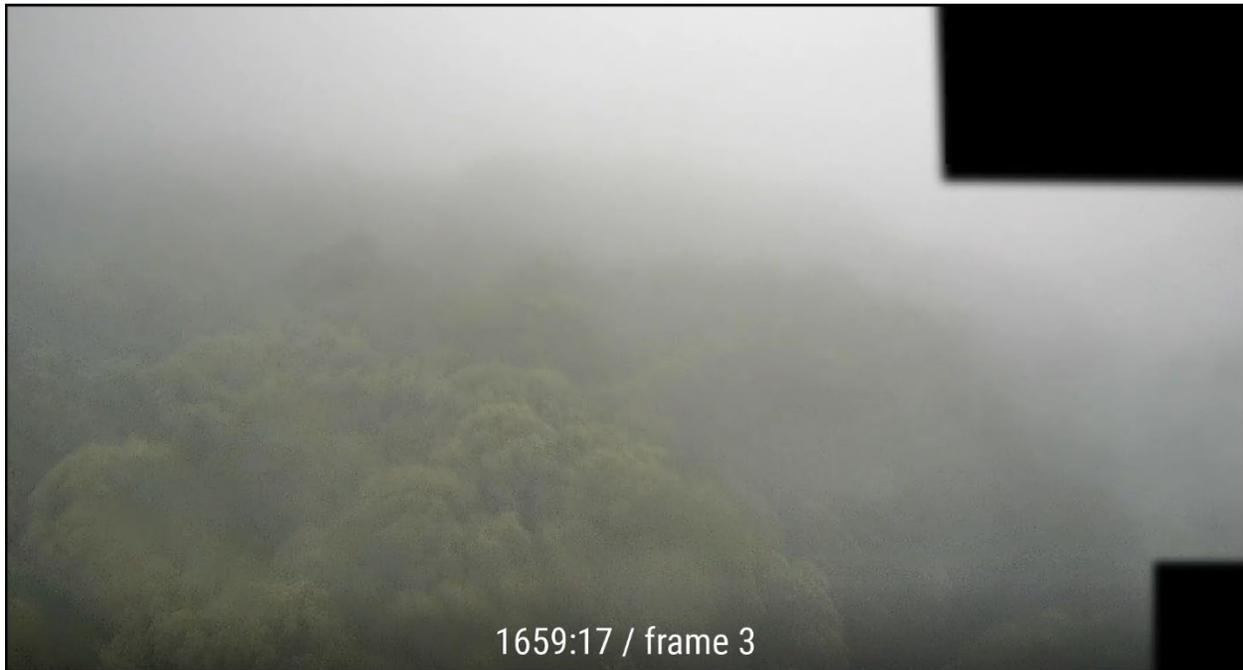
Figure 14. Company 2 pilot's tour about 1659 (before reversing course).

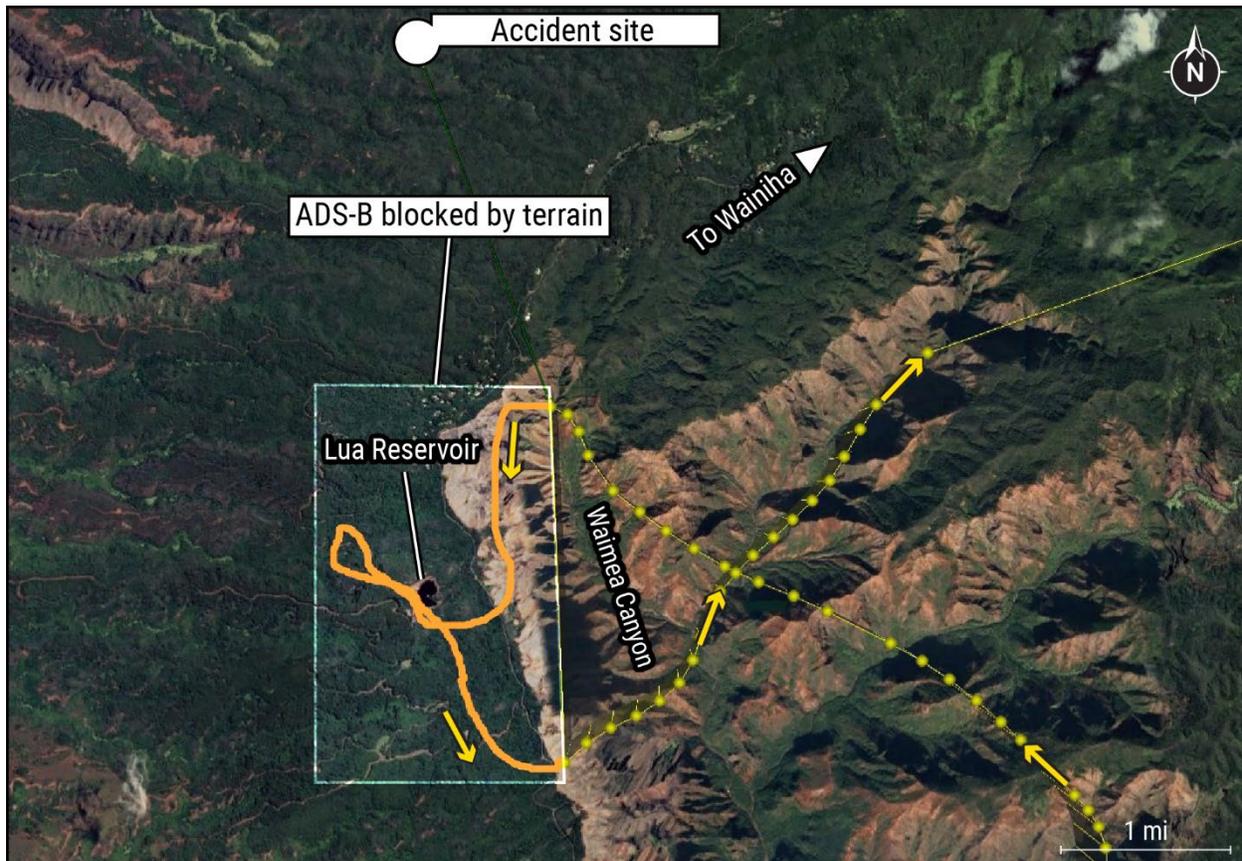
The Company 2 pilot's helicopter was equipped with Automatic Dependent Surveillance-Broadcast (ADS-B) Out capabilities that provided aircraft position information.¹⁴ Due to signal blockage from the high terrain, no ADS-B data were available for portions of this tour flight, including the course reversal after it exited Waimea Canyon. This pilot provided the available ADS-B data and described the approximate flight track in the area where data were unavailable.¹⁵ The flight track information (both data-derived and estimated) show that, after the pilot reversed course, the tour continued south before diverting northeast toward Wainiha (see Figure 15).

¹⁵ The Company 2 pilot's description was used to draw the approximate flight track shown in figure 15. A subsequent review of the flight's onboard video showed that the helicopter's actual flight track crossed over Lua Reservoir from south to north before the pilot reversed course (figure 15 shows the track passing the reservoir without overflying it).

Figure 15. Approximate flight track of Company 2 pilot's tour diversion.

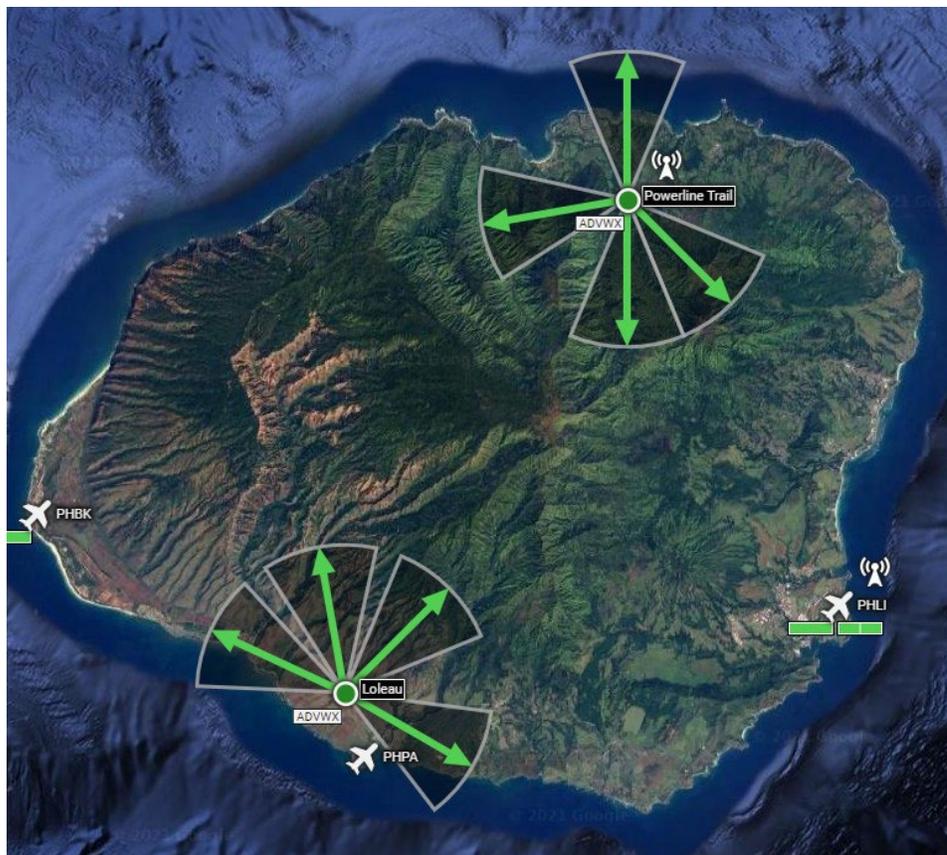
As of the date of this report, two locations on Kauai (and three on the islands of Oahu and Hawaii) had operational weather camera installations. One installation on Kauai was on the southwest side of the island (Loleau) and the other was on the north (Powerline Trail). (See Figure 18 for the locations and directions of those weather cameras.)

Figure 18. Weather camera installations completed in 2021 on Kauai (Source: FAA).
