Aviation Investigation Report AIR-23-01

# Abrupt Loss of Pitch Control and Water Impact

## West Isle Air dba Friday Harbor Seaplanes de Havilland DHC-3, N725TH

Mutiny Bay, Washington  
September 4, 2022

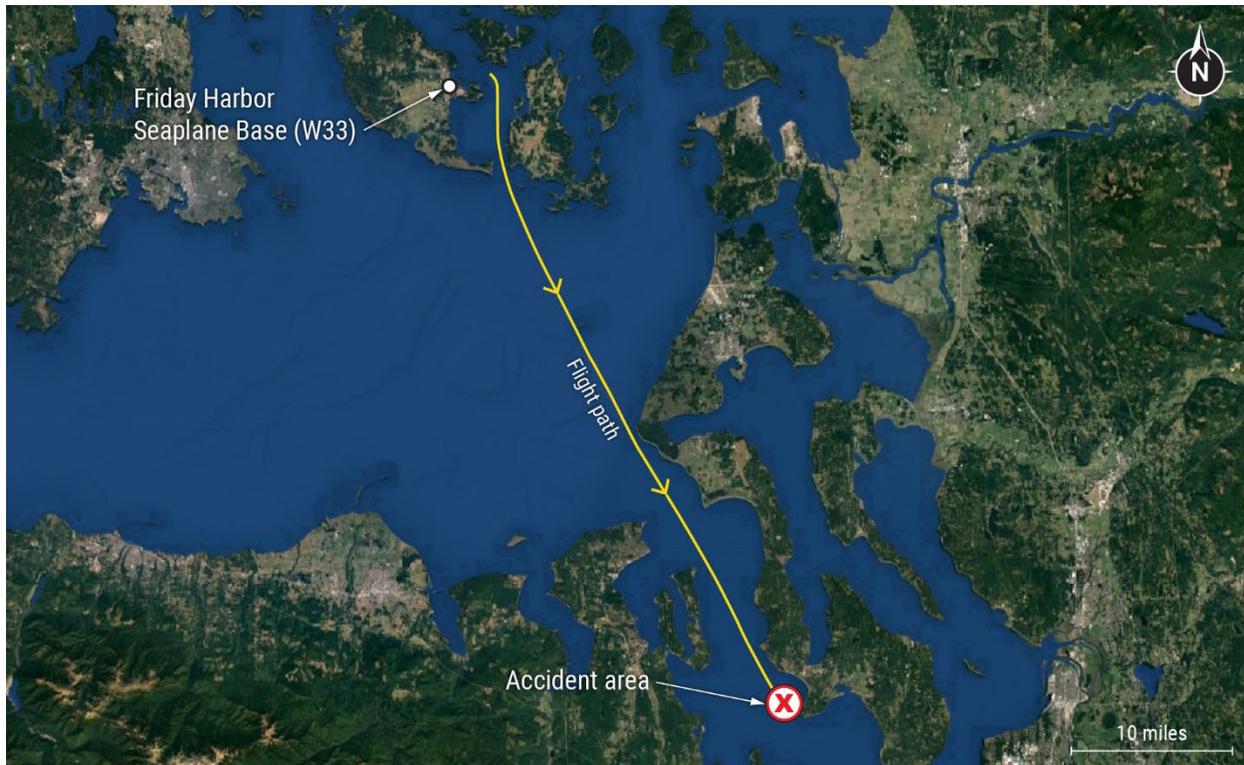
was more than 9,500 ft per minute (the flightpath of the airplane is depicted in figure 1).<sup>3</sup>

**Figure 1.** Flightpath of the accident airplane based on ADS-B data.

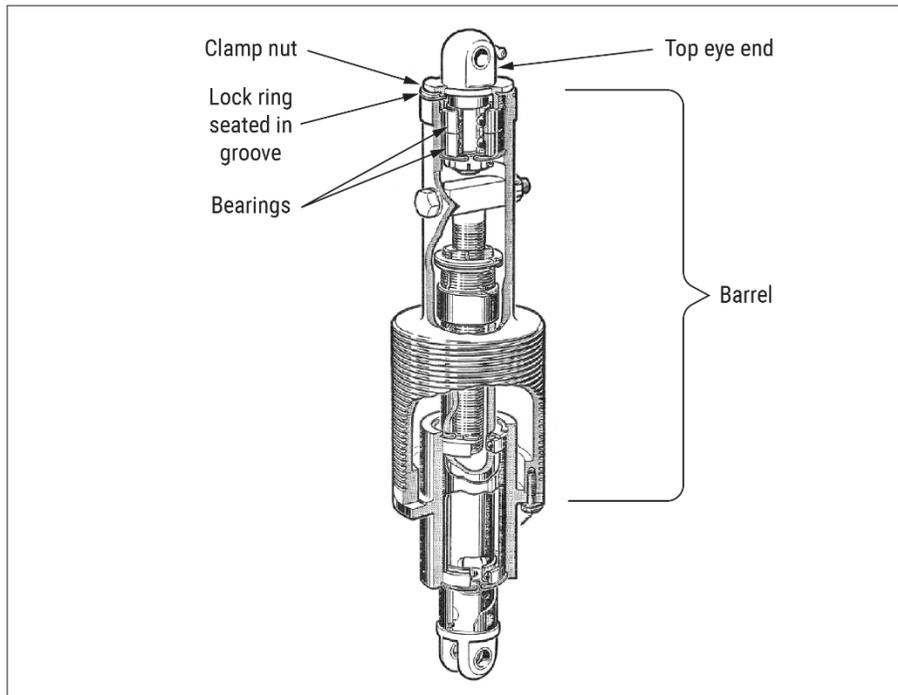
The horizontal stabilizer trim actuator is attached to the horizontal stabilizer with a bolt that connects the top eye end of the actuator to the rear mounting structure on the stabilizer. According to the DHC-3 aircraft maintenance manual (AMM), a clamp nut attaches the top eye end and bearing assembly to the barrel of

the actuator (see figure 4). Both the clamp nut and the barrel end of the horizontal stabilizer trim actuator are threaded so that the clamp nut can be securely screwed into the actuator barrel. The bearing assembly is designed to allow the barrel of the actuator to freely turn around the top eye end.

**Figure 4.** Horizontal stabilizer trim actuator (Source: Viking Air).

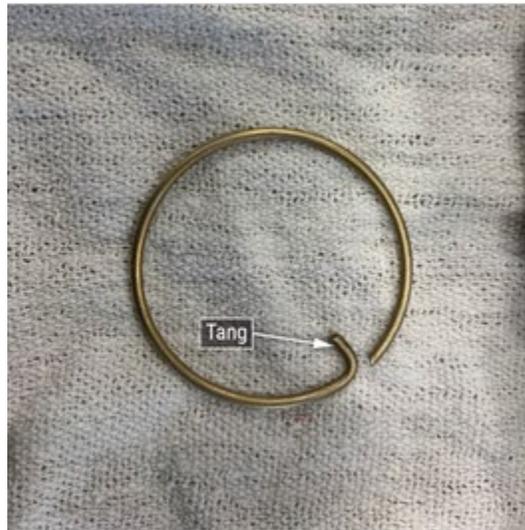
During normal assembly (at the time of manufacture), once the clamp nut is properly screwed into the horizontal stabilizer trim actuator barrel, a hole is drilled through the clamp nut (utilizing the existing hole in the lock ring groove of the barrel as a guide) that aligns with another hole in the lock ring groove on the actuator barrel.<sup>9</sup> When the lock ring is installed on the barrel, the tang portion of the lock ring (the portion that is bent inward, as shown in figure 5) must pass through the hole in the actuator barrel and into the hole in the clamp nut, engaging both components and preventing the clamp nut from unscrewing from the actuator barrel.

**Figure 5.** Exemplar lock ring.

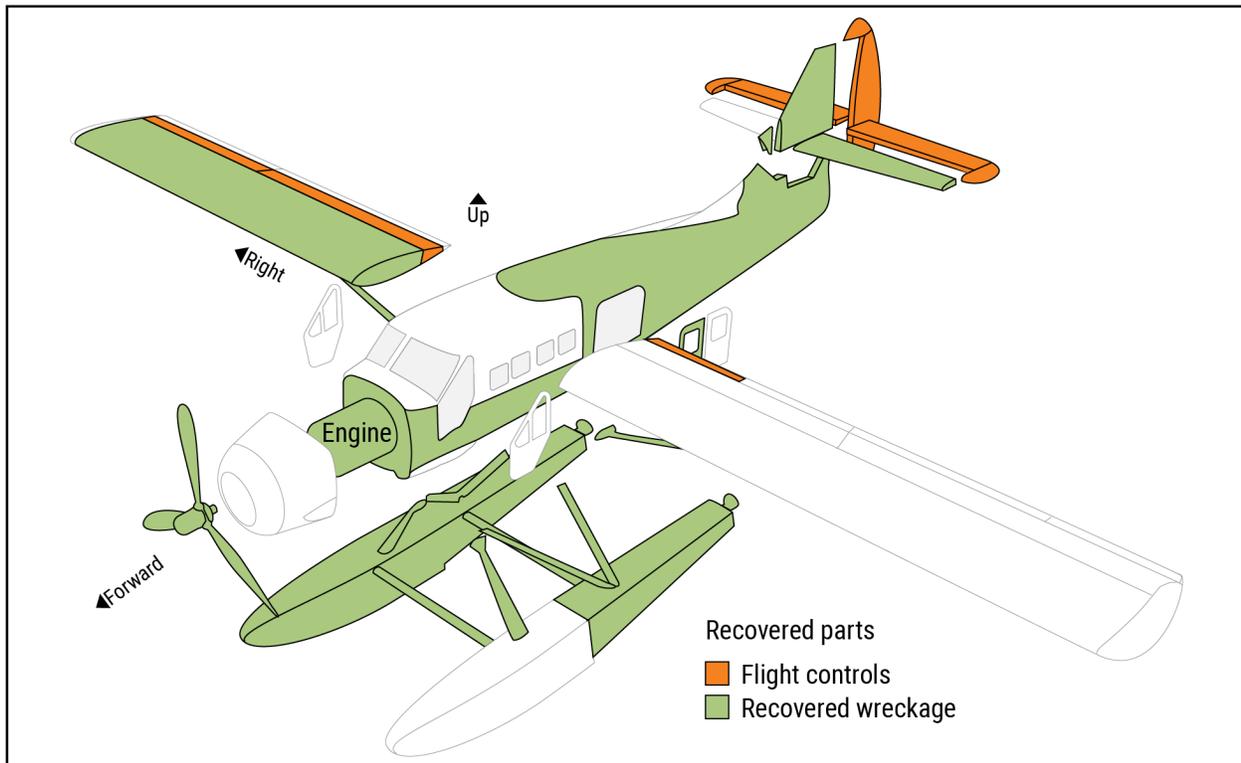
The airplane impacted Mutiny Bay and sank to a depth of about 200 ft. Wreckage was recovered between September 6 and September 30, 2022. After recovery from Mutiny Bay, the wreckage was transported to a secure facility for examination. The main items recovered included the nose fuel tank, engine mount and engine, propeller hub and blades, forward fuselage, center fuselage, tail section (empennage), right wing, most of the floats, some sections of flaps, and the left and right elevators (see figure 6).

**Figure 6.** A diagram of the recovered wreckage and flight controls (Source: Viking Air, recreated by NTSB).

The aft fuselage and empennage were separated from the rest of the airplane during recovery. The left side of the horizontal stabilizer, vertical stabilizer, and the lower portion of the rudder remained attached to the empennage. The left and right elevators were separated from the horizontal stabilizer.

An indentation in the shape of the horizontal stabilizer leading edge was observed on the left side fuselage skin just forward of the stabilizer cutout. The horizontal rib assembly installed in the aft fuselage below the horizontal stabilizer (shelf) and the fuselage side skins were crushed downward near the location of the stabilizer rear spar. Linear (fore-aft) scrapes were observed on the horizontal stabilizer lower skin rivet lines coincident with the edges of the shelf.

Most of the right side of the horizontal stabilizer was fractured off and not recovered. About 2 feet of the forward spar and leading edge of the right horizontal stabilizer remained attached. The forward end of this section was pulled outboard away from the fuselage and had a downward bend located about 6 inches from the root. The remaining part of the stabilizer fractured from this section on a 45° angle downward and aft. A downward indentation on the leading edge started at the stabilizer root and extended outboard about 2 feet.

The center and left side of the horizontal stabilizer remained attached to the forward hinge points in the aft fuselage and was twisted clockwise (as viewed looking down) about 15° around the center of the stabilizer. The entire left side of the stabilizer was mostly intact but was damaged and bent.

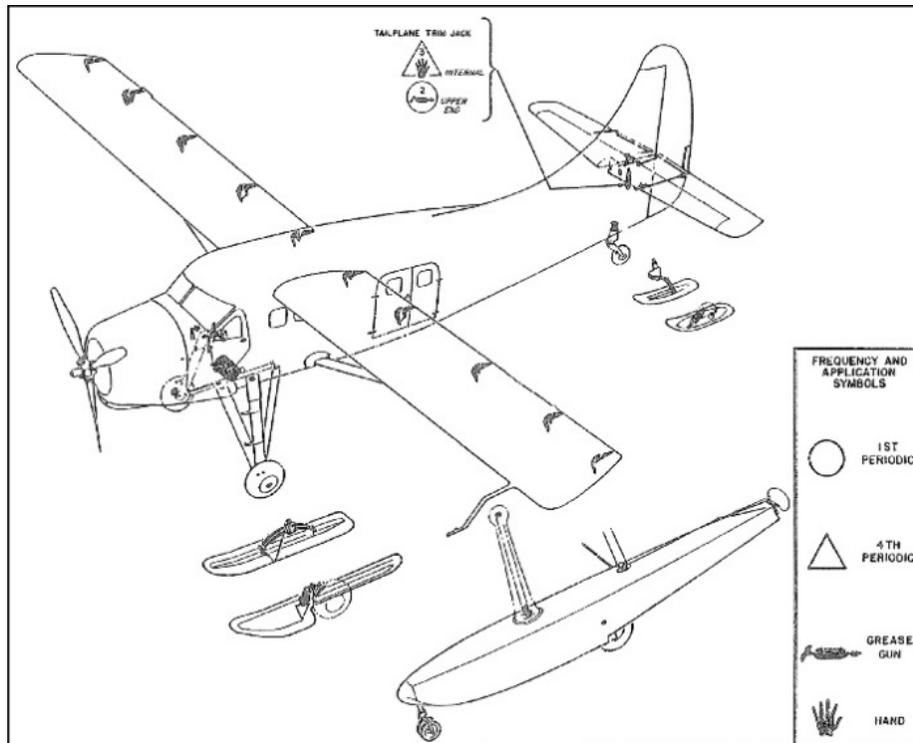
Regarding a lubrication schedule for the horizontal stabilizer trim actuator, a review of the DHC-3 AMM revealed a lubrication diagram that included symbols to specify the frequency and type of application; no written instructions were included regarding the lubrication requirements (see figure 13).<sup>45</sup> Based on the diagram, maintenance personnel should apply one type of grease to the upper end of the horizontal actuator using a grease gun at each 100-hour inspection and internally apply another type of grease, by hand, every 400 hours.<sup>46</sup>

**Figure 13.** Lubrication diagram for the airplane (Source: Viking Air, edited by NTSB).
