Aviation Investigation Report AIR-25-04

In-Flight Separation of Left Mid Exit Door Plug, Alaska Airlines Flight 1282, Boeing 737-9, N704AL

Portland, Oregon

January 5, 2024

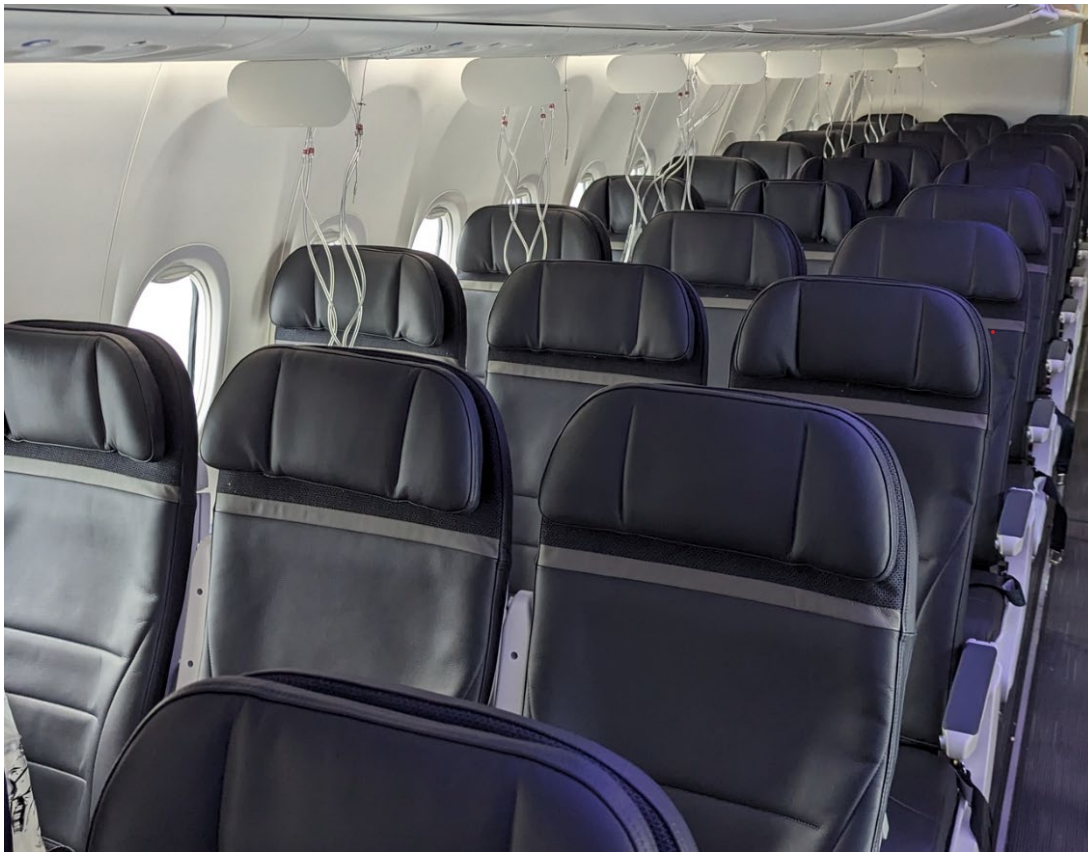
Figure 9. Photograph showing the passenger service unit doors open above the outboard (window) seats on the right side of the airplane.

Note: The tubing for the four deployed oxygen masks is visible.

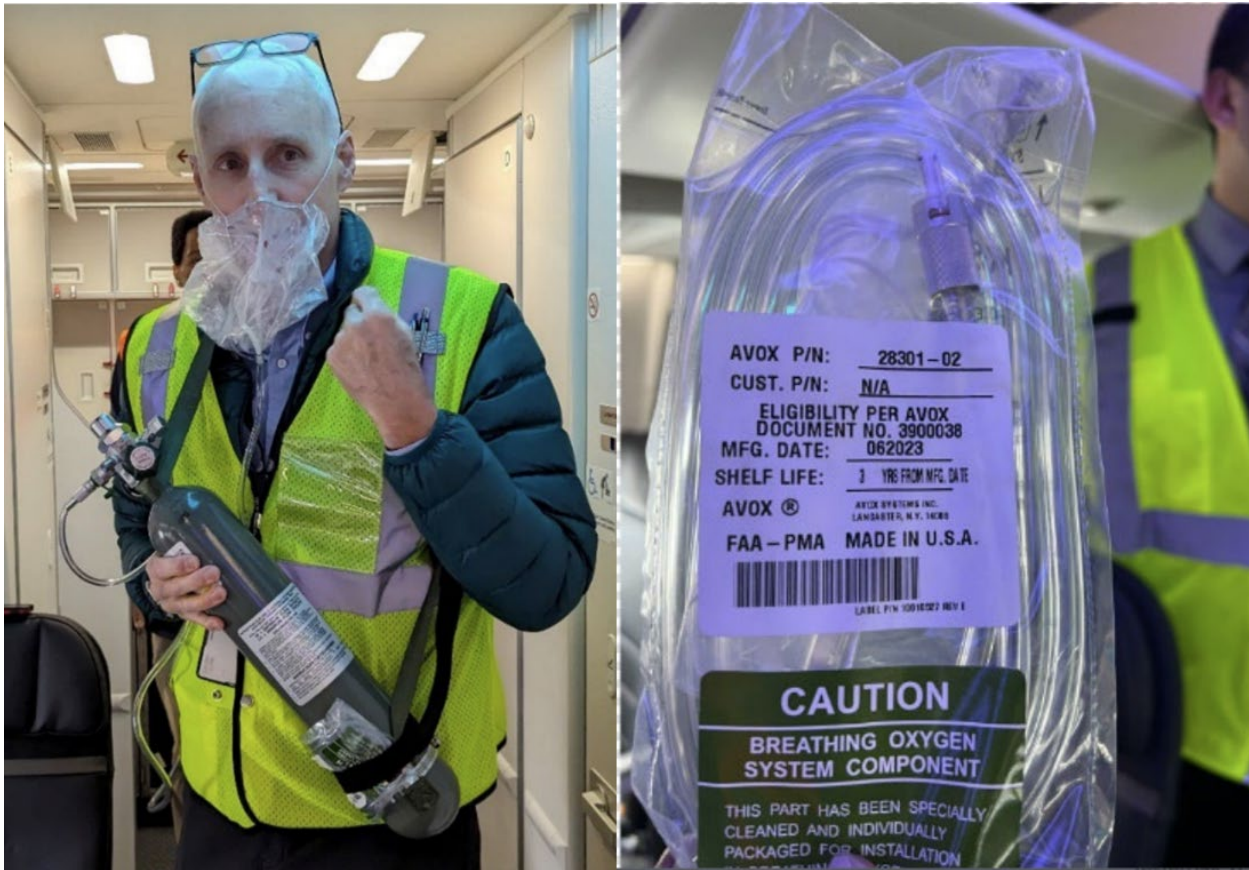
Another portable oxygen bottle was found lying on seat 34D; one mask was found out of its packaging and unfolded with the tubing uncoiled. The spare mask remained in its packaging, and the gauge read 1450 psi.

The opened masks on each bottle consisted of a plastic bag with two exhalation (vent) holes, a flexible metal nose strip, and an elastic strap (see figure 15).

Figure 15. Side-by-side photographs of the mask and shoulder strap of a portable oxygen bottle on the accident airplane being worn (left) and a closeup of the packaging for a spare mask and tubing (right). (Source for both photographs: Boeing)

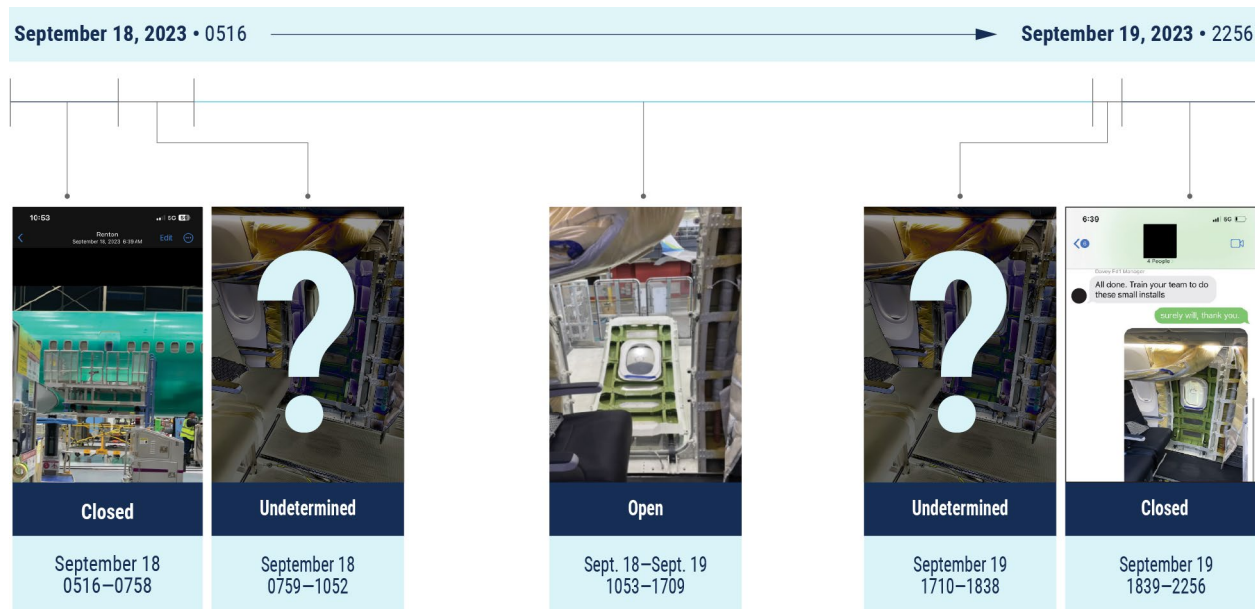
The investigation determined the left MED plug was open at least as early as 1053 on September 18, 2023, and remained open until at least 1709 on September 19, 2023, to allow access for the rivet work. Figure 17 shows the timeline for the opening and subsequent closure of the left MED plug based on the investigation's review of all available information.

Figure 17. Timeline showing the periods for which evidence indicated the left MED plug was in a closed or open position and the periods for which its position was undetermined.
