Aviation Investigation Report AIR-26-02

Midair Collision over the Potomac River PSA Airlines Flight 5342, Mitsubishi Heavy Industries (MHI) RJ Aviation CL-600-2C10 (CRJ700), and US Army Priority Air Transport Flight 25, Sikorsky UH-60L

Washington, DC
January 29, 2025

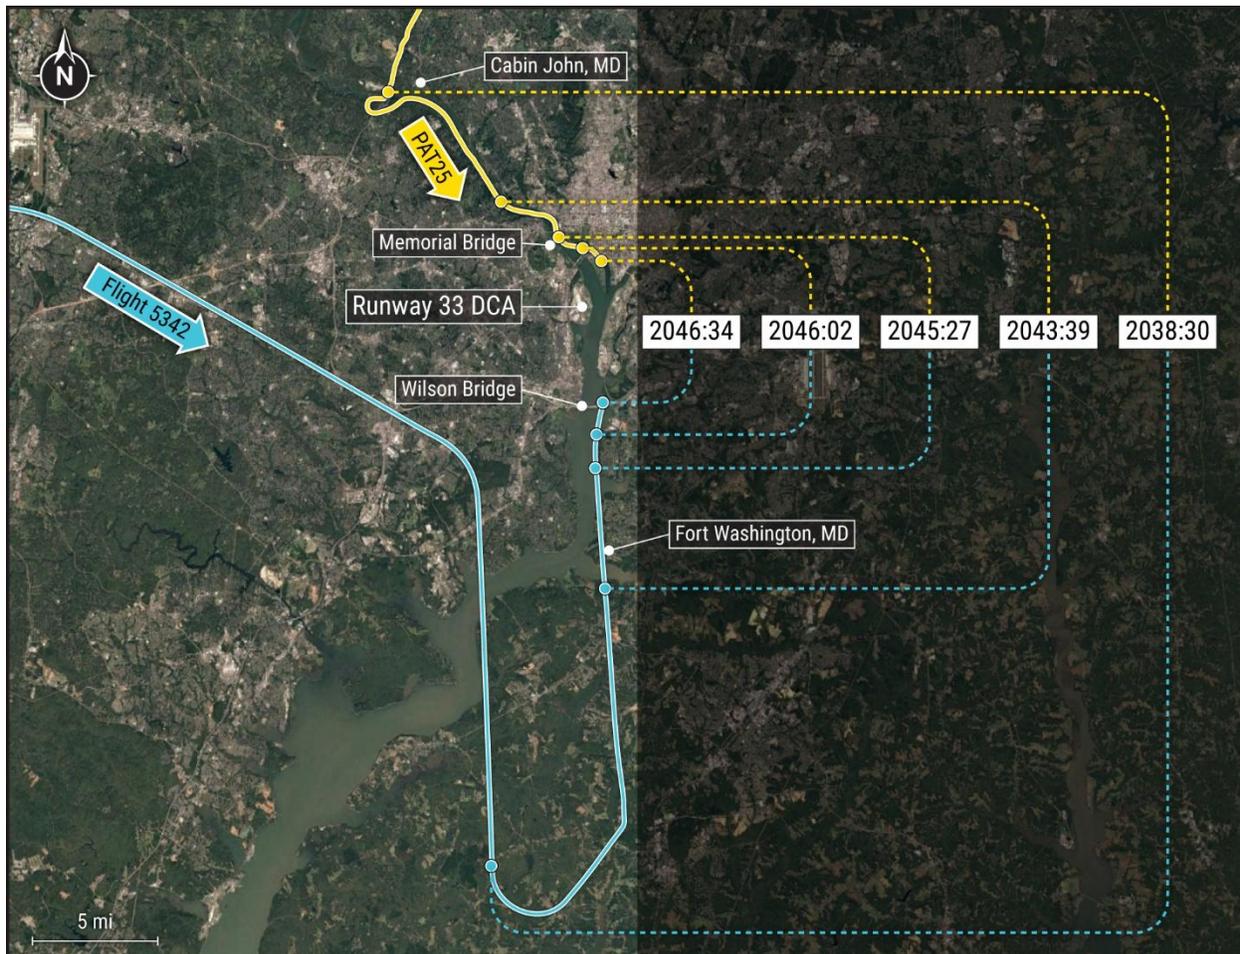
About 2038:30 (or 9:29 before the collision), while descending from 1,400 ft mean sea level (msl), the helicopter reached Cabin John, Maryland, where Helicopter Route 1 began. The pilot initially turned west before the IP advised that they had turned the wrong direction. The helicopter subsequently circled toward the east while continuing its descent, joined Route 1, and continued south along the Potomac River at 800 ft msl (see figure 1).

Figure 1. Locations and flight paths of flight 5342 and PAT25 showing aircraft positions from 2038:30 to 2046:34.

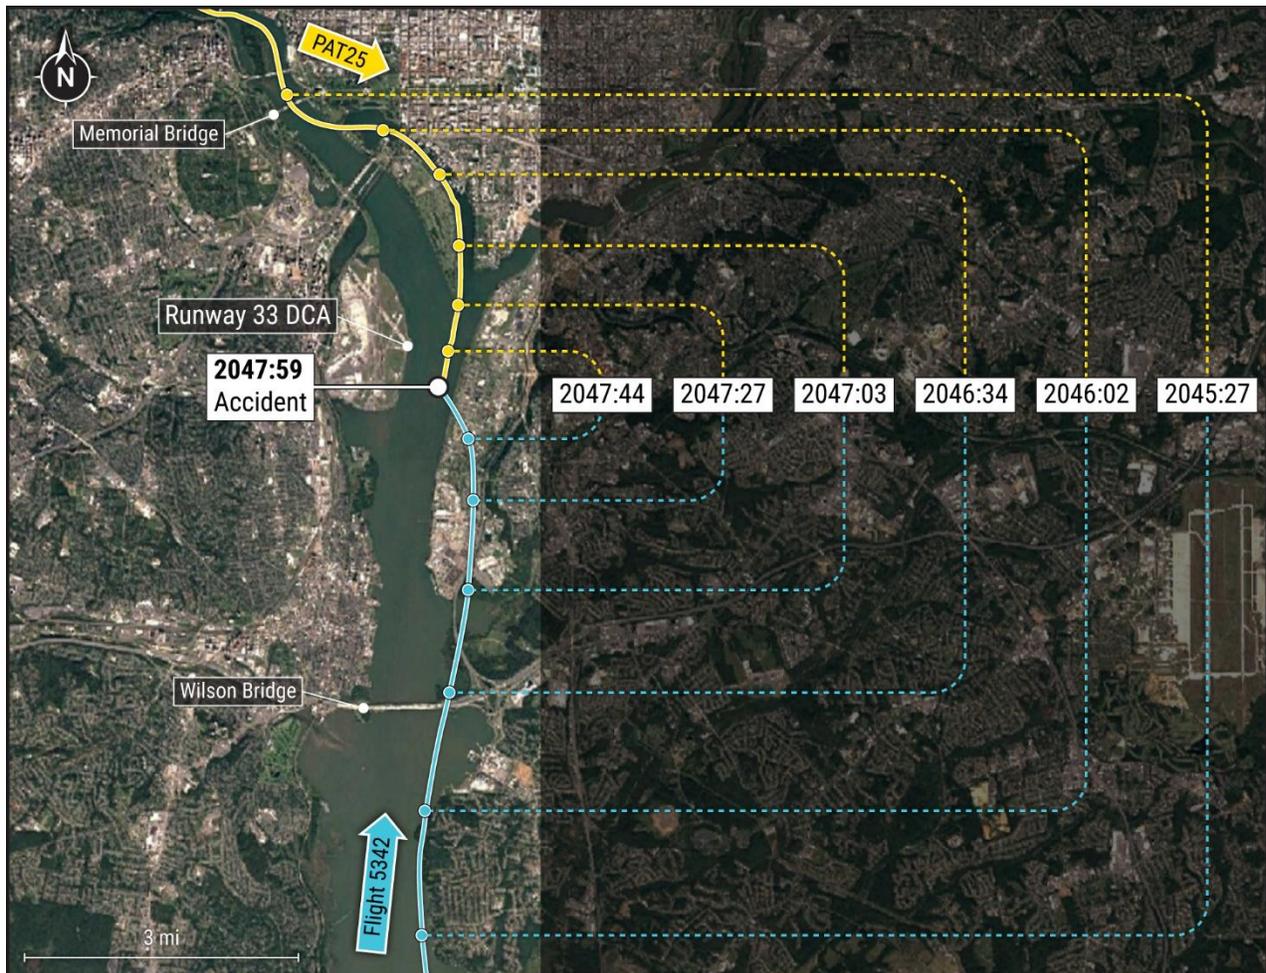
Figure 2. Locations of flight 5342 and PAT25 from 2045:27 through 2047:59.

According to radar data, the controller received a conflict alert beginning at 2047:33 (or 26 seconds before the collision).¹⁷ At 2047:39 (see figure 2), the controller contacted the helicopter, stating, “PAT two five do you have the C-R-J in sight?” The conflict alert was audible in the background of this transmission.¹⁸ The controller’s query to PAT25, with the conflict alert audible in the background, was audible on the airplane’s CVR. Data from the airplane’s FDR and CVR also indicated that, about this time, at a radio altitude of 448 ft, the crew received a traffic alert and collision avoidance system (TCAS) traffic advisory (TA), which included the aural annunciation, “Traffic. Traffic.” Information recorded on the FDR did not indicate if the TA on the TCAS display provided the crew with information on the bearing, or

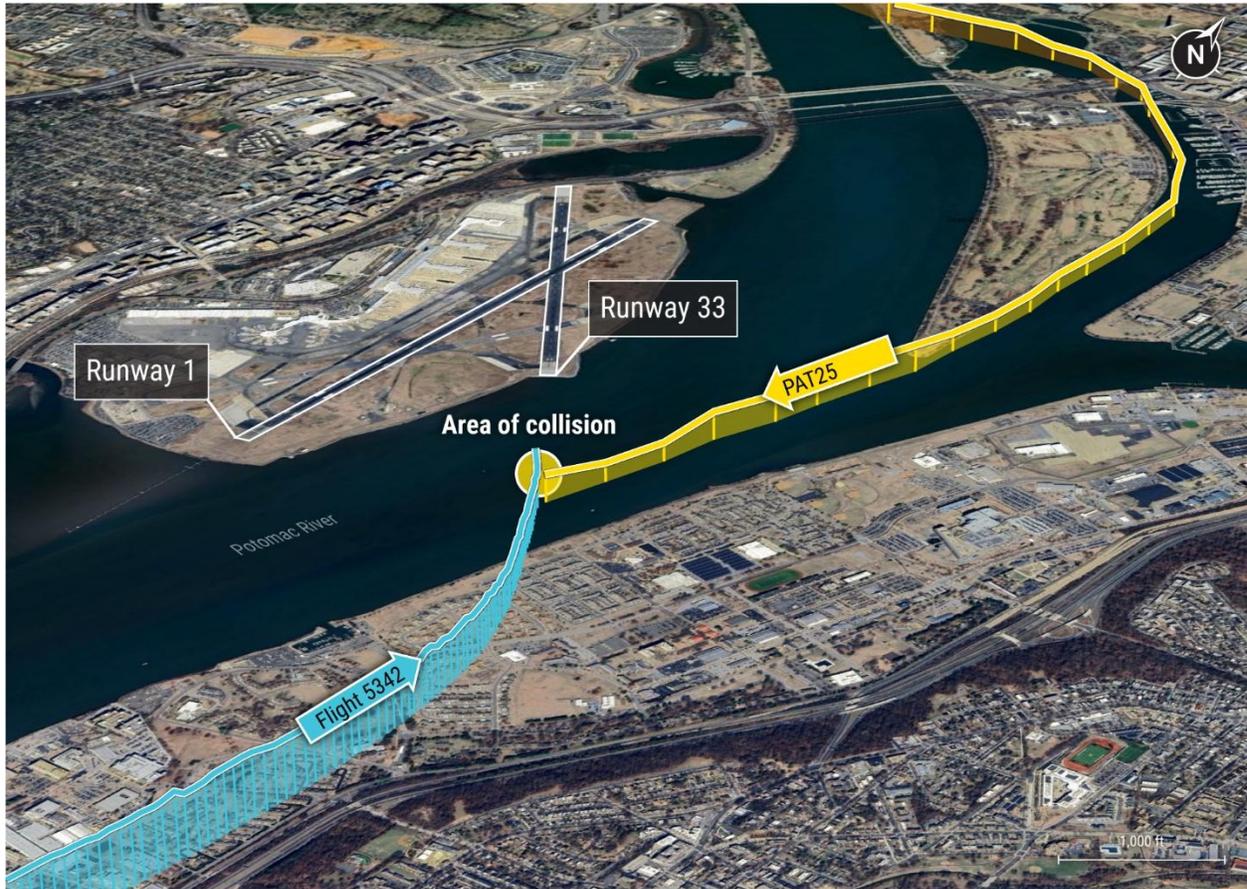
position, of the conflicting traffic. The CVR indicated that the crew did not verbally acknowledge the TA, nor did they discuss looking for the traffic. The aircraft were about 1 nm apart with a closure rate of about 200 knots. Figure 3 shows the final portions of the flightpaths of both aircraft as they converged.

Figure 3. Oblique aerial illustration of the Automatic Dependent Surveillance–Broadcast flight track for flight 5342 (yellow line) and the composite data-derived flight path for PAT25 (blue line) converging near DCA.

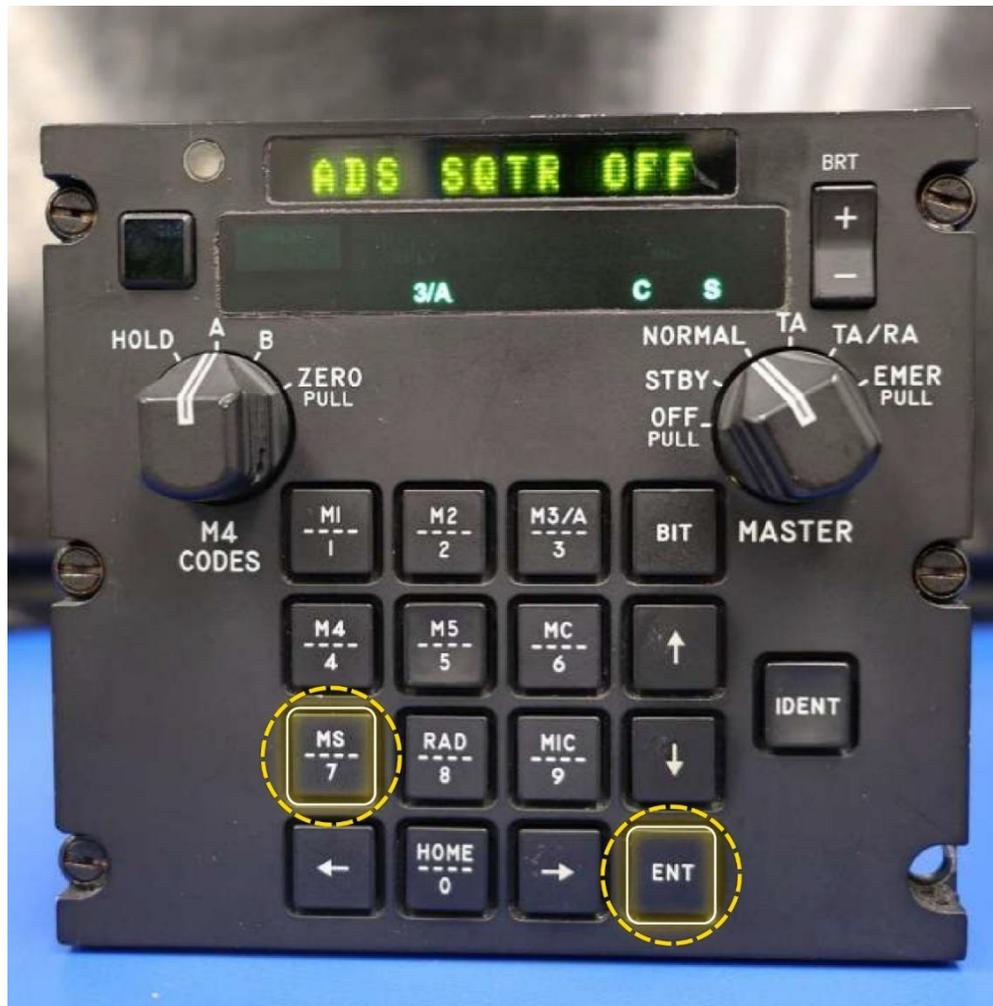
Figure 5. A UH-60L transponder with the ADS-B squitter turned off. (Source: BAE Systems)

Note: Mode S can be enabled by pushing the two highlighted buttons, MS-7 and ENT, in sequence.

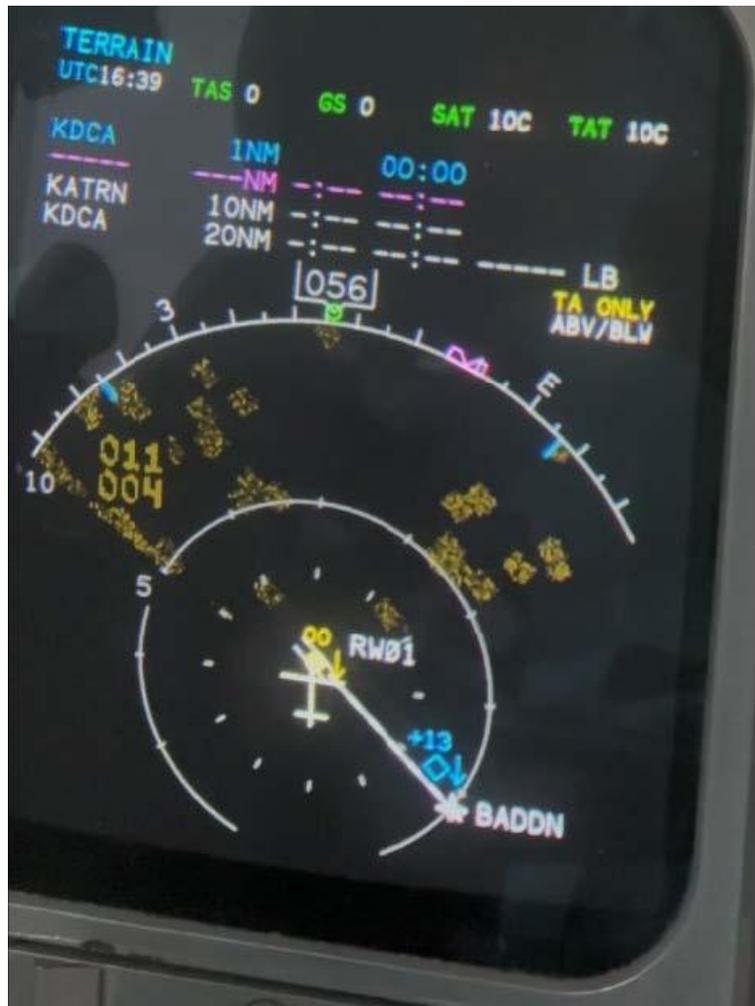
Figure 11. MFD in an exemplar CRJ700 showing an active TA.

Note: This photograph was taken in an exemplar CRJ on the ground. The conflicting traffic in this TA is depicted by the yellow diamond, annotated with "00," which is shown over the ownship depiction (white airplane) in the bottom center of the image, indicating that the traffic is at nearly the same altitude as the own-ship. The text "TA ONLY" shown in yellow on the upper right side of the image indicates the mode of the TCAS system: RAs are automatically inhibited below 1,000 ft agl (± 100) feet; the crew can also manually select TA ONLY mode.

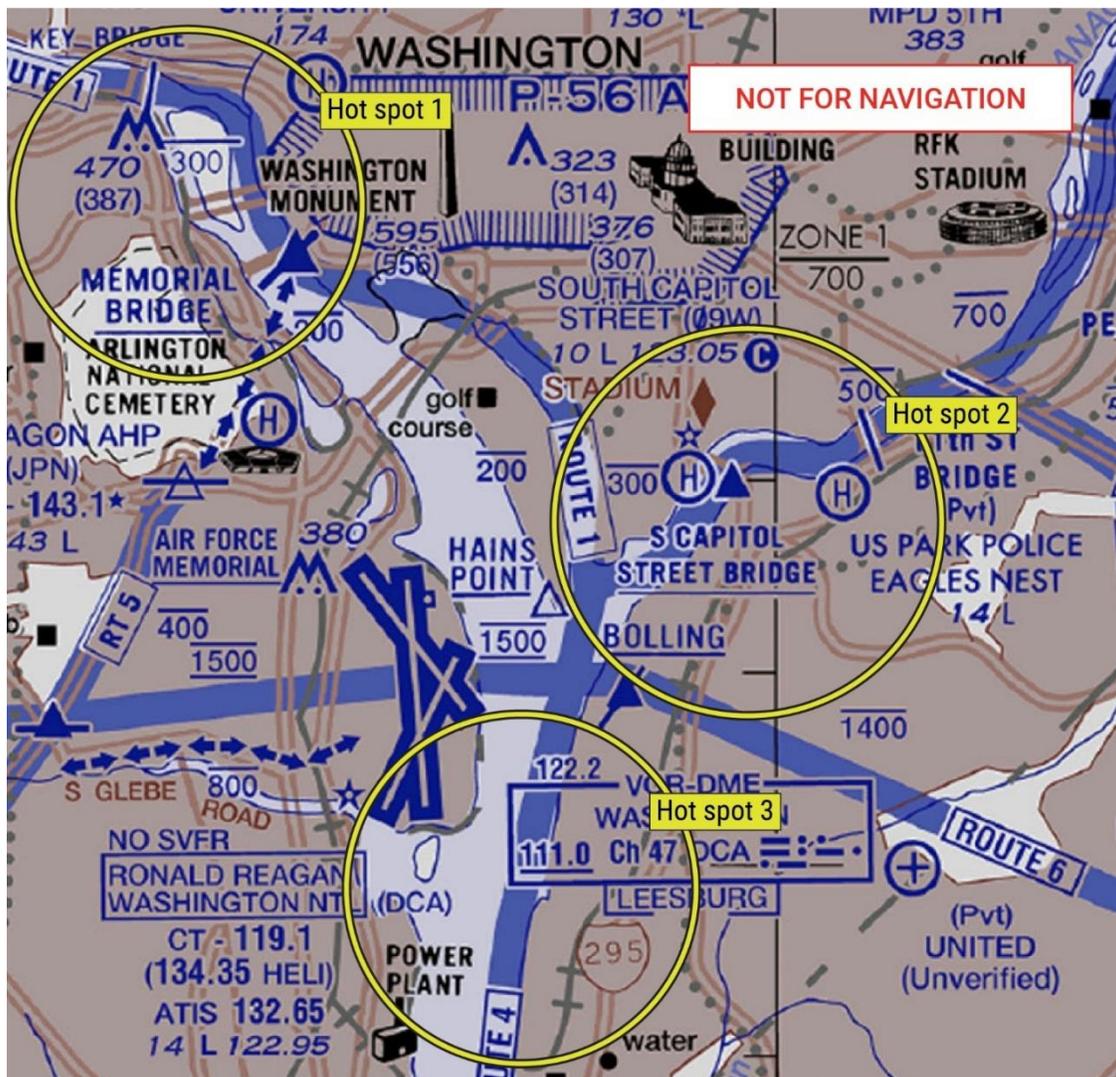
Figure 16. Helicopter route chart excerpt with proposed hotspots circled.

In addition to these suggested changes, the proposal included the addition of three “hotspots” to the helicopter route chart, which were areas that the HWG had identified as posing an increased risk of midair collision based on review of Preliminary Aviation Risk Identification and Assessment (ARIA) Reports (PARs).^{58,59} The intent of the proposed hotspots was to increase pilot and controller awareness and vigilance in those areas. The proposed hotspots included the area of Route 4 and the runway 33 final approach path (where both the 2013 NMAC and this accident occurred), Route 1 in the vicinity of South Capitol Street, and Route 1 near the Memorial Bridge (see figure 16).

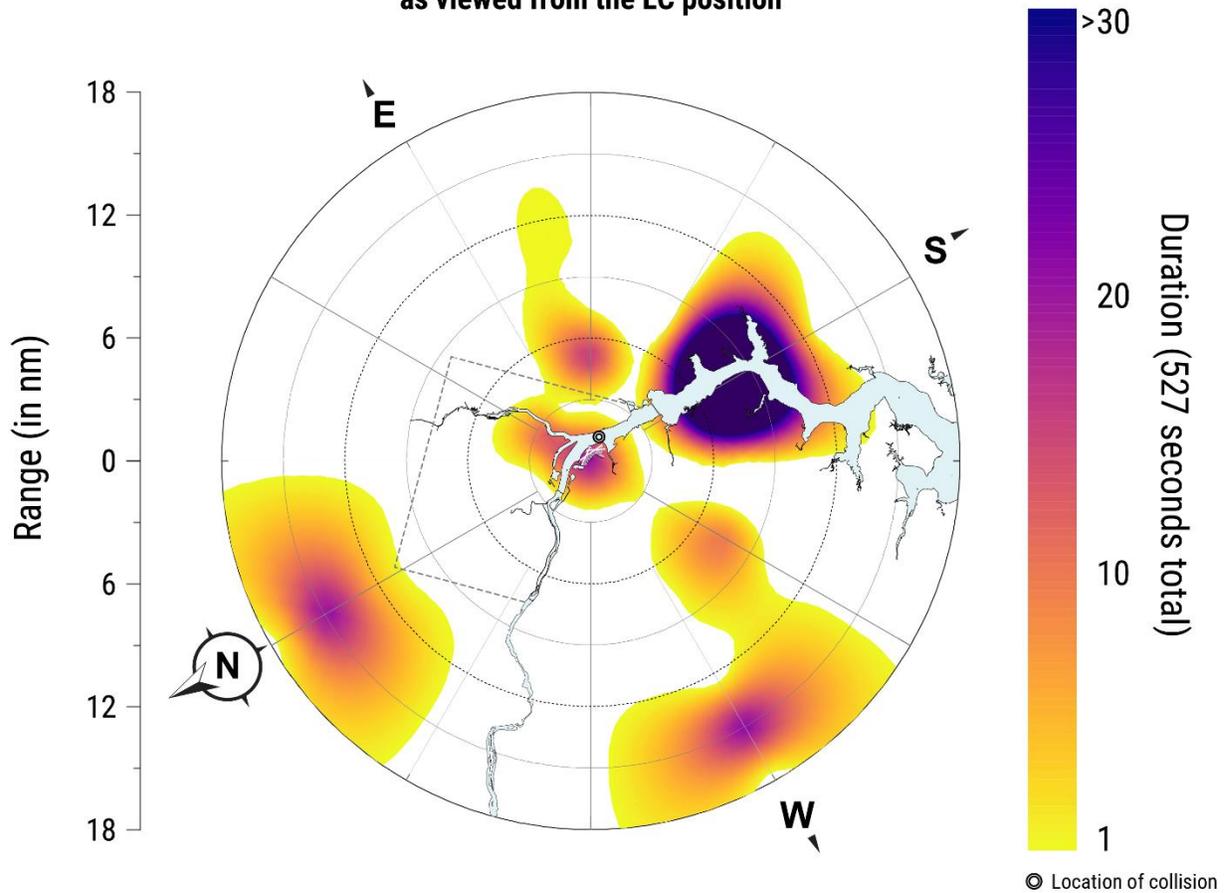
Figure 21. Heatmap of the direction, distance, and duration of the LC controller's communications with aircraft from 2030 to 2047:59 (impact), as viewed from the LC position.

Of the 17 minutes and 59 seconds before the collision, the LC controller was engaged in radio communications with aircraft—either speaking or receiving—for 8 minutes and 46 seconds, or about 49% of the time. A complementary heatmap focusing on the 2 minutes before the collision is presented in figure 22; during this period, the LC controller was attending to radio communications with aircraft for 72 seconds, or 60%, of the time.

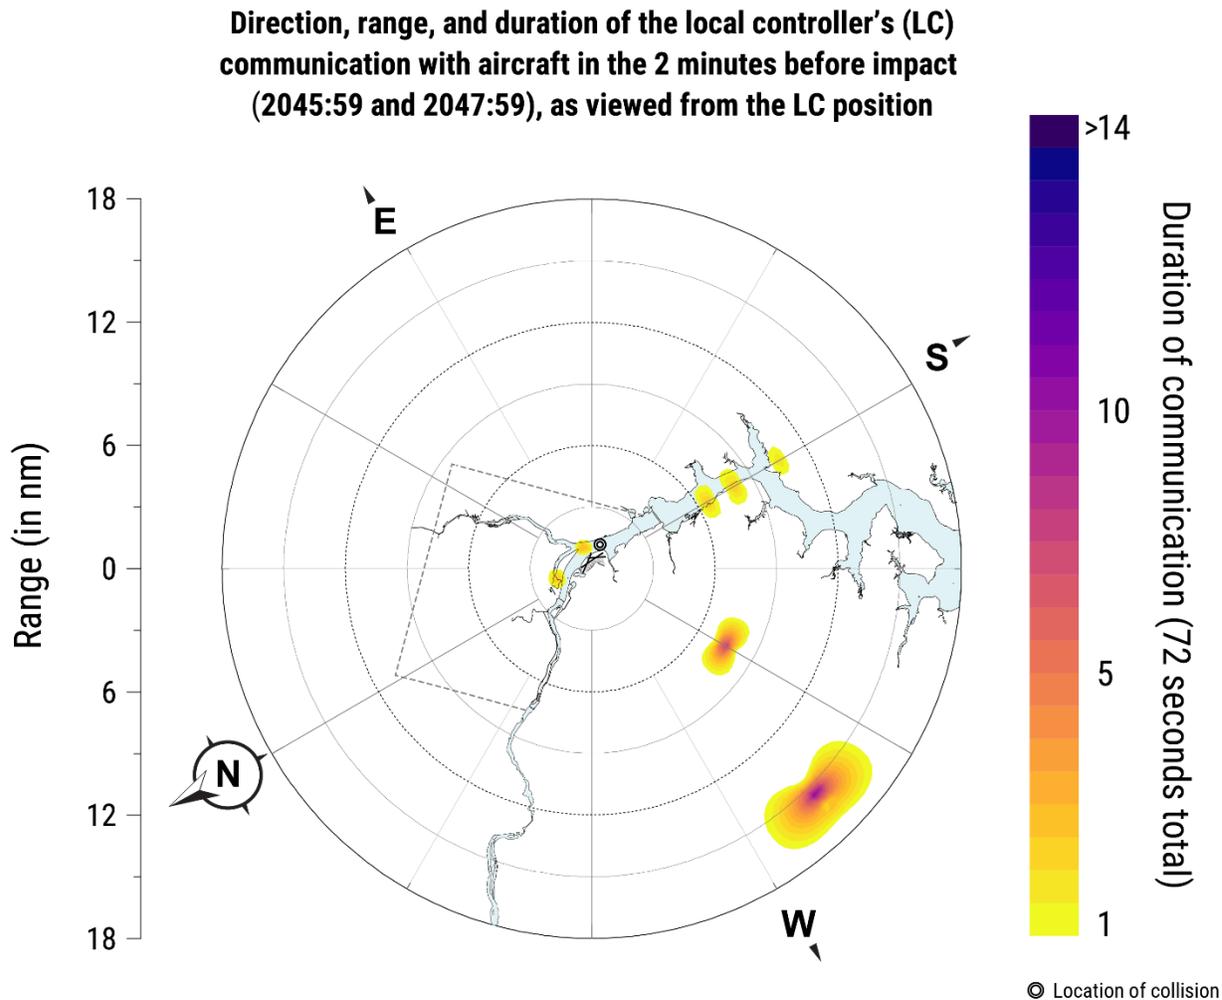
Figure 22. Heatmap of the direction, distance, and duration of the LC controller's communications with aircraft in the 2 minutes before impact (2045:59 to 2047:59), as viewed from the LC position.

The conflict alert was audible during two brief mic keys from the controller at 2047:37.8, and would have been visible on the controller's control tower radar display (CTRD). Less than 2 seconds later, about 20 seconds before the collision, the LC controller asked PAT25 if they still had the CRJ in sight. Three seconds later, the LC instructed PAT25 to pass behind the CRJ. PAT25 confirmed the aircraft was in sight and requested visual separation; the LC controller then stated "vis separation." At 2047:54 (5 seconds before the collision), AAL472 contacted the tower a third time, and the LC controller was communicating with that airplane when the collision occurred.

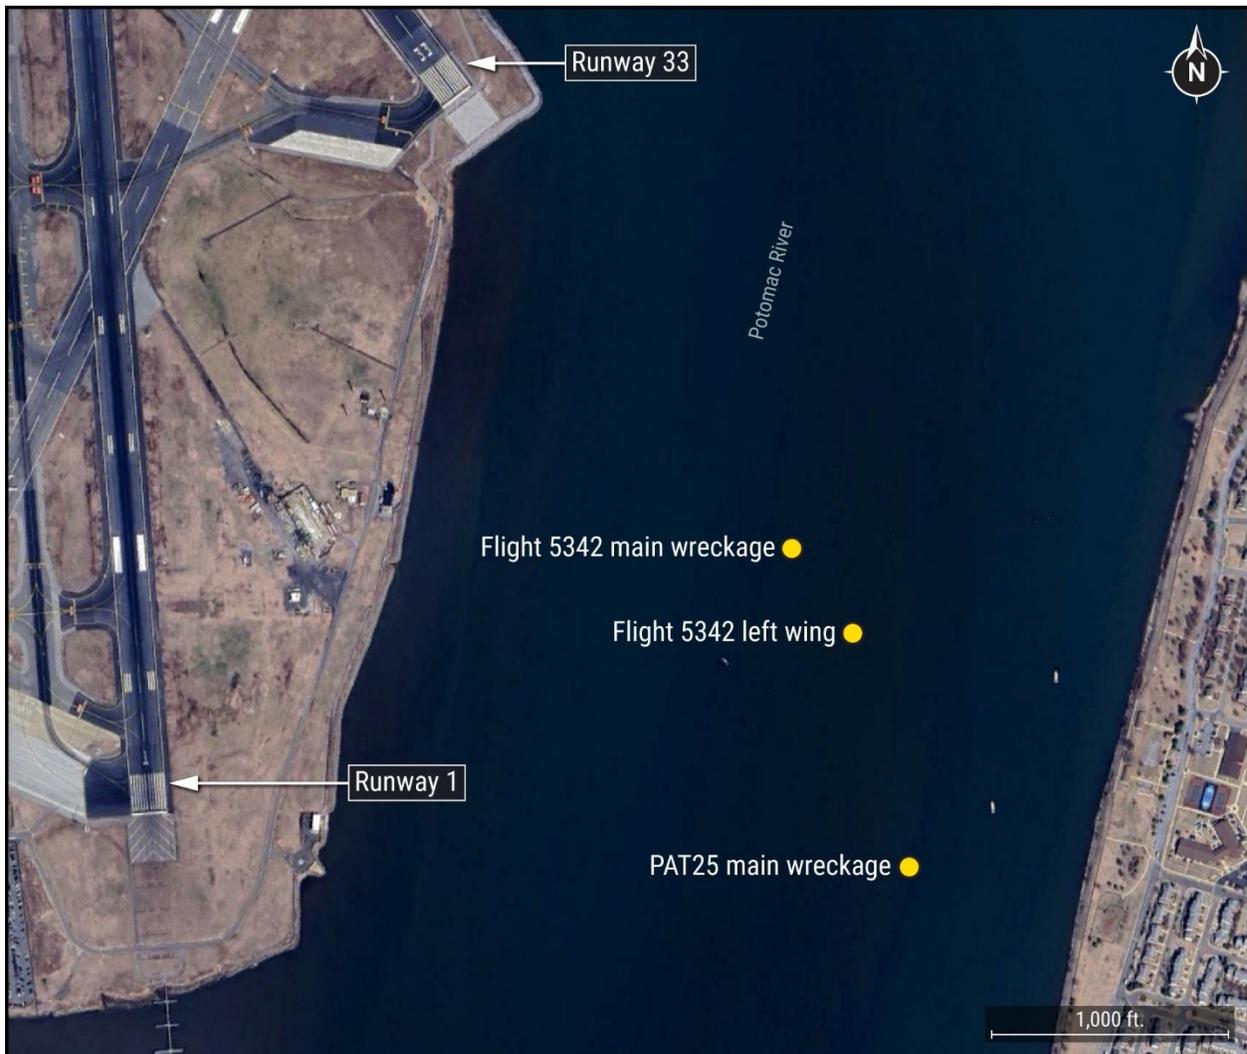
Figure 26. Diagram of main wreckage locations in the Potomac River.

The wreckage of both aircraft were located in the Potomac River in water depths ranging between 1 and 8 ft depending on location and tidal conditions. The helicopter wreckage was about 3,730 ft southeast of the approach end of runway 33 and included most of the major structure. The airplane was fragmented into several pieces centered about 2,345 ft southeast of the approach end of runway 33. The outboard left wing was recovered away from the main airplane wreckage, about 2,790 ft southeast of the approach end of runway 33. Figure 26 shows the wreckage locations in relation to the airport.

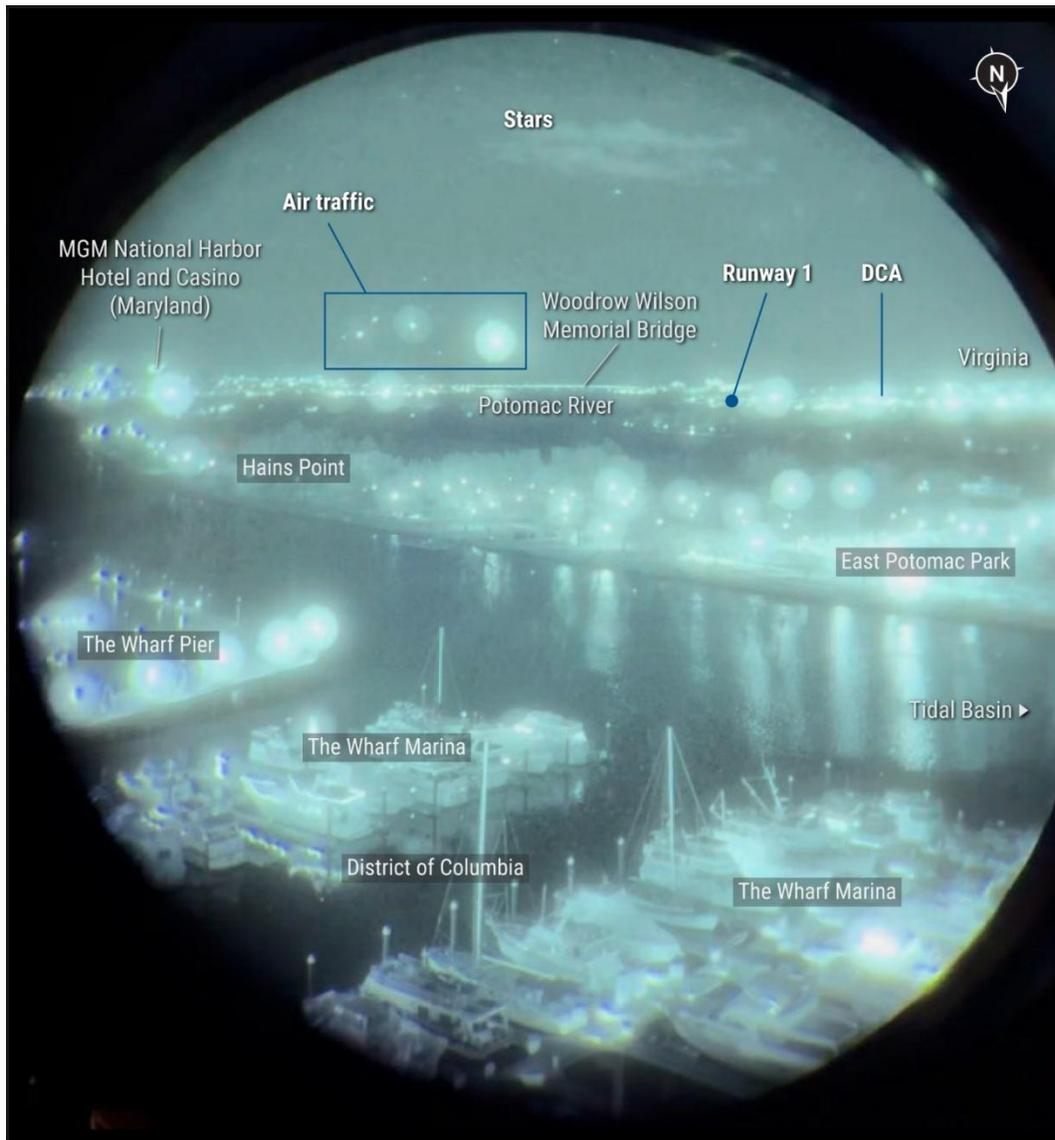
Figure 36. White phosphor night vision goggle view of airplanes approaching runway 1 at DCA.

The NTSB took observation photos from the top of a building located about 2 nm northeast of DCA when airport operations were in a north configuration (airplanes approaching from the south). The photos were taken through white phosphor ANVIS 9 NVGs, which have the same optical performance as the accident helicopter crew’s NVGs. The photos captured multiple airplanes approaching runway 1 at DCA. The airplanes appeared as points of light with no obvious aircraft structure and their relative distance from the observation point was difficult to discern. Figure 36 shows an example of a view through the white phosphor ANVIS 9 NVGs, as captured in a frame from a video recorded by an iPhone held to one of its viewing lenses.

Note: Image was captured in a frame from a video recorded by an iPhone held to one of the NVG's binocular viewing lenses. Capturing clear images through the NVGs' eyepieces is difficult; investigators found that the actual view through NVGs is sharper and clearer than depicted in the figure. The image is provided to depict the appearance of ground cultural lighting and airborne aircraft in the accident area when viewed through NVGs. The vantage point from which this image was captured (160 ft agl) is about 100 ft lower than the altitude at which the helicopter was flying (about 260 ft agl) and offset about 800 ft from the centerline of its flight path. However, at a distance of over 5 nm, the difference in angular displacement of the aircraft above the horizon would be imperceptible to the viewer. Thus, the cluster of aircraft above the horizon approaching DCA is similar to what the crew would have seen from the helicopter.

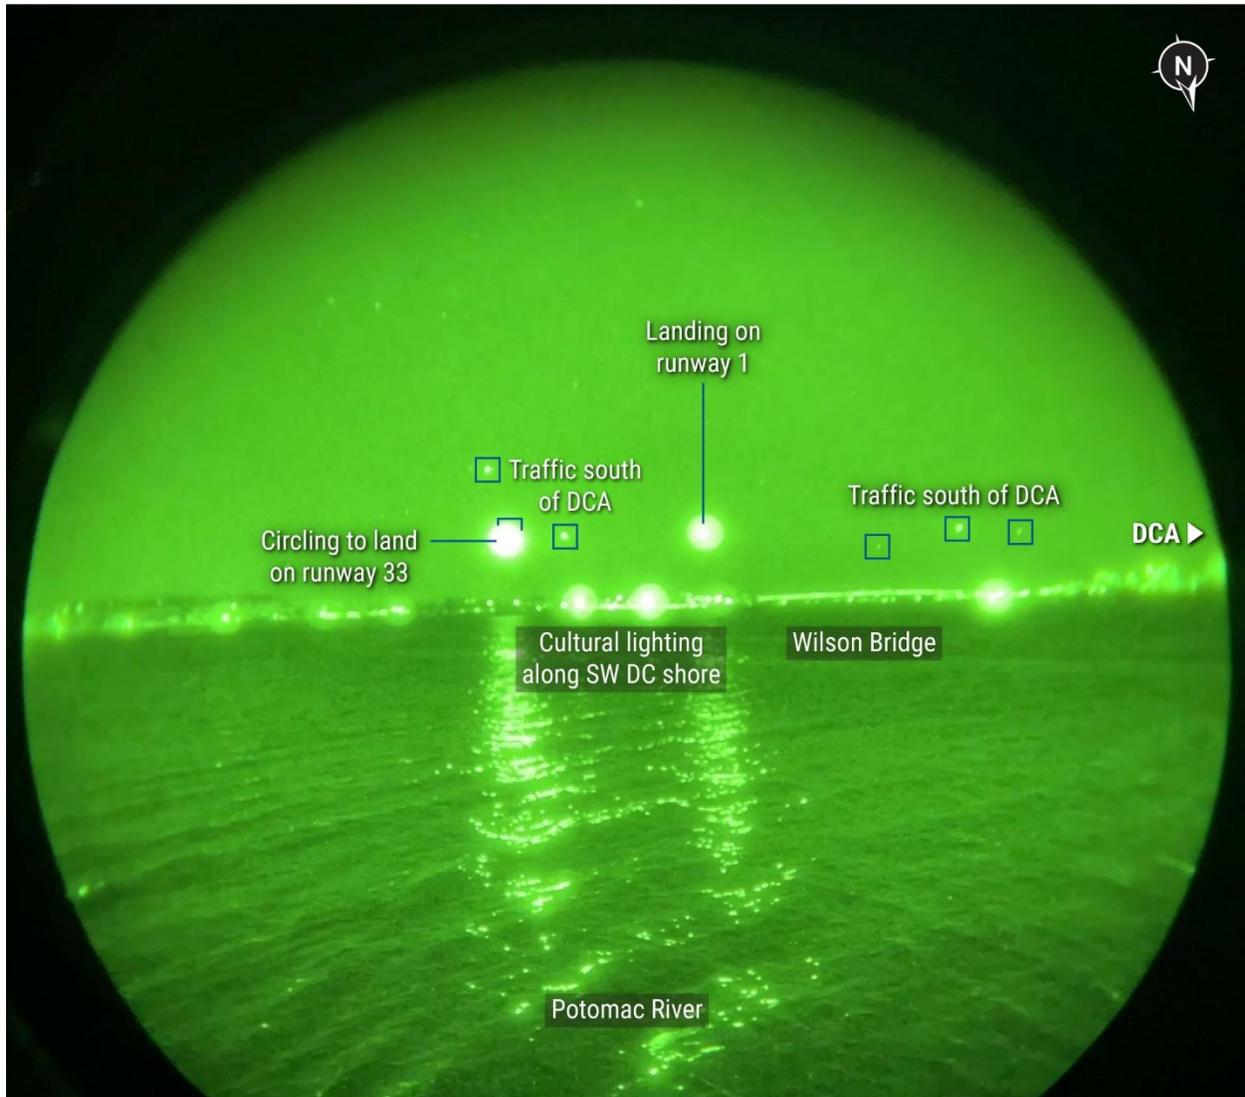
Figure 37. Green phosphor night vision goggle view of airplanes approaching DCA from the south, as seen from Hains Point.

Figure 37 shows an example of the view looking south from Hains Point through green phosphor ANVIS 9 NVGs, as captured in a frame from a video recorded by an iPhone held to one of its viewing lenses.

Note: Image was captured in a frame from a video recorded by an iPhone held to one of the NVG's binocular viewing lenses. Capturing clear images through the NVGs' eyepieces is difficult; investigators found that the actual view through NVGs is sharper and clearer than depicted in the figure.

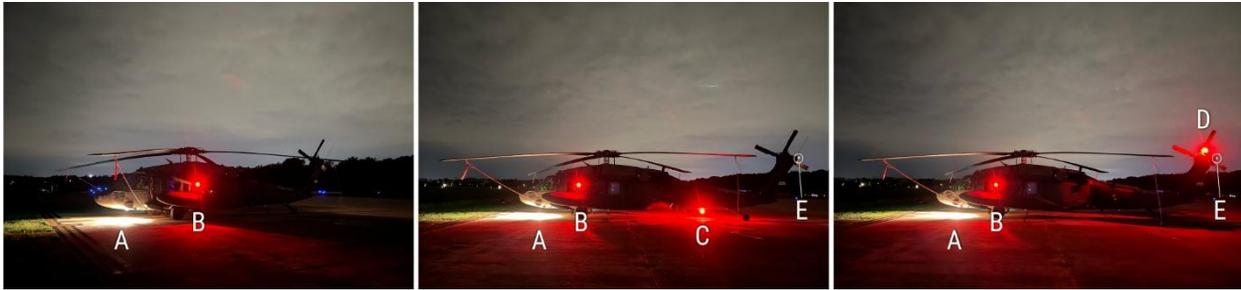
Figure 38. Left view of a UH-60L showing landing light (A), left navigation light (B), flashing lower anti-collision beacon (C), flashing upper anti-collision beacon (D), and tail position light (E).

The NTSB Vehicle Recorder Division reviewed multiple video files that captured the accident from cameras located at various sites to determine the status of the exterior lights on both aircraft before the collision. The helicopter was equipped with seven exterior lights; left, right, and tail position lights, upper and lower anti-collision beacon lights, a landing light, and a search light, as shown in figure 38.

Note: The search light, which was not illuminated at the time of the accident, is similarly not illuminated, labeled, or depicted in this figure.

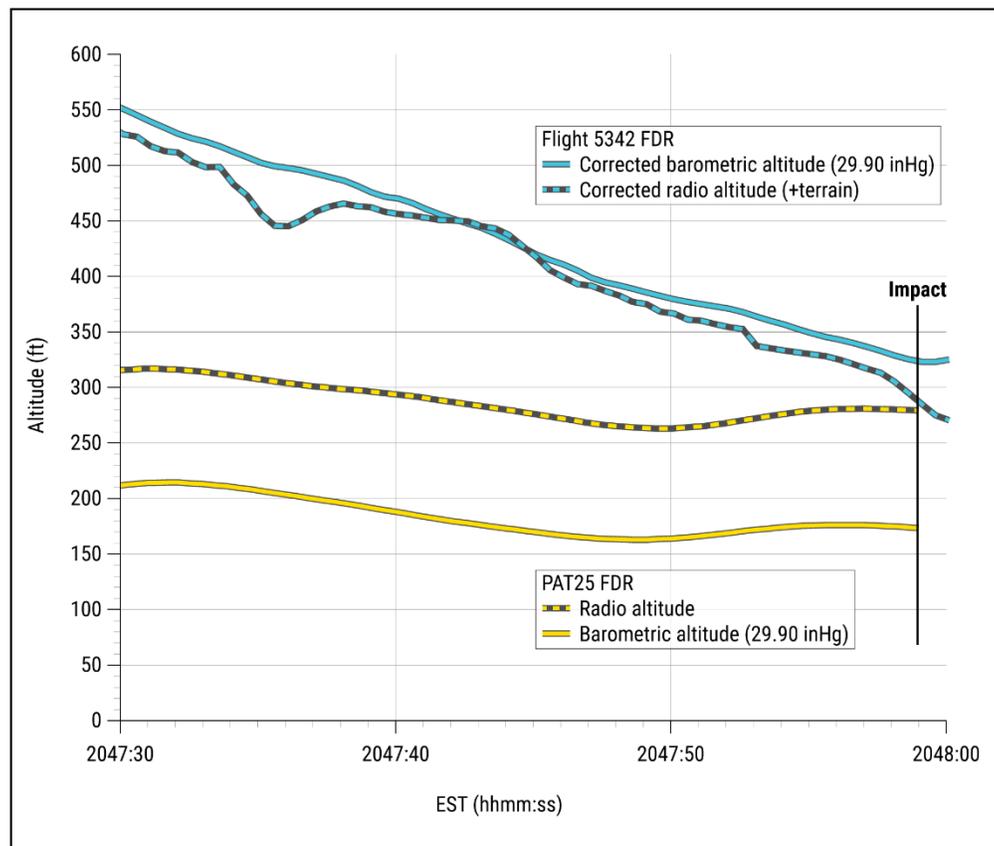
Figure 41. FDR-corrected radio and barometric altitudes for the airplane and helicopter for the flights' final 30 seconds.

The collision occurred at an altitude of 278 ft msl. At the time of the impact, the FDR data for each aircraft showed that their respective radio altitudes were within 10 ft, consistent with the helicopter impacting the underside of the airplane, as confirmed by the wreckage examination. The helicopter's barometric altitude, however, was about 100 ft lower than the other recorded altitudes, as shown in figure 41.

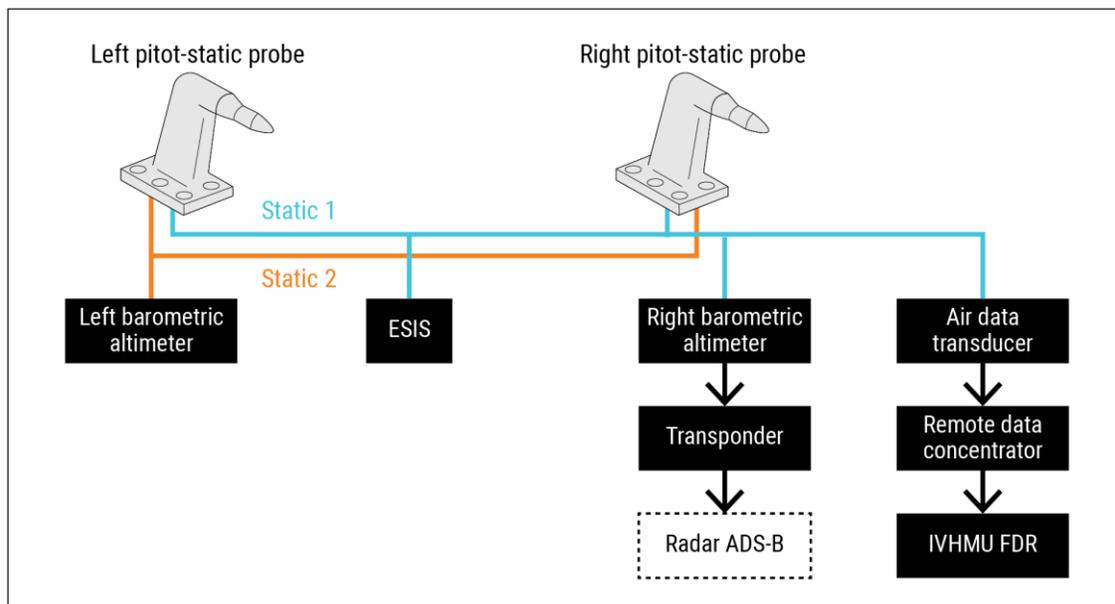
during the accident flight. Correcting the pressure altitude to reflect barometric altitude found the resulting altitude to be 80 to 100 ft lower than the known field elevations. Although changes in pressure altitude recorded by the helicopter's FDR reflected changes in radio altitude, the absolute values observed were too low to be considered accurate for the purposes of the investigation.

Avionics diagrams showed that the static pressure from the pitot-static system was measured by the air data transducer, where it was converted to an altitude based on the ISA standard model, uncorrected for local atmospheric conditions. This pressure altitude value was subsequently sent to the remote data concentrator, which converted that information into a data stream that was provided to the IVHMS, including the FDR, for recording. Separately, the static pressure was sensed by each pilot's barometric altimeter and converted to an altitude indication independently. Each pilot would adjust their altimeter's barometric setting via their Kollsman window. The uncorrected pressure altitude from the right side barometric altimeter was sent to the airplane's transponder, which transmitted the pressure altitude data when configured to do so. Figure 42 shows a diagram of the helicopter's static system.

Figure 42. Diagram of the Sikorsky UH-60L static system.

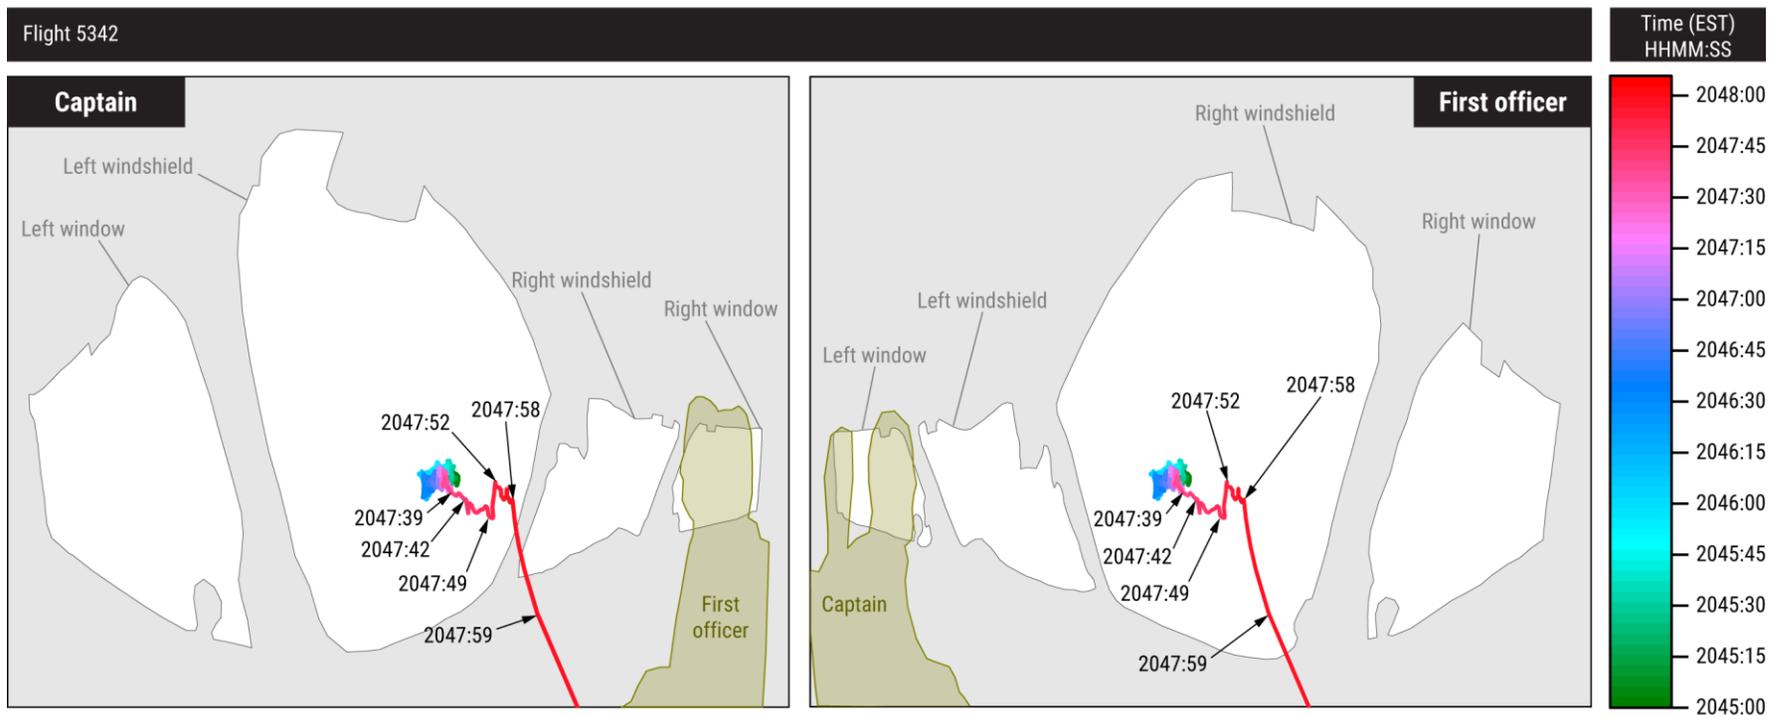
Laser scans of an exemplar CRJ were used to determine how the structure of the airplane would have affected the pilots' view outside. Figure 44 shows the view from the left (captain's) and right (FO's) seats with the structure of the airplane shown in gray and the outlines of the pilot in the opposite seat shown in olive yellow. The shapes are distorted so that the view out all four windows can be shown together. The colored line shows where in the window the helicopter would have been visible to the captain and FO during the final 3 minutes of the flight. From 2045 to 2047:58, the helicopter would have been in the lower right corner of the left windshield for the captain and in the lower third of the right windshield for the FO.

Figure 44. Viewing angles of PAT25 from the captain's (left) and FO's (right) seats of flight 5342, looking straight ahead.

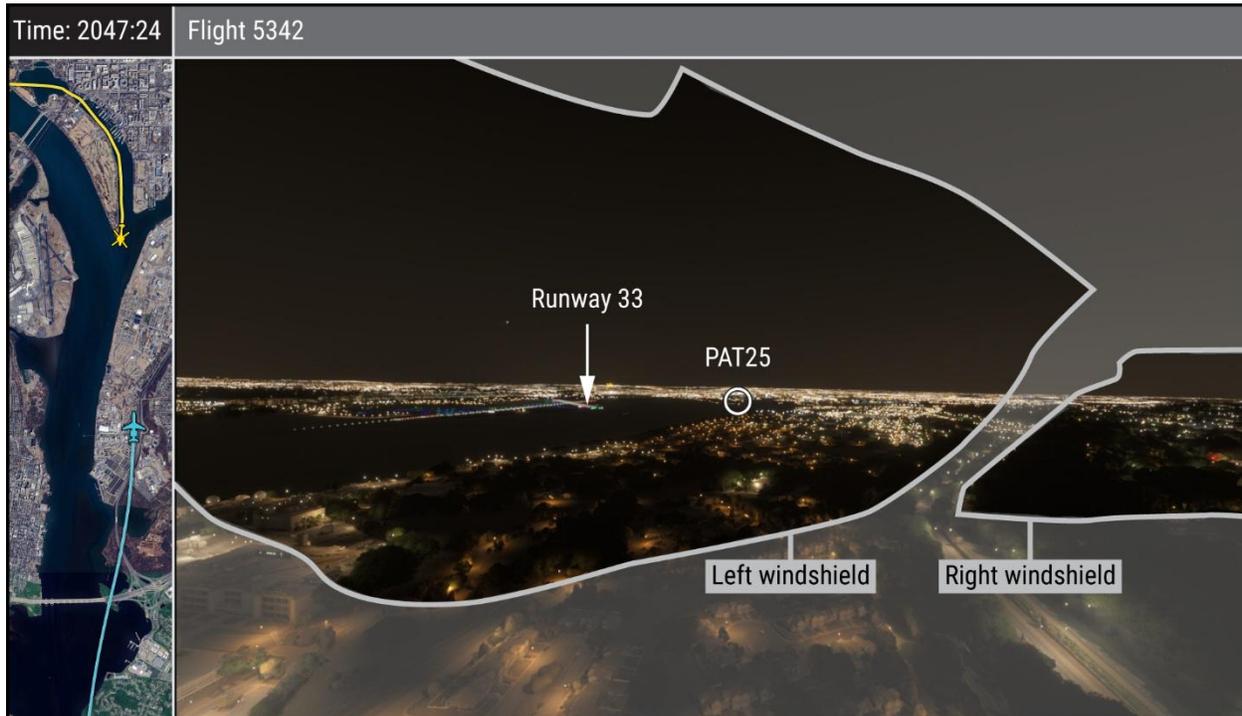
However, during most of the time it was in view, the helicopter would have appeared in the airplane's windscreen as a small object spanning less than 1° of azimuth and elevation.¹⁰⁶ Figure 45 shows a simulated view from the left (captain's) seat of flight 5342; simulated views from the right (FO's) seat are not presented because the background views would be similar.

Figure 45. Simulated view from the left seat of flight 5342 at 2047:24 (35.3 seconds before the collision), looking straight ahead.

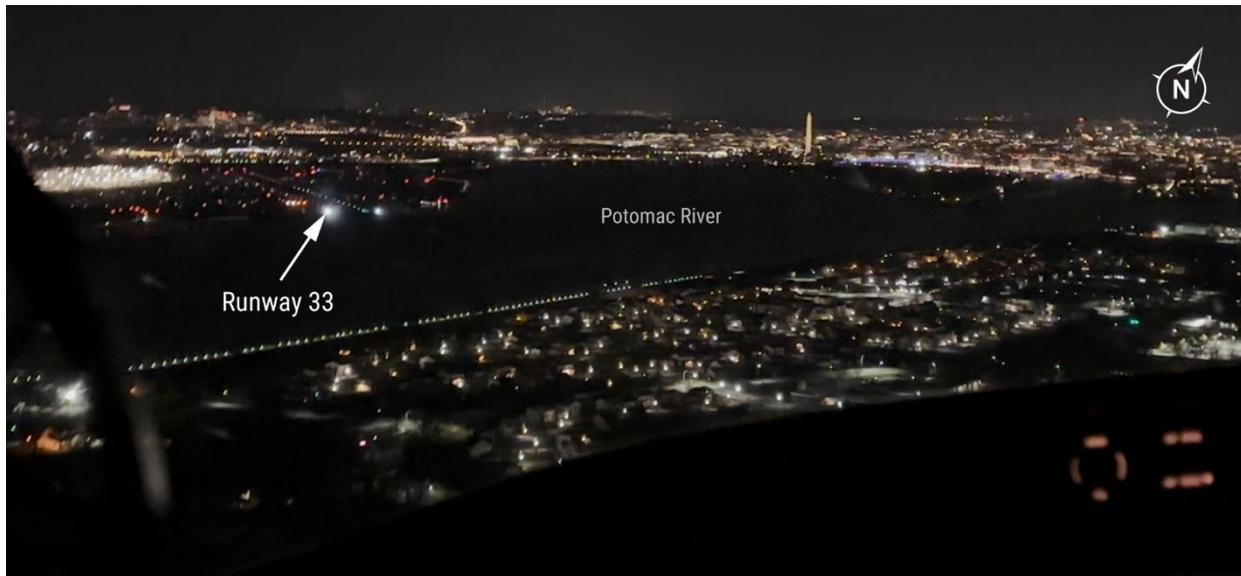
Until about 10 seconds before the collision, the helicopter would have been difficult to visually detect and identify against the cultural lighting of Washington, DC. Figure 46, a frame from a video recorded on an Apple iPhone inside the cockpit of a CRJ turning for final approach to runway 33 during an NTSB night observation flight (discussed in section 1.11.4.4), shows the extent of this cultural lighting. In the simulation, the helicopter emerged from the city lights and appeared against the dark background of the Potomac River about 2047:49. Between 2047:54 and 2047:58, the helicopter's fuselage would have grown significantly in the pilots' fields of view, and

Figure 46. Cultural lighting around Washington, DC, as captured in a video frame recorded on an Apple iPhone inside the cockpit of a CRJ turning for final approach to runway 33 during an NTSB night observation flight.

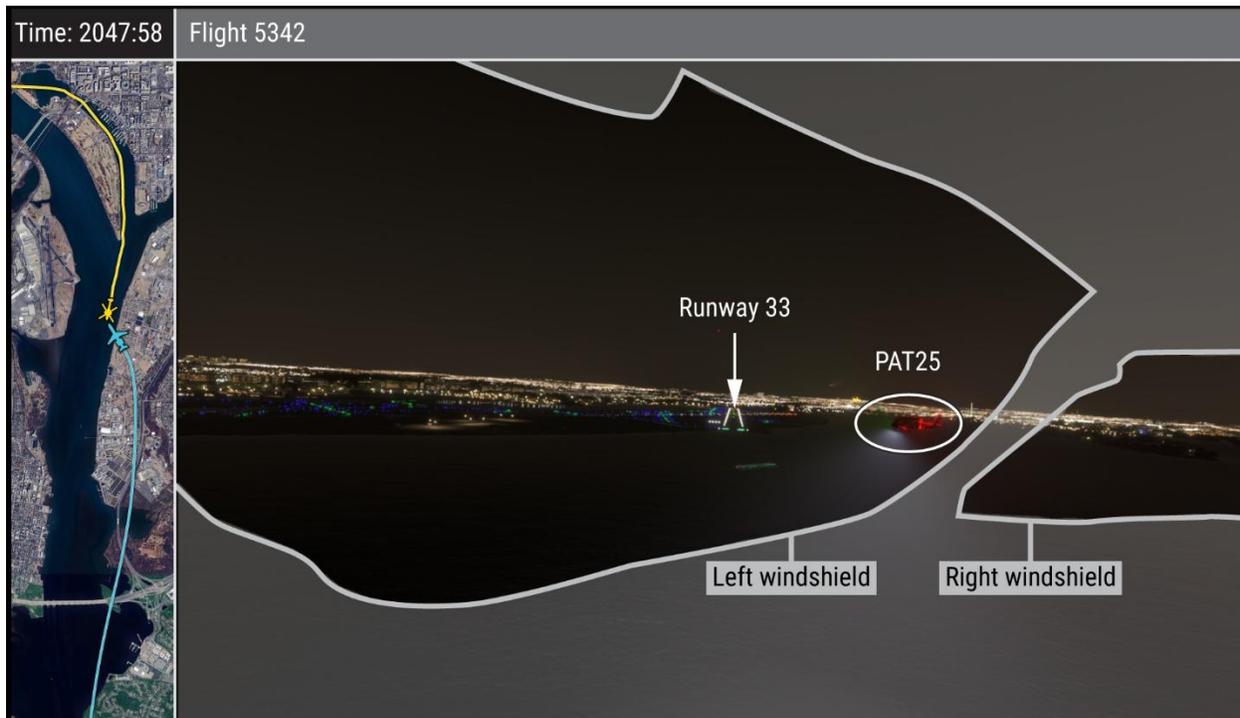
at 2047:58 (1.3 seconds before the collision), the helicopter was apparent in the simulation, as shown in figure 47.¹⁰⁷

Figure 47. Simulated view from flight 5342's left (captain's) seat at 2047:58 (1.3 seconds before collision), looking straight ahead.
