Aviation Investigation Report AIR-26-02

Midair Collision over the Potomac River PSA Airlines Flight 5342, Mitsubishi Heavy Industries (MHI) RJ Aviation CL-600-2C10 (CRJ700), and US Army Priority Air Transport Flight 25, Sikorsky UH-60L

Washington, DC
January 29, 2025

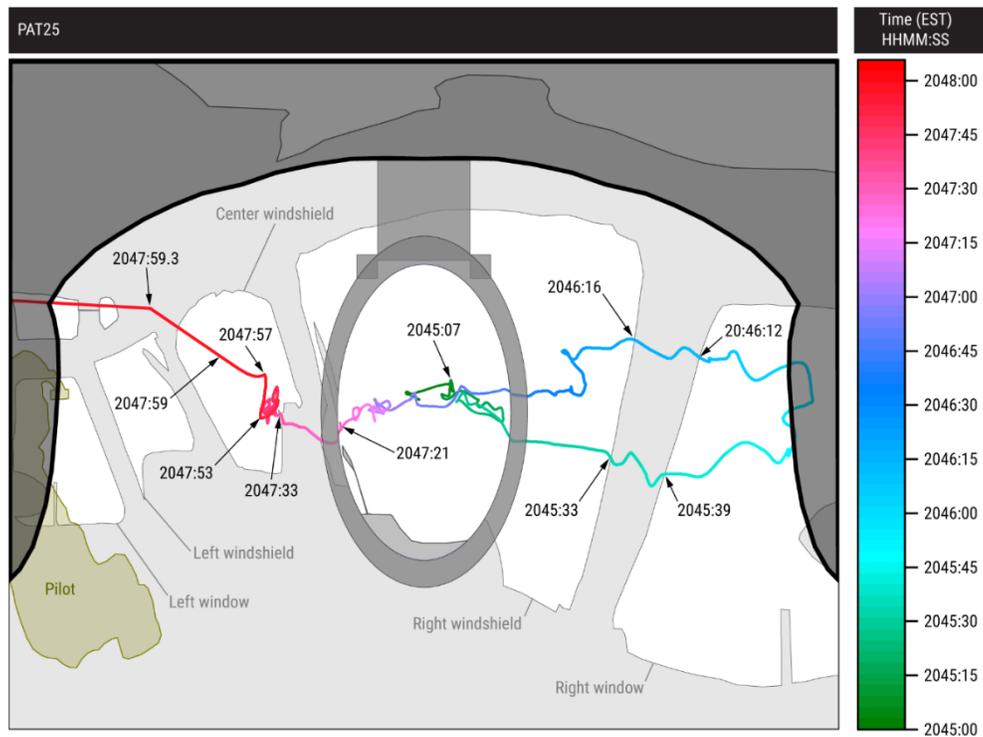
Like the airplane, laser scans of an exemplar UH-60L helicopter were used to determine how the structure would have affected the view outside. Figure 49 shows the view from the perspective of the IP in the right seat. The structure of the helicopter is shown in light gray, the outline of the pilot in the left seat is shown in olive yellow, and the structures of the NVGs and flight helmet are shown in dark gray.¹⁰⁸ The shapes are distorted so that the view out all five windows can be shown together. The solid multicolored line shows where in the helicopter's windows the airplane would have been visible to the IP during the final 3 minutes of flight, with the color of the line corresponding to the time the airplane would have appeared in that location, per the color scale on the right side of figure 49.

Except for brief periods when it was obscured by the cockpit window pillars, the airplane would have been in the helicopter IP's field of view for the 3-minute period before the collision.

Figure 49. Viewing angles of the airplane from the IP's position (right seat) inside the helicopter, looking straight ahead.

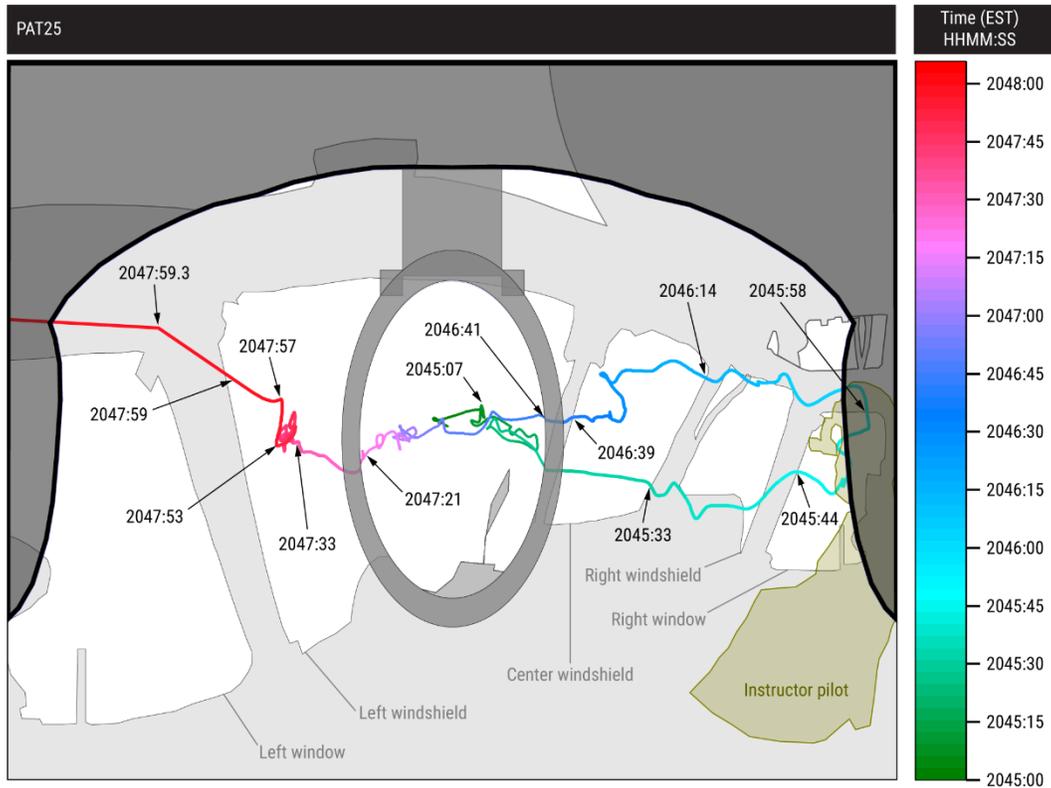
Figure 50 shows the airplane's location for the last 3 minutes of the flight from the perspective of the pilot in the left seat. After about 2046:42 (1 minute 16 seconds before the collision), the airplane would have appeared unobstructed in the left windshield.

Figure 50. Viewing angles of the airplane from the position of the helicopter pilot (left seat), looking straight ahead.

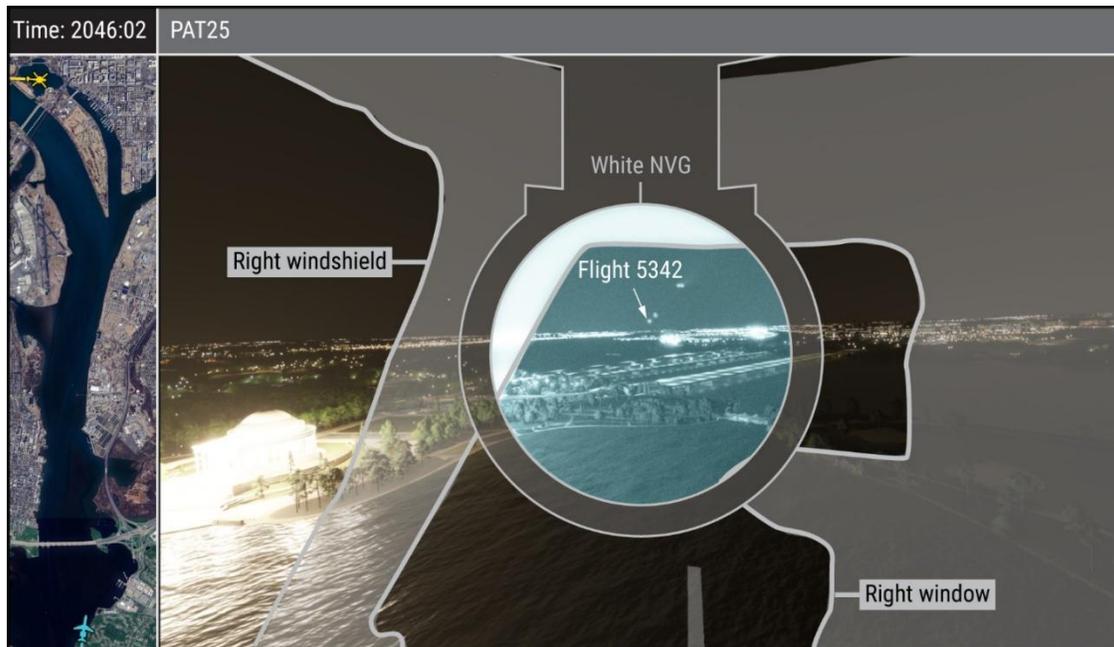
At the time of the controller's first traffic advisory to PAT25 (2 minutes 57 seconds before the collision) the airplane was in a position that would have required the IP to rotate his head to the right and look out the right cockpit window to visually acquire it, as shown in figure 51. From the pilot's view on the left side of the cockpit, the airplane would have been obscured by the IP and aircraft structure.

Figure 51. Simulated view from the right seat of the helicopter at 2046:02 (2 minutes 57 seconds before the collision), about the time of the initial traffic advisory, as seen looking 80° to the right.

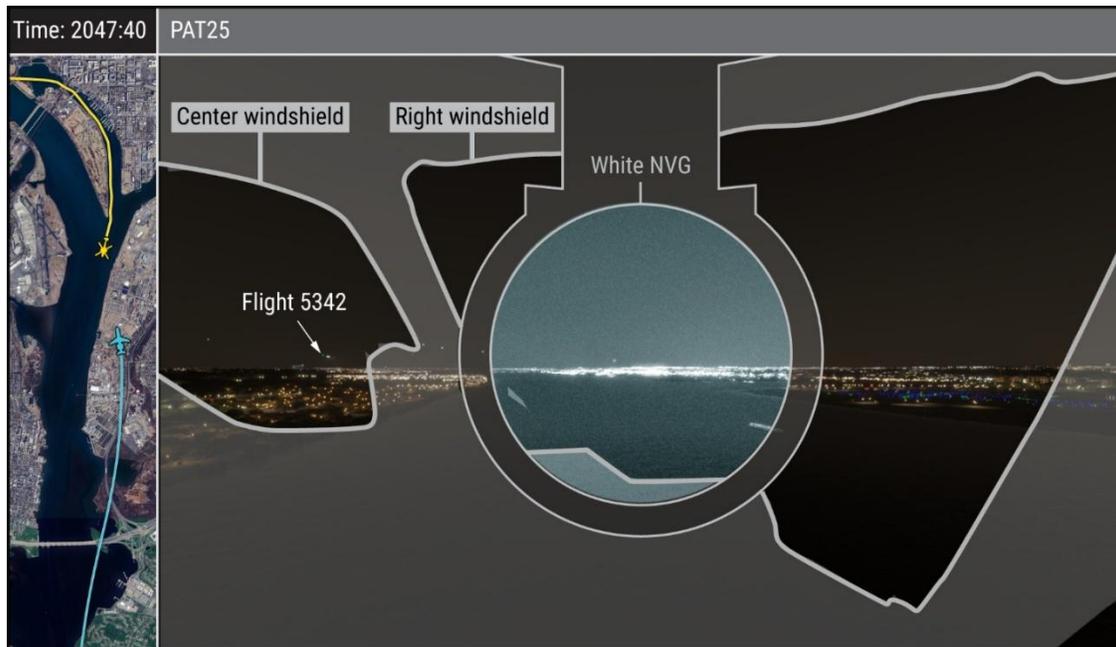
After 2047:26, about 33 seconds before the collision, the airplane would have passed to the left of the IP's field of view provided by the NVGs when focused straight ahead; therefore, to visually acquire the airplane, the IP would have had to turn his head to the left and look out the center windshield. Figure 53 shows the simulated view from the IP's position about 19 seconds before the collision. Figure 54 shows the simulated view from the pilot's position about 19 seconds before the collision. From the pilot's perspective, the airplane would have appeared in the left windshield, and would have remained in the pilot's left windshield until just before the collision occurred.

Figure 53. Simulated view from the right (IP's) seat of the helicopter, looking straight ahead, at 2047:40 (19 seconds before the collision) about the time ATC asked if the helicopter had the CRJ in sight.

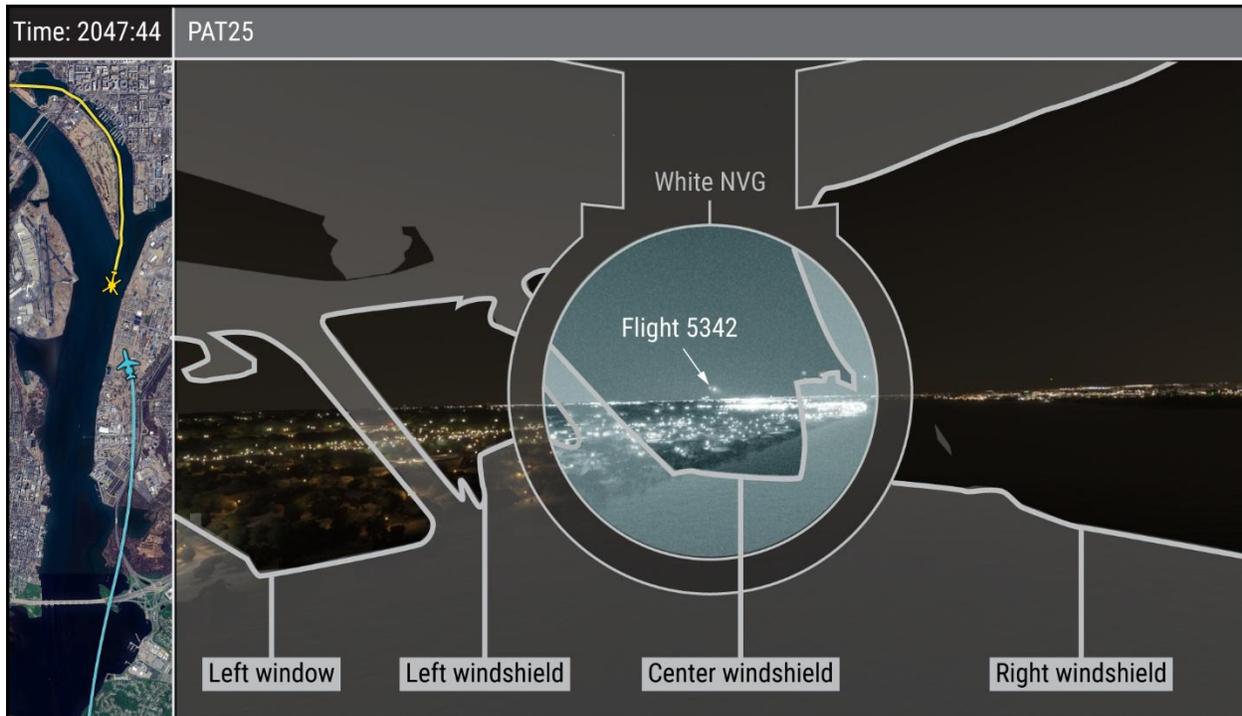
From about 2047:44, about 15 seconds before the collision, the airplane appeared in the simulation above the cultural lighting on the ground, but close to the horizon and just above a brightly-lit hotel in the area of the National Harbor southeast of DCA, as shown in figure 55.

Figure 55. Simulated view from the right (IP's) seat of the helicopter, looking 38° to the left, at 2047:44 (15 seconds before the collision) depicting flight 5342's position just above the horizon through white phosphor NVGs.

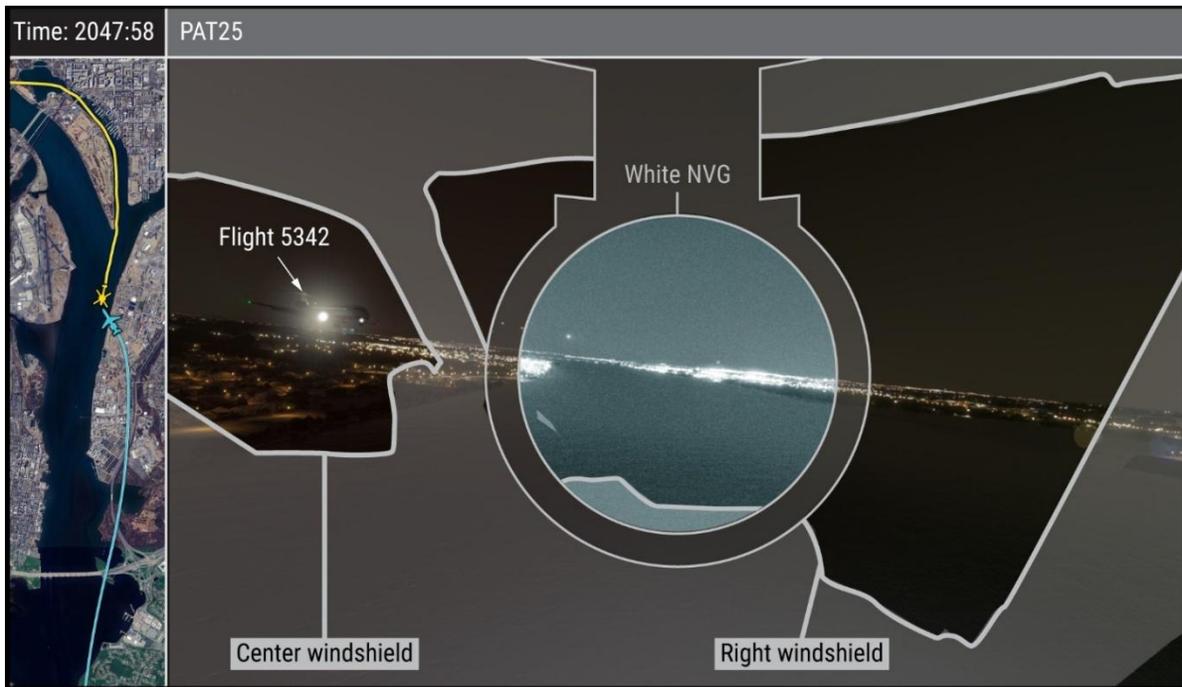
Just before the collision, the airplane would have suddenly increased in size in the helicopter's windscreen, as shown in figure 56, which depicts the IP's perspective from the right seat. Figure 57 depicts the view from the pilot's perspective in the left seat at 2047:58.

Figure 56. Simulated view from the right (IP's) seat of the helicopter at 2047:58 (1 second before the collision), looking straight ahead.

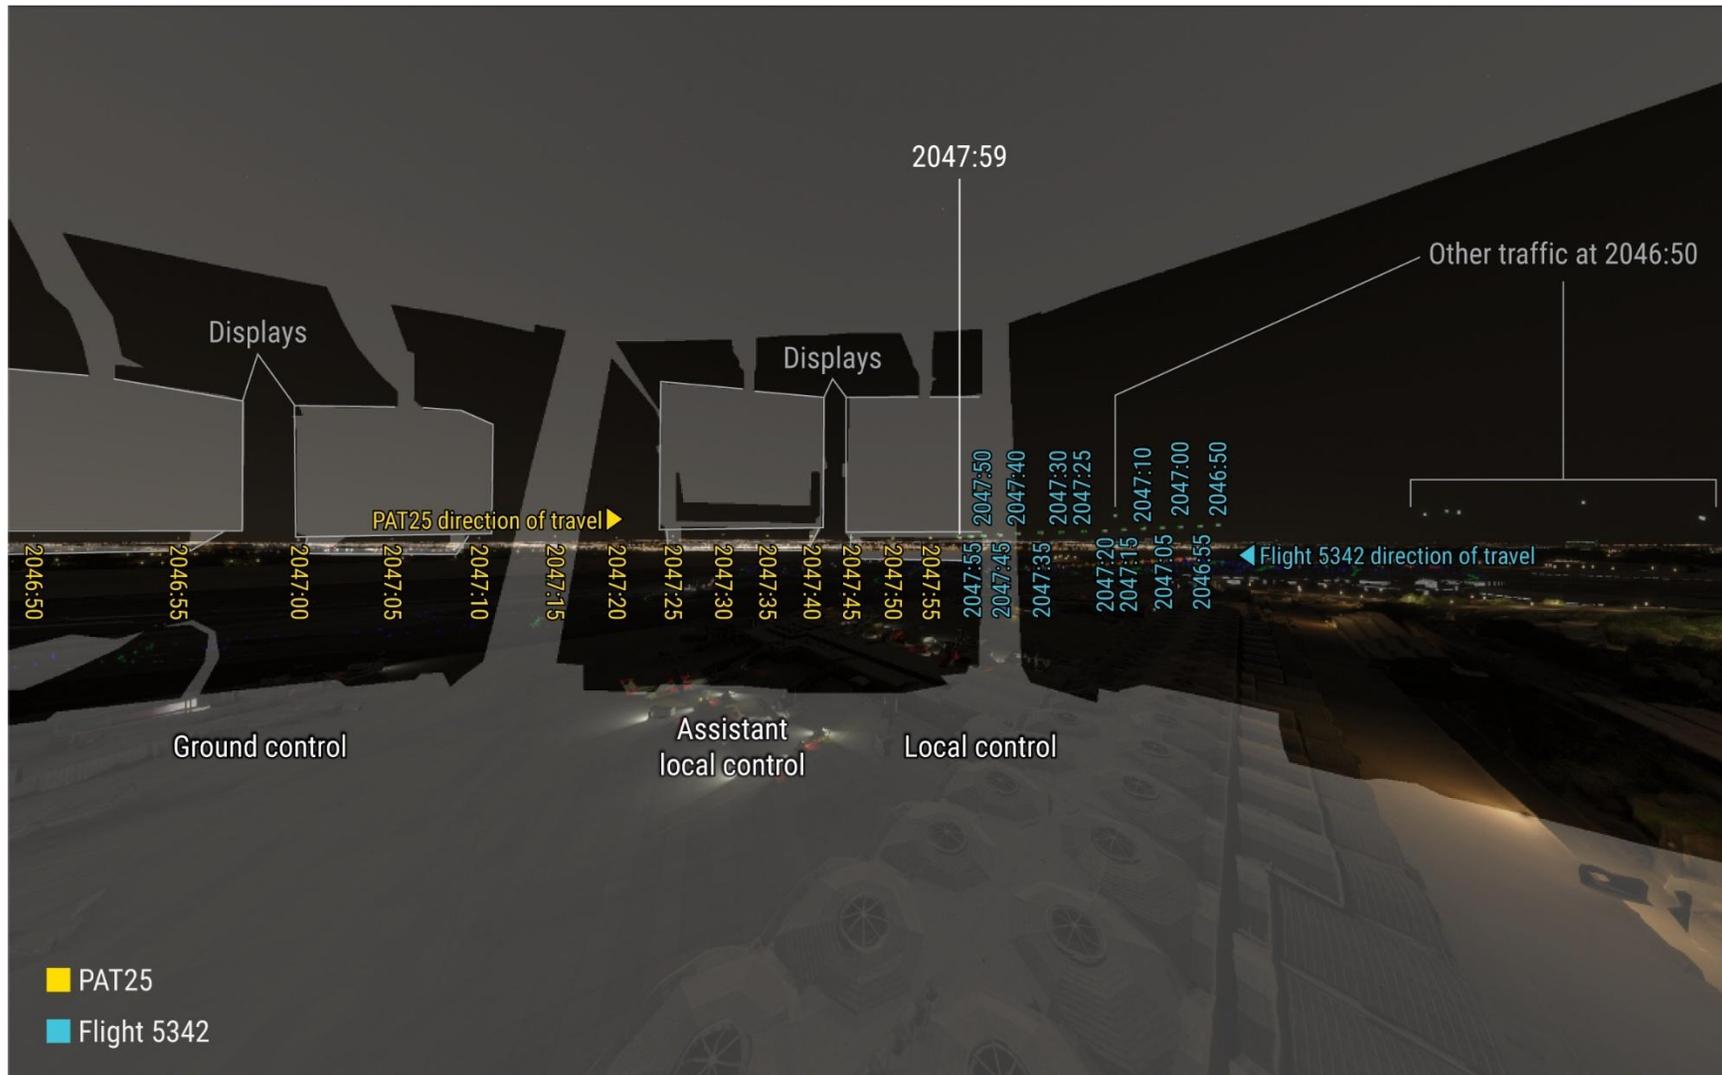
Laser scans of the DCA ATCT cab were used to define the geometry of the cab's windows and the locations of several screens near the top of the windows. These scans were used to generate a simulation of the view from the LC controller's seat, including any obstructions to vision. Figure 60 depicts the simulated tracks of each aircraft as viewed through the tower cab from the LC controller's perspective, with the cab structure and interior equipment (which would have obscured his view) depicted in gray. Figure 61 presents a plot of the viewing angles of flight 5342 and PAT25 from the LC controller's workstation. These images assume a stationary position, and do not account for uncertainty in the LC controller's actual position or the freedom he had to move around. Figure 62 presents a photograph taken from the LC position during an NTSB observation.

Figure 60. Simulation of the views from the ATC tower cab of the helicopter and airplane during the approximate minute before the accident, with aircraft positions at the labeled times.

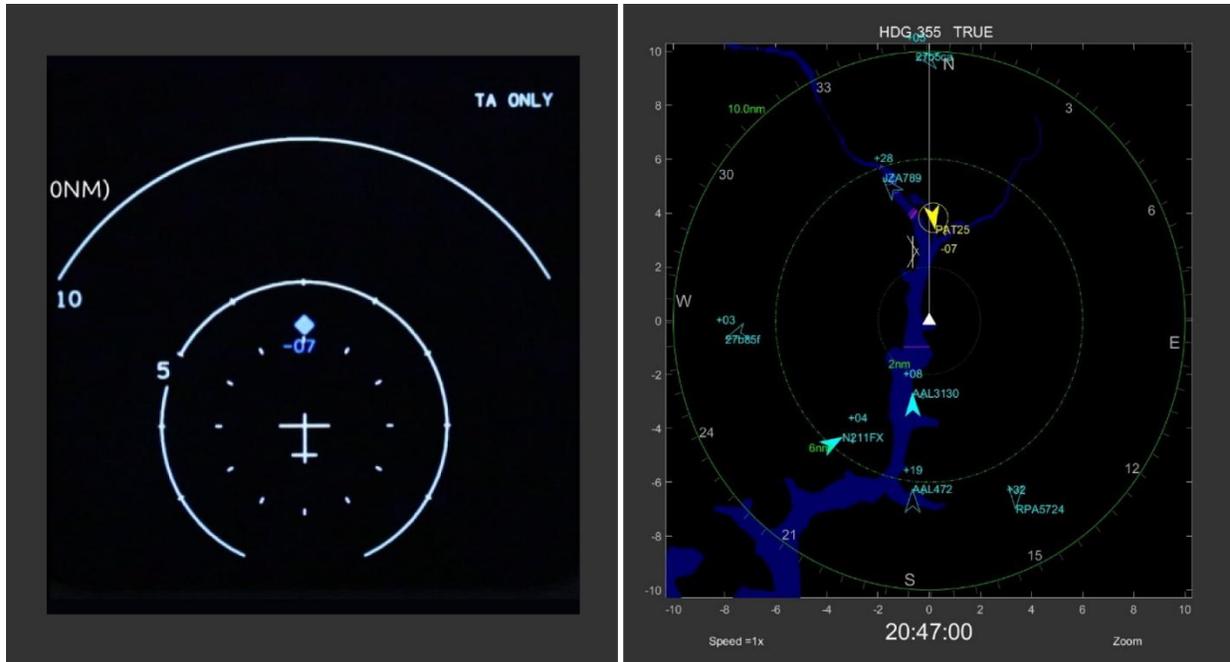
Figure 63 shows a simulated TCAS display (left), similar to the actual display presented to the pilots of flight 5342, and a simulated CDTI display (right) consistent with what the pilots would have observed at 2047:00 (59 seconds before the collision), had the airplane been equipped with an ADS-B based CDTI. The ADS-B based CDTI would have provided the first alert regarding PAT25 at this time, which was 40 seconds before the crew received the TCAS TA. The CDTI would have provided a second aural alert regarding PAT25 about 35 seconds before the collision and 16 seconds before the crew received the TCAS TA. Figure 64 presents a

Figure 63. Simulated view of TCAS display at 2047:00 (59 seconds before the collision) from flight 5342's cockpit (left), compared with a simulated ADS-B In-based CDTI display using ATAS symbology and alerting criteria (right), which the airplane was not equipped with.

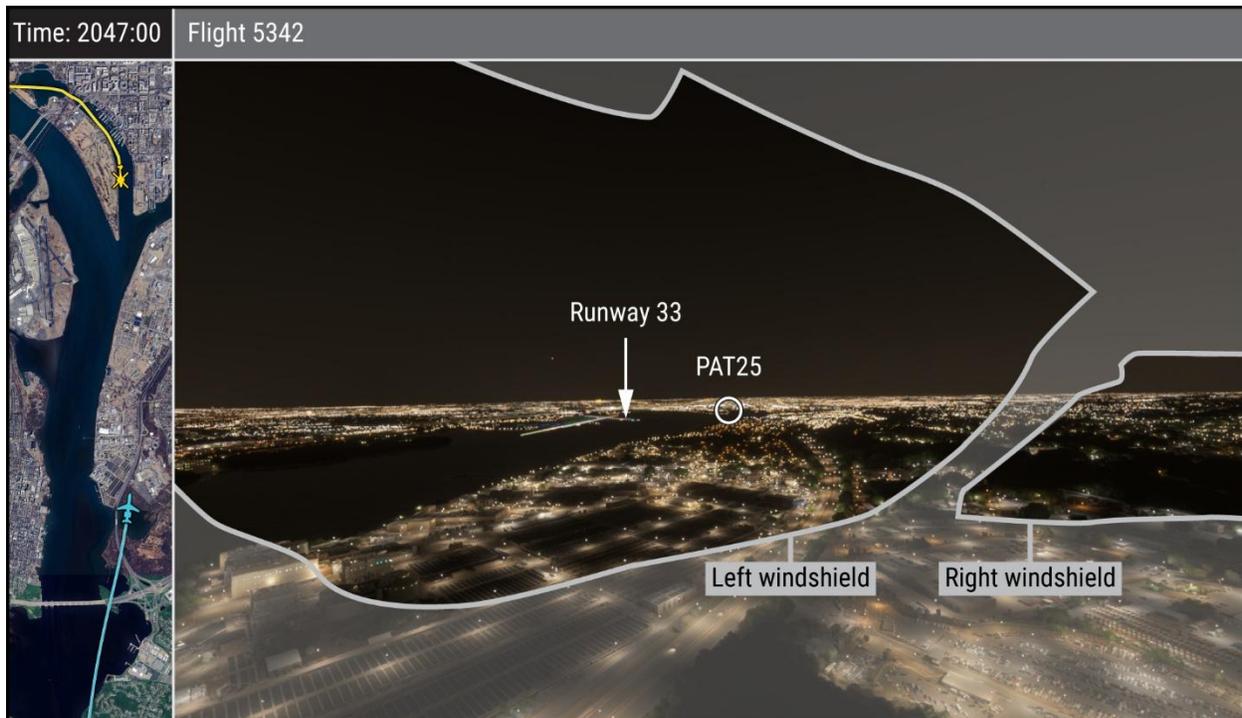
Figure 64. Simulated view from the left (captain's) seat of flight 5342 at 2047:00 (59 seconds before the collision), looking straight ahead.

Note: Had the airplane been equipped with an ADS-B based CDTI, it would have provided the crew of flight 5342 with the first alert regarding PAT25 at this time (2047:00, or 59 seconds before the collision). However, because the airplane was equipped instead with TCAS, the crew only received its first TA alert 40 seconds later, at 2047:40 (or 19 seconds before the collision).

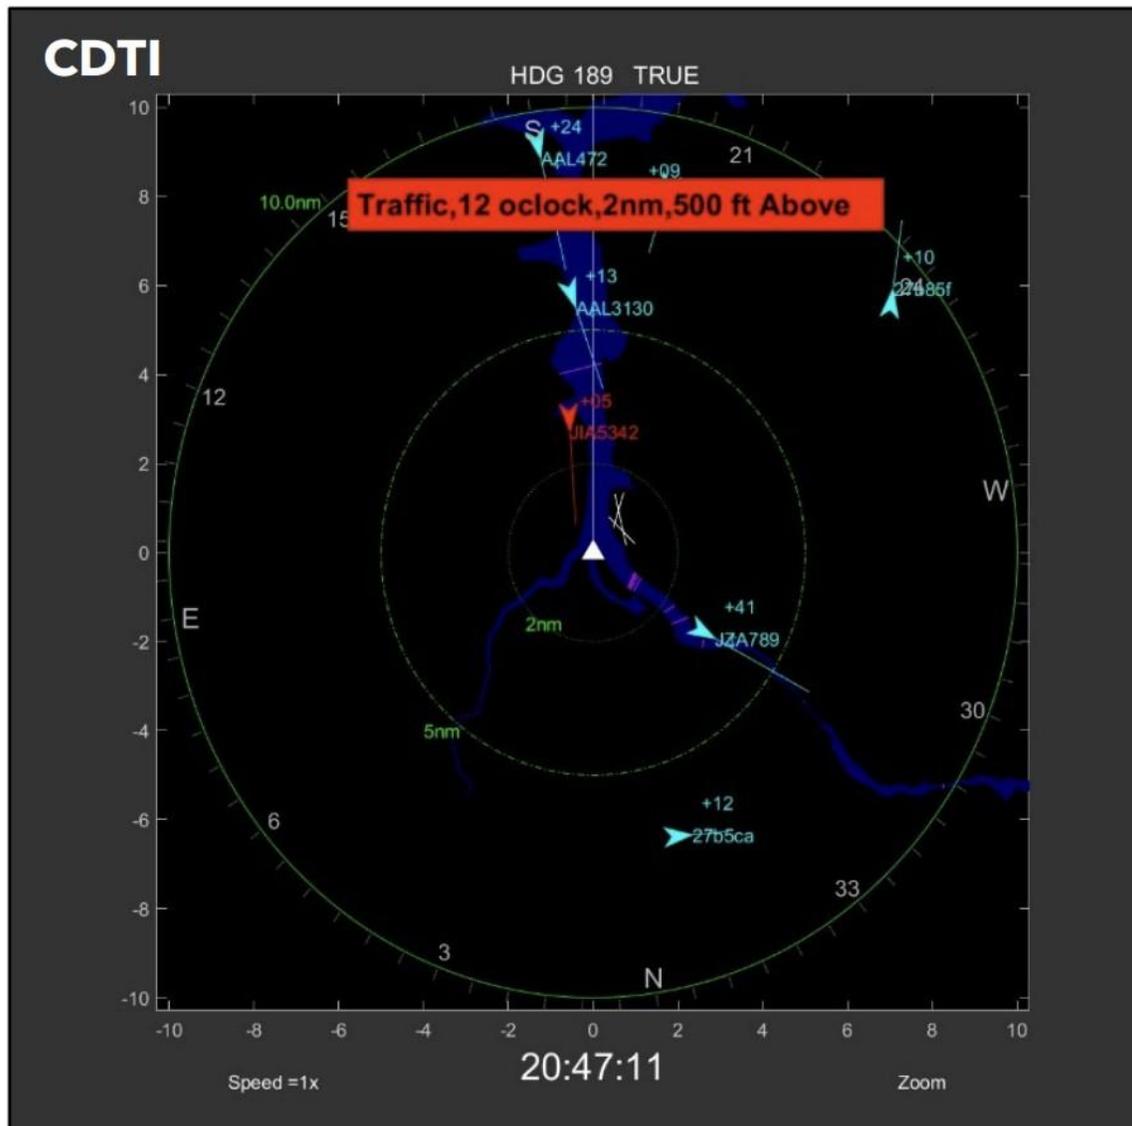
The ForeFlight CDTI display onboard the helicopter could have generated a visual and aural alert concerning the airplane at 2047:11, or 48 seconds before the collision, as shown in figure 65. The aural alert would have comprised the annunciation, "Traffic, 12 o'clock, 2 miles, 500 ft above." At this time, the helicopter was only 9 ft above the 250-ft aural alerting threshold. Figure 66 presents a simulated view from the IP's (right) seat of PAT25 at 2047:11, when the Foreflight CDTI that was onboard the helicopter could have provided a visual and aural alert concerning flight 5342.

Figure 65. Simulated ForeFlight display and visible text alert (shown in red box) at 2047:11 (48 seconds before the collision).

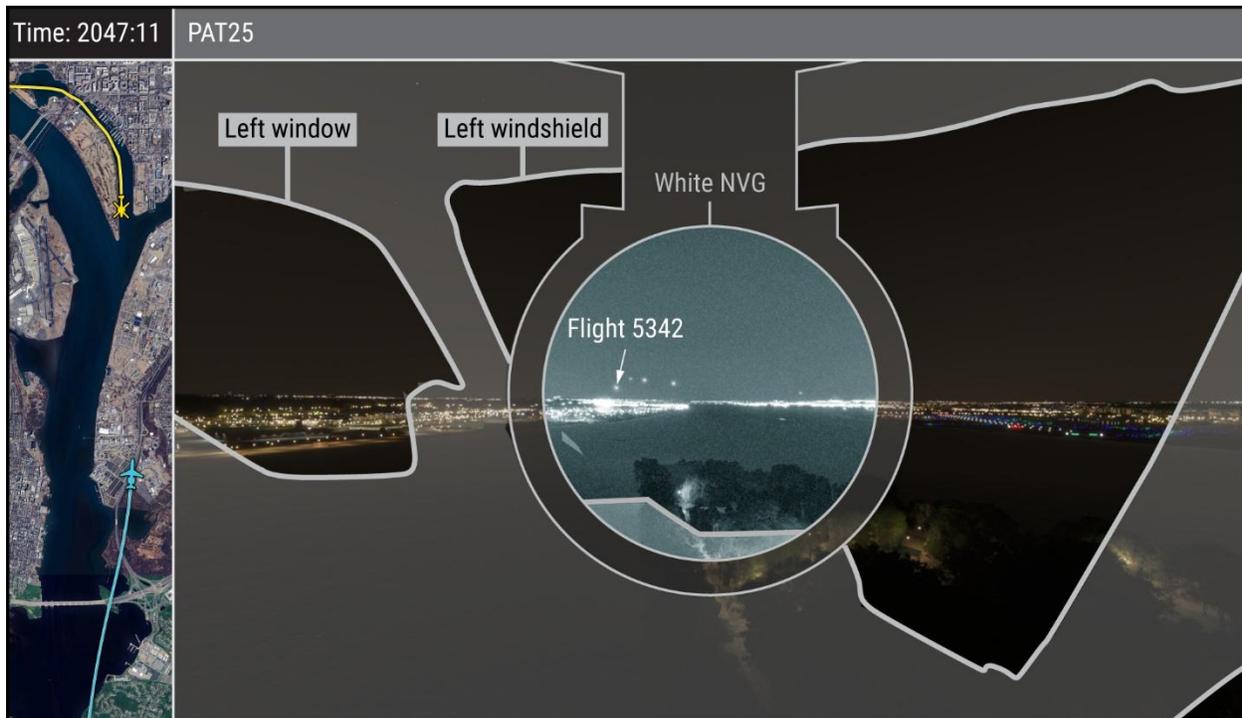
Figure 66. Simulated view from the right (IP's) seat of PAT25 at 2047:11 (48 seconds before the collision), as seen looking straight ahead.

Note: At this moment, the Foreflight CDTI running on the helicopter flight crew's tablets would have displayed the visible text alert shown in the red box in figure 65, and the application would have annunciated an aural alert, "Traffic, 12 o'clock, 2 miles, 500 ft above," which would have been audible to the flight crew, had the flight crew's helmets been equipped to receive audio from the tablets—which they were not. Additionally, Army pilots do not visually monitor the tablets while flying low level on DC helicopter routes because, according to postaccident interviews, the flying task was too demanding.

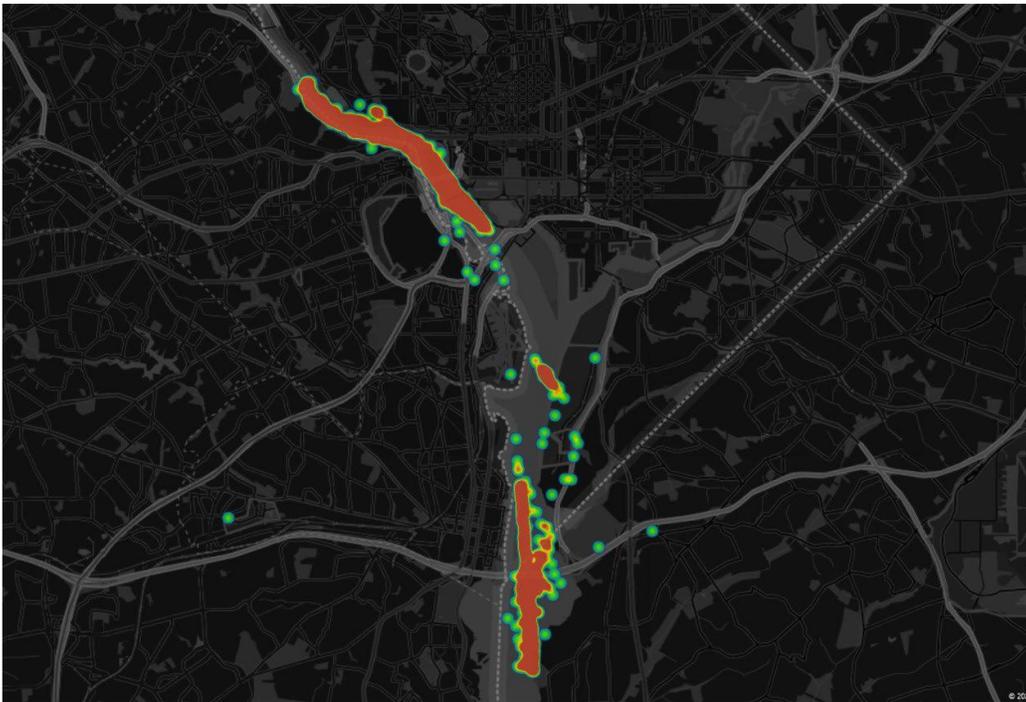
PDARS was also used to examine encounters at various proximities between fixed-wing airplanes and helicopters. For arriving and departing airplanes and helicopters flying on Routes 1 or 4 over the period January 2018 to February 2025, there were 4,067 encounters (65.6 encounters per month) in which separation was less than or equal to 1,000 ft and 348 encounters (5.6 encounters per month) in which separation was less than or equal to 500 ft. Figure 70 shows a heat map produced

using PDARS data that depicts the locations of encounters between fixed-wing traffic arriving and departing DCA and helicopters operating on Routes 1 and 4.

Figure 70. Heat map produced using PDARS data depicting frequency of encounters between arriving and departing airplanes and helicopters flying on Routes 1 or 4 at altitudes from 500-1000 ft, from January 2018 to February 2025. (Source: FAA)

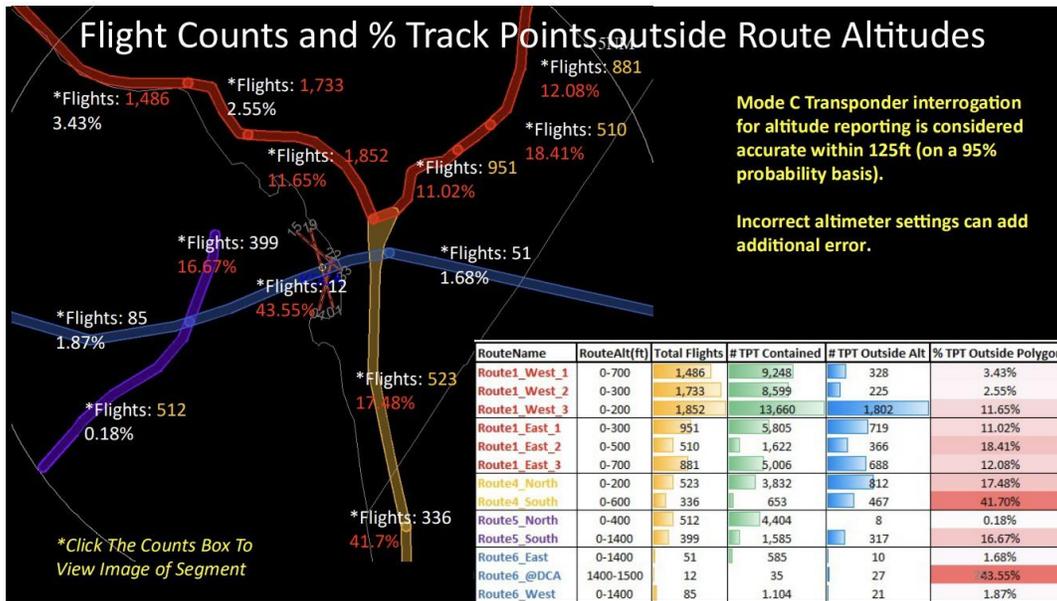
A separate PDARS analysis for the 13-month period of January 1, 2024, through January 30, 2025, identified 13,866 helicopter flights on the DC helicopter routes within 5 nm of DCA, of which 10,990 helicopter flights (79.2%) were military flights. "Track points" and flights that flew above route altitudes were calculated for 13 segments on four helicopter routes.¹⁵⁰ The percentage of track points estimated to be above published route altitudes ranged from 0% to 44% for the 13 segments, as shown in figure 71. For the northern segment of Route 4, which included the area of the collision, 17% of all track points exceeded altitude limits. Further analysis found that of the 523 flights that transited this route segment, 260 flights (49%) had at least 1 track point within this segment above route altitude limitations.

Figure 71. Results of analysis of Potomac TRACON data processed by PDARS for various segments of the Washington, DC, area helicopter routes. (Source: FAA)

Note: The number of helicopter track points within and outside of published route altitudes are shown.
