National Transportation Safety Board

Highway Accident Brief

Accident Number: HWY15MH004
Accident Type: Bus roadway departure and collision with moving train
Location: Interstate 20, Ector County, near Penwell, Texas
Date and Time: January 14, 2015, 7:50 a.m.
Vehicles: 2015 Blue Bird Vision bus, modified for prison transport
Union Pacific train ZLCMN2, consisting of 4 locomotives and 58 loaded railroad intermodal flatcars
Fatalities: 10
Injuries: 5

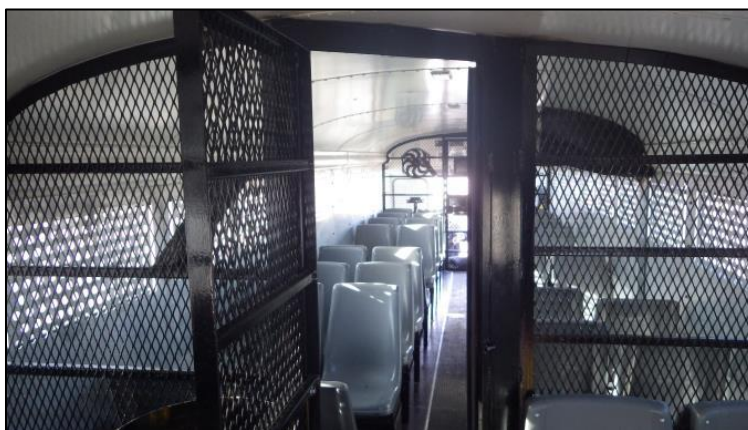
Metal partitions separated the bus interior into a driver's area, segregation area, general population area, and rear guard area (figure 5). The driver's area provided two seats for correctional officers, while the rear guard area provided one seat for a correctional officer. The windows along both sides of the bus were covered by perforated metal sheeting.

Figure 5. Interior of exemplar prison transport bus.
