National Transportation Safety Board

Highway Accident Brief

Accident Number: HWY14FH013
Accident Type: Motorcoach run-off-road and overturn
Location: State Route 1 ramp to US Route 13 north, Red Lion, New Castle County, Delaware
Date and Time: September 21, 2014, 4:15 p.m.
Vehicle: 1996 Setra S215 HDH
Fatalities: 3
Injuries: 48

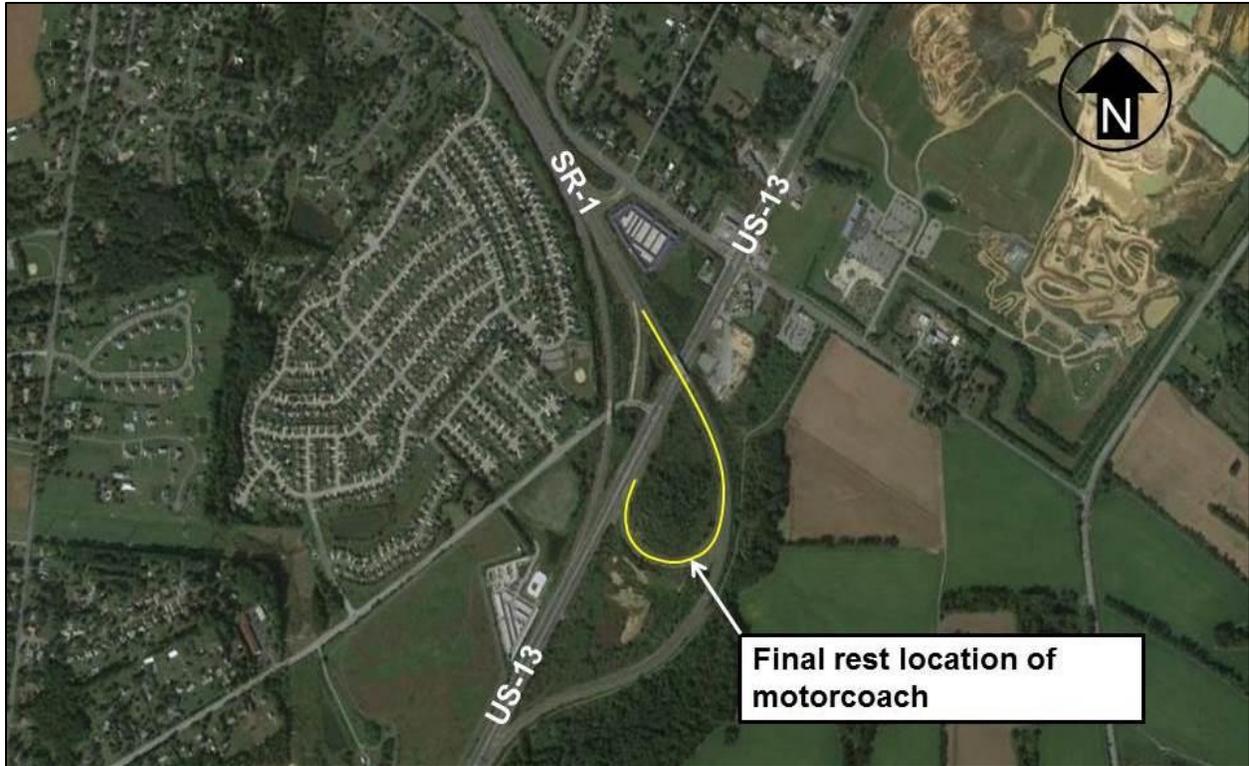
At the point where the SR-1 access ramp curves sharply to the right, the driver failed to negotiate the curve, and the motorcoach departed the left edge of the roadway. The motorcoach entered an earthen area, rotated clockwise, and overturned onto its left (driver) side and partially onto its roof, coming to rest about 25 feet off the roadway (figure 2).

Figure 1. Curved access ramp (yellow line) from southbound SR-1 to US-13 north, showing final rest location of motorcoach. (Sources: Esri, DigitalGlobe, GeoEye, Earthstar Geographics, Centre National d'Etudes Spatiales/Airbus DS, US Department of Agriculture, US Geological Survey, Aerials Express, Getmapping, Aerogrid, Instituto Geografico Nacional, Instituto Geografico Portugues, Swisstopo, and GISuser)
