National Transportation Safety Board

Highway Accident Brief

Collision Between Car Operating with Partial Driving Automation and Truck-Tractor Semitrailer Delray Beach, Florida, March 1, 2019

Accident Number:	HWY19FH008
Accident Type:	Intersection collision involving partially automated vehicle
Location:	Southbound US Highway 441, Delray Beach, Palm Beach County, Florida
Date and Time:	Friday, March 1, 2019, 6:17 a.m. eastern standard time
Vehicle 1:	2018 Tesla Model 3
Vehicle 2:	2019 International truck-tractor in combination with 2008 Vanguard semitrailer
Fatalities:	1
Injuries:	0

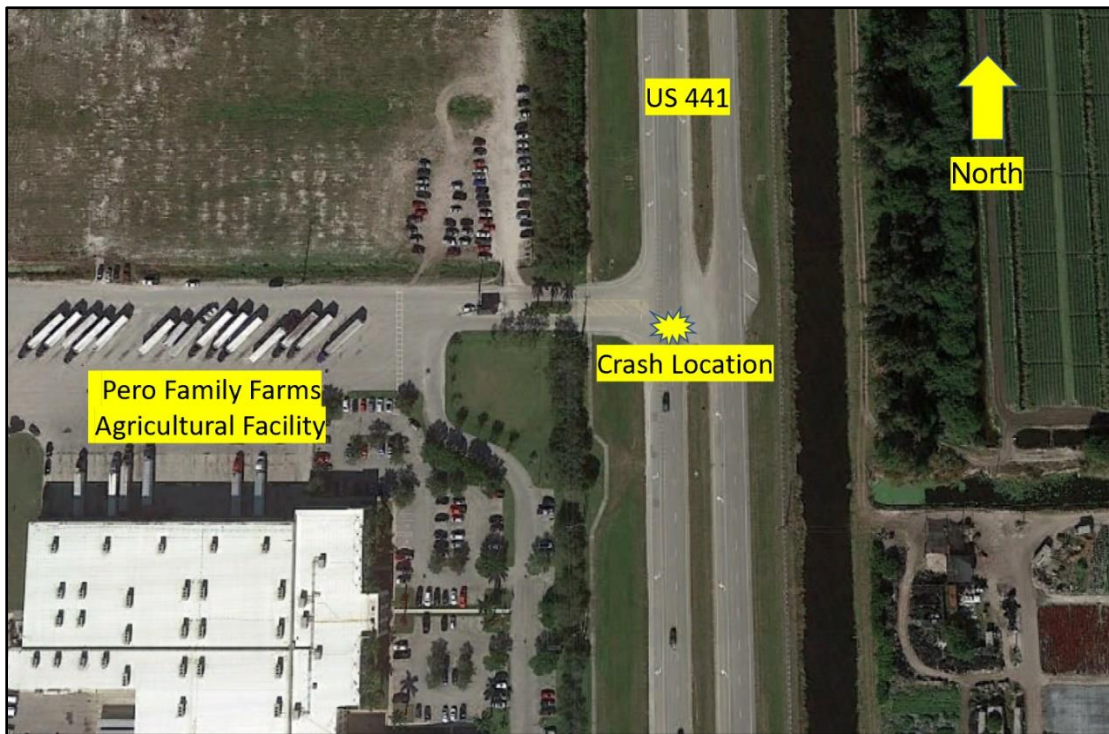
Figure 3. Satellite image of US 441 in Delray Beach showing crash location. (Source: Google Earth image dated January 2019, annotated by NTSB)

At the crash location, US 441 has two 12-foot-wide travel lanes in each direction (figure 3). The median is 25 feet wide. In the southbound direction, a 12-foot-wide left-turn lane allows vehicles to cross the highway and proceed north. A 12-foot-wide right-turn lane provides access to the private driveway into the Pero Family Farms agricultural facility on the west side of the highway. Bicycle lanes, each 5 feet wide, border both sides of the highway. The driveway to Pero Family Farms is divided into two lanes, with a center median, and is controlled by a stop sign on the south side. There is no artificial lighting near the intersection. However, the crash occurred just before the beginning of civil twilight, when some ambient lighting was available.⁸
