National Transportation Safety Board

Highway Accident Brief

Failure of Overhead Electrical Conduit Support System in Lehigh Tunnel and Subsequent Truck-Tractor Crash, I-476, East Penn Township, Pennsylvania, February 21, 2018

Accident Number:	HWY18FH006
Accident Type:	Impact of truck-tractor semitrailer combination vehicle with broken overhead electrical conduit; subsequent crash
Location:	Interstate 476 (I-476; Pennsylvania Turnpike) southbound, Lehigh Tunnel, East Penn Township, Carbon County, Pennsylvania
Date and Time:	February 21, 2018, 6:02 p.m. eastern standard time
Vehicle:	2017 International truck-tractor in combination with 2017 Strick semitrailer
Fatalities:	1
Injuries:	0

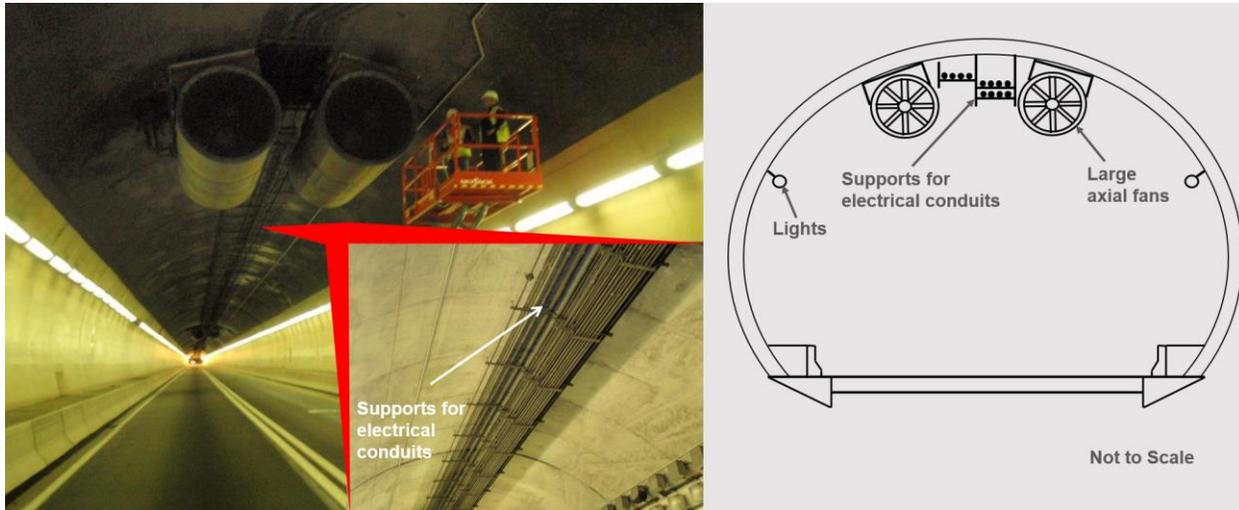
Figure 4. Photo of Lehigh Tunnel no. 2 and detail drawing of its electrical conduit and support system. (Photo source: HDR Engineering, Inc., 2016 Tunnel Inspection Report)

Configuration. In the area of tunnel no. 2 where the failure occurred, the suspended electrical conduit system consisted of three levels: top, bottom, and side.⁹ The top level held about 13 conduits ranging from 1 to 2 inches in diameter; the bottom level held about 9 conduits ranging from 0.75 to 2 inches in diameter; and the side level held 6 conduits ranging from 0.75 to 3 inches in diameter. The conduits, which ran parallel to the roadway, were supported by transverse-oriented support struts attached to mechanical anchors in the tunnel ceiling by ⁵/₈-inch-diameter threaded stainless-steel anchor rods (figure 5). The conduit support struts were typically spaced at about 6-foot intervals throughout the length of the tunnel. Nuts and washers held the struts in place on the anchor rods.
